Insight Inspections

Property Inspection Report

16301 Fincastle Dr. , Austin , TX 78717
Inspection prepared for: Qiu Shan
Date of Inspection: 10/10/2015 Time: 9:30 am
Age of Home: Built in 2005 Size: 2,472 sq/ft.
Weather: 75 Degrees

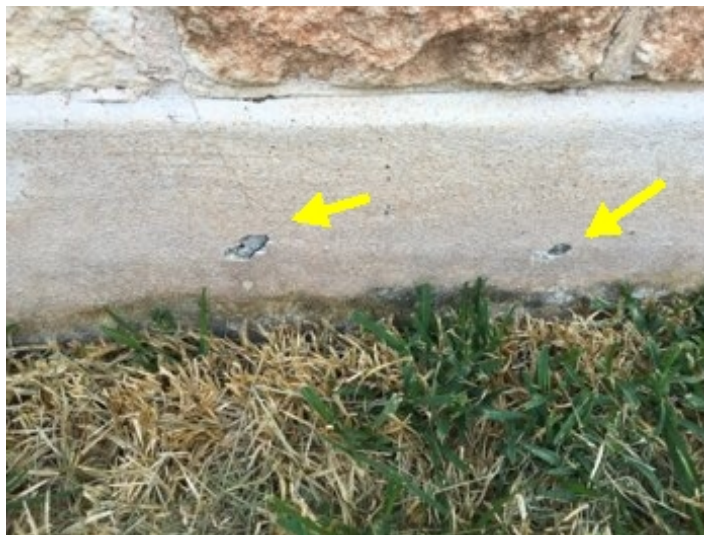
Observed cracking to the skin (parge) coat. The skin coat is the cometic layer applied to the surface of the foundation.

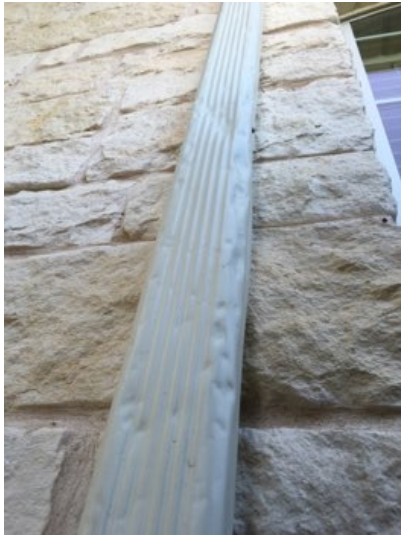
Hail damage observed to downspouts at the front side of the home.

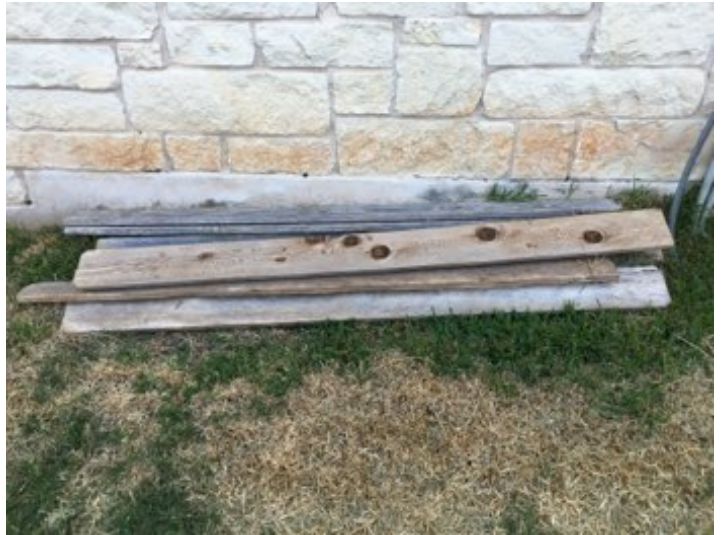
Wood located directly against structure. Recommend storing unused wood away from the home. Evidence of wood destroying insects present in wood.

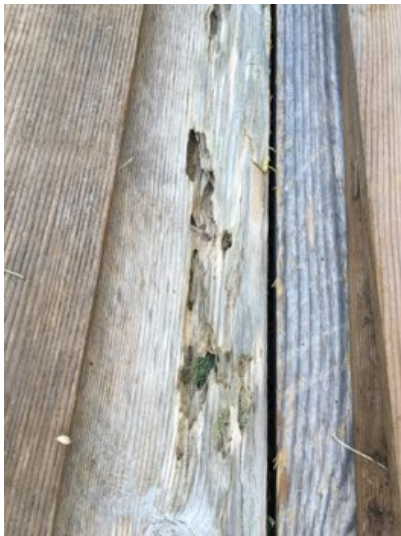
Wood located directly against structure. Evidence of wood destroying insects (Termites) present in wood.

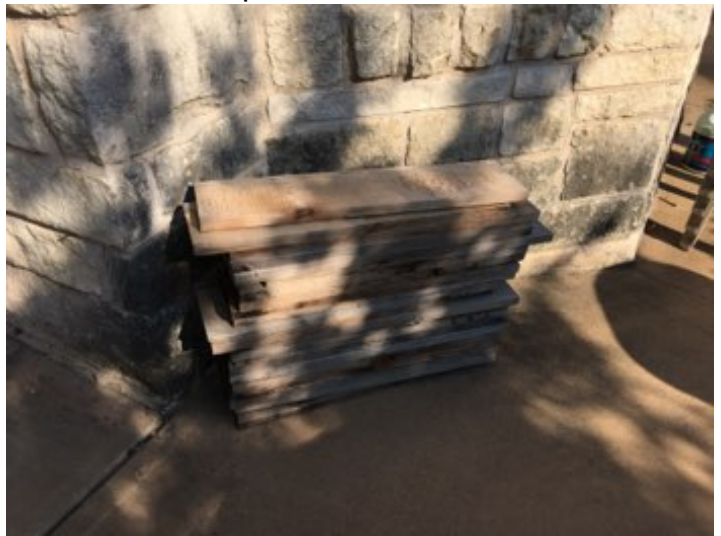
Wood located directly against home.

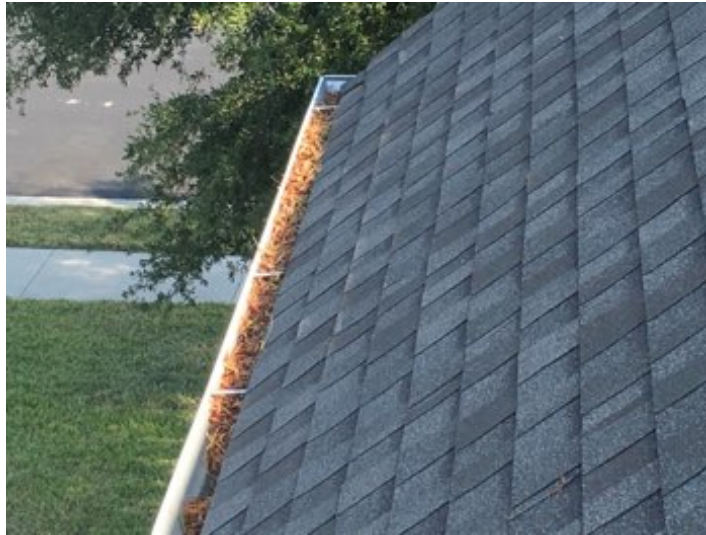
Leaves present in gutters at the front side of the home.

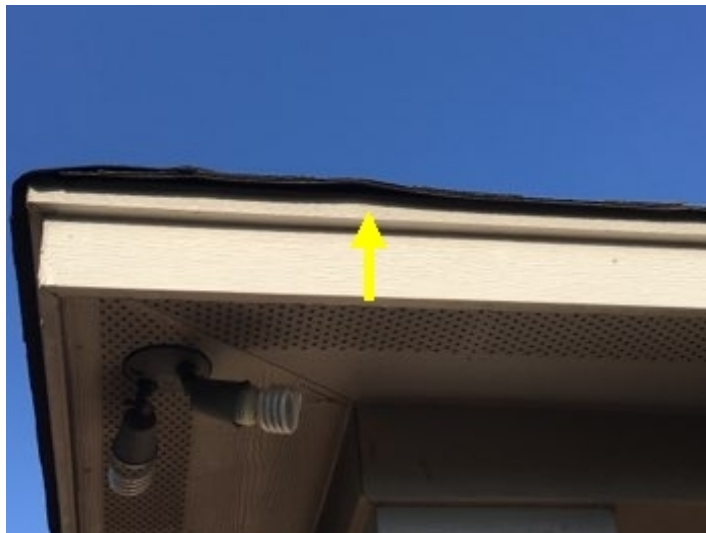
Missing drip edge flashing.

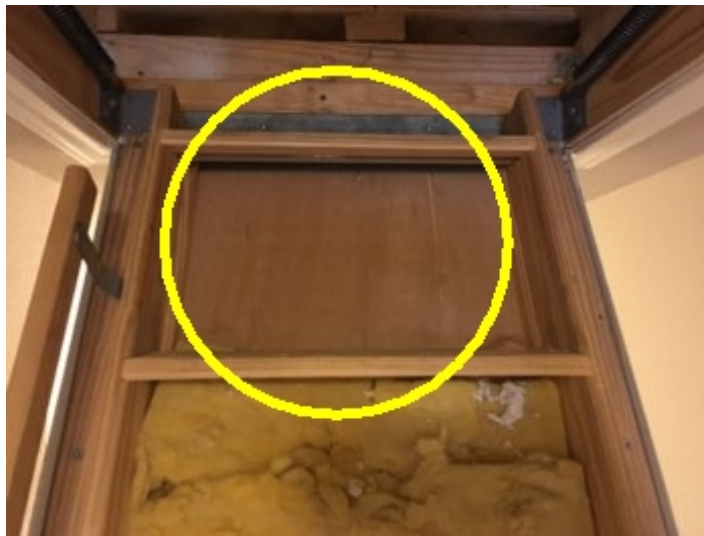
Attic stairway hatch is not properly insulated. Top stair is missing insulation.

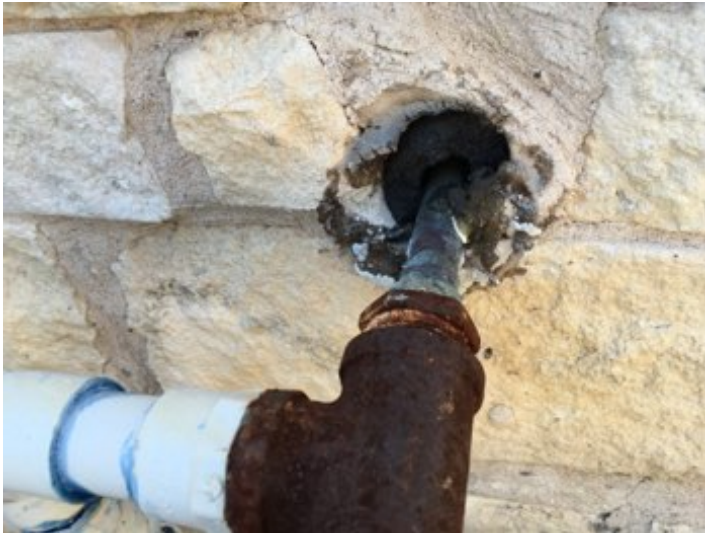
Exterior gas line on the right side of the home is not properly sealed with siding materials.

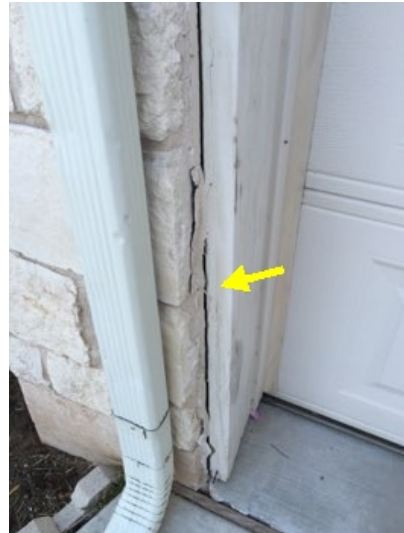
Exterior garage trim is not properly sealed. Recommend sealing to prevent pest and water intrusion.

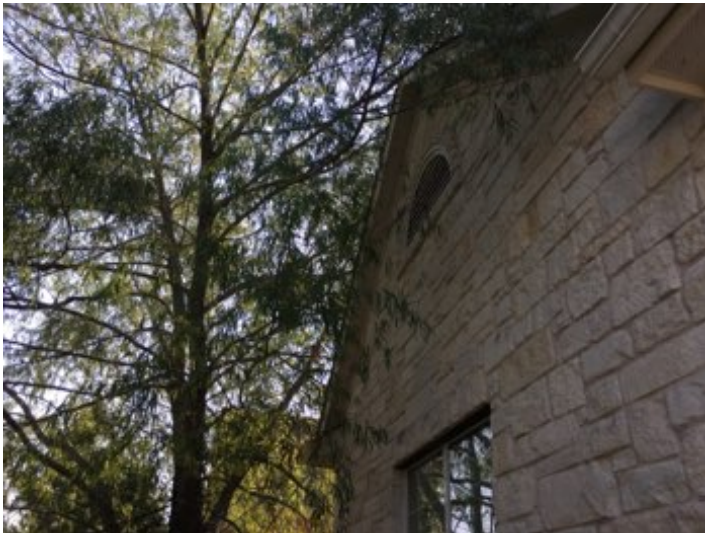
Vegetation / Trees in direct contact with siding materials at the front side of the home.

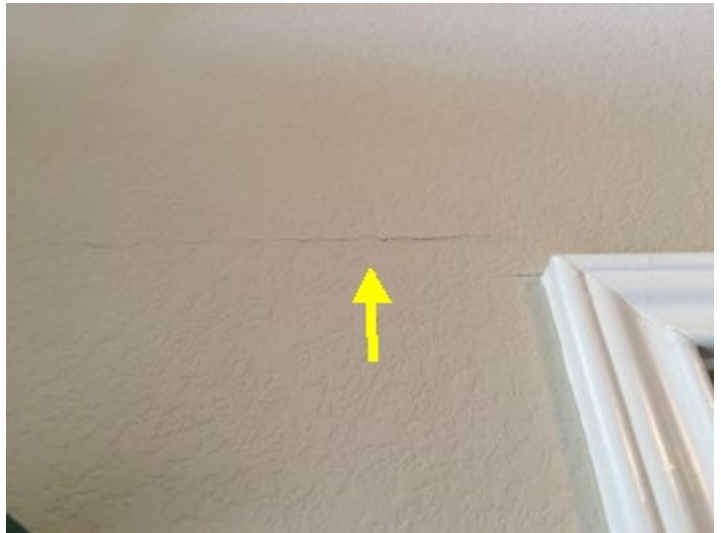
Crack observed to interior wall above french doors leading to front living area.

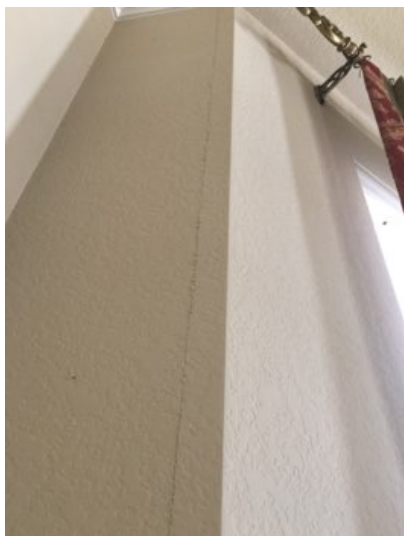
Crack observed to interior wall in breakfast nook.

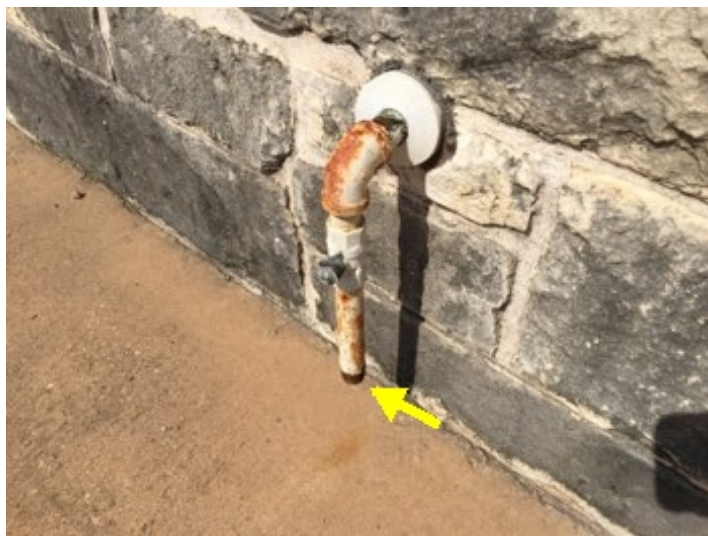
Recommend adding a nipple (cap) to exterior gas line at the back side of the home.

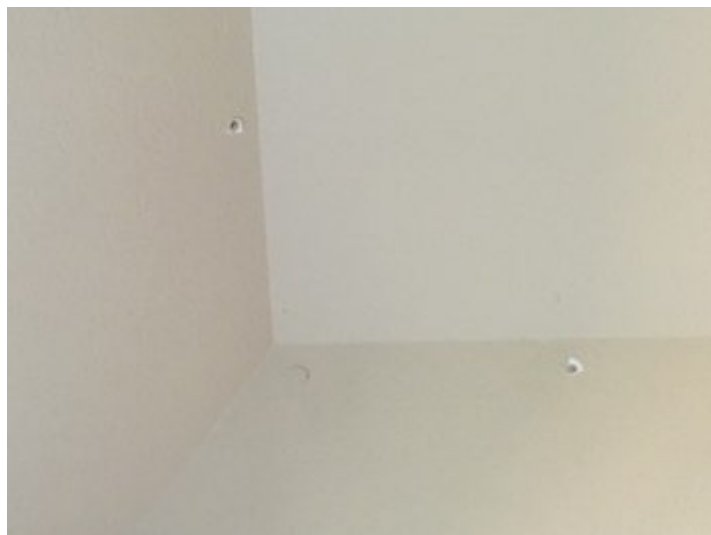
Nail pops observed to ceiling in dining area.

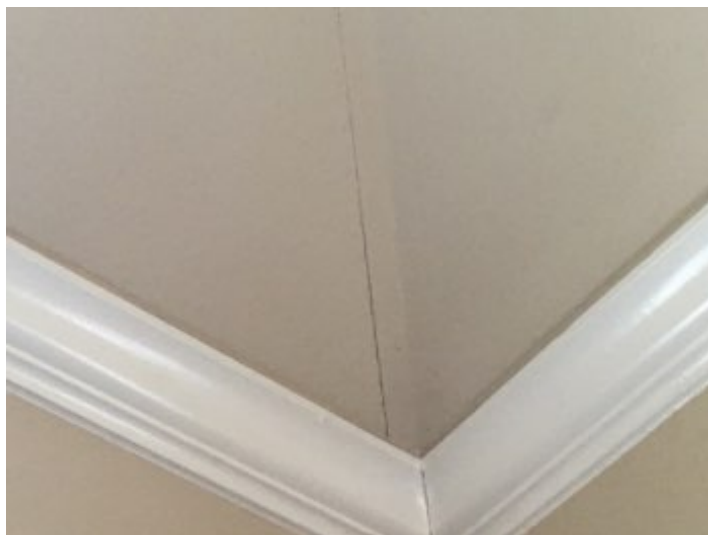
Crack observed to ceiling at front right corner of home.

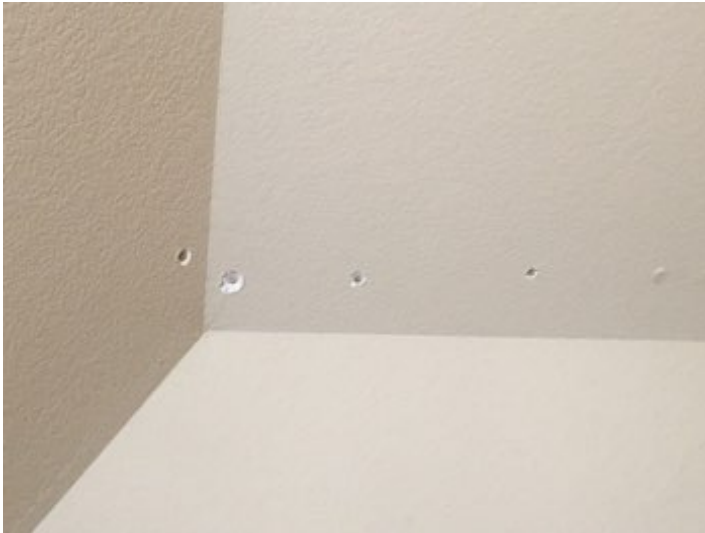
Nail pops observed to ceiling I master bedroom.

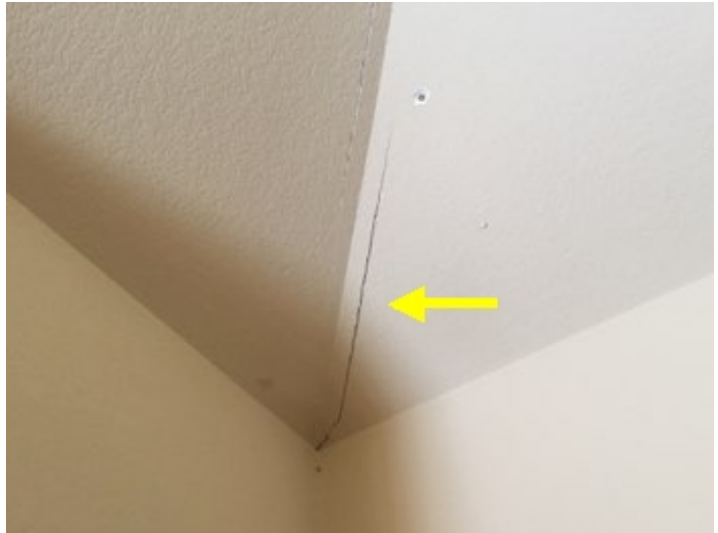
Crack observed to ceiling in master bedroom.

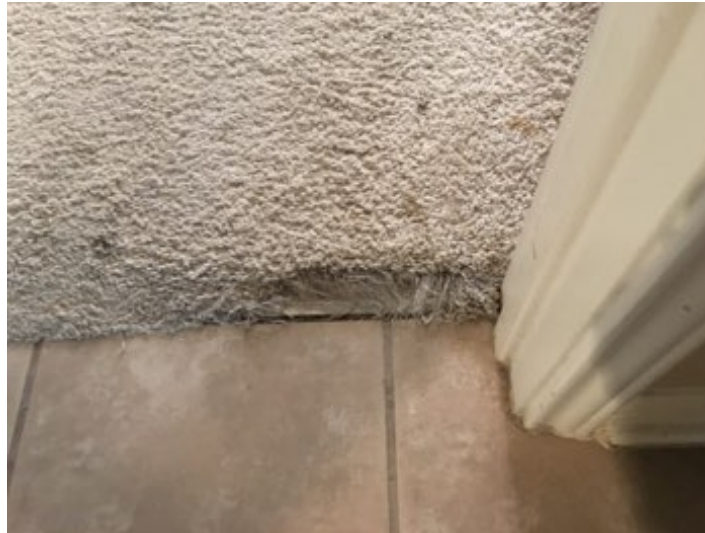
Tear observed to carpet at master bedroom.

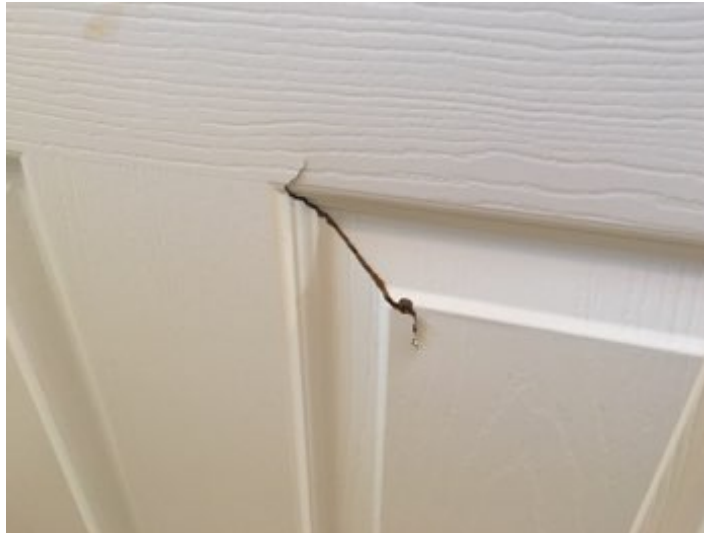
Damaged door leading into master bathroom commode.

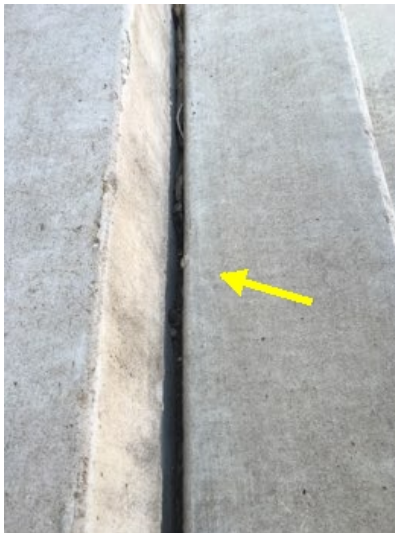
Deterioration observed to wooden joint at front entry stairs. Recommend sealing to prevent water penetration.

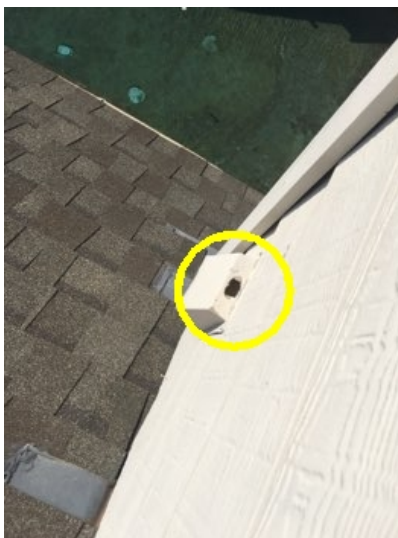
Air intake vent cover is damaged at the chimney.

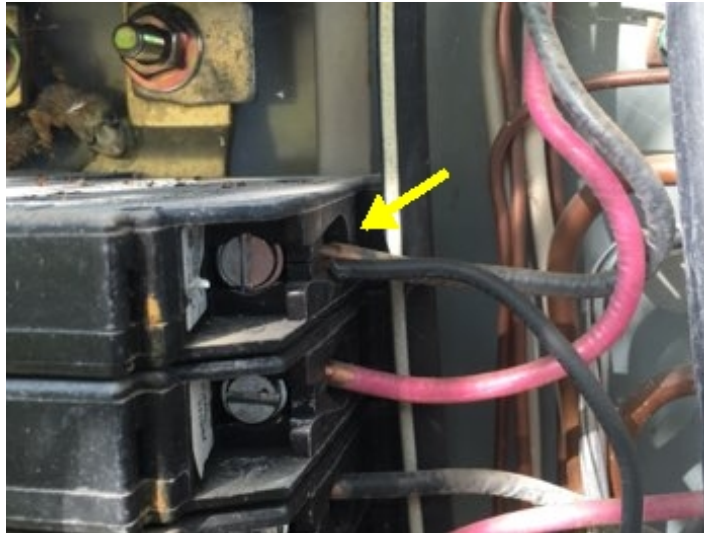
Double tapped breaker observed at exterior service panel.

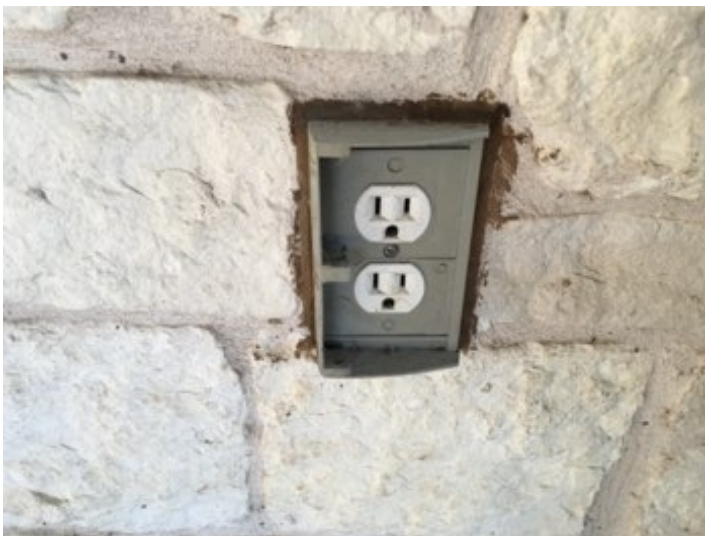
Exterior outlet at back patio missing cover

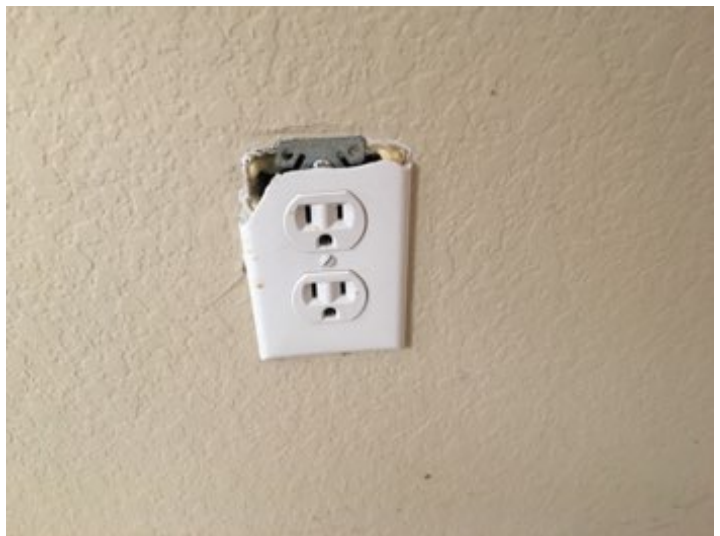
Damaged faceplate present at outlet in breakfast nook.

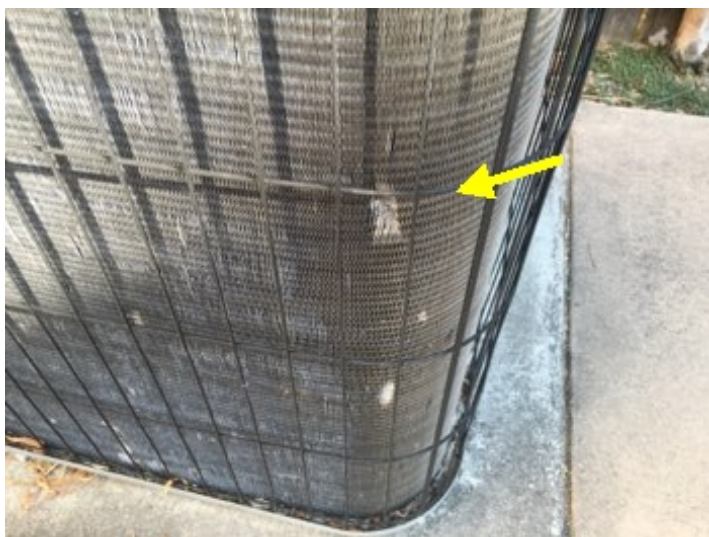
Hail damage present to exterior condensing unit fins.

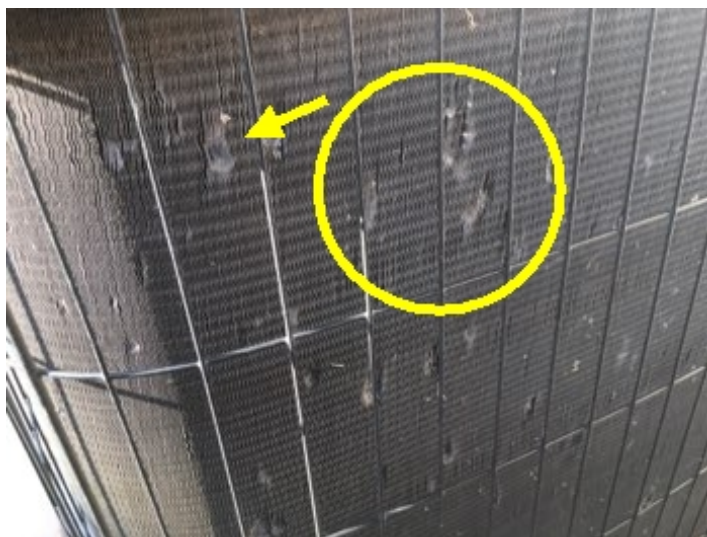
Hail damage present to exterior condensing unit fins.

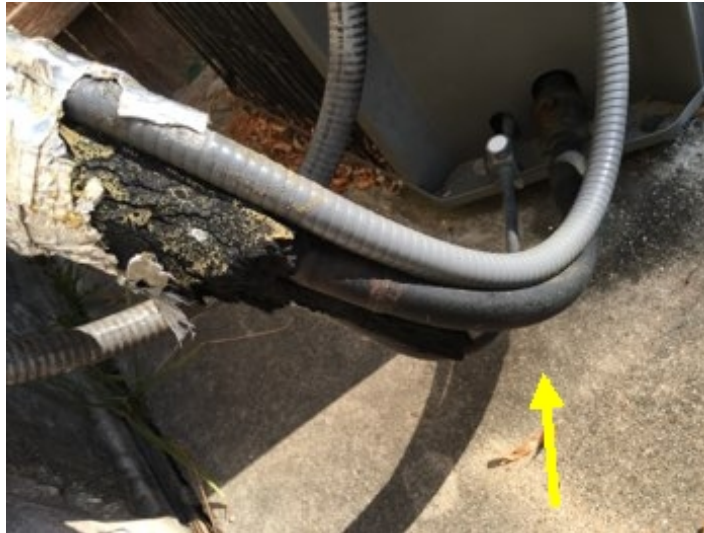
Deteriorated insulation present to exterior condensing unit refrigerant line. Recommend replacement.

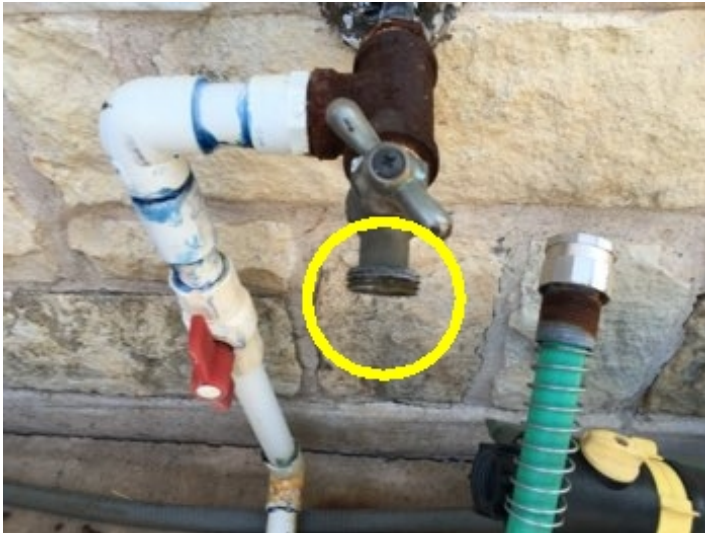
Missing backflow preventer on exterior water spigot at he back right side of the home.

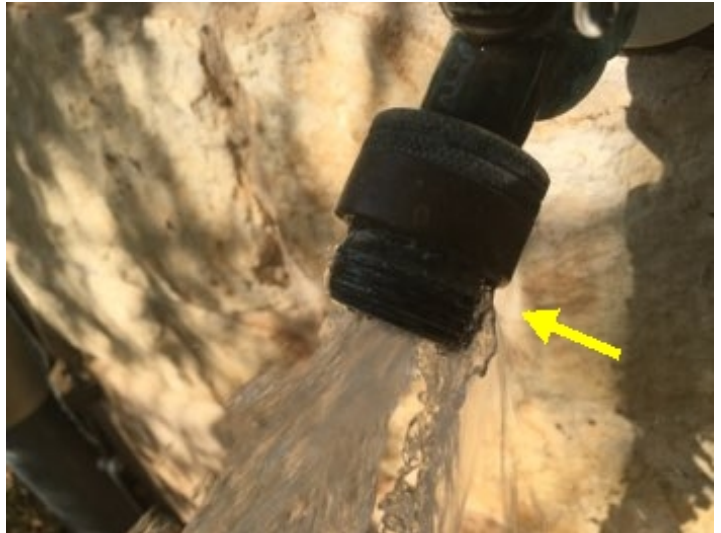
Hose bib at front left side of the home leaking around the back flow prevention. Hose bib is not properly sealed with exterior wall.

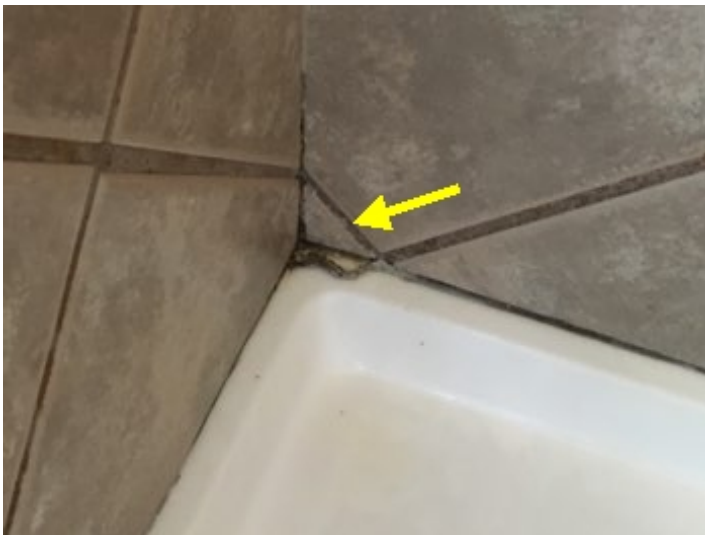
Deteriorated sealant present at master bathroom shower enclosure.

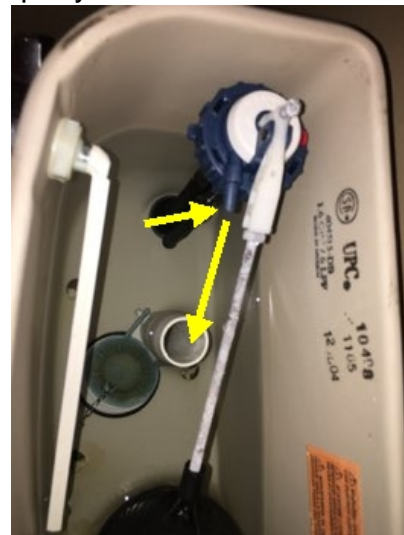
Toilet assembly in hallway full bathroom is missing its fill tube.

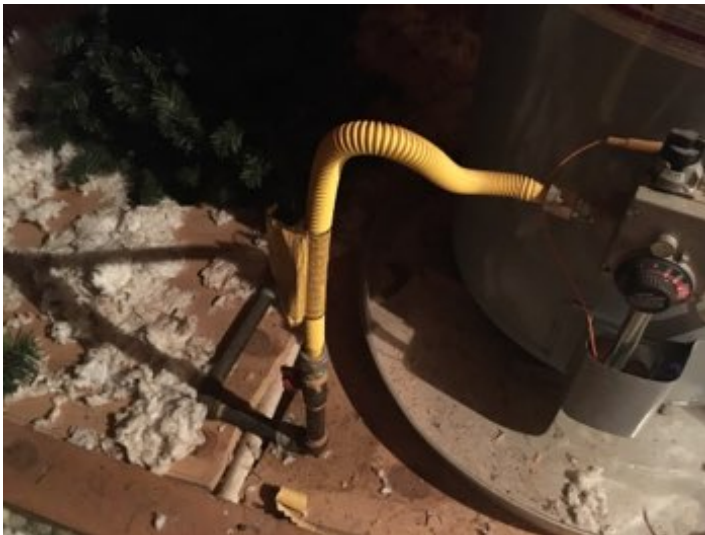
Missing drip leg to gas line.

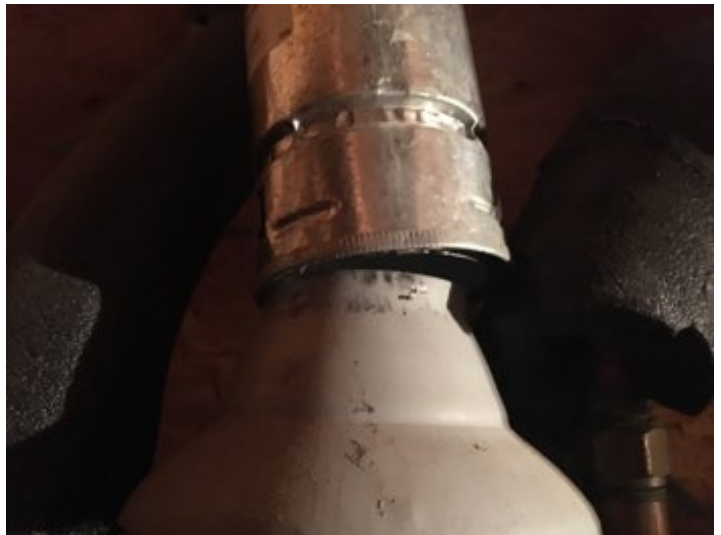
Water heater vent not properly attached. Vent is melting insulation located too close to termination point.

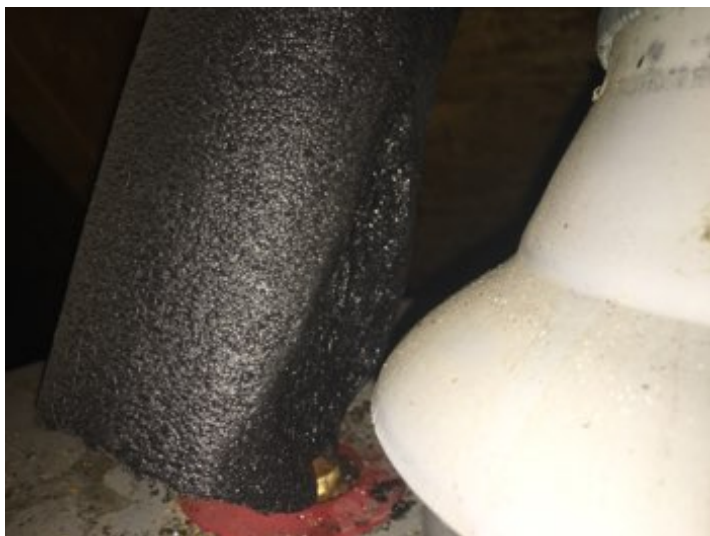
Insulation to water heater supply lines in direct contact with vent. Melting of insulation observed.

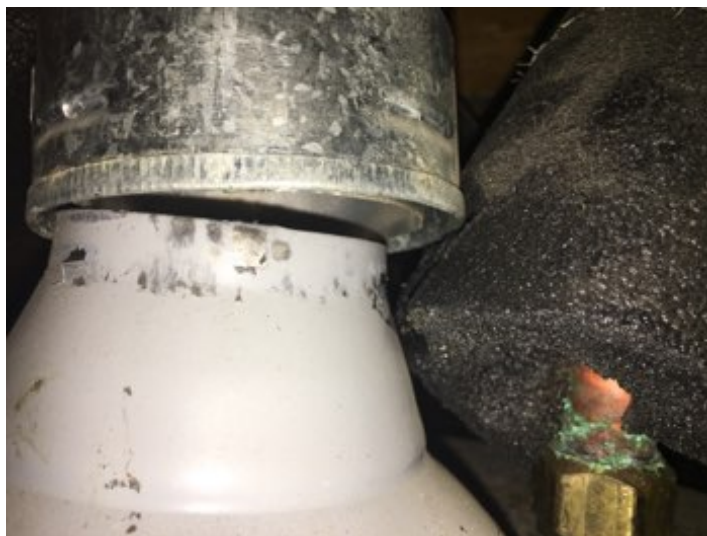
Insulation to water heater supply lines in direct contact with vent. Melting of insulation observed.

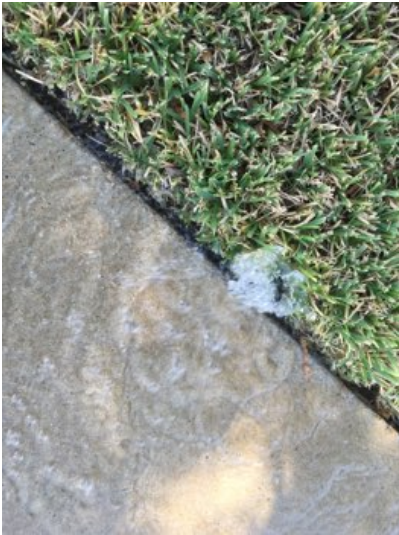
Zone 1 has a broken sprinkler head present in the front yard.

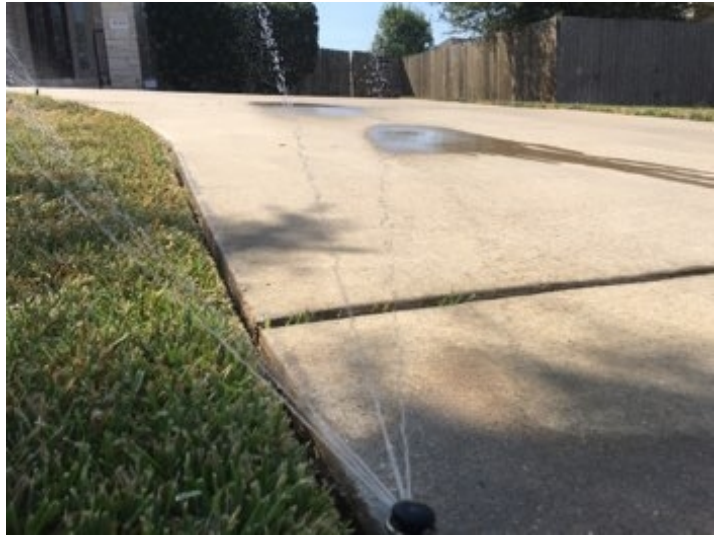
Zone 1 sprinkler head at front corner of yard spraying against driveway. Recommend adjustment

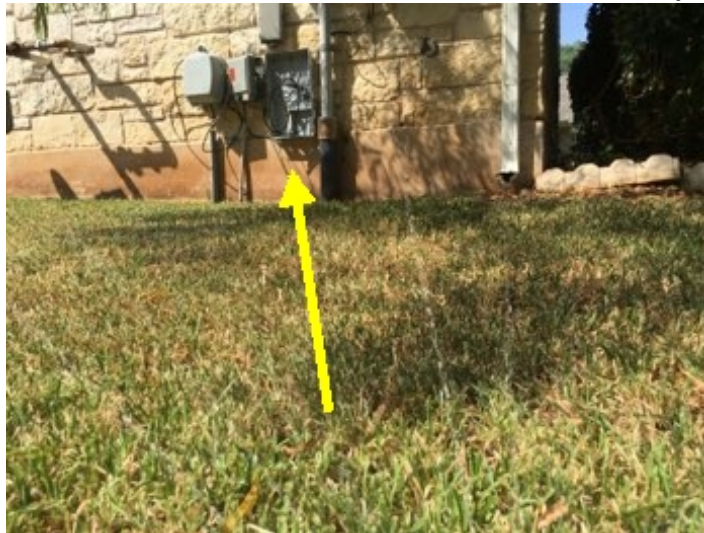
Zone 1 sprinkler head at left side of yard spraying against cable equipment/ electrical panel and home. Recommend adjustment.

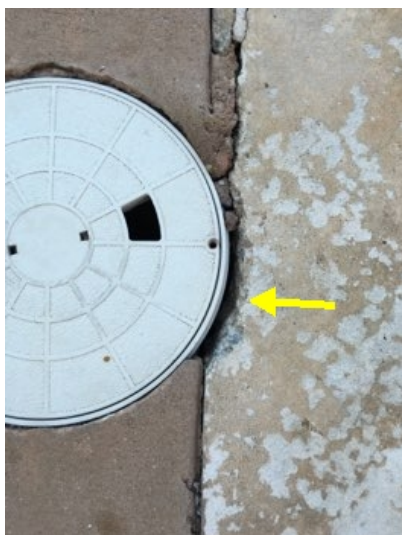
Gap observed to sealant around drain.
Recommend sealing all gaps in pool decking to prevent water intrusion.

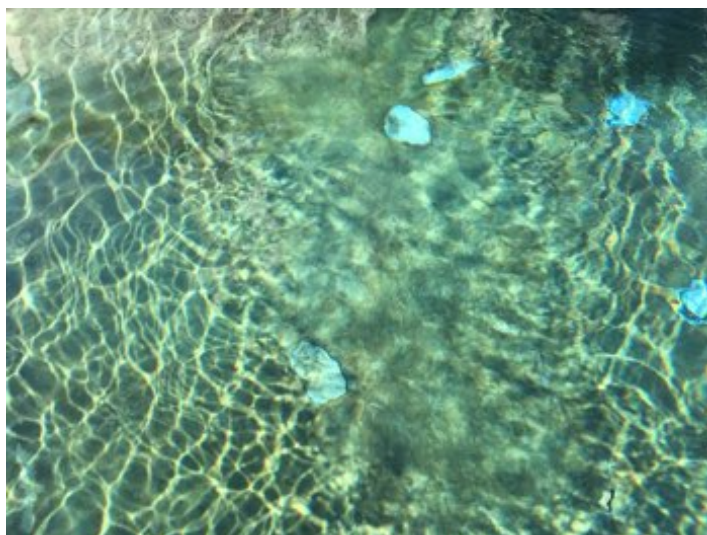
Deterioration observed to topcoat at base of pool and spa. Recommend evaluation from a licensed pool specialist.

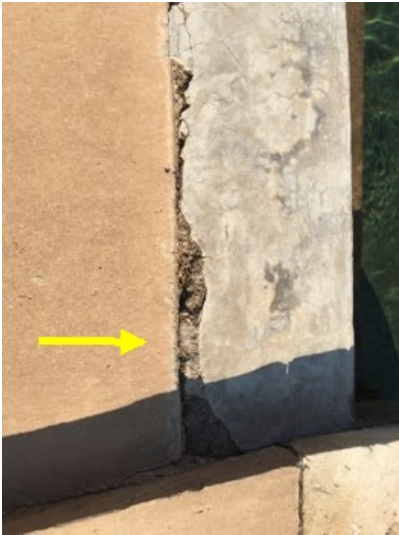
Damaged concrete observed around the backside of the pool.

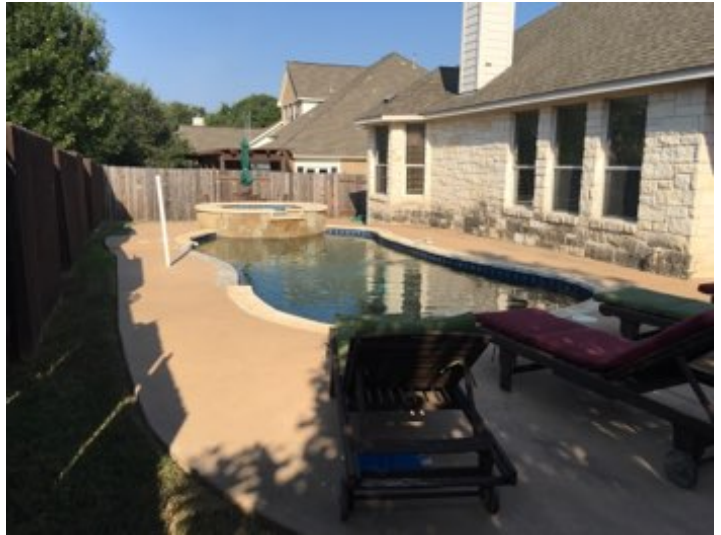
Safety fence missing around pool area.
