Home Inspection Report

4124 Scott Road

Inspection Date:
March 25, 2014

Report Number:
1140317

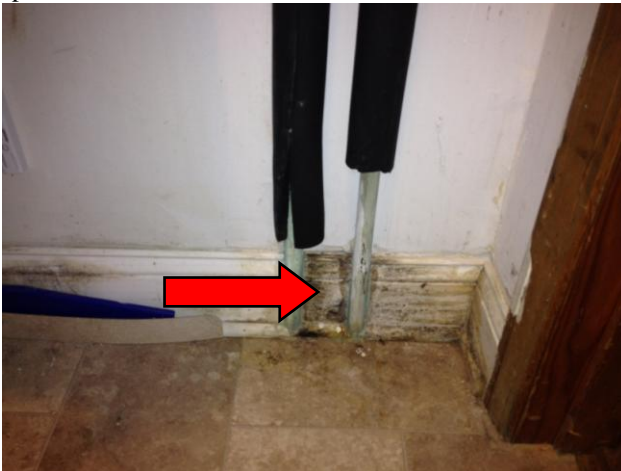
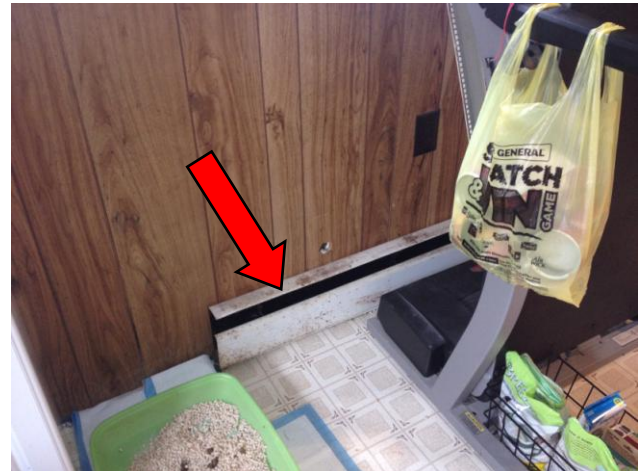
1. **Repair:** The bath exhaust fan is inoperative in the front bathroom. Bath fans offer a means of removal of moisture from the home to prevent damage to interior components. Repair as necessary.
2. **Repair:** Signs of fungal growth was observed on interior components (e.g. kitchen pantry walls and some baseboard radiators). Several factors are involved in the development and growth of fungus on building materials. Most notably elevated moisture, which may be a result of condensation forming on the boiler piping. Removal of the fungus and correction of the conditions that contribute to the growth and spread is needed (e.g. insulating boiler pipes). Identifying strains of fungus or health risks is beyond the scope of this inspection. You should consult an air quality/environmental specialist for more information, if desired.

- **Repair:** Signs of fungal growth was observed on interior components (e.g. kitchen pantry walls and some baseboard radiators). Several factors are involved in the development and growth of fungus on building materials. Most notably elevated moisture, which may be a result of condensation forming on the boiler piping. Removal of the fungus and correction of the conditions that contribute to the growth and spread is needed (e.g. insulating boiler pipes). Identifying strains of fungus or health risks is beyond the scope of this inspection. You should consult an air quality/environmental specialist for more information, if desired.

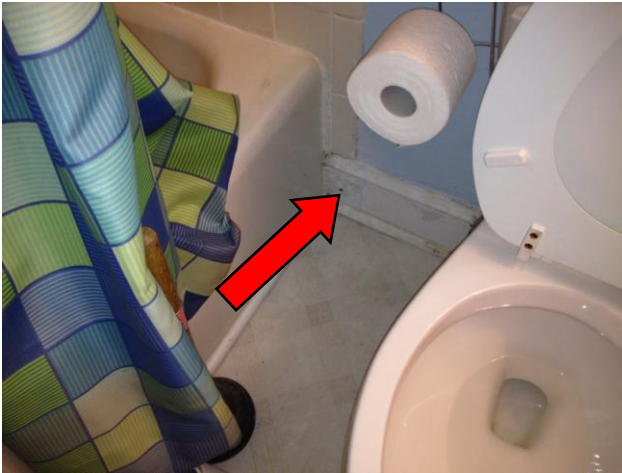
3. **Repair:** Water damage was noted on the front bath wall (wall between the tub and toilet). Water leaking into non-sealed areas can cause moisture damage and promote the growth of fungus. Repair as necessary, including any damage that may be revealed in concealed areas.

- **Repair:** Water damage was noted on the front bath wall (wall between the tub and toilet). Water leaking into non-sealed areas can cause moisture damage and promote the growth of fungus. Repair as necessary, including any damage that may be revealed in concealed areas.

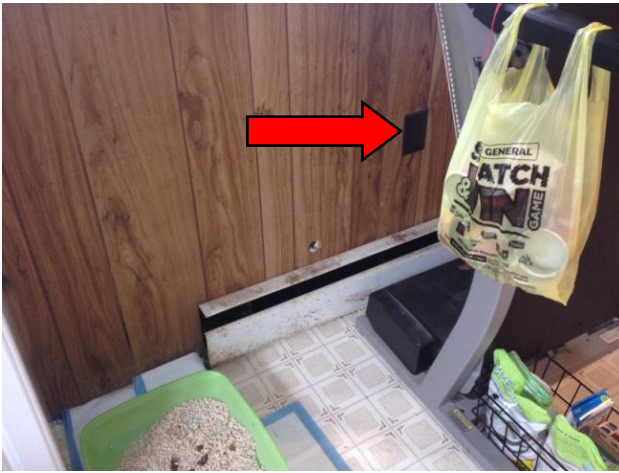
10. **Repair:** An electrical outlet rear laundry area (right wall) has reversed polarity (i.e. it is wired backwards). Outlets in this type of location need to have GFCI protection for occupant safety. Repair as necessary. This outlet and the circuit should be investigated and repaired as necessary. There may be additional outlets in the home that require repair since only a sample (one per wall per room) was checked. Some outlets are not accessible due to the placement of furniture in the home. It is recommended that any additional outlets found to be in need of repair be corrected also.

- **Repair:** An electrical outlet rear laundry area (right wall) has reversed polarity (i.e. it is wired backwards). Outlets in this type of location need to have GFCI protection for occupant safety. Repair as necessary. This outlet and the circuit should be investigated and repaired as necessary. There may be additional outlets in the home that require repair since only a sample (one per wall per room) was checked. Some outlets are not accessible due to the placement of furniture in the home. It is recommended that any additional outlets found to be in need of repair be corrected also.

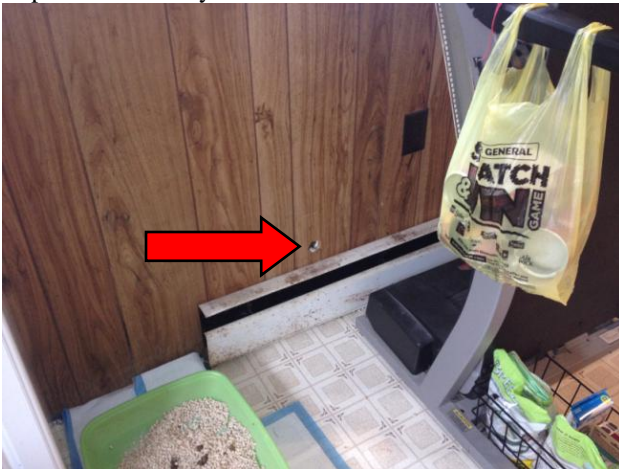
11. **Repair:** Abandoned wiring at the rear laundry area (left wall) should be removed or appropriately terminated in a covered junction box. Abandoned wires still connected to the electrical system expose occupants to an electrical hazard. Repair as necessary.

- **Repair:** Abandoned wiring at the rear laundry area (left wall) should be removed or appropriately terminated in a covered junction box. Abandoned wires still be connected to the electrical system expose occupants to an electrical hazard. Repair as necessary.
