# INSPECTION REPORT

For the Property at:  
**12 LAZY RIVER ROAD**  
GREEN SPRING, WV

Prepared for: DEBORAH MILLER  
Inspection Date: Tuesday, September 10, 2013  
Prepared by: David Wingenbach

RE: Report No. 1370  
12 Lazy River Road  
Green Spring, WV

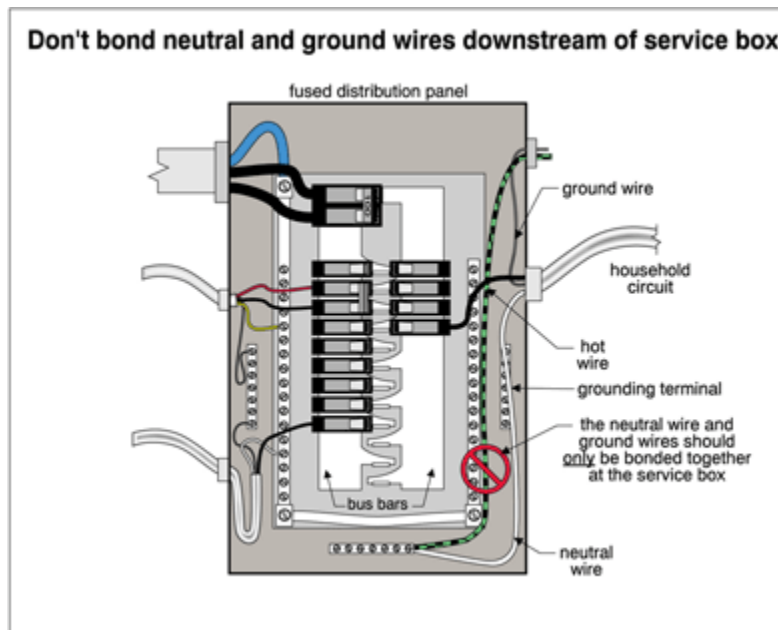
**9. Condition:** • [Neutral and ground wires bonded at subpanel](#)

**Task:** Correct

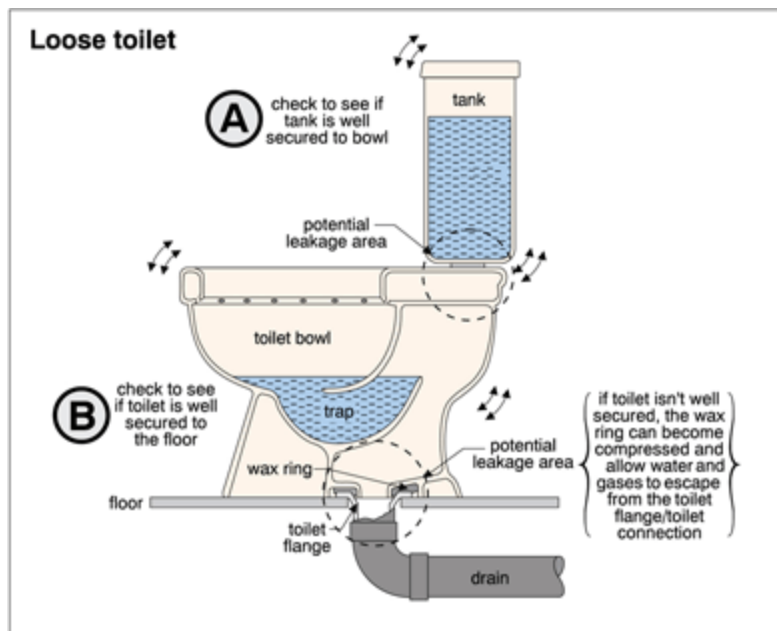
### 17. Condition: • [Loose](#)

The toilet in the hall bathroom is loose.

**Implication(s):** Chance of water damage to contents, finishes and/or structure | Sewage entering the house

**Task:** Repair

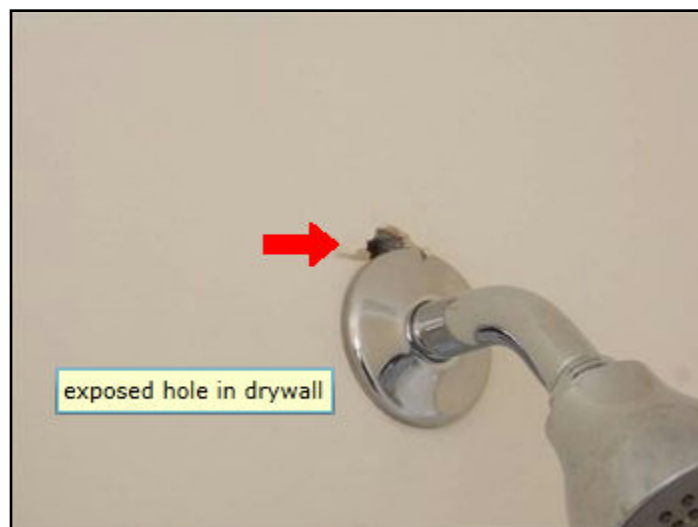
17.

### 18. Condition: • There is an open hole in the drywall above the shower head.

**Implication(s):** Water leaking into the wall structure.

**Task:** Repair

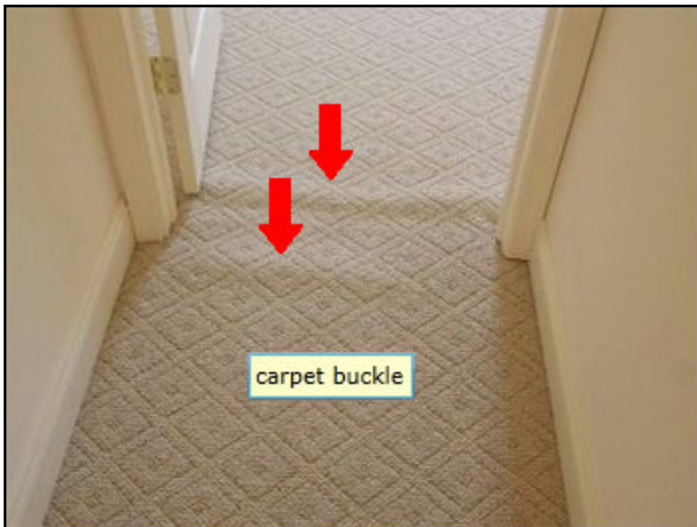
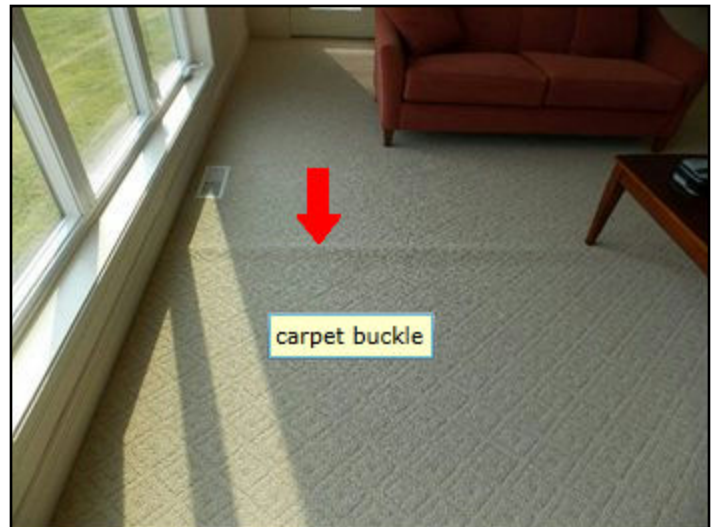
### **20. Condition:** • [Buckled](#)

**Implication(s):** Cosmetic defects | Trip or fall hazard

**Task:** Repair

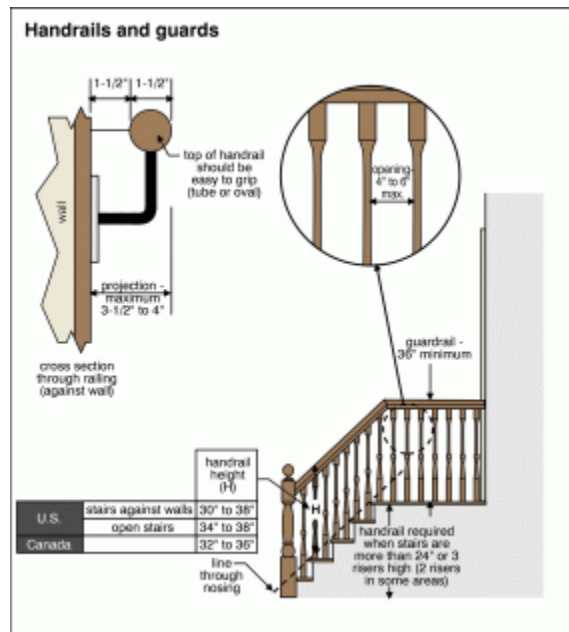
### **23. Condition:** • [Missing](#)

**Implication(s):** Fall hazard

**Task:** Install
