RE: Level B Investigation
102 Mesa Drive
Austin, Texas
Job No.: 1314006000.0100
Firm No.: 002685

SLAB SURFACE CONTOURS

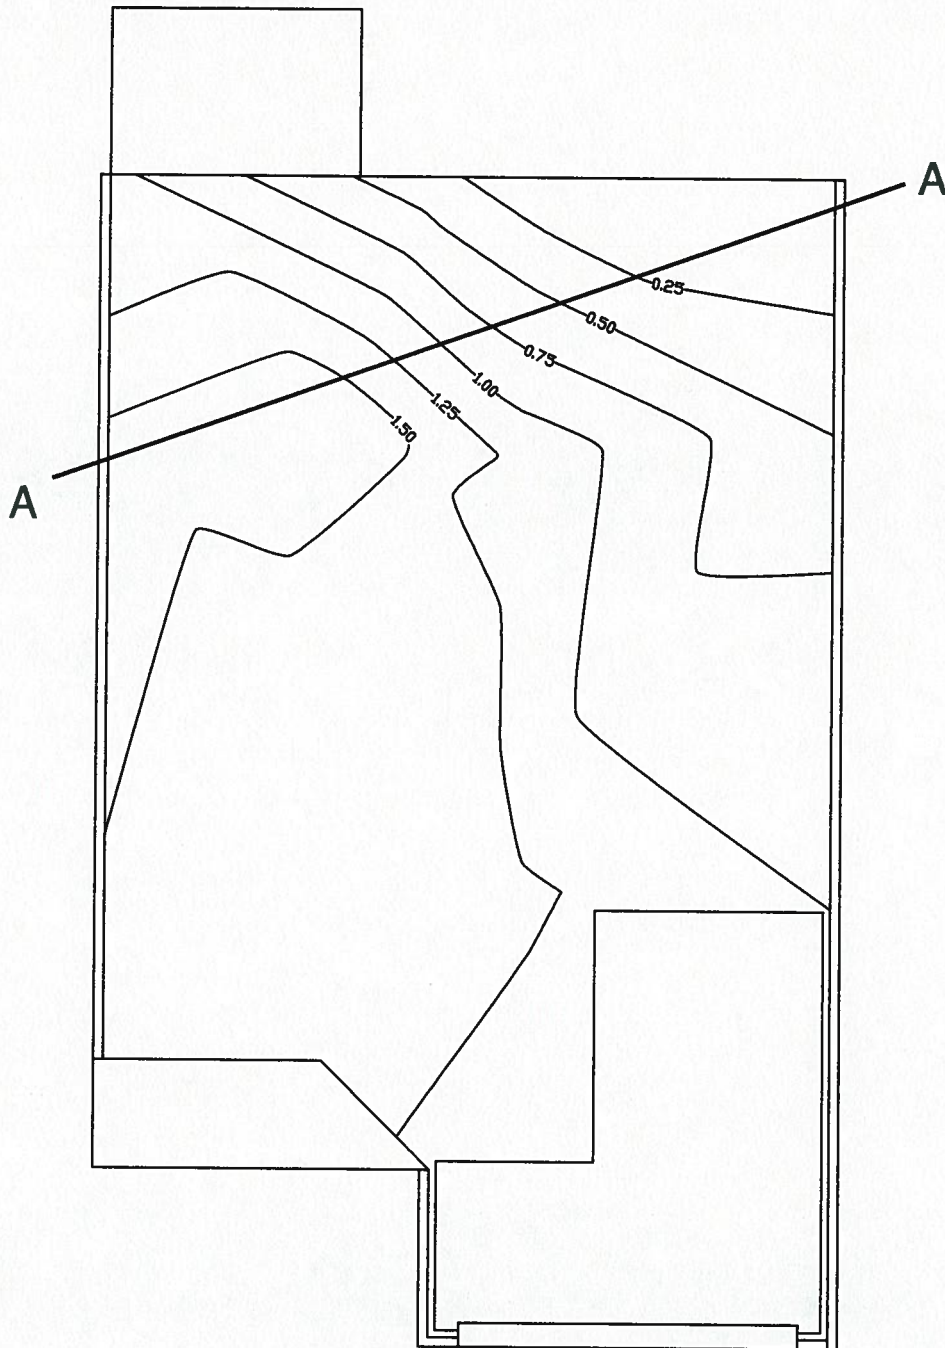
Based on ASCE criteria, the foundation has not failed, nor is there a defect. This foundation does not violate the maximum guidelines established by ASCE for foundation performance. See below:

- MAXIMUM value for global TILT A-A = 4.44 Inches

- ACTUAL value for global TILT A-A = 1.60 inches
- MAXIMUM value for global DEFLECTION A-A = 1.23 inches
- ACTUAL value for global DEFLECTION A-A = 0.45 inches

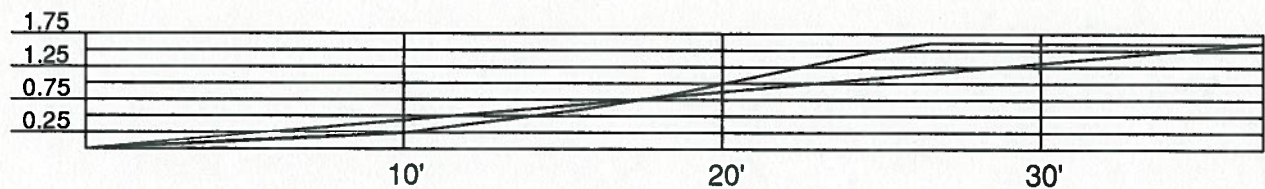
SECTION A-A

TILT = 1.60" IN 37' (1% = 4.44")
DEFLECTION = 0.45" IN 37' (L/987)
