DON ILLINGWORTH & Assoc. Inc. firm #4308 Consulting Structural Engineers
2401 Ave. J Suite 206 Arlington, TX 76006 817-649-1544 fax. 817-649-1545

March 13, 2013

RE: 7345 CO Road 283
Terrell, Texas

ELEVATION SURVEY

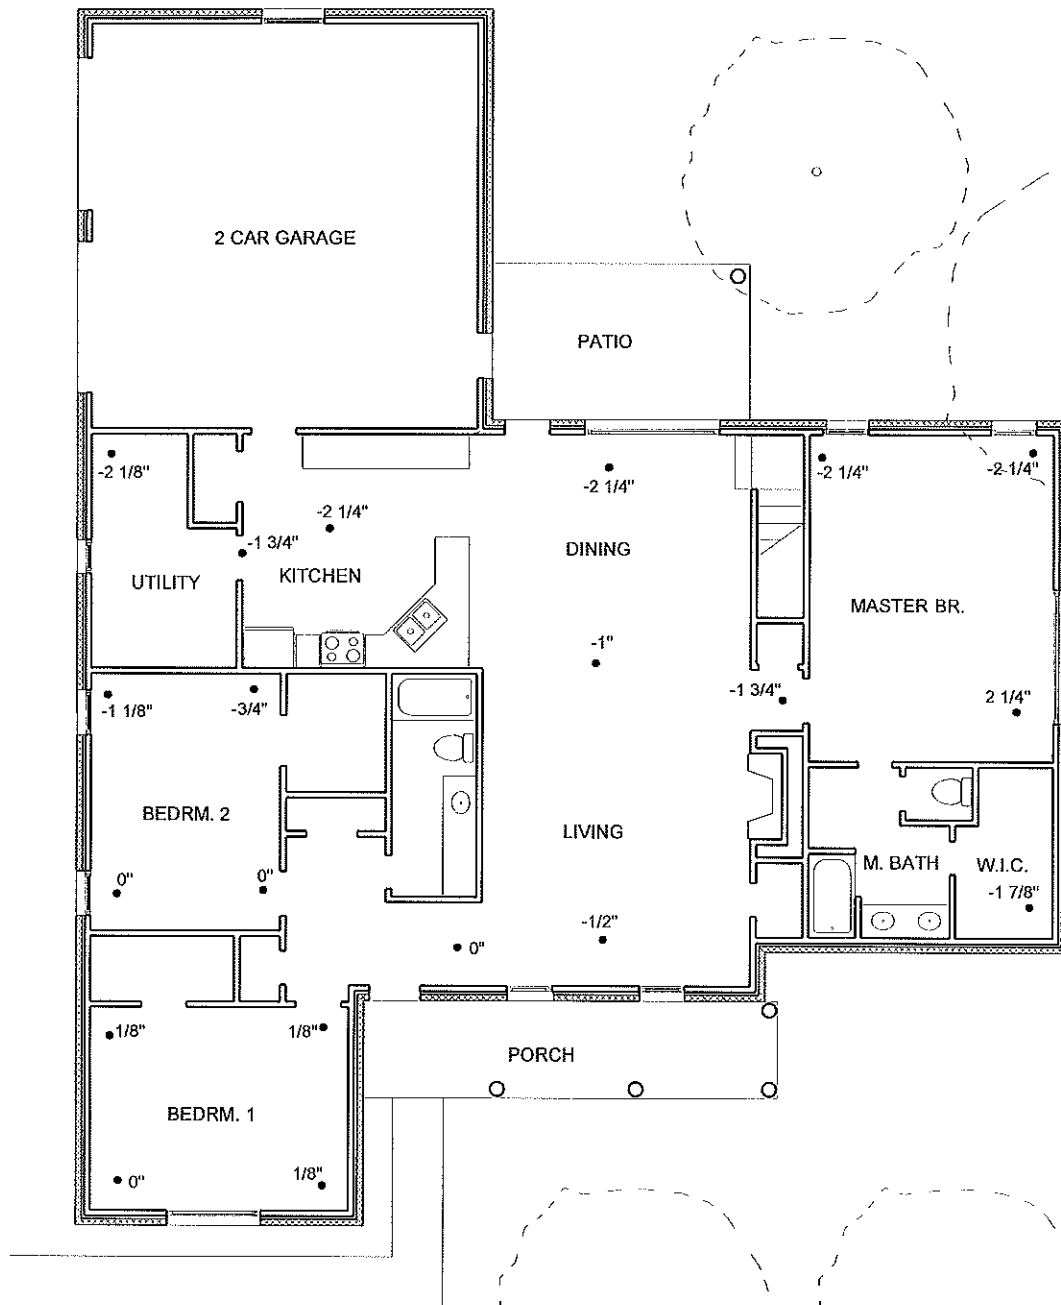
The floor elevations show the floor is relatively level and well within normal tolerances. The high point of the foundation is the front bedroom and the low area is uniformly along the back. The differences in elevation are due to original construction and/or normal foundation movement. Most likely, it is a combination of both, however, it is not a problem because the foundation is doing an excellent job of supporting the structure above. There are several brick and mortar cracks on the east side. These appear to be cracks from normal seasonal foundation movement. There are no corresponding cracks on the interior which shows there is not noteworthy foundation movement. In my opinion, the residence is in very good condition, and there are no cracks, material separations, or out-of-square doors that indicate foundation problems.

The attached sheet shows floor elevations at the RE: residence. None of the allowables for deflection or tilt have been exceeded as shown in the floor elevations. It is my opinion the foundation is serving its intended function, which is to support the structure above, even though there is very minor cosmetic distress which can be repaired.

The structure is built on a slab-on-grade foundation which may move or "float" as a result of the swelling of the soil due to seasonal moisture changes. Minor cracks in the sheetrock and brick are normal and may require repair as a typical maintenance item. Proper yard and house maintenance are extremely important and will help reduce foundation movement and associated problems. It is very important to water the yard during the dry season and to have good drainage so water will drain away from the house during the wet season. Trees, also, draw a significant amount of moisture from the soil, and additional watering may be required in the area of the trees. Gutters and downspouts would help improve drainage along the east side.
