Re: **Visual Inspection**
Residence at 185 C.R. 2142
Canton, Texas
GeoConsultants, LLC Project No. 1224

Relative Floor Elevation Survey

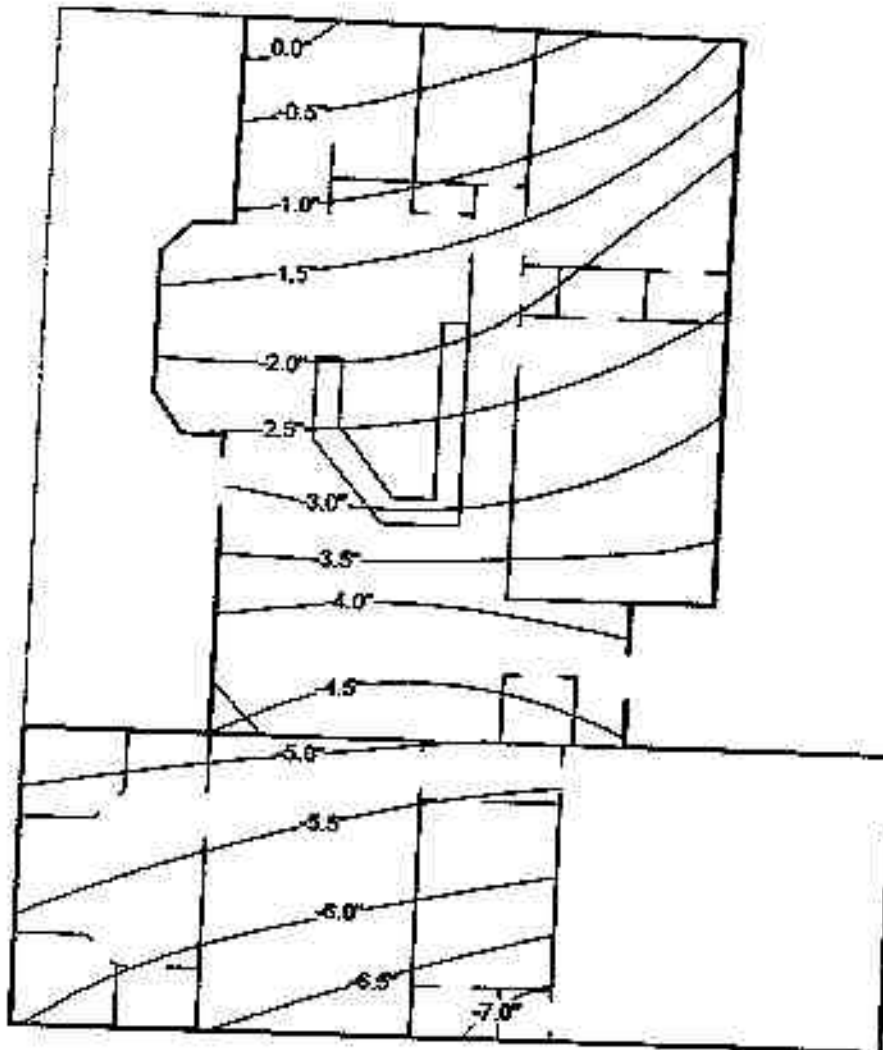
The results of our relative floor elevation survey are attached to this letter. A review of the plan indicates that the foundation has a change in elevation of approximately seven (7) inches with the high side on the north end. The contours for the changes in elevation appear to be fairly uniform along the slope, indicating that the concrete for the slab surface was most likely placed and finished in the elevations noted across the foundation.

* **Conclusions** - Based on the conditions observed and the discussion herein, it is my professional opinion that the slope of the foundation is most likely the result of the foundation forms being placed out of level during construction. If the noted slopes were from settlement, there should be more areas exhibiting distress with cracking and trim separations. Additionally, this magnitude of post-construction movement should have resulted in broken water and drain lines and poor drain line performance on the lower (west) side of the foundation. Without these conditions present, it becomes intuitively obvious that this was an error made in the layout of the foundation forms.
