# PROPERTY INSPECTION REPORT

Concerning: 13018 Rudys Way Streetman, Texas

By: Chuck McClanahan #5461

08/17/2012

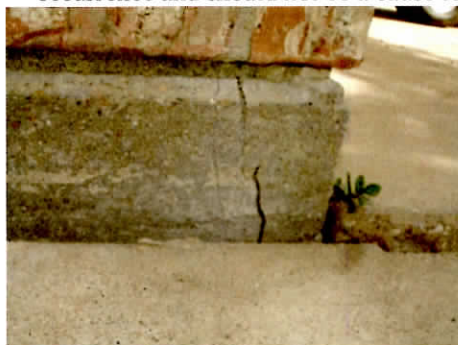
The corner edge of the foundation is cracked and/or missing. This is a common occurrence and should not be a cause for alarm.

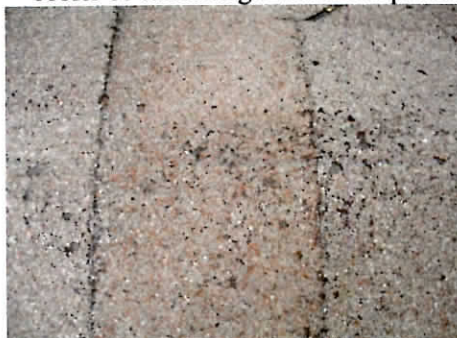
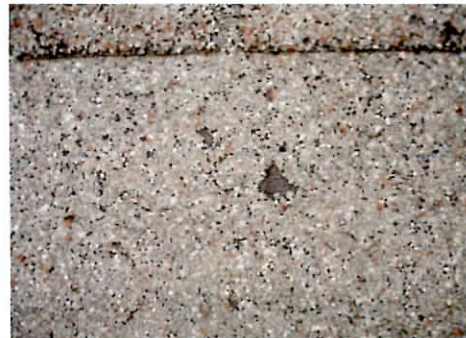
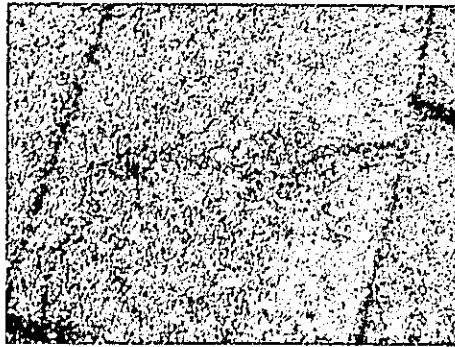
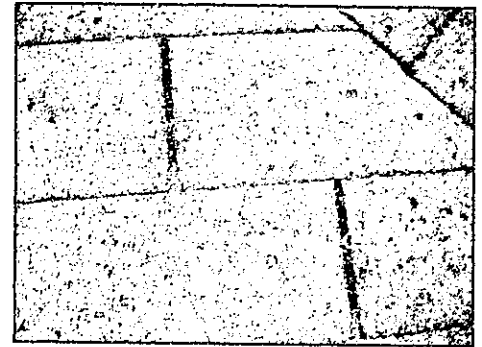
The roofing is nearing the end of its life cycle. It is recommended that a professional roofer be called to get a second opinion.

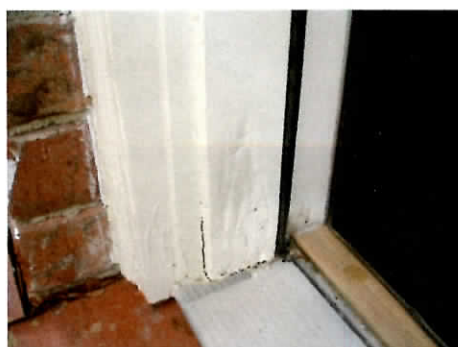
The upper porch doors casing has had past repair.

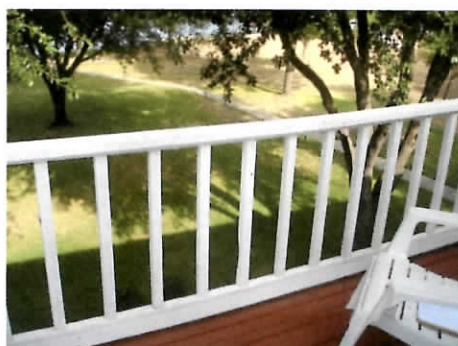
The openings in the upper and lower porch railing are large enough to allow an object of 4 inches in diameter to fall through.

For improved safety, it is recommended that a railing be provided for the steps at the lower porch.

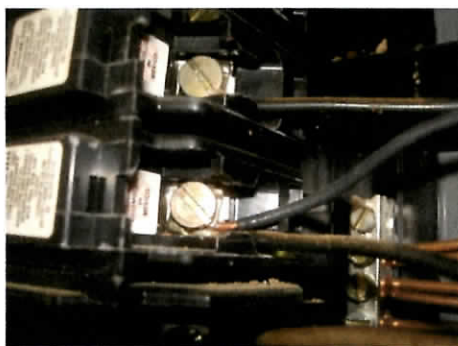
Circuits within the main distribution panel that are doubled up (referred to as "double taps") should be separated. Each circuit should be served by a separate fuse or breaker.

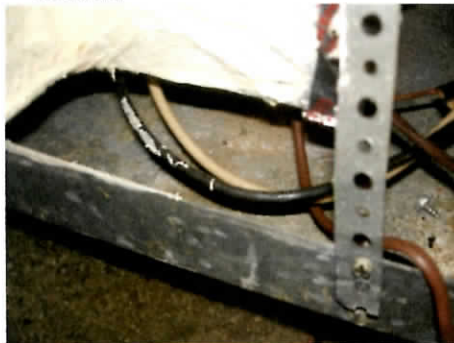
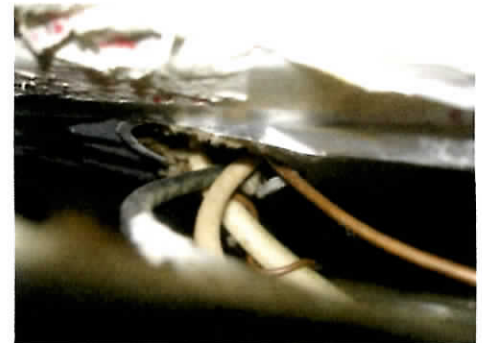
A "bushing" should protect the electrical supply wire as it enters the units (3 units). The "bushing" protects the wire from being cut by the metal's edge and also holds the wire secure. In most cases it's recommended that the entire wire be run inside a conduit.

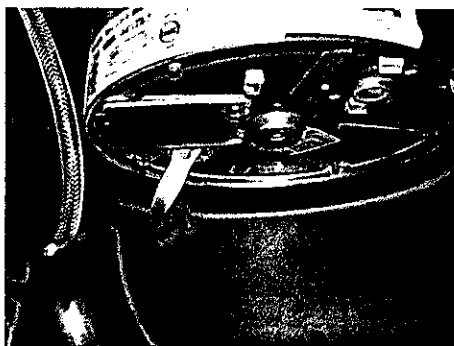
☐ ☐ ☐ ☒ B. Food Waste Disposer *Comments:*  
No bushing was observed to protect and hold the wires in place.
