TEXAS ASSOCIATION OF REALTORS® SELLER'S DISCLOSURE NOTICE

CONCERNING THE PROPERTY AT 18381 Deerview Ln
New Ulm, TX 78950

18381 Deerview Lane - New Ulm 78950

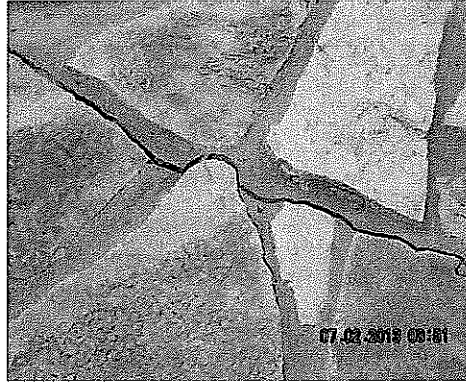
Mortar crack in stone on right side of entry.

Recommendations: Verify the cause of and/or request information on the repaired crack over the back doors in the dining room; repair the wall under the SE bath lavatory; repair the defective mortar joints in the stone veneer of the arched entry; and correct the other items noted.

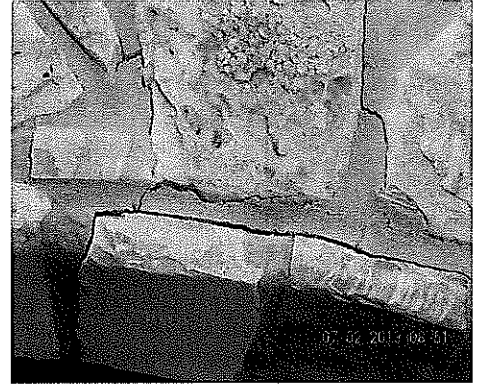
Mortar crack in stone on front of entry.

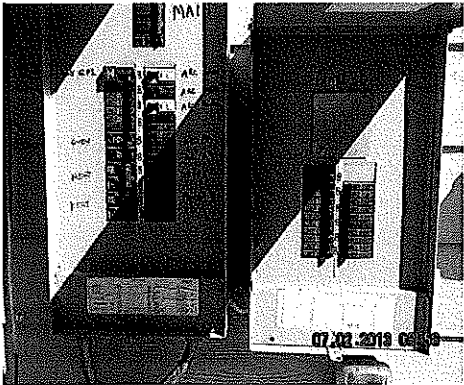
Service panels - not all breakers are labeled.

Recommendations: Employ the services of a licensed electrician to verify ampacities, grounding, polarity, overcurrent protection, ground-fault protection and to otherwise meet the current standards. Correct all other electrical deficiencies noted here and in the section above.

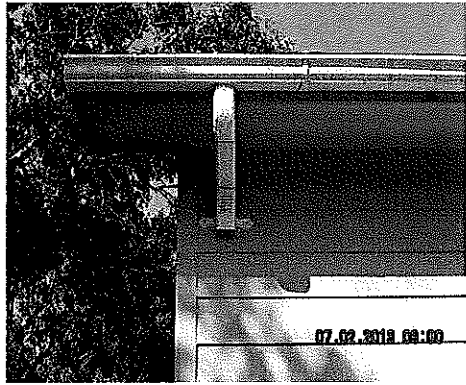
Grading and Drainage - Comments: The grading and drainage of the site appeared adequate but the grading in the front flower beds was poor. Down spouts were incomplete in the rear with some corrosion; and the gutters were full of debris. Also, the slab exposure was poor in places with some terrain above the weep holes.

Down spouts incomplete.

Recommendations: Improve the grading in the flower beds to ensure surface water will drain away from the foundation and off the site; complete the down spouts; clean out the gutters; and improve the slab exposure where applicable.

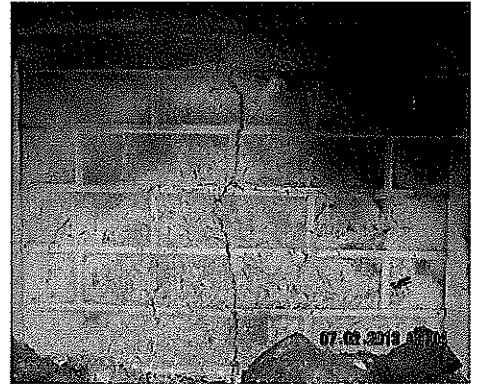
☒ ☐ ☐ ☒ J. ✓ Fireplace/Chimney - Comments: The wood burning fireplaces (2) appeared functional. However, they were dirty from normal use and each unit had a crack in the back of the firebox. Some flashing was rusty around one chimney.

Crack in back of both fireplace fireboxes.

Recommendations: Have the units cleaned and serviced; repair the cracks in the fireboxes; and paint the exposed and rusty flashing.

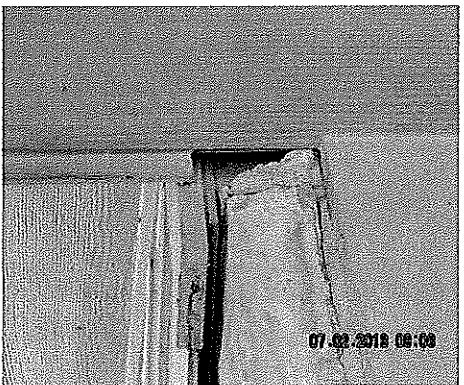
Top of wall not sealed at NW corner.

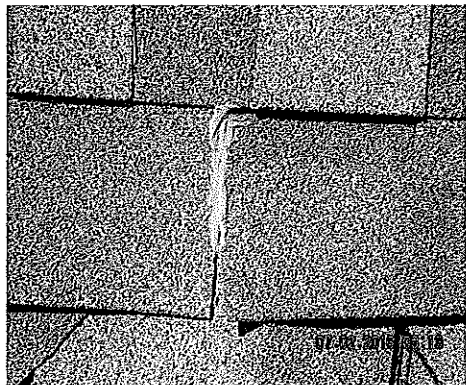
Caulking on shingles.

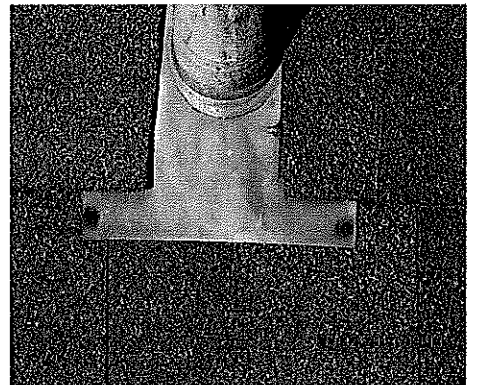
Nail heads rusty and not caulked in roof jacks.

Recommendations: Request warranty information on the shingles; trim the limbs; caulk the exposed nail heads; and correct the other items noted.

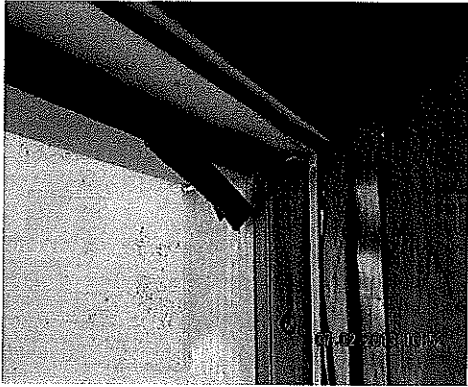
Weather stripping damaged in back door casing
in master suite.

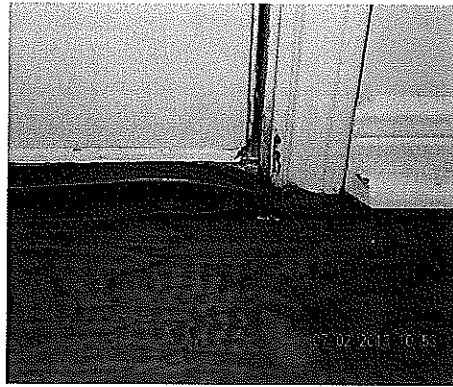
1. There were cracks on the ceiling in the garage.
2. The ceiling was not sealed at the wires to the openers in the garage.
3. There were cracks in the taper of the ceiling in the family room.
4. There were cracks on the floor of the garage.
5. The floor was partially buckled at the back door in the master suite with evidence of water penetration. Outdoor threshold added KMS

Evidence of water penetration on the floor at the
back door in master suite.

Recommendations: Verify the cause of and repair the flooring at the back door in the master suite; and correct the other items noted.

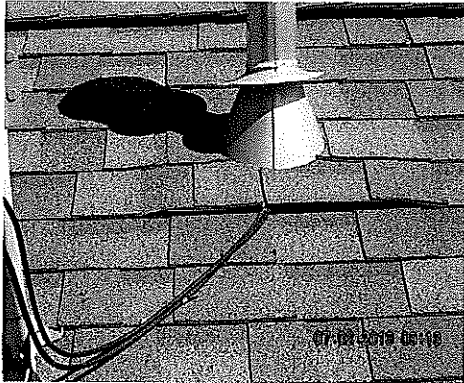
Satellite dish cable has roof jack kicked up at water heater vent pipe.

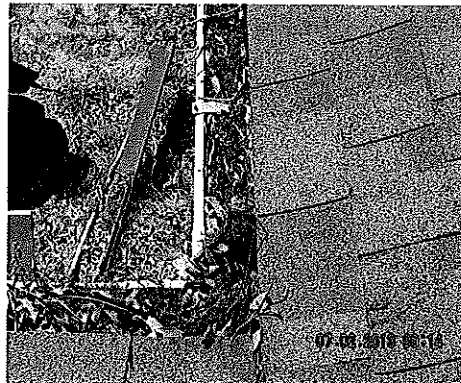
Debris in gutters.

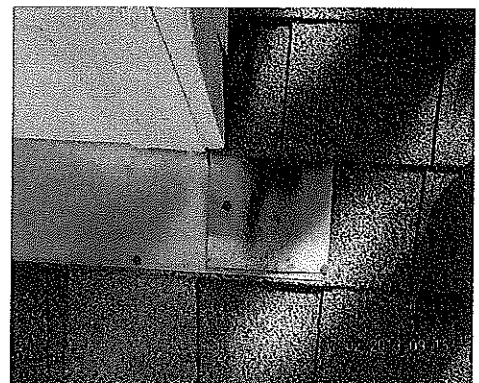
Flashing rusty at fireplace chimney.

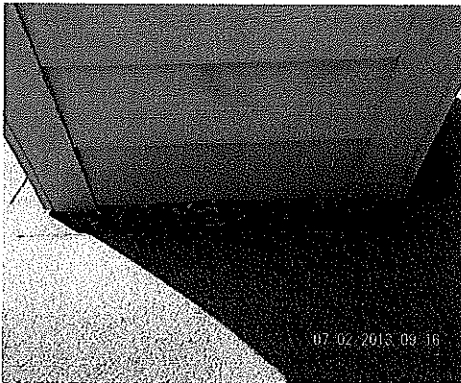
Leave piled up behind chimney.

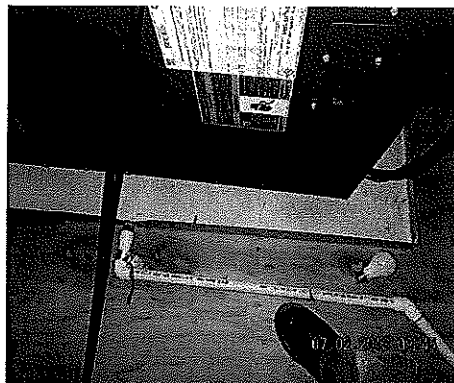
Corrosion in overflow pan.

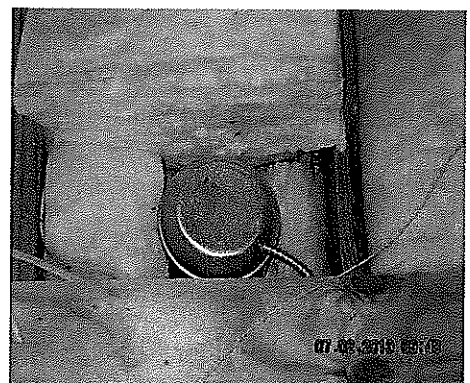
1. One rafter was cut short of the ridge board and a piece of framing was shimmed in between to make of the difference.
2. The service walk was inadequate to one furnace and the other furnace was over 20' from the attic access.
3. Insulation and wood was too close to the recessed light fixtures.

Insulation and wood too close to recessed light fixtures.

Recommendations: Provide an adequate service walk; and provide the required clearance around the recessed light fixtures.

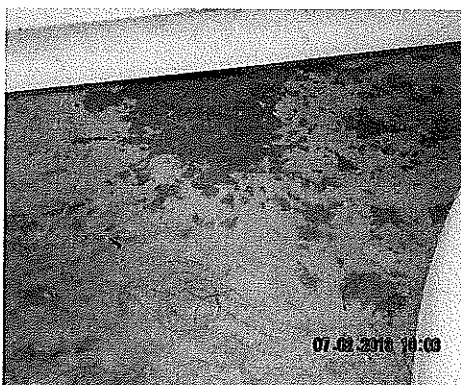
Leak from commode in hall bath.

Recommendations: Repair the leak at the commode; verify the cause of the slow draining lavatories; and correct the other items noted.

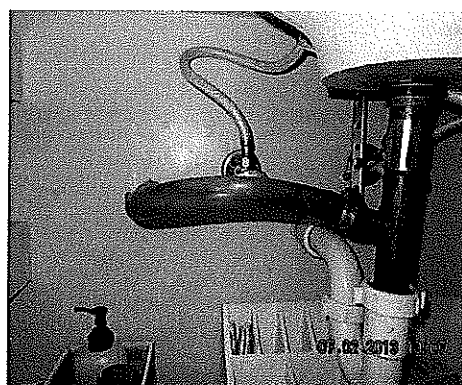
Condensate line uphill and holding water in hall bath.

Recommendations: Correct the installation of the primary condensate line; and correct the other items noted.**IV. PLUMBING SYSTEM**☒ ☐ ☐ ☒ **A. Water Supply System and Fixtures***Location of Water Meter:* on-site water well*Location of main water supply valve:* front of garage*Static water pressure reading:* not verified*Comments:*

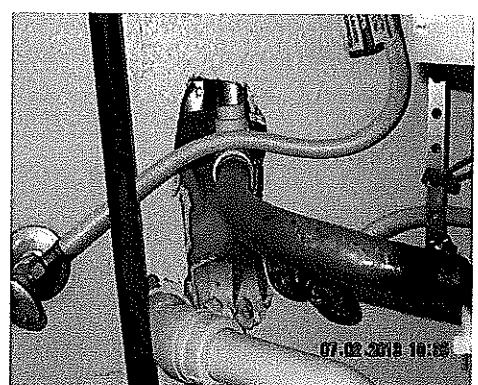
Wall cut open under lavatory in SE bath.
