CONCERNING THE PROPERTY AT 1326 HAPPY HOLLOW RD.  
Brenham, TX 77833

ADDITIONAL INFORMATION PROVIDED BY INSPECTION

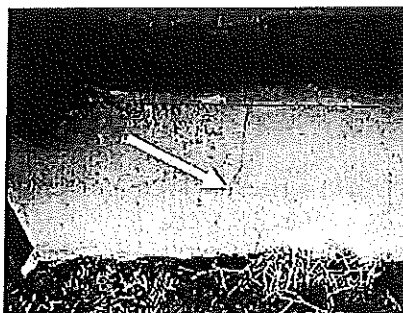
The foundation is performing as intended. No significant problems were observed. I did notice a hairline crack at the right front corner of the main house however I do not consider it structurally significant.

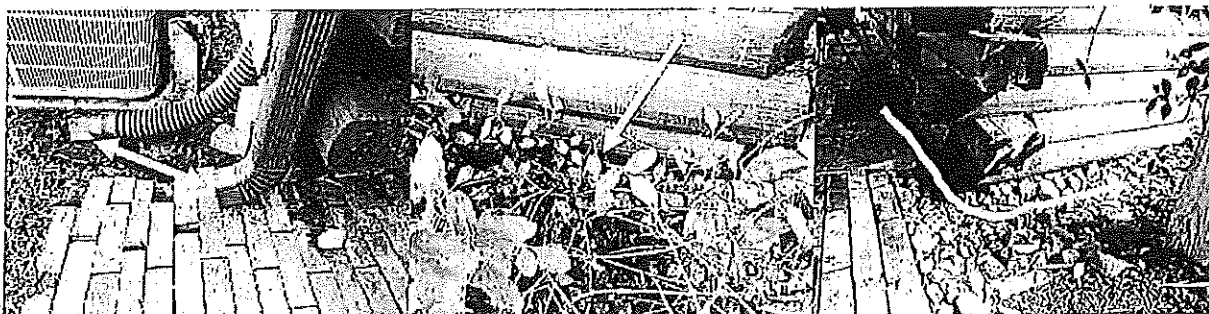
- Logs and (ph) plank siding are immediately at grade in several locations. To be fair, the plank siding is cedar which is naturally decay resistant.
- Gutter downspouts are terminating immediately at the foundation. One downspout has an extension but it is disconnected. Downspouts should terminate 5' away.
- Vegetation is blocking the site area between grade and the lower logs.

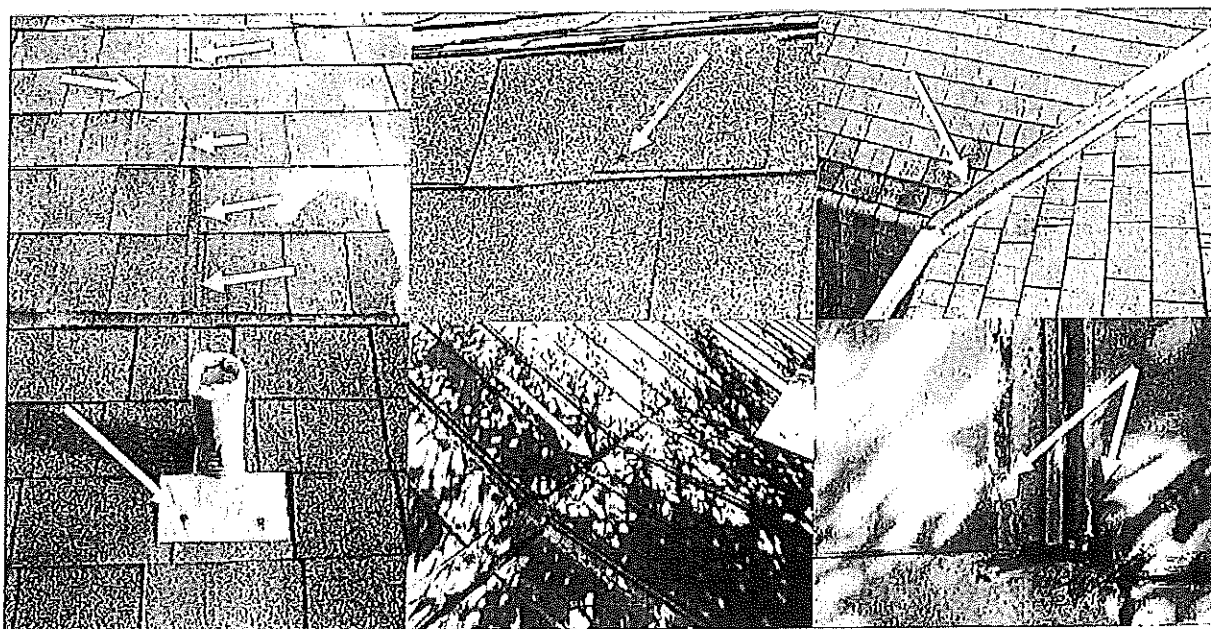
- Rusted valley flashings.
- A few exposed nail heads – need to be caulked to seal around them and at least one shingle where a nail is backing out – leak concern during a wind driven rain event.

- Evidence of shingle repair on the front left mansard roof area. The new shingle butt joints are not offset per typical manufacturer specs – leak concern.

- The 5-V metal should be placed only on a roof with a 3" in 12" minimum roof pitch per typical manufacturer specs. The lower slope area of the pool house is a 1 ½" in 12" pitch – potential leak issues during a high volume rain event due to water spilling over the low corrugations of this material.

- Open screw holes where a rake trim was removed on the pool house when the carport was added – potential leak concern.
- No transition flashing from the steeper carport pitch to the door awning cover. In all fairness however, even if the transition leaks, rain could also blow under the awning.

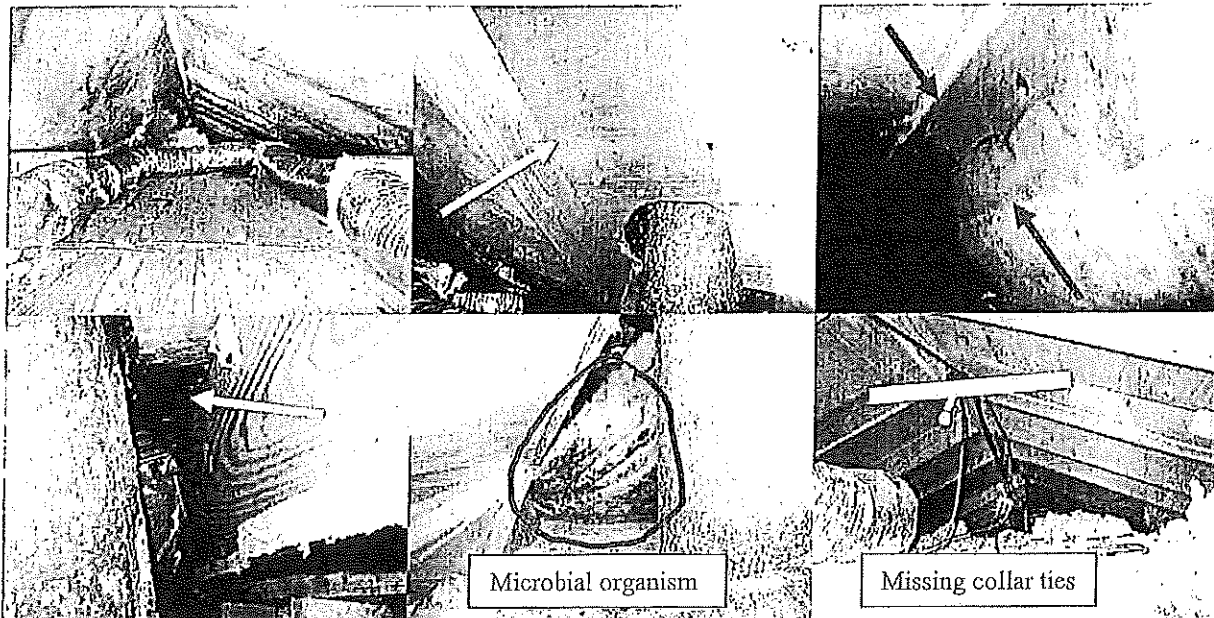
- The attic of the main house addition has a plastic barrier fastened to the underside of the rafters which is vapor "impermeable". That means that water vapor cannot get out of the house. This should never be done in the Southern climate. Fiberglass insulation is installed between the plastic, rafters, and the roof deck. This can lead to microbial organism growth. I did notice some growth near the chimney flue. I also observed what appears to be an active leak around the chimney flue. I suggest removing the plastic and taking whatever measures needed to remove the microbial growth and repair the roof leakage. The insulation is also falling out of the installation (none between red arrows). Should you replace the insulation with more fiberglass material, please consider that studies have shown it must be covered on all six sides to preserve the R-value. Make sure to use a vapor permeable membrane this time.

- Rodent activity and rodent nests in the insulation.
- Missing collar ties where the rafters attach to the ridge. Collar ties are a horizontal framing member used to tie the opposing rafters together and keep the ridge from separating.

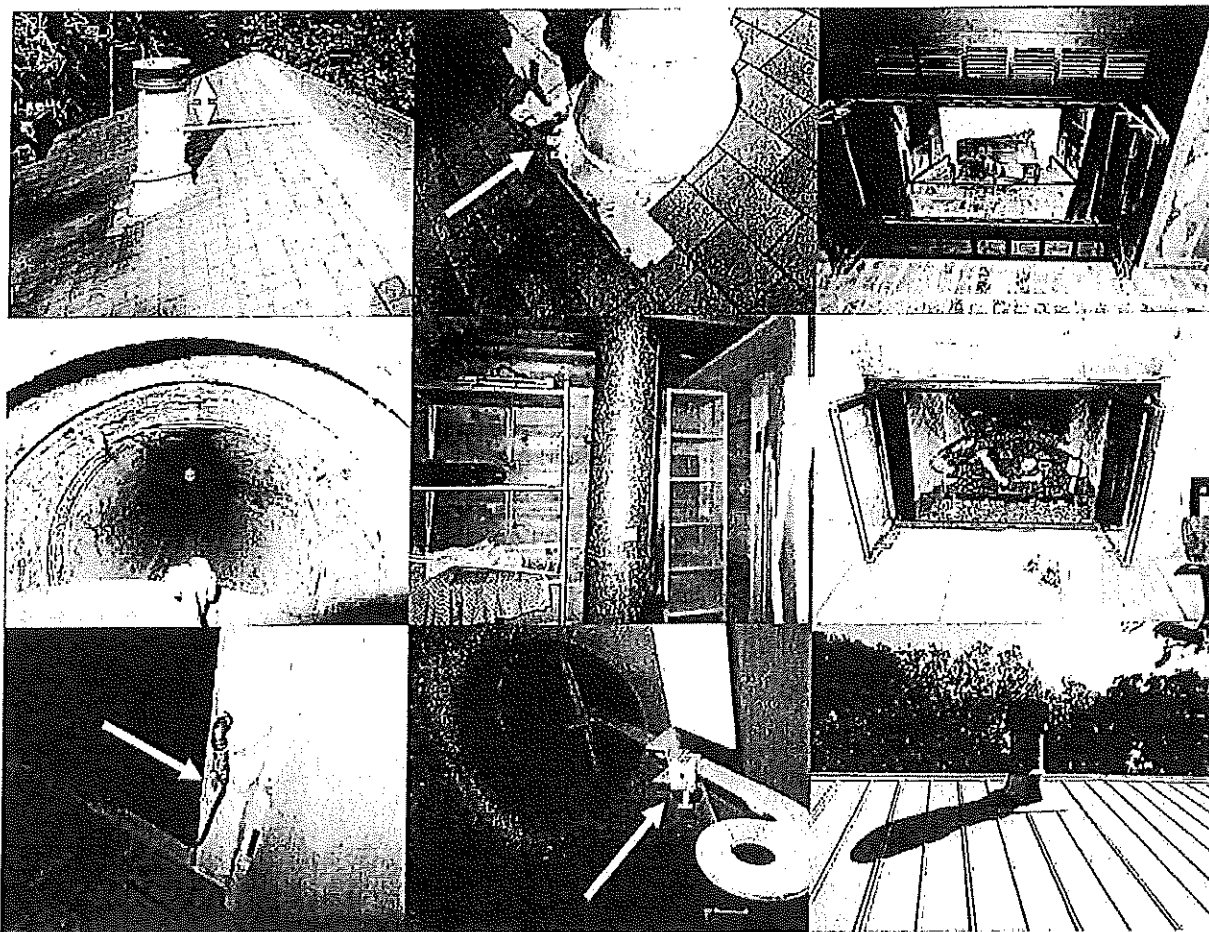
- The flue should be 2' above the closest roof area within 10' and is currently about 15" – may cause the chimney not to draw smoke adequately.
- Rusted flashing and evidence of water leakage in the attic around the flue.
- The pool house damper clip is improperly installed on the damper. It is on the damper handle and not on the damper itself – see manufacturer specs.
- No sediment trap on the gas line at the valve (PH).

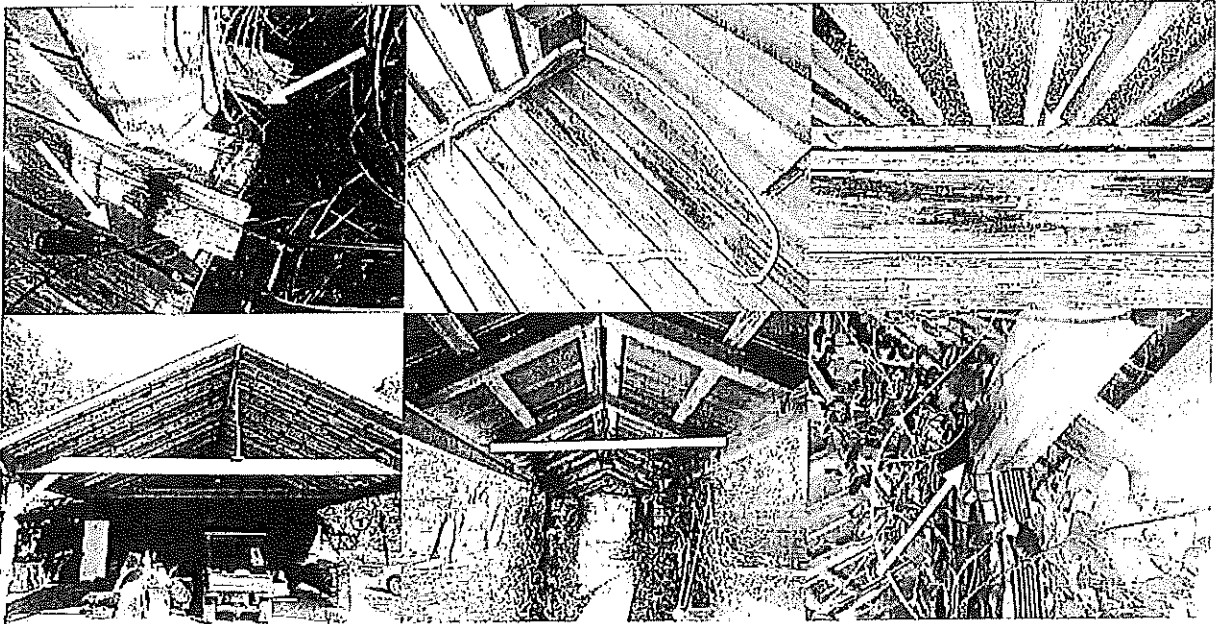
- Two beams are supported only by nails – should have a beam hanger or notched into the post top. Also, it could benefit from a rafter tie at least at mid-span of each section. This would help keep the beams from spreading apart.

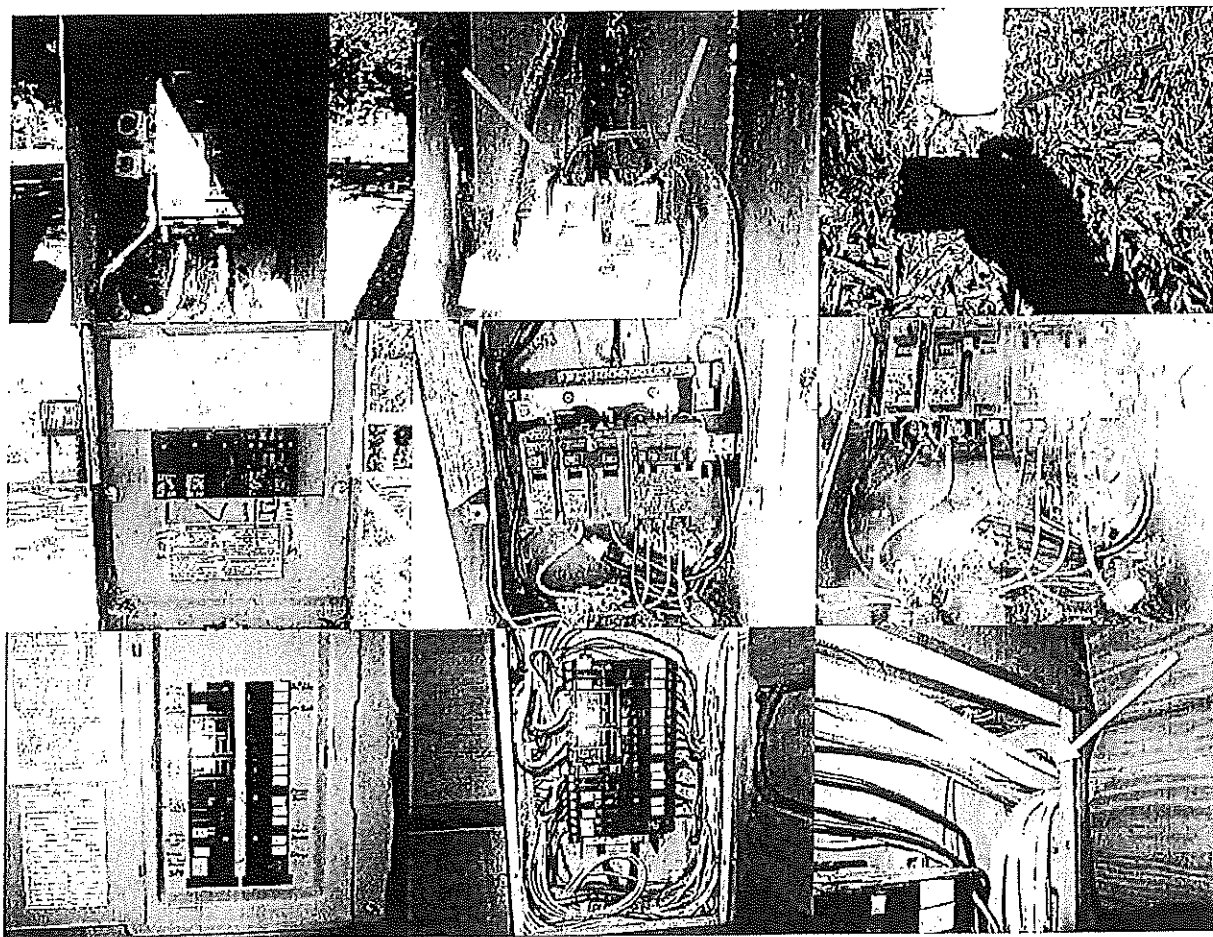
- Wiring entering the breaker panel without grommets or cable clamps.
- Missing trip ties.
- Comment: There is one 6/2 wire inside the house breaker panel which has a 70amp breaker. It is for the 2<sup>nd</sup> floor furnace. This wire got very hot during operation of the furnace. It could possibly be acceptable for a 75amp circuit however I did not check the type of wiring to verify this. If you are having a professional electrician checking the other items listed above, I suggest that he check this issue as well.

- Breakers are not all permanently labeled.

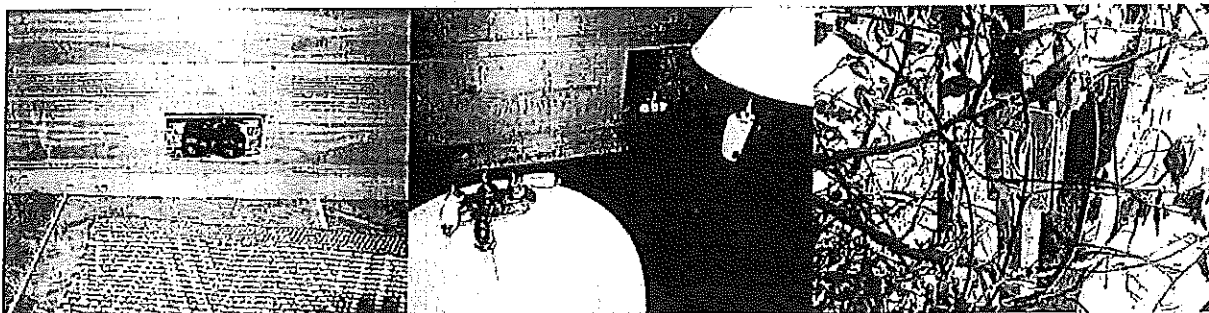
- Missing receptacle cover plates.
- GFCI are not in all required locations and those on site are not all functioning properly.
- Found several receptacles; especially in the kitchen which show a "bad ground". I opened one receptacle cover plate and the ground wire was properly connected. The issue must be somewhere else in the circuit.
- The 3-way switch for the walkway cover lighting is not functioning properly.
- Comment: I did not check for a 3-way light switch at the top and bottom of the stairs. It should be installed if not present.
- Several light fixtures not functioning – may need bulbs.

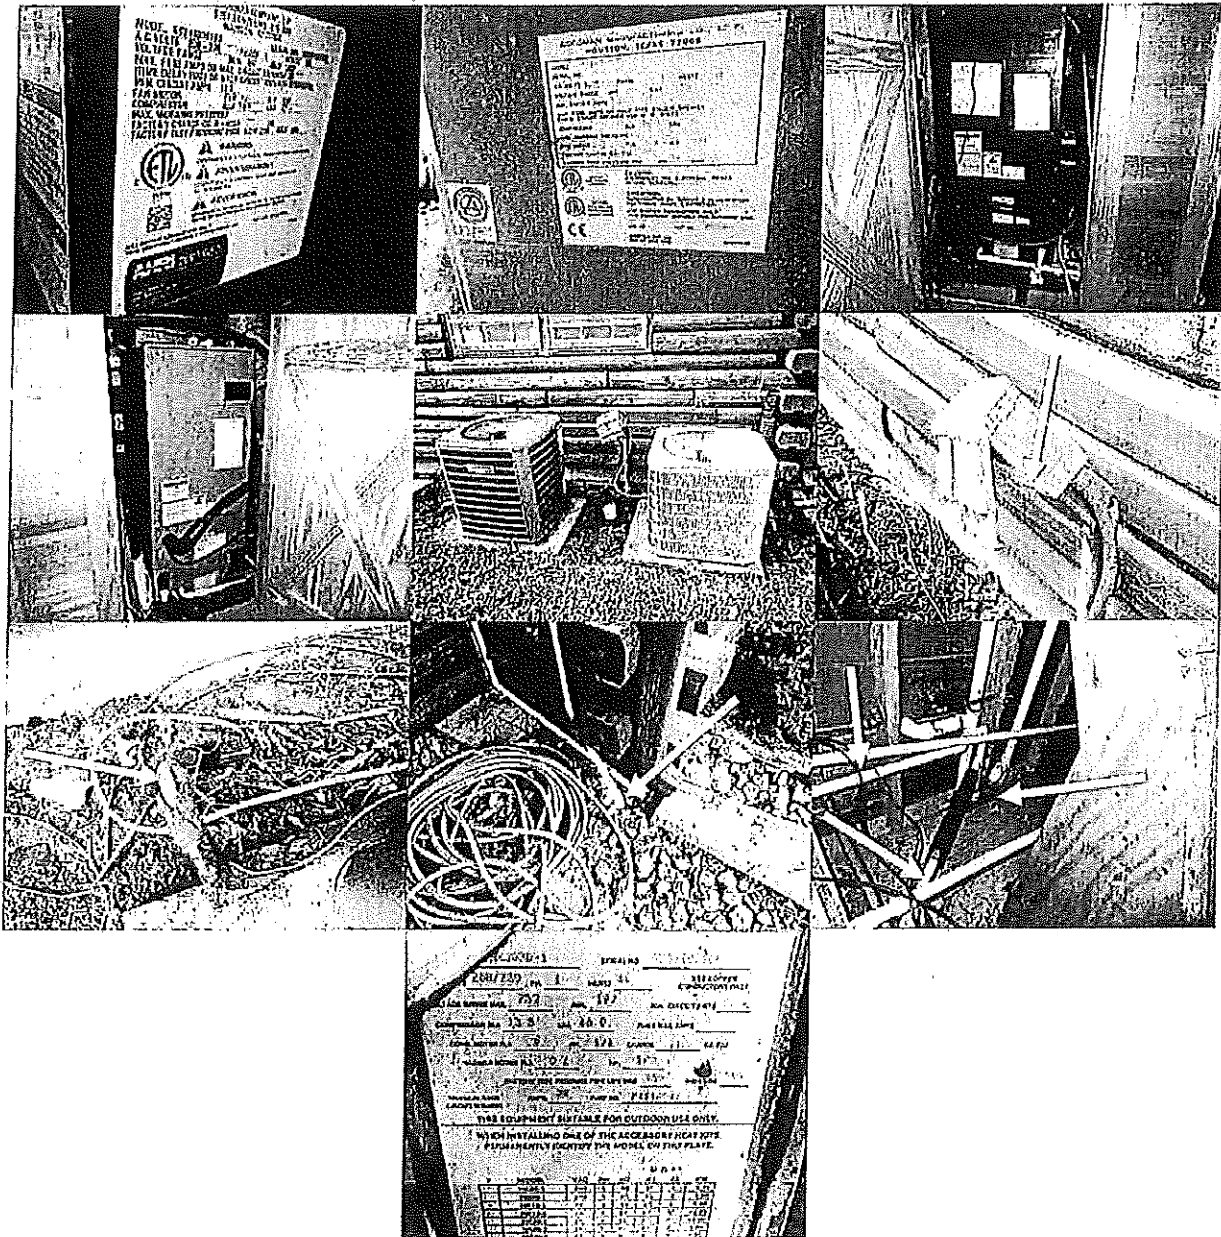
- One unit has a 40amp breaker installed and the maximum should be 30amp.
- The disconnect boxes on the main house are disconnected from the supply conduit – needs repair.
- Missing insulation on the refrigerant line.
- The main condensate is terminating at the foundation. It should terminate further away so as not to cause a foundation concern.

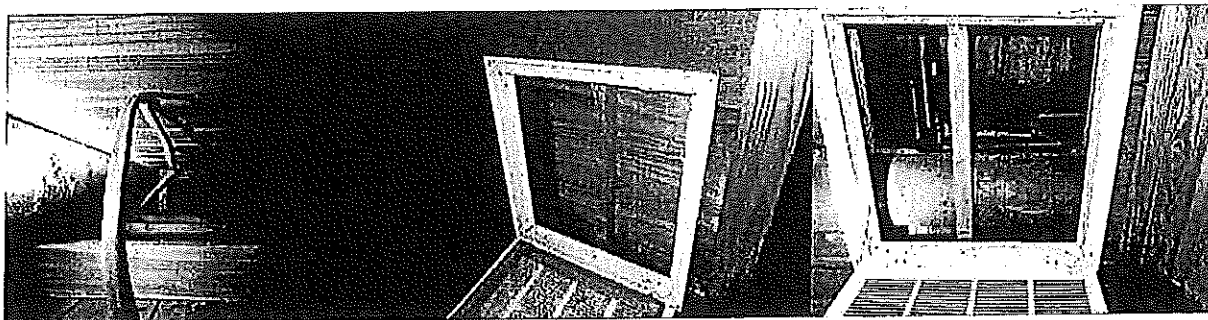
- The return air chase is partially plank siding. I suspect that the planks leak air between the planks themselves which means that air may be bypassing the filter and causing the coils to get dirty – decreased efficiency of the AC unit.
- Comment: Two ducts on one unit are leaking at the plenum; however since the ducts are inside the conditioned space, it should not matter. That is if the insulation is fixed in the attic.

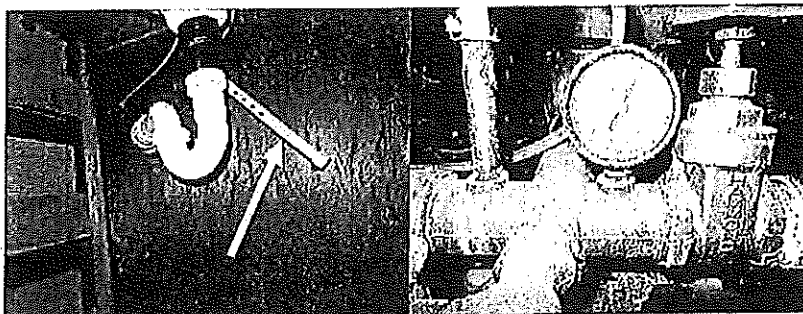
- No backflow devices on exterior faucets.
- Leaking water on the "Hot" water supply at the kitchen sink.
- Slightly loose commode.
- Sink stopper not functioning in at least two locations.

*REPAIRED*

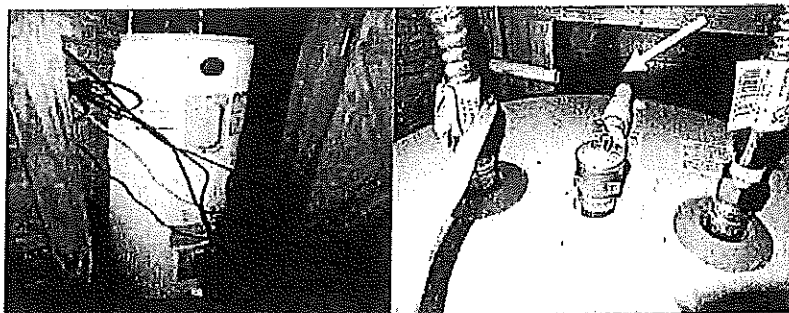
- I did not see a drain line for the drain pan exiting the building. Should the heater leak, you may have 50 gallons of water in the house.
- The TPR line is disconnected. Should this valve open, you may have 50 gallons of scalding hot water in the house. Please be aware that most manufacturers limit the maximum number of elbows from this valve to the termination point to 4 and a 35' maximum run. The line must also terminate within 6" of grade.
- The unit is not bonded to the water lines.
