## HOME INSPECTIONS INC.

**Prepared For:** Steven L. Rinehart

**Concerning:** 29442 Hegar Road Hockley, Texas 77447

**By:** Thomas Martin #7790

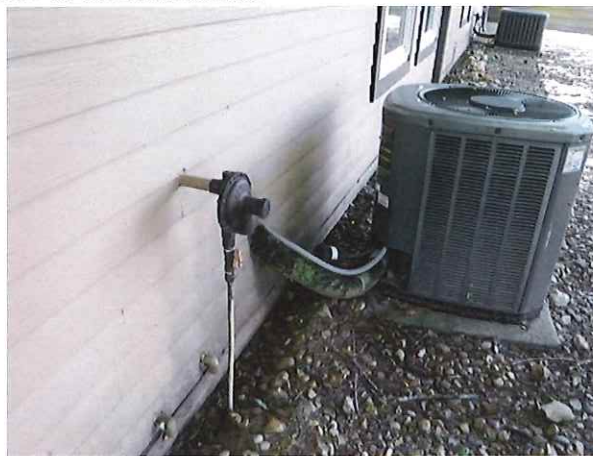
- ★ The bricks, stored items and debris should be removed away from the foundation to prevent masking evidence of wood destroying insects entering the residence.
- ★ There is a channel at the back side of the home due to the soil line being too high. This provides an area for water to sit too close to the foundation.

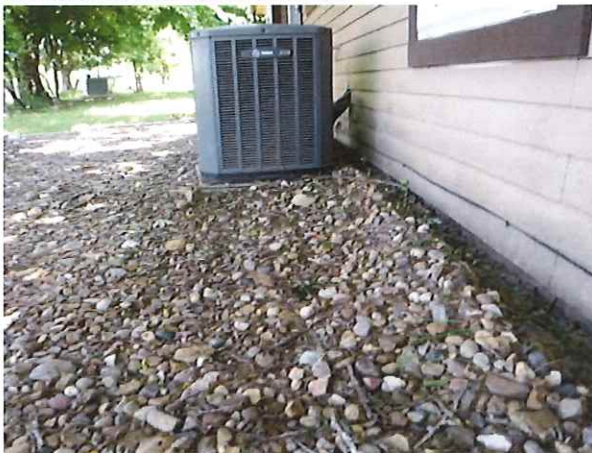
- ★ The grading at areas around the house does not properly direct water away from the foundation. The code requires a minimum fall of 6 inches in the first 10 feet of the foundation. REF IRC R401.3 Gutter systems and underground drainage systems can also be useful tools in directing water away from the foundation. Note: Standing water can cause foundation problems, mosquito infestations and lawn disease.

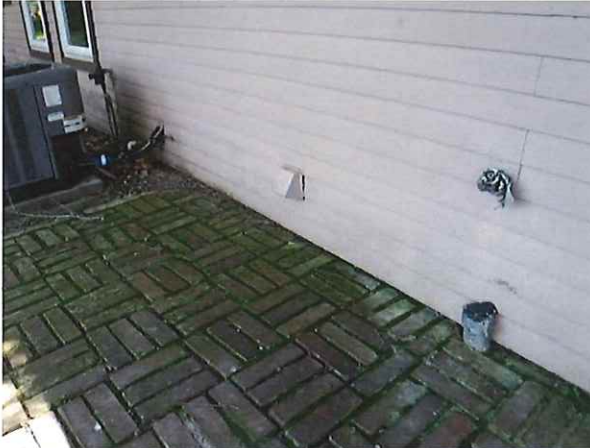
- ★ The hardy cement board siding is in contact with the ground. Hardy board manufacturers installation instructions recommend a minimum of 2" of clearance to patios and paved surfaces.

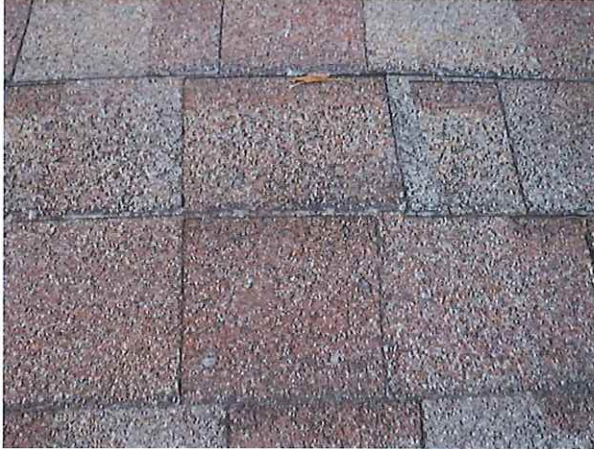
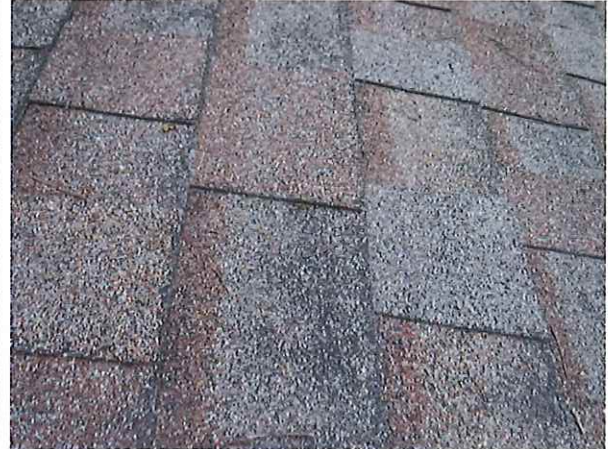
Note: There were areas of roof repairs observed at the front left corner and back side.

Note: The roof is nearing the end of its serviceable life due to one or more of the following conditions; brittle / cracked shingles or excessive granular loss of the shingles.

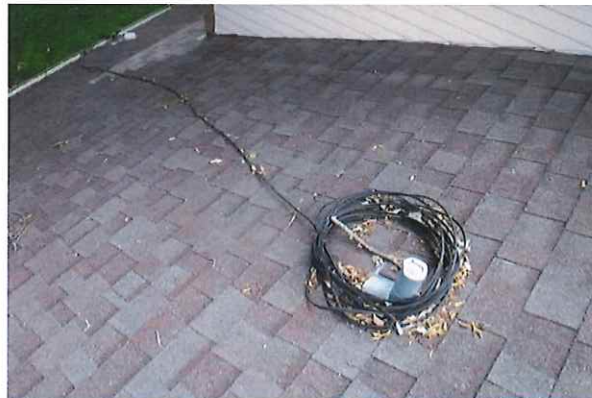
★ There is a section of loose coiled cable at the back-side roof.

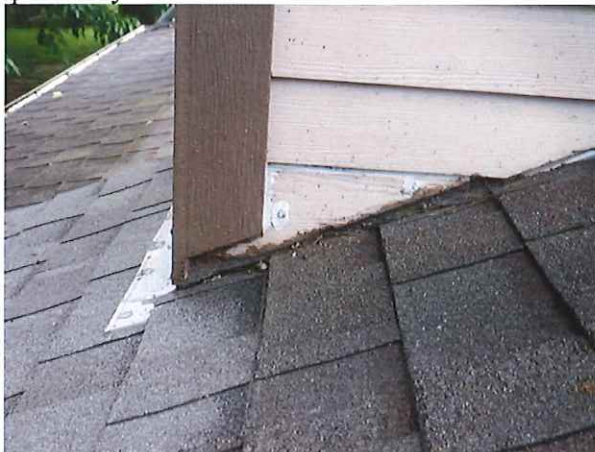
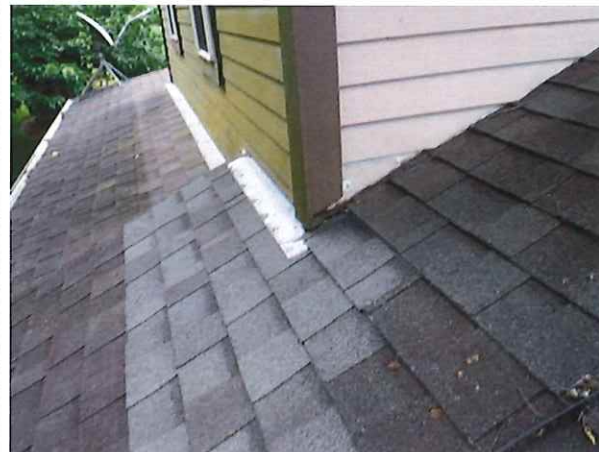
- ★ There is missing or improperly installed flashing at the following locations; back left corner. The area is covered in sealant; not a proper repair. This could allow water penetration if not properly repaired by a licensed roofer.

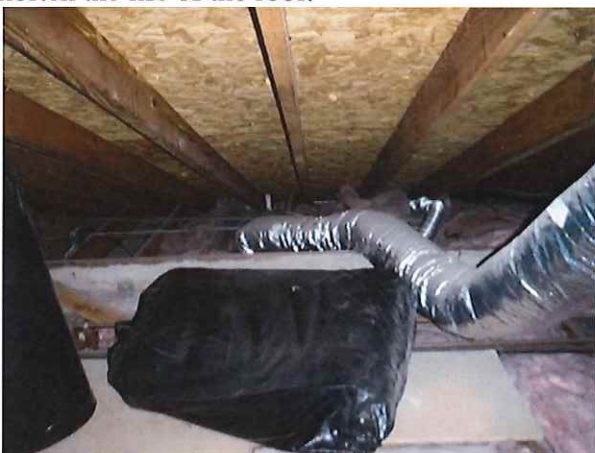
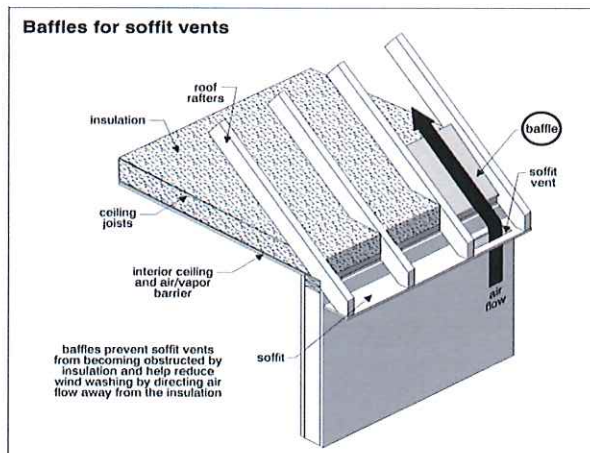
- ★ The soffit ventilation at the eve of the roof appears to be covered with insulation. Recommend the installation of baffles to ensure that the insulation is removed from the vent. "A minimum of 1-inch space shall be provided between the insulation and the roof sheathing at the location of the vent." REF IRC R806.3 Insufficient attic ventilation will increase the cost of utility bills and shorten the life of the roof.

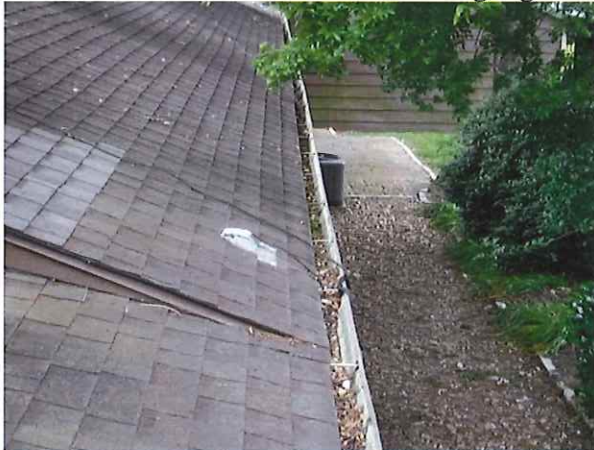
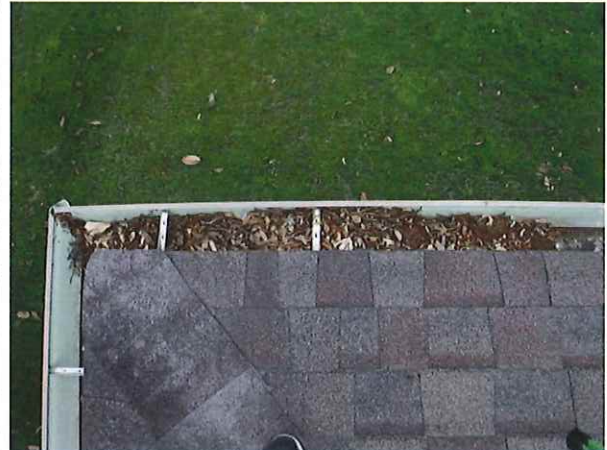
- ★ The rain gutters are full of debris at several locations. Recommend the installation of debris guards at all sides for less maintenance and longer gutter life.

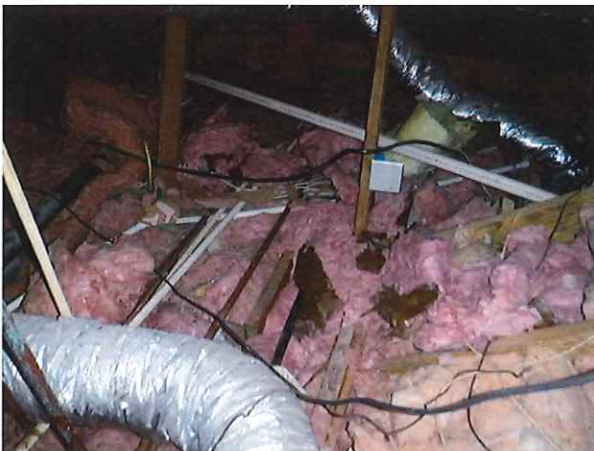
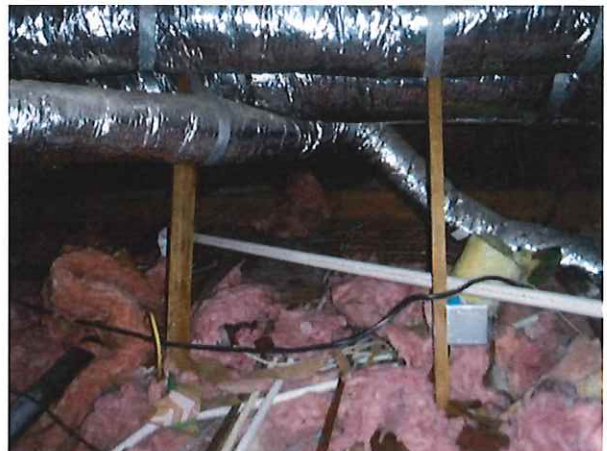
- ★ There is evidence of rodents in the attic by trampled / uneven insulation or of rodent droppings. Recommend quarterly pest control by a licensed professional.
- ★ The insulation installed in the attic is misplaced, trampled and missing. Recommend installing 12 inches of loose fill attic insulation or the equivalent of an R-30 value to make the home more efficient. An R-30 value is the recommend R-value for this region. REF IRC TABLE N11023.1

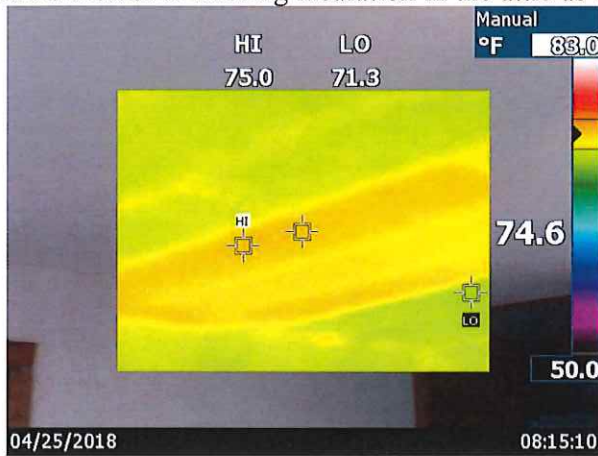
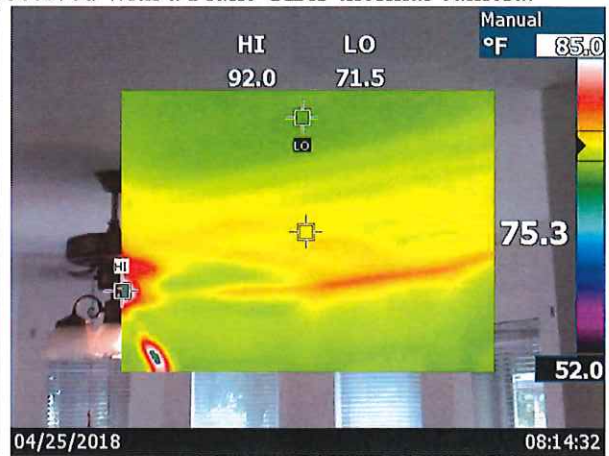
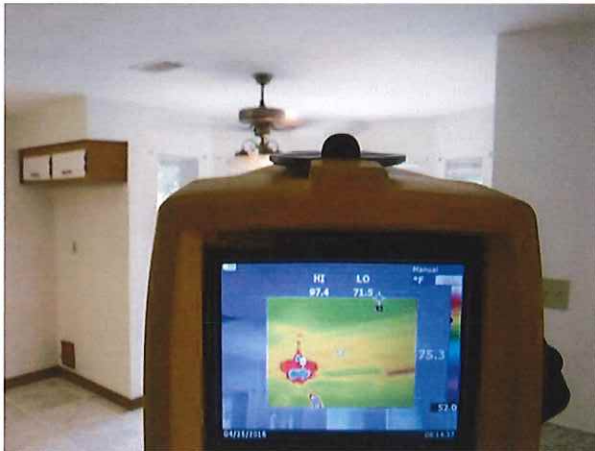
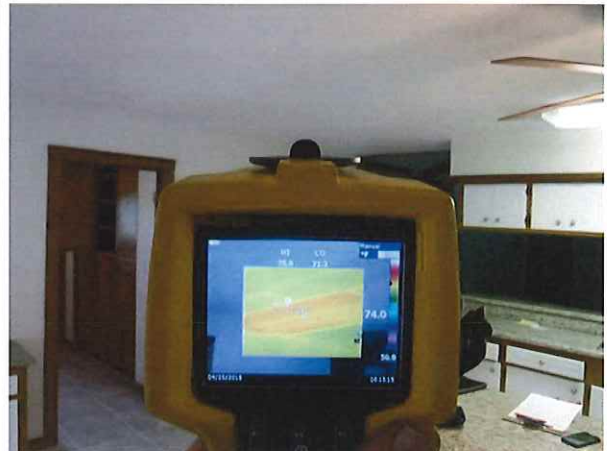
- ★ There are areas of missing insulation in the attic as observed with a Fluke TIR1 thermal camera.

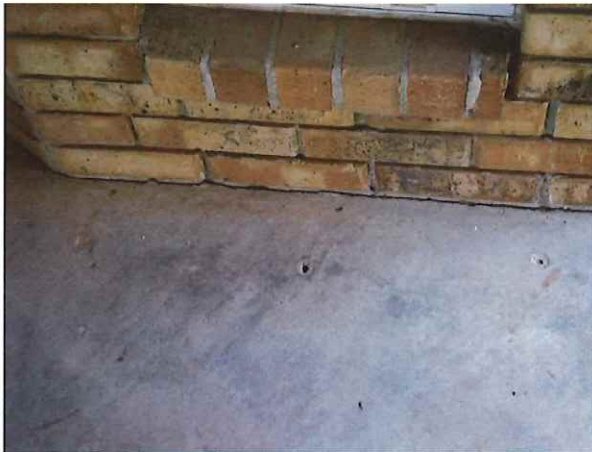
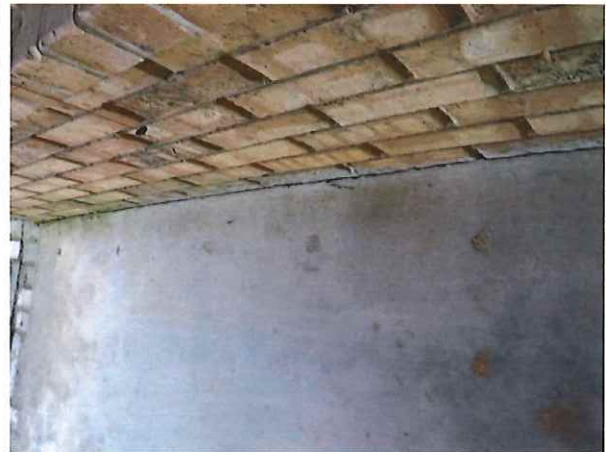
Note: There is evidence of previous termite treatment of the house either by drill marks around the foundation or a treatment sticker. Recommend inquiring with the seller to see if there is a transferable warranty available.

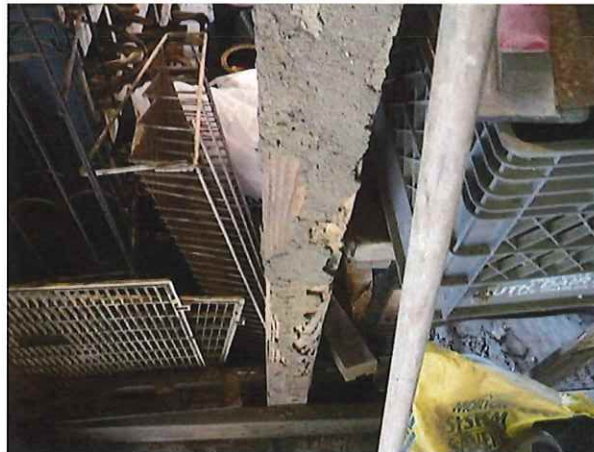
★ There is termite damaged material in the garage. No active termites were located.

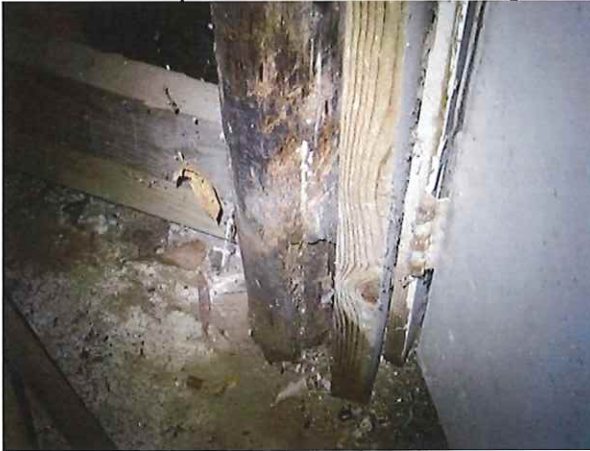
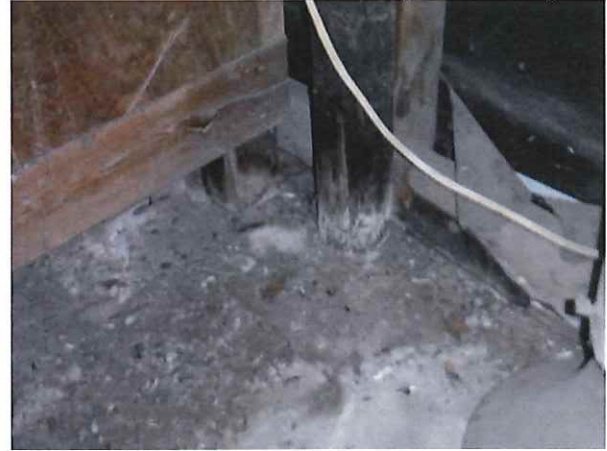
- ★ There are several posts that have some damage at the base of the barn. The barn is of pole framing.

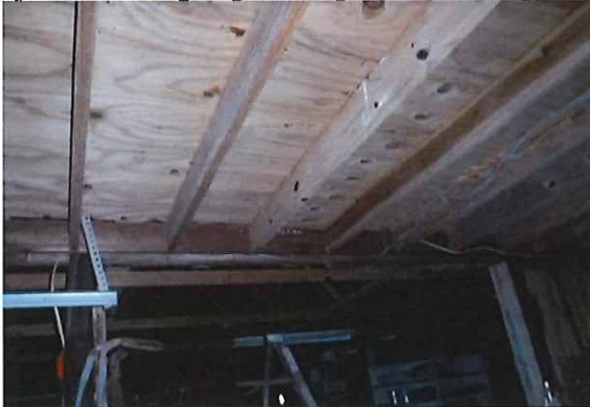
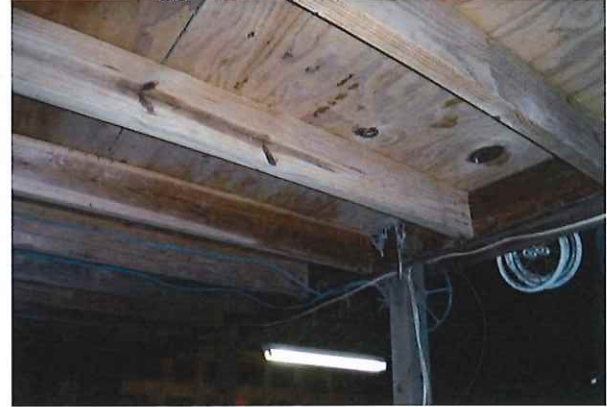
- ★ The joists for the garage ceiling area for storage above are missing joist hangers.

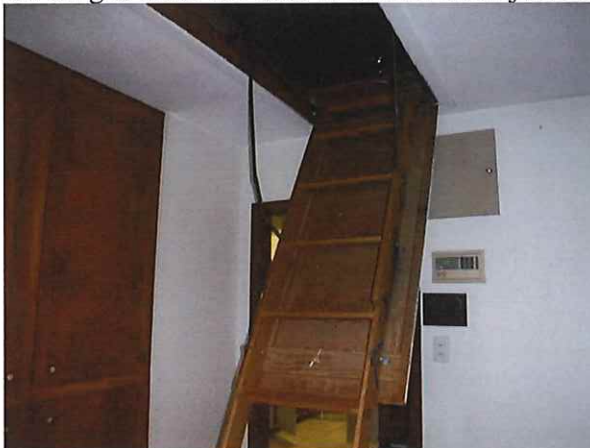
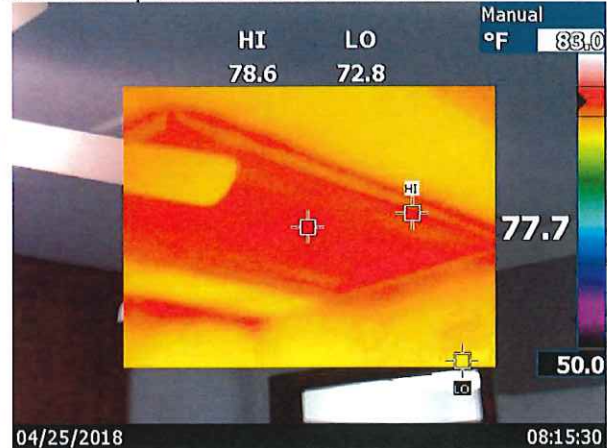
- ★ The attic access door is not insulated and the gap at the door frames are not properly sealed / insulated with expanding foam. The door should be insulated with a hardboard insulation panel. The thermal image shows the transfer of heat and temperature differential. Recommend making a box out of a hardboard insulation panel to fit the entire door opening high enough to clear the door hinges when the door is closed. Then just remove and replace the box for access.

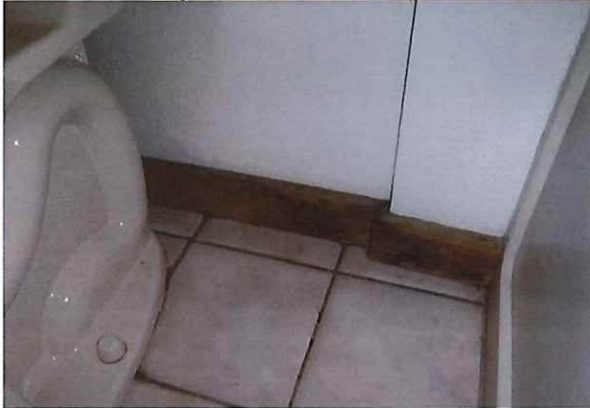
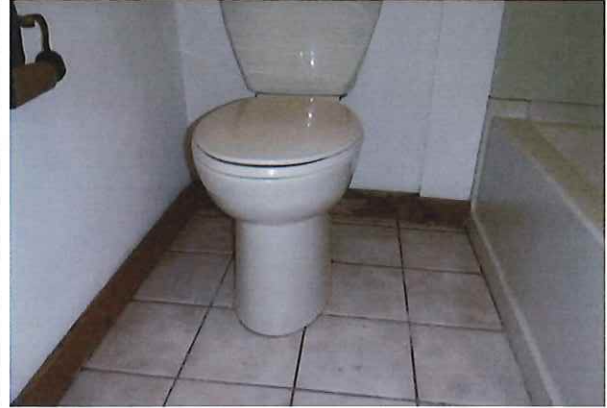
- ★ There are water stains at the guest bath base boards; probably due to high soil at the back exterior. The area was dry at the time of inspection as checked with a Delmhorst moisture meter.

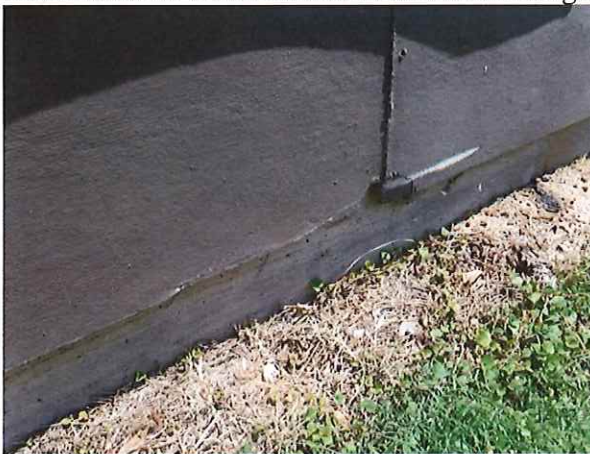
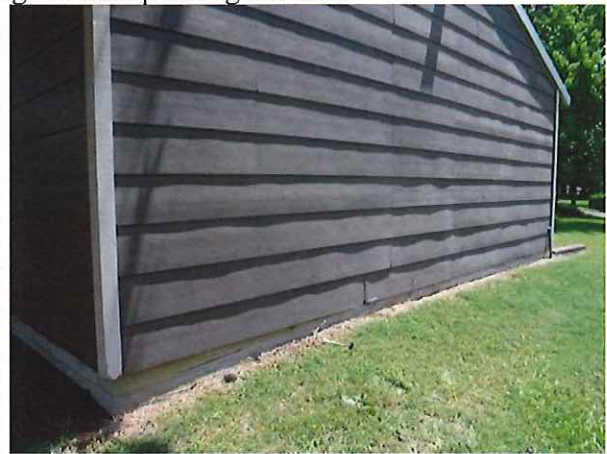
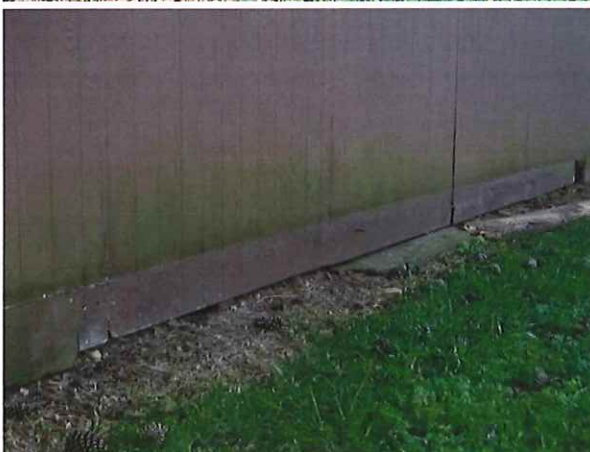
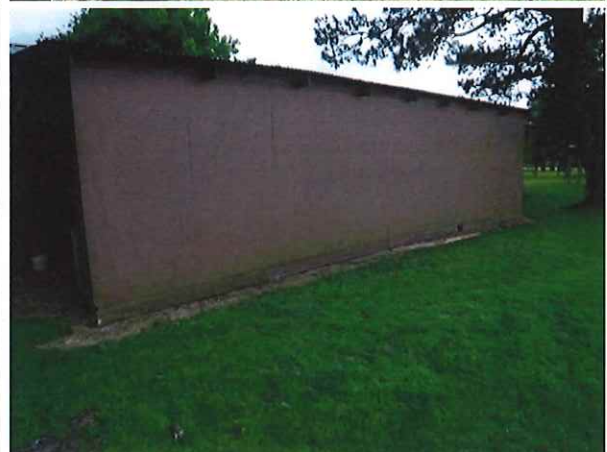
- ★ There are areas observed of wood to ground contact. These areas are more susceptible to wood decay and termite activity; garage at several locations.
- ★ There are areas of wood rot observed around the garage and shop siding material.

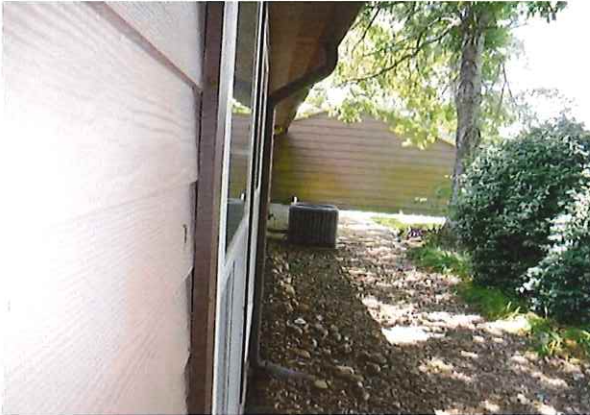
- ★ The hardy board trim is over the siding around the windows creating a gap for pests; incorrect according to hardy installation instructions. Hardy board installation instructions show the siding material to butt up to the trim board prevent any gaps in material. The image is from the hardy board installation instructions.

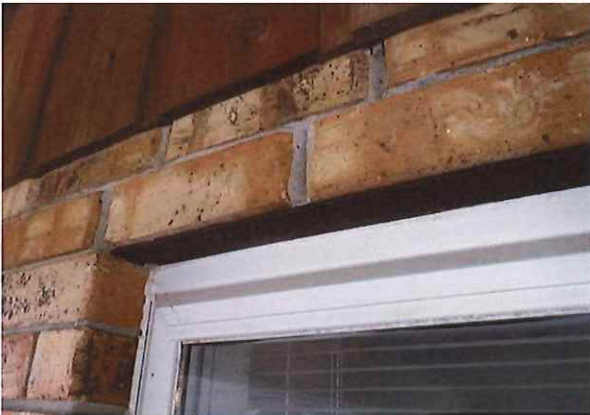
**Rusting lintels**

- ★ The lintels are rusting and above the windows / doors. When metal rusts' it expands and can cause brick cracks.

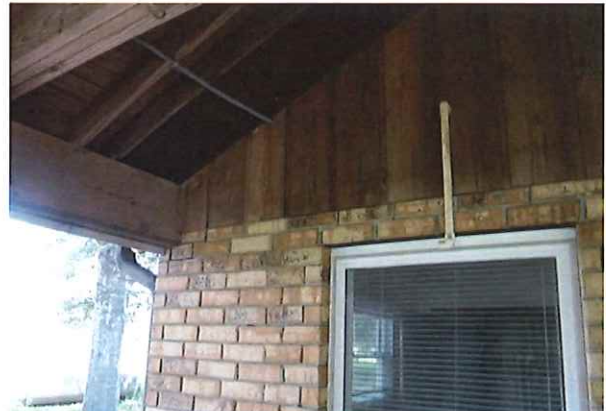
- ★ The sealant at most penetrations of the house is deteriorated or gaps in material. All penetrations and openings around the exterior should be properly sealed with caulk, screen mesh, expanding foam or mortar as needed to keep out moisture and unwanted pests (Do not seal up weep holes where the brick meets the slab).

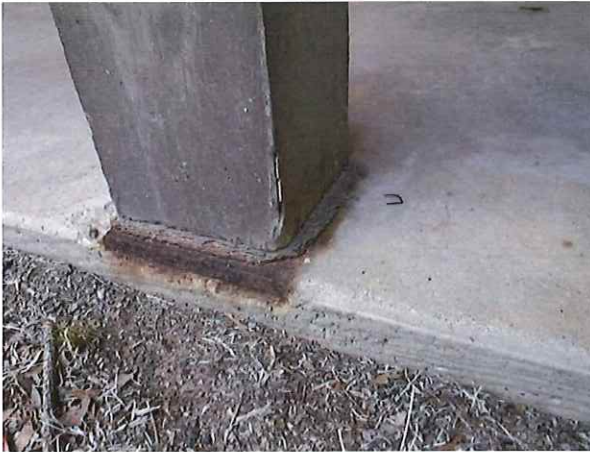
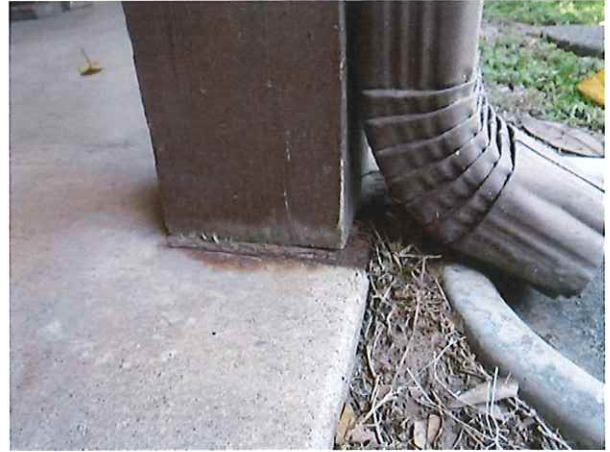
- ★ The columns should not be in contact with the ground to help in the prevention of wood rot and prevent conducive conditions for termites. A better way is to install a metal bracket support at the bottom.
- ★ The metal pad below the supports are much rusted. The metal should be treated.

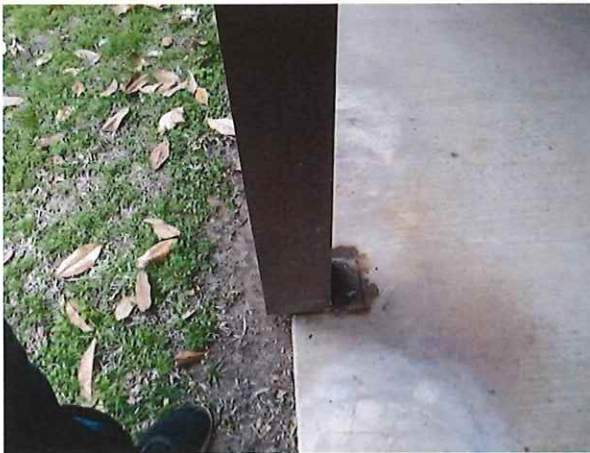
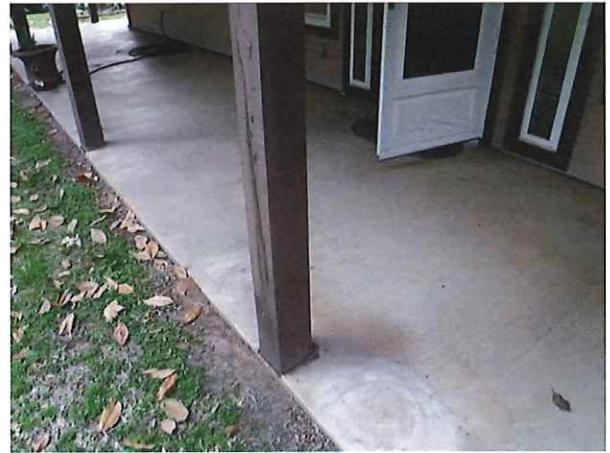
- ★ There is a loose beam to the right of the front door.

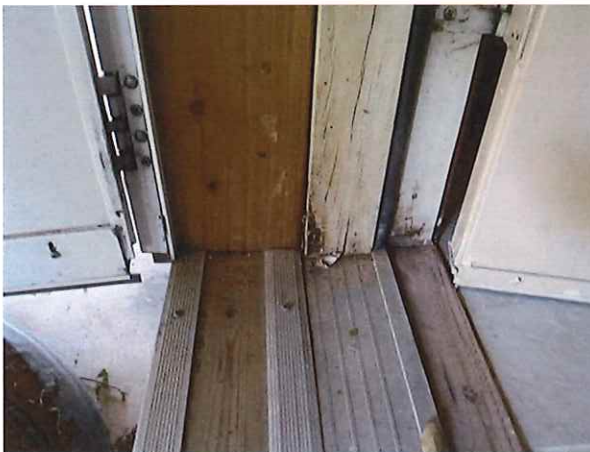
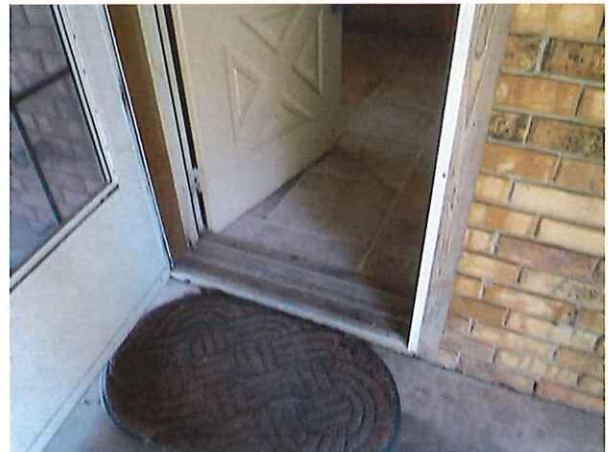
★ The bottom edge of all exterior door frames and threshold are not properly sealed. The bottom of the trim board should have a solid caulk bead around the entire exposed area to prevent wood rot.  
Note: The exterior trim is wood and the bottom cut end will absorb moisture and rot if not fully sealed.

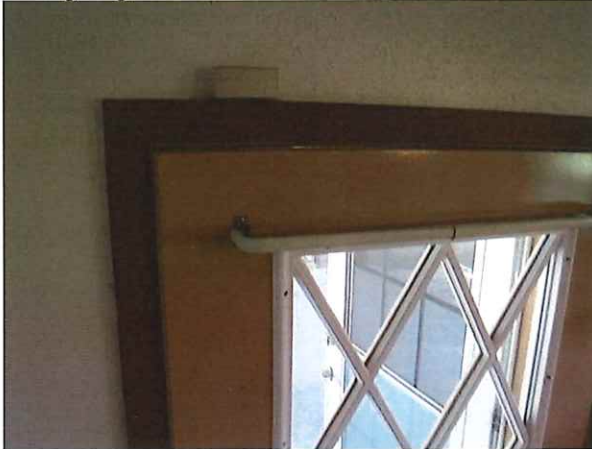
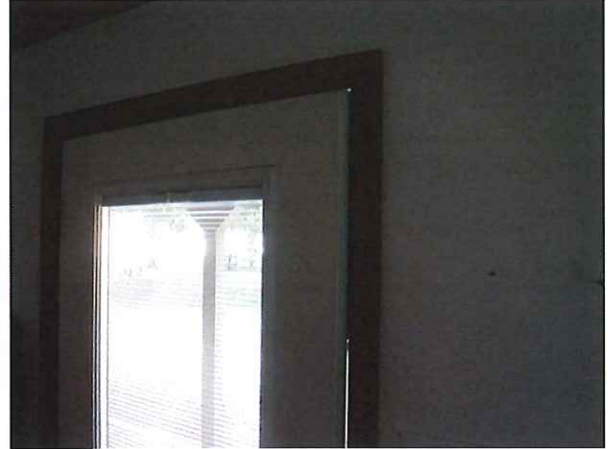
- ★ The door rubs the frame at the top and requires adjustment to close properly; master and side door to the garage.

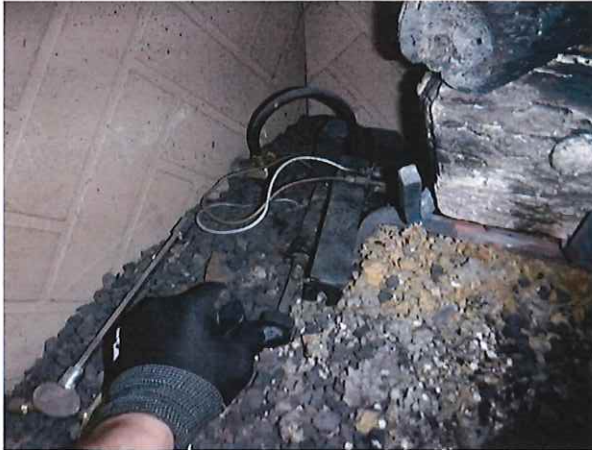
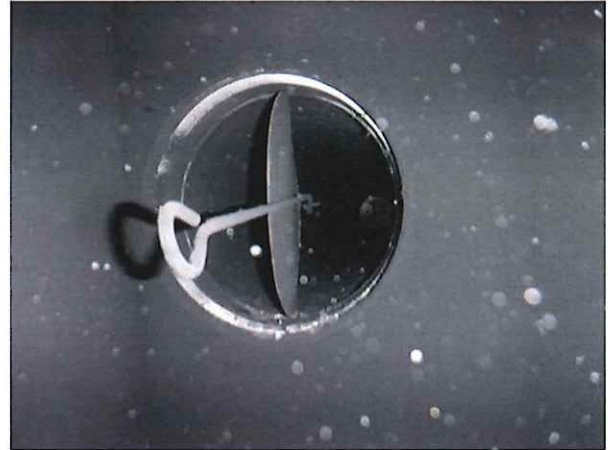
- ★ The pilot would not light.
- ★ All gas fireplaces should have a required damper bracket that prevents the damper from completely closing to allow gas to escape to the exterior in the case of a gas leak. REF IRC 2433.1

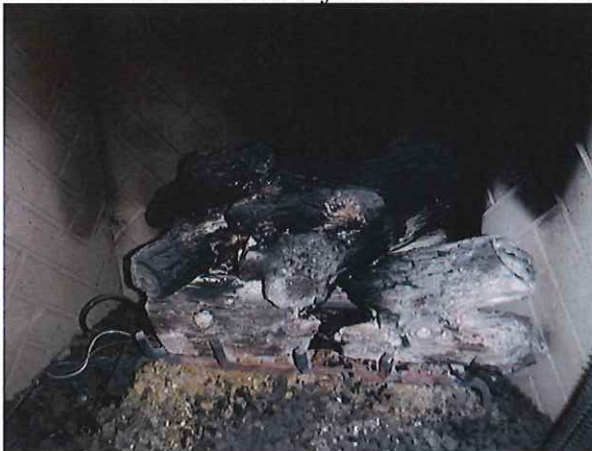
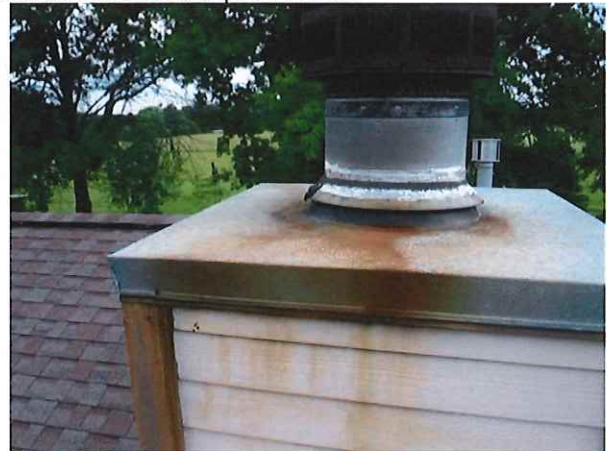
- ★ The chimney cap is rusted; recommend to sand, prime and paint or replace to prevent rust holes in the cap.
- ★ The soot build-up on the faux logs indicates improper combustion air & fuel mixture. Recommend service to clean soot and adjust air/fuel mix to reduce/eliminate soot production.

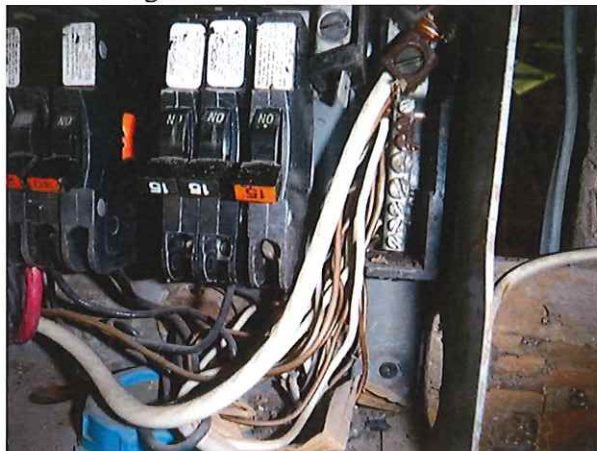
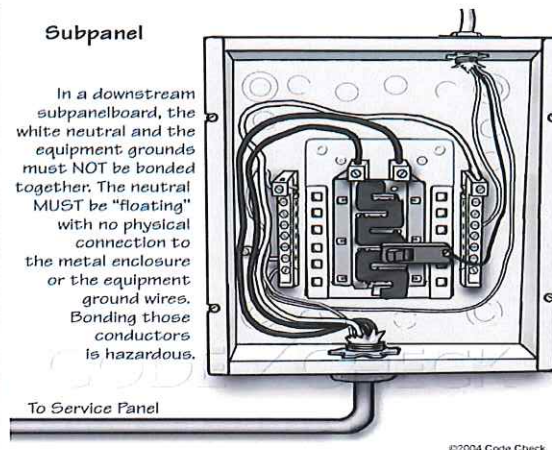
- ★ The sub-panel(s) neutral and ground wires should not be bonded together; garage. "A grounding connection shall not be made to any grounded circuit conductor on the load side of the service disconnecting means". REF IRC E3507.2

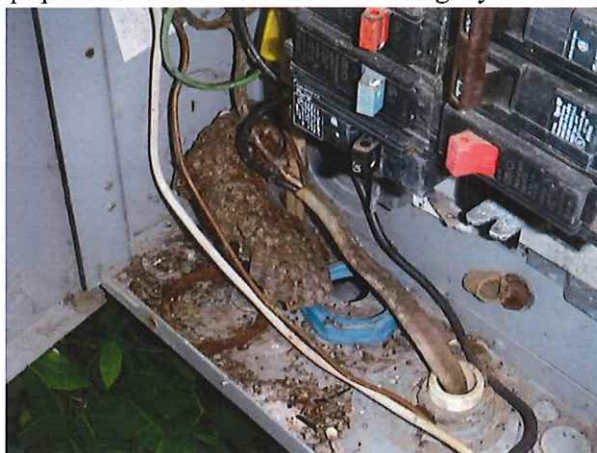
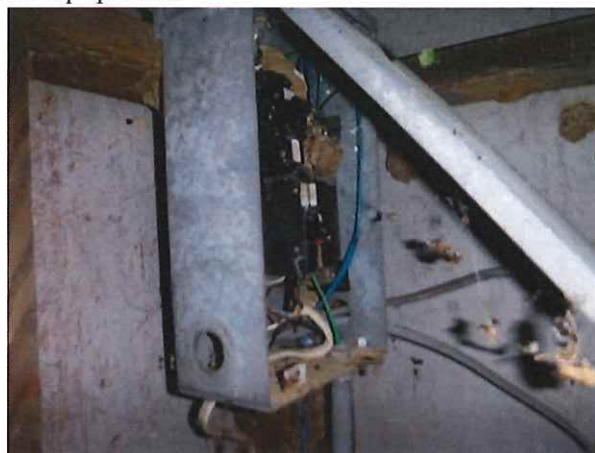
- ★ There are knock out covers missing leaving a hole or space for pests to enter.
- ★ There are missing grommets where wiring enters panel; all locations.
- ★ The electrical panel is contaminated with paint / foreign debris. "Internal parts of electrical equipment, including bus bars, wiring terminals, insulators and other surfaces, shall not be damaged or contaminated by foreign materials such as paint, plaster, cleaners or abrasives, and corrosive residues. There shall not be any damaged parts that might adversely affect safe operation or mechanical strength of the equipment such as parts that are broken; bent; cut; deteriorated by corrosion, chemical action, or overheating. Foreign debris shall be removed from equipment." REF. IRC E3304.6 Integrity of electrical equipment.

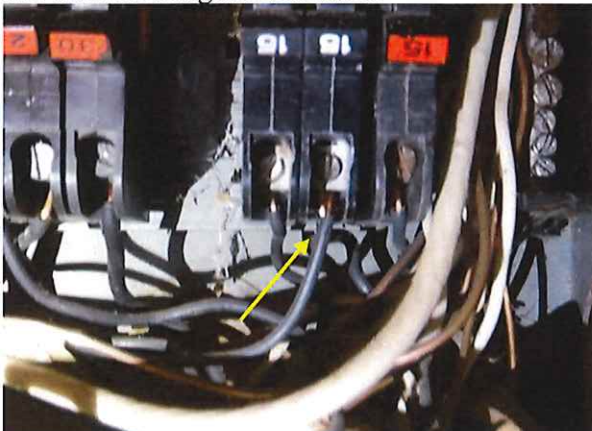
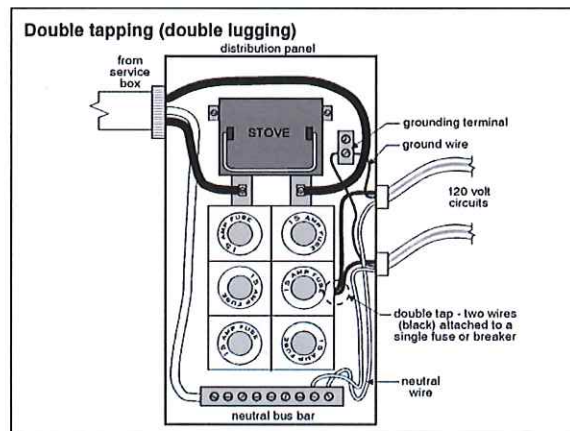
**VIOLATION** (pointing to multiple wires on one terminal)

- ★ There is a breaker in the panel with more than one conductor. Double lugging at an electrical connection can cause excessive heat or loose connection. Each device or branch wiring should have its own designated breaker.

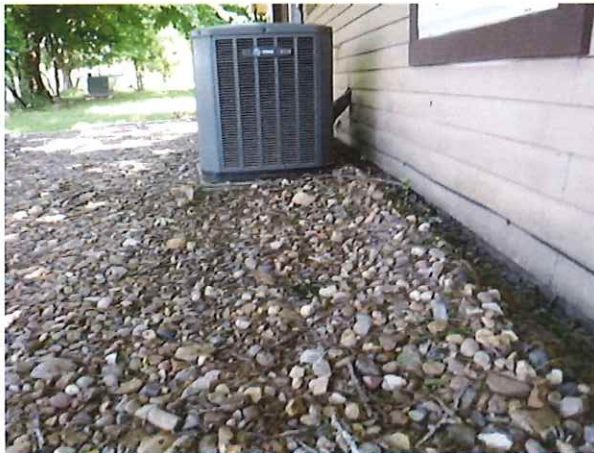
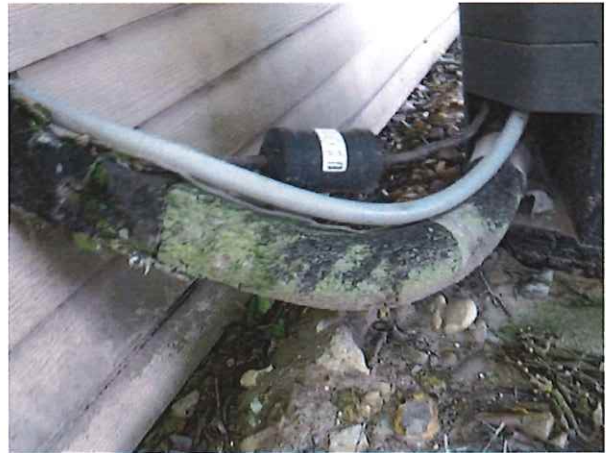
- ★ A section of suction line insulation is missing and/or damaged near condenser.
- ★ The condensing unit is on or near the ground. Recommend elevating 3 inches from the ground to protect from vegetation and moisture damage.

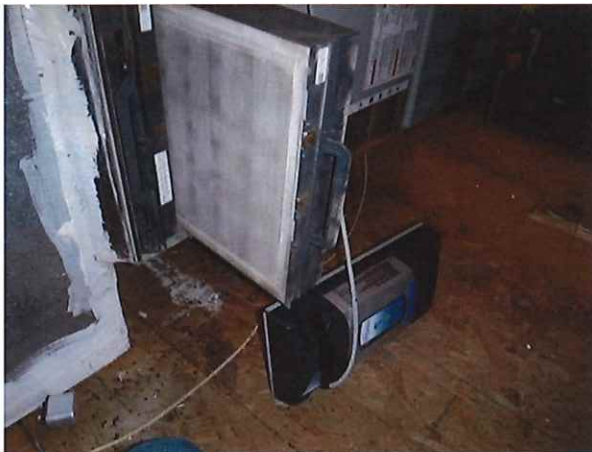
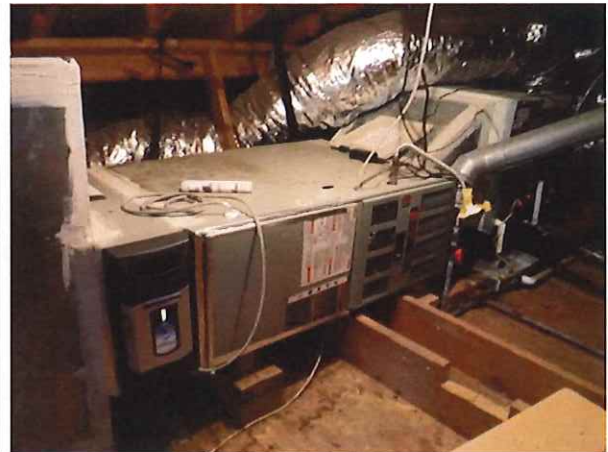
- ★ The filters at the returns should not be used with using the media filtration system. To much stress on system to pull air and not needed.

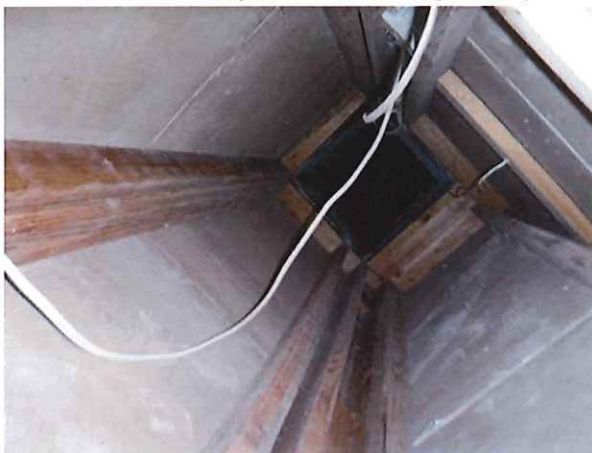
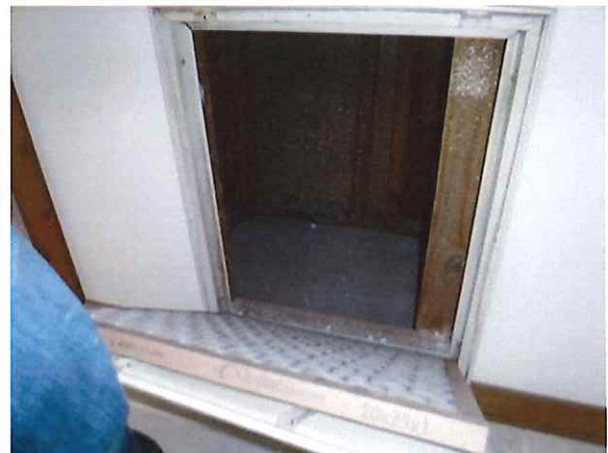
- ★ The return air duct is not sealed allowing air to be pulled from between the walls and flooring. This will reduce efficiency and increase operating costs.

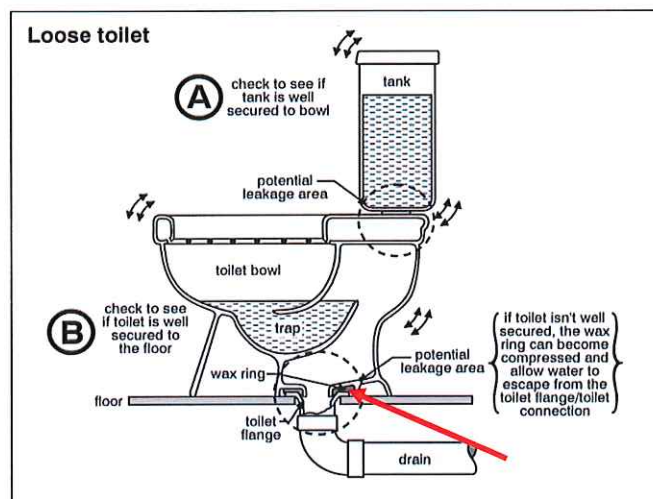
- ★ The base of the commode is loose where it connects to the floor. Recommend replacing the hardware and wax ring for the bowl and ensure there is not leakage at the floor; master and guest bath.

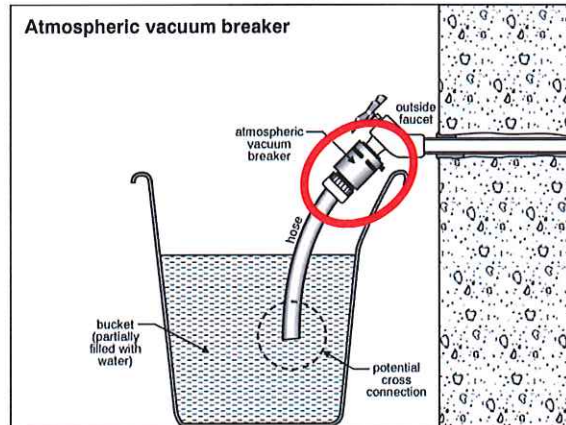
★ Exterior hose bibs are missing required back flow prevention devices. They protect our clean water supply from possible contamination and can be purchased at most hardware stores.

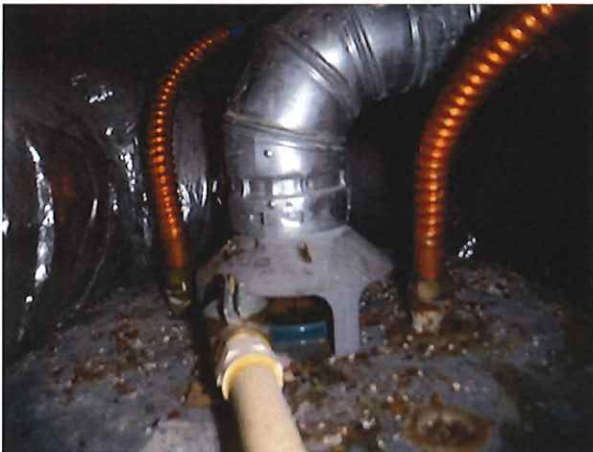
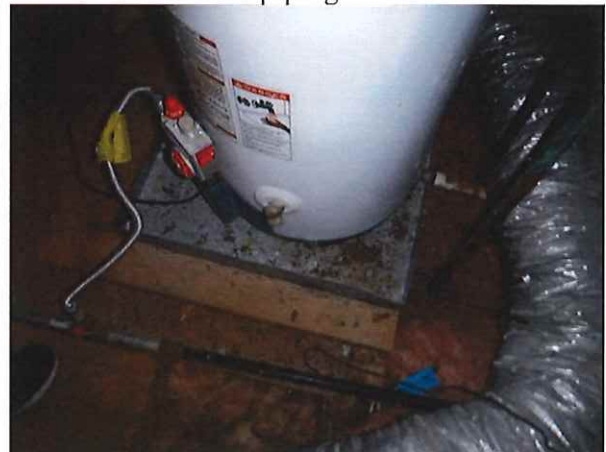
- ★ The vent pipe is not secured at the roof penetration. The exhaust vent should have a metal strap securing it to the rafters.
- ★ The water heater is in the house without a drain pan; if ruptured it would cause damaged to interior walls and floors.
- ★ There is insulation and debris inside of the drain pan which can clog the drain line.
- ★ There corrosion from dissimilar metals and lack of dielectric union at the piping connections.

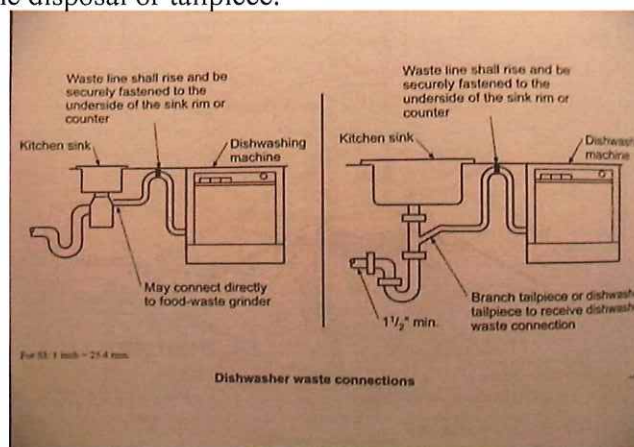
- ★ There is rust observed at some areas on the dish racks.
- ★ The panel cover is damaged at the buttons.
- ★ The dishwasher drain line should be elevated above the drain to prevent gray water from entering the dishwasher from the disposal or tailpiece.

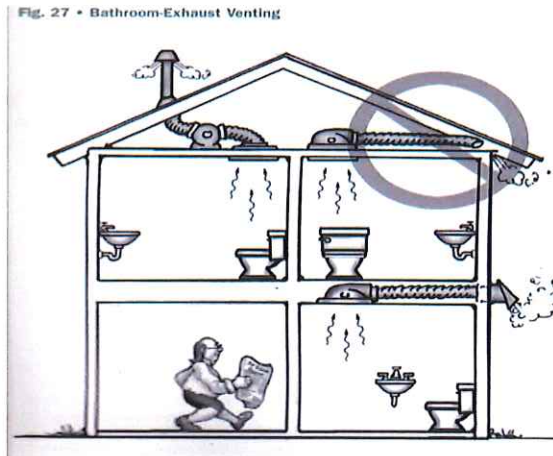
- ★ The bathroom vents should go to the exterior. The soffit or eave of the house is designed as an intake for attic ventilation not for an exhaust.
