Edward W. Timmons Jr., P. E.  
Consulting Geotechnical Engineer  
P.O. Box 2836  
Santa Cruz, California 95063  
(408) 479 4731

Job No. 94-968

Re: Report of Soil Investigation  
Residential Construction - Existing Building Site  
362 Smith Road - APN 109-112-04  
Salsipuedes Rancho Area

Subject: GEOLOGIC HAZARDS ASSESSMENT, APN 109-112-04  
LOCATION: 362 Smith Road  
OWNER: Arriaga

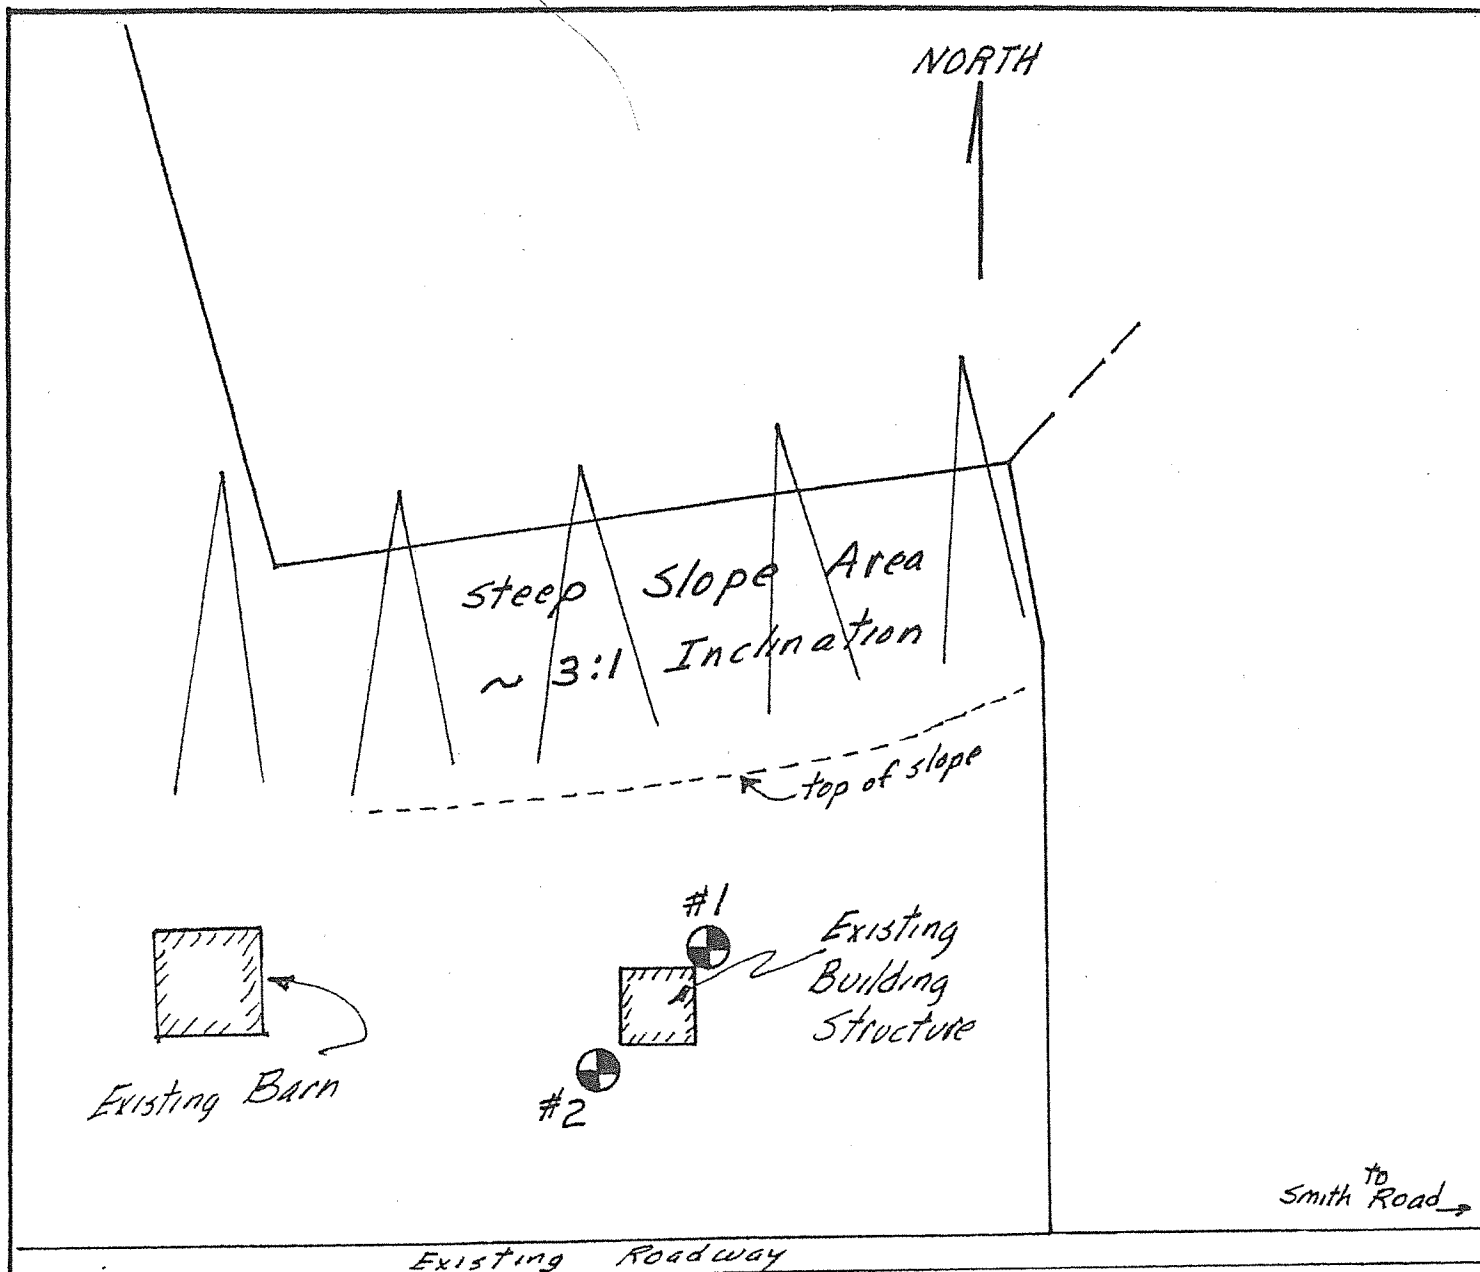
SITE PLAN  
Scale: 1"=100' (approx.)  
Test Hole

soils encountered were classified as to type, strength and settlement characteristics. The location of the test holes are shown on the attached site plan, Figure 1, and the logs of the soils are shown on Figure 2. In addition, available published geologic maps and the County Geologic Hazards Assessment report dated February 18, 1994 were reviewed so as to correlate those previous findings with the actual field findings and to evaluate the seismic conditions at the site.

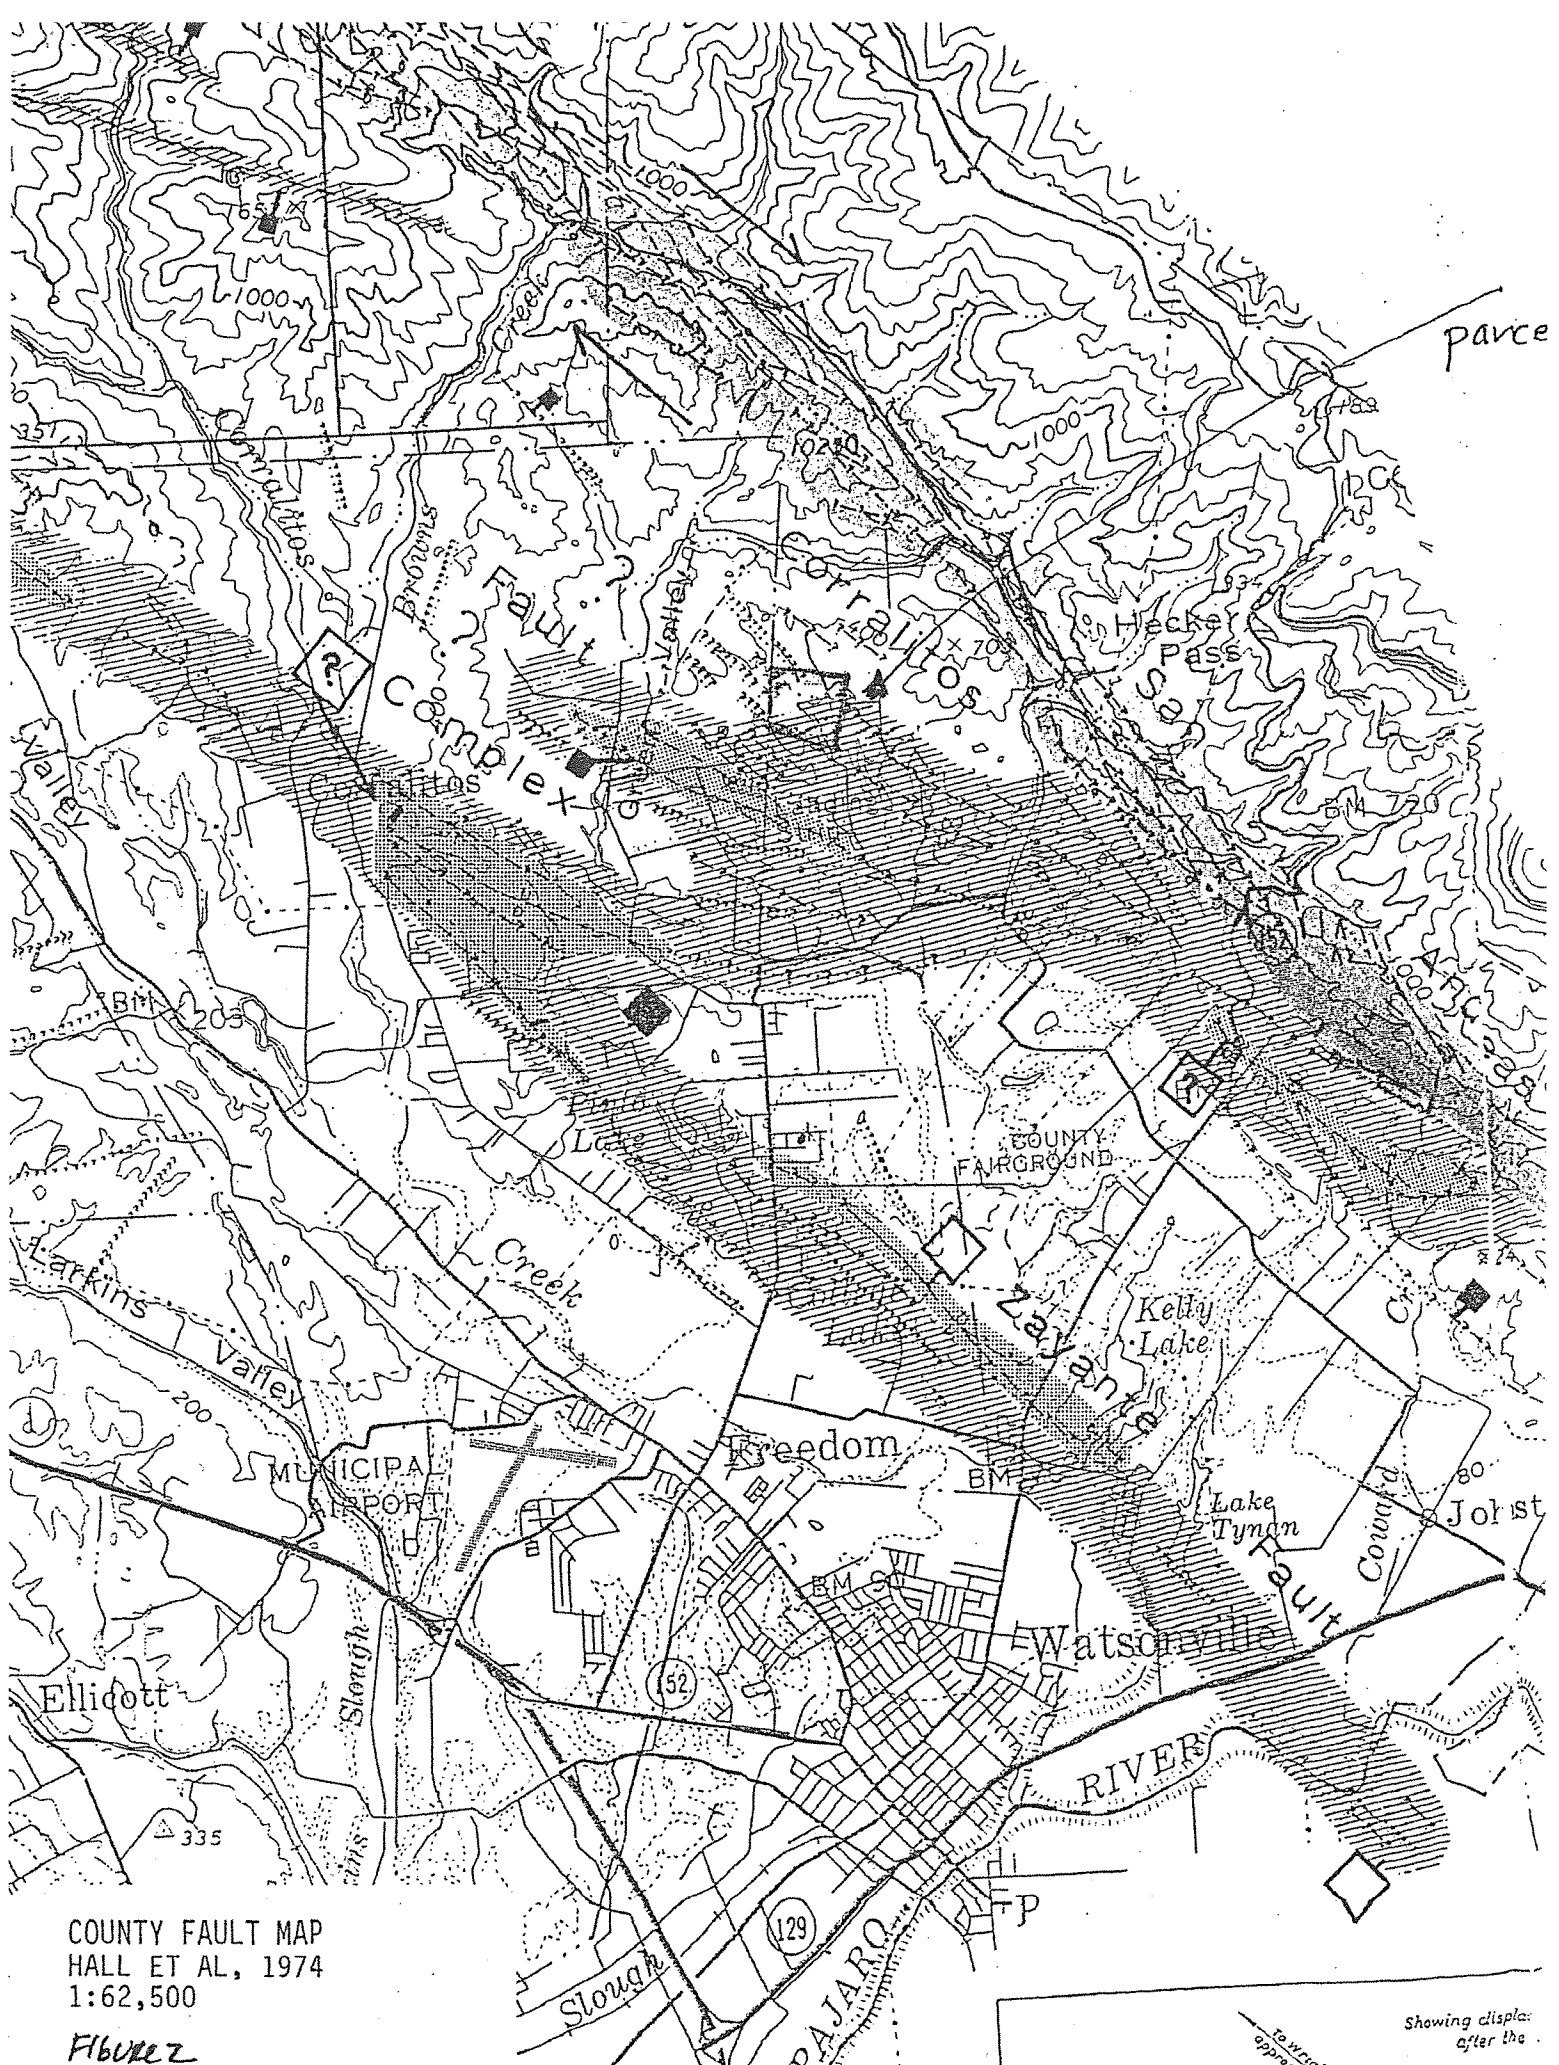
Figure 2

This property is located in a seismically active region of northern California, as the October 17, 1989 earthquake amply demonstrated. Figure 2, the county fault map, gives an overview of the tectonic setting of the

Further, potentially active fault traces can exist without any surface indications. Note that on the County fault map depicting potential for ground surface rupture (Figure 2), the parcel is in the area labeled "insufficient data." Not enough is known about the Corralitos Complex or the location of fault traces to determine where the hazard lies on the continuum from "low" to "high."
