Coy Knap  
133 Old Wards Ferry Rd #E  
Sonora, CA 95370

June 9, 2015

The following described evidence was recovered on May 28, 2015 by Land & Structure, in the vicinity of the original corners of the 54.23 acre parcel of land described in Document # 2013000582. Please refer to the attached referenced images and the attached reduced copy of Volume 3 of Subdivisions at Page 68, Volume 9 of Parcel Maps at Pages 5 and 85, Volume 20 of Parcel Maps at Page 36, and Volume 6 of Record of Surveys at Page 61 for the locations of the monuments described below.

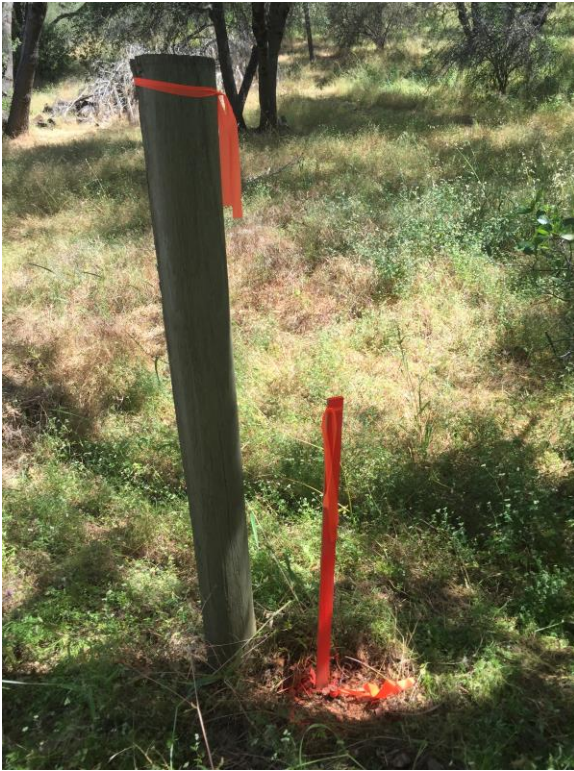
Image 1

- 1) A 5/8" rebar tagged L.S. 3159 was recovered. The found rebar is 0.1' +/- above the surface of the natural grade and is located 1' +/- from a 6" dia. wood post (see Image 1). The recovered monument is thought to be record per Volume 9 of Parcel Maps at Page 5

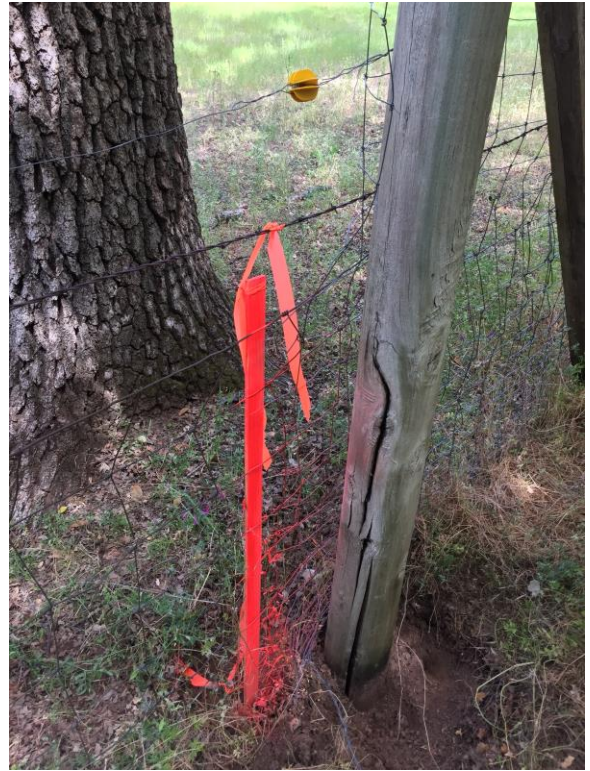
Image 2

- 2) A 5/8" rebar tagged L.S. 3159 was recovered. The found rebar is 0.1' +/- above the surface of the natural grade and is located 0.3' +/- West of a wire fence and 1' +/- from a 6" dia. wood post (see Image 2). The recovered monument is thought to be record per Volume 9 of Parcel Maps at Page 5.

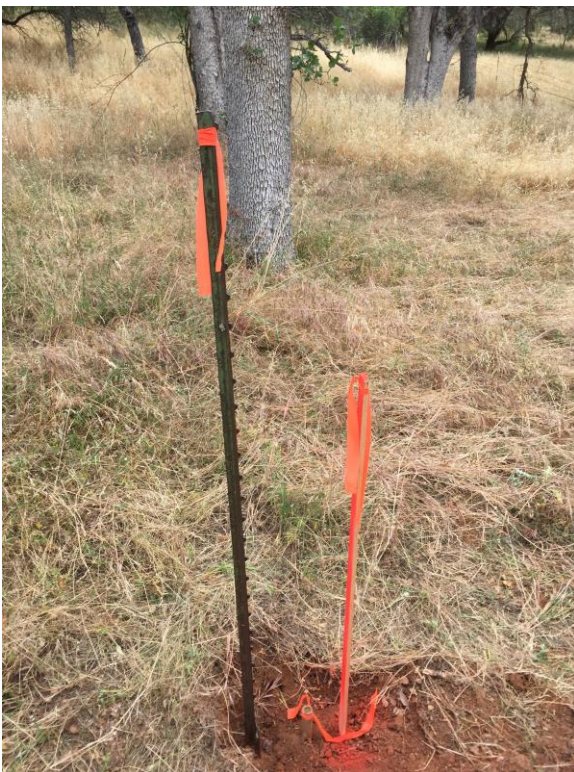
Image 3

- 3) A 3/4" iron pipe tagged L.S. 3159 was recovered. The found iron pipe is flush with the surface of the natural grade and is located in a small clearing, 10.8' +/- from a 16" white oak. A green "T" post was found in the vicinity and was set 0.4' +/- from the found iron pipe (see Image 3). The recovered monument is thought to be record per Volume 6 of Record of Surveys at Page 61.

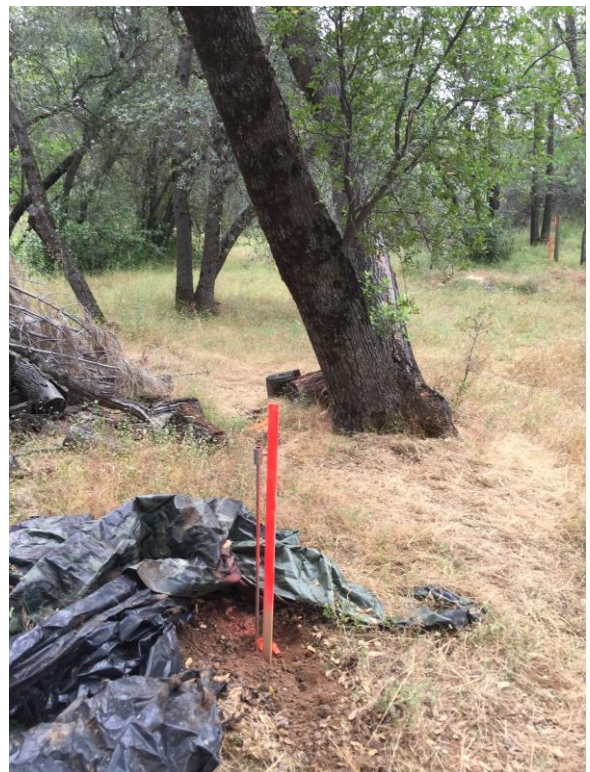
Image 4

- 4) A 5/8" rebar tagged L.S. 3159 was recovered. The found rebar is 0.1' +/- below the surface of the natural grade and is located adjacent to a 3/8" dia. aluminum rod, and 7.4' +/- from a 20" oak (see Image 4). The recovered monument is thought to be record per Volume 9 of Parcel Maps at Page 5

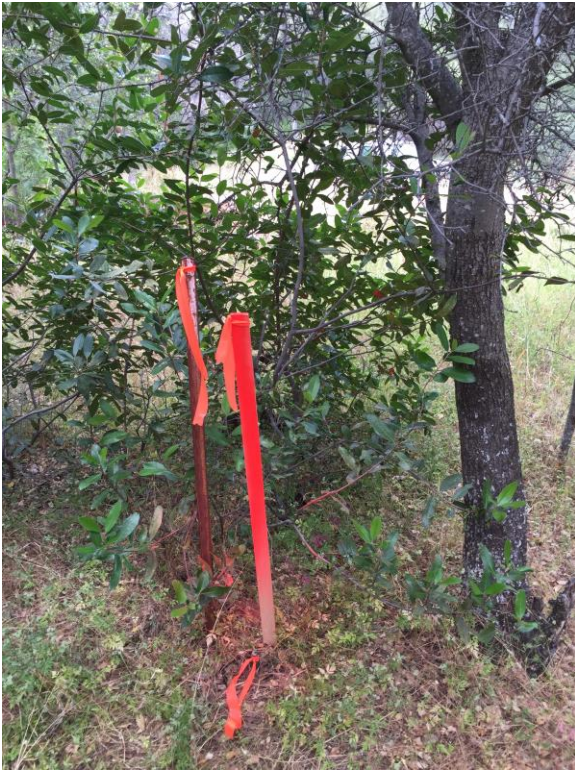
Image 5

- 5) A 5/8" rebar tagged L.S. 3159 was recovered. The found rebar is 0.1' +/- above the surface of the natural grade and is located adjacent to a red "T" post and 2' +/- from a 4" oak (see Image 5). The recovered monument is thought to be record per Volume 9 of Parcel Maps at Page 5

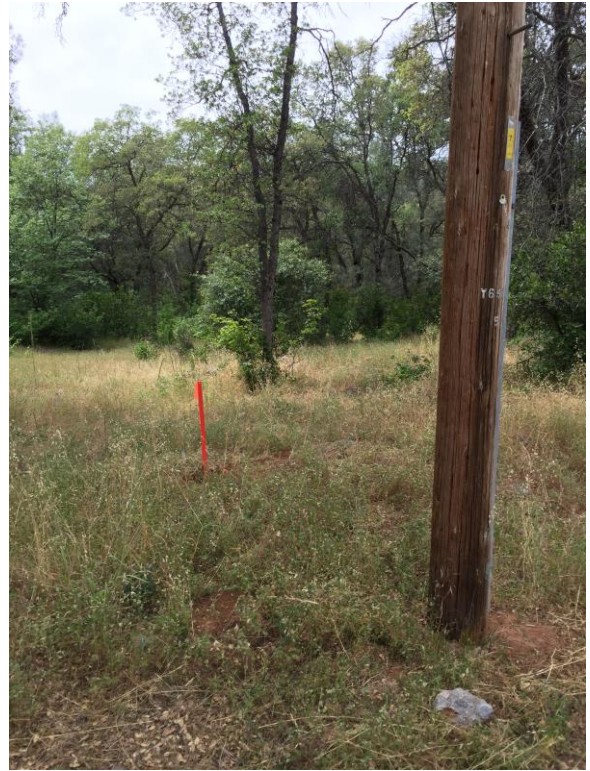
Image 6

- 6) A bent 5/8" rebar with a damaged tag stamped L.S. 3159 was recovered. The found rebar is 0.2' +/- below the surface of the natural grade and is located 10' +/- westerly of a utility pole (see Image 6). The monument recovered is thought to be record per Volume 9 of Parcel Maps at Page 5

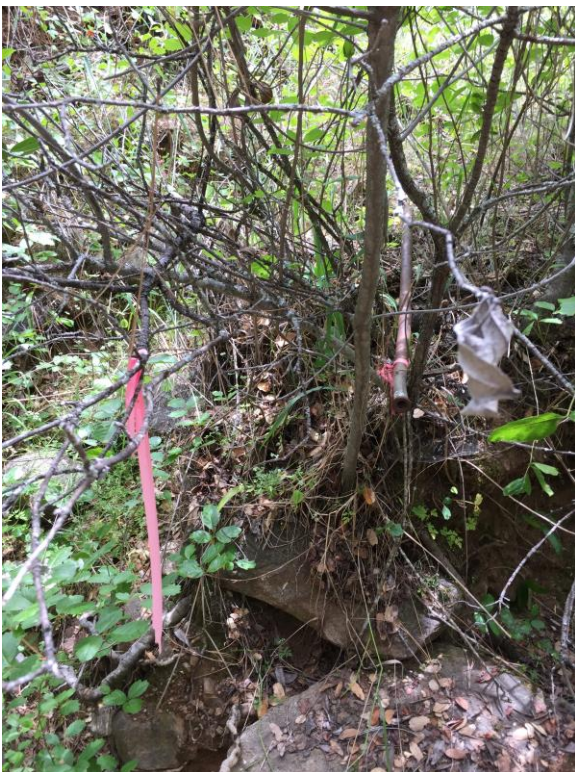
Image 7

- 7) A 3/4" iron pipe tagged L.S. 3159 was found pulled and lying on the bank of a drainage in the vicinity of the true corner (see Image 7).
- 8) A 3/4" iron pipe tagged L.S. 3159 was recovered. The found iron pipe is 0.3' +/- above the surface of the natural grade and is located near the flow line of a drainage course (see Image 8). The recovered monument is thought to be record per Volume 3 of Subdivisions at Page 68

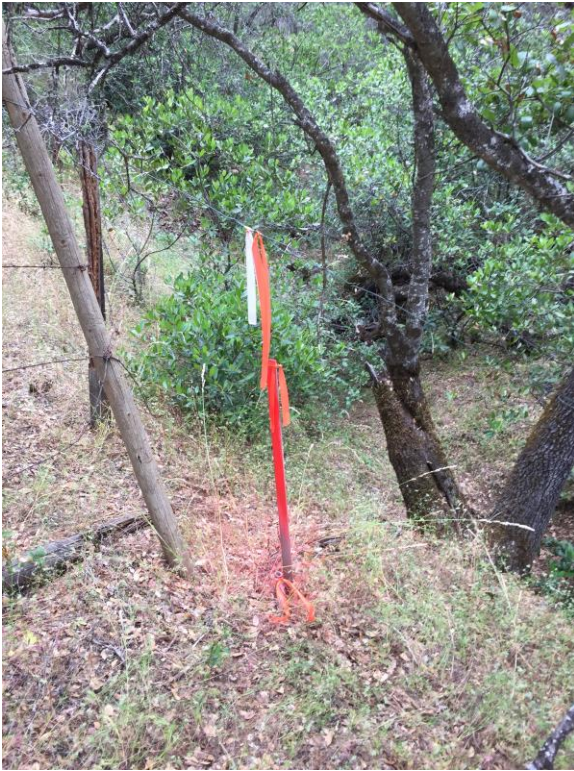
Image 9

- 9) A 3/4" iron pipe tagged L.S. 3159 was recovered. The found iron pipe is 0.2' +/- above the surface of the natural grade and is located 1.2' +/- from a 3" dia. wood post at a fence corner (see Image 9). The recovered monument is thought to be record per Volume 3 of Subdivisions at Page 68.

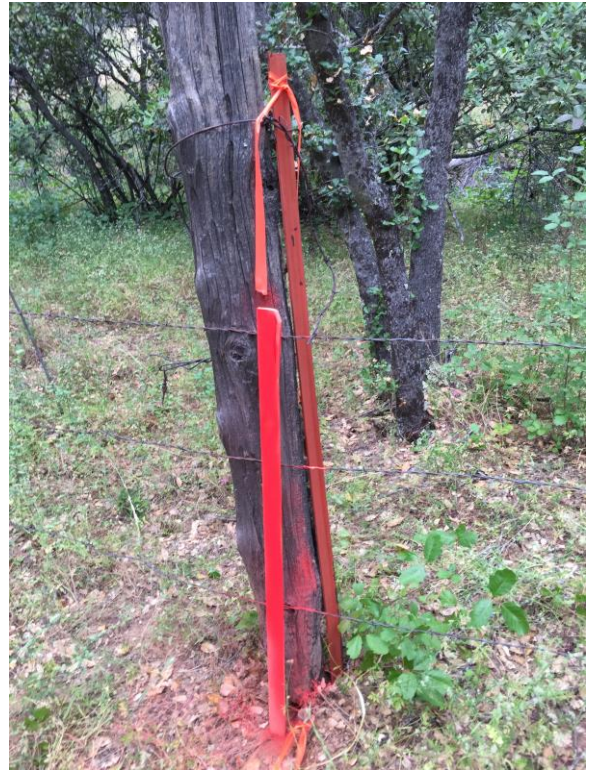
Image 10

- 10) A found 3/4" iron pipe tagged L.S. 3159 was recovered. The found iron pipe is 0.2' +/- above the surface of the natural grade and is located in a wire fence line at the base of a large wood post (see Image 10). The recovered monument is thought to be record per Volume 3 of Subdivisions at Page 68.

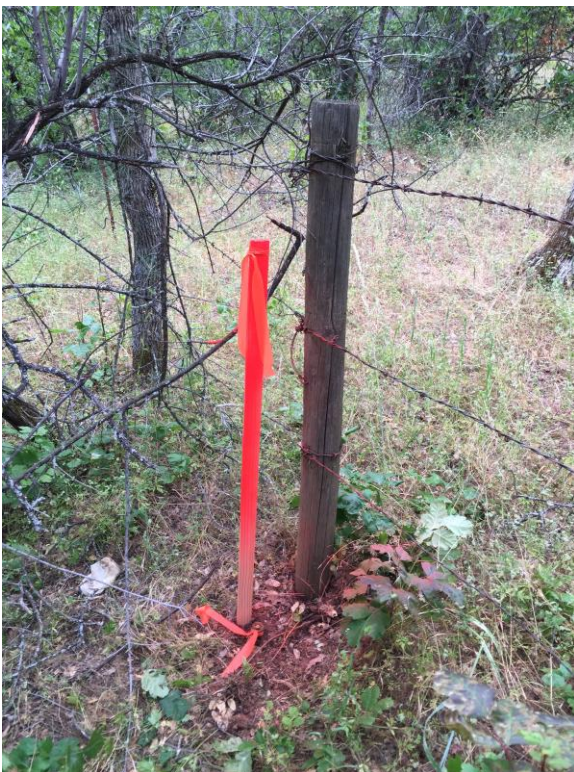
Image 11

- 11) A 3/4" iron pipe tagged L.S. 3159 was recovered. The found iron pipe is flush with the surface of the natural grade and is located in a wire fence line at the base of a 4" dia. wood post (see Image 11). The recovered monument is thought to be record per Volume 3 of Subdivisions at Page 68.

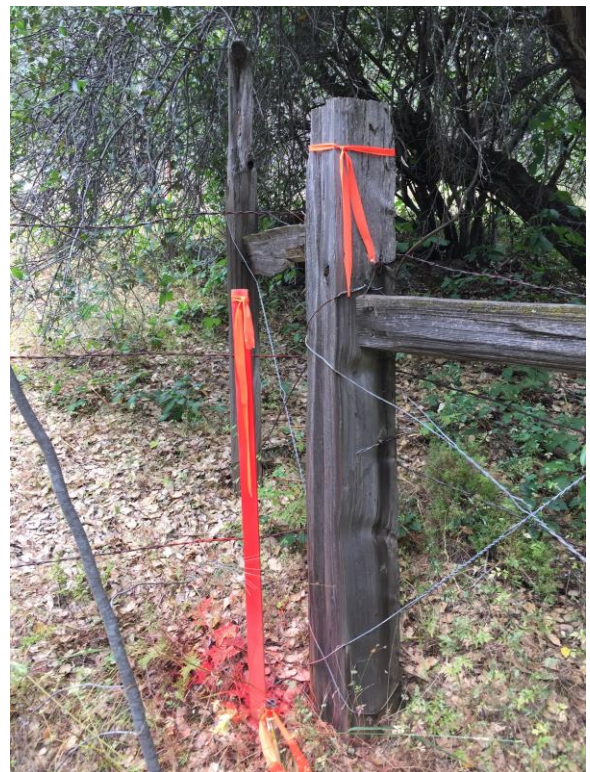
Image 12

- 12) A 3/4" iron pipe tagged L.S. 3159 was recovered. The found iron pipe is 0.3' +/- above the surface of the natural grade and is located in a wire fence line at the base of the wood corner post (see Image 12). The recovered monument is thought to be record per Volume 3 of Subdivisions at Page 68

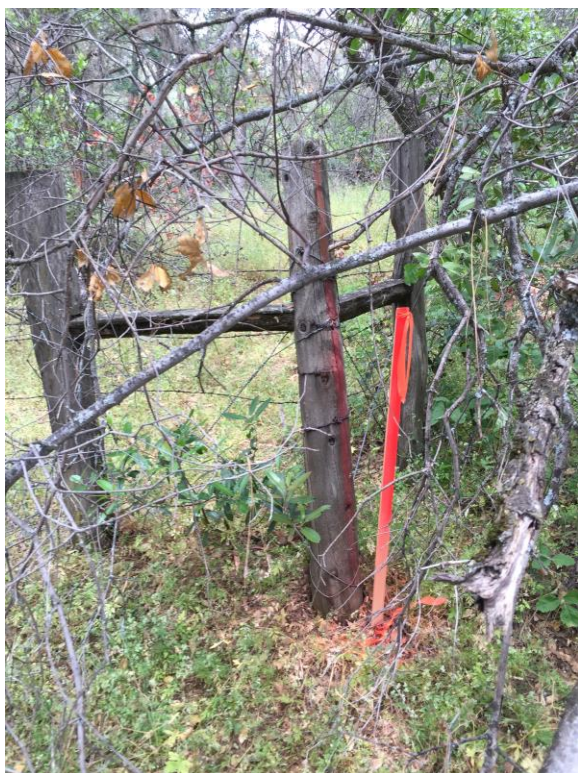
Image 13

- 13) A 3/4" iron pipe tagged L.S. 3159 was recovered. The found iron pipe is 0.1' +/- above the surface of the natural grade and is located at the base of large wood post at a fence corner (see Image 13). The recovered monument is thought to be record per Volume 3 of Subdivisions at Page 68.

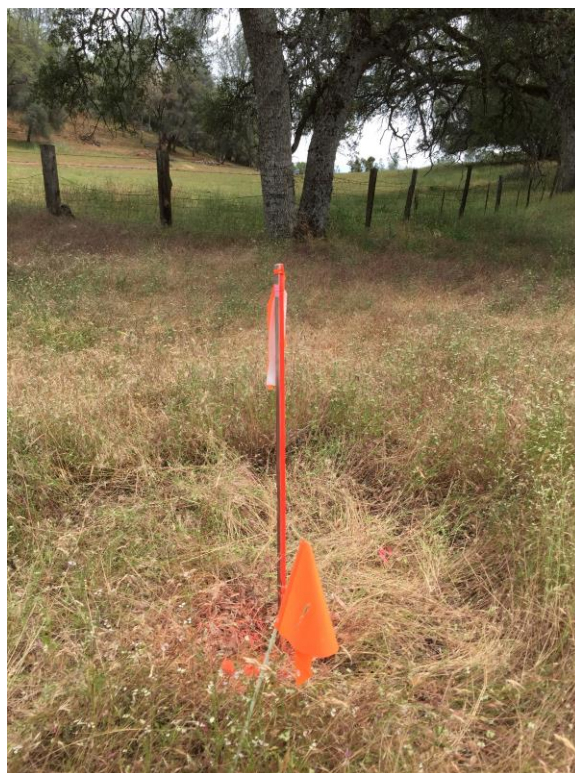
Image 14

- 14) A 3/4" iron pipe tagged L.S. 3159 was recovered. The found iron pipe is flush with the surface of the natural grade and is located in a small mound of stone in a clearing (see Image 14). The recovered monument is thought to be record per Volume 6 of Record of Surveys at Page 61.
