# PROPERTY INSPECTION REPORT

**Concerning:** 250 Pin Oak Drive, Brenham, TX 77833

**By:** Jonathan Dooley TREC # 22163 / Dooley Home Inspection 9/13/2018

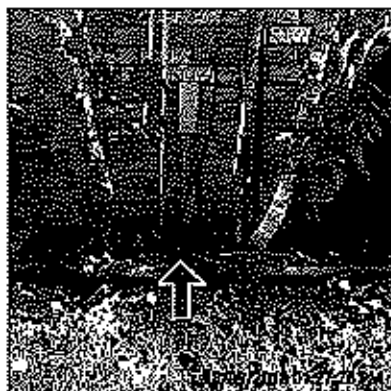
Grade Too High

Height of soil at Right Side is too high in areas, which can result in water and insect intrusion. Ideally, you want a 6-8 inch of clearance between the soil and brick veneer. Recommend lowering grade around the house so that 6 inches of slab is showing. Here is a helpful article: [How to Fix the Slope Grading Around a House](#)

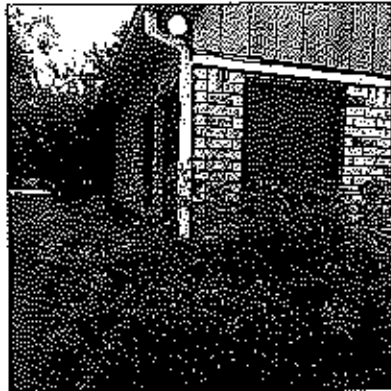
#### Trim Bushes

Vegetation growing on or near the exterior walls may introduce insects, pests and/or accelerate deterioration of the exterior wall covering by retaining moisture. The Inspector recommends trimming/removing vegetation from touching exterior walls.

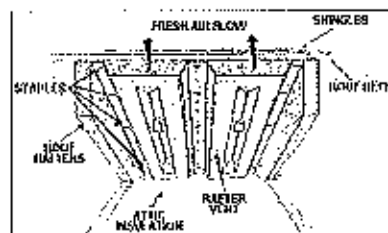
At the time of the inspection, the Inspector observed no deficiencies in the condition of the home structure. Missing Baffles to hold back insulation from blocking vents. Recommend adding to promote airflow from soffit vents to ridge. At time of inspection, most of the vents looks blocks by insulation, therefore blocking intended air flow.

**Approximate Depth of Insulation:** 3"-5" Insulation Improvements may be cost effective, depending on the anticipated term of ownership. Insulation Fiberglass (Batts) insulation is old, settled and has less than six inches thick or just under 22 R Value in Attic. Heat and Cool air loss can occur more. Condensation can cause mold or wood deterioration. Recommend adding insulation to improve energy efficiency.

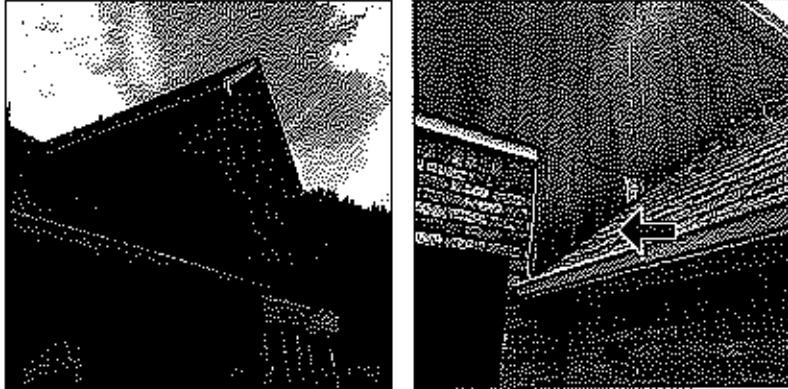
The siding is deteriorated on bottom edge along the 2nd story dormers rear of home. Further deterioration can occur if not corrected. A qualified person should repair or replace as needed.

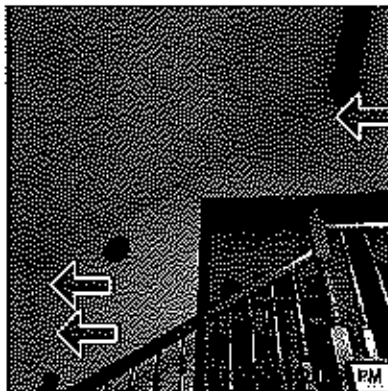
#### Minor Drywall Cracking

Vertical hairline settlement cracks in drywall noted at top of staircase. Tape line cracks around doors and windows are typical of this age house and should not be cause for alarm. Recommend sealing cracks and monitoring areas. The rate of movement cannot be predicted during a one-time inspection. If further movement is noticed, contact a foundation expert for evaluation and possible remedies.

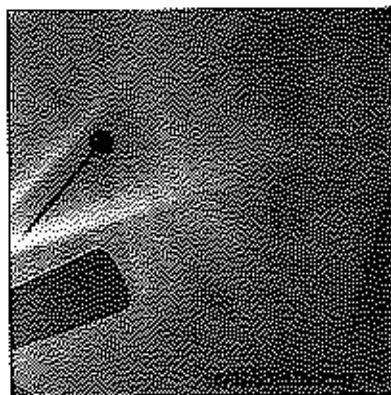
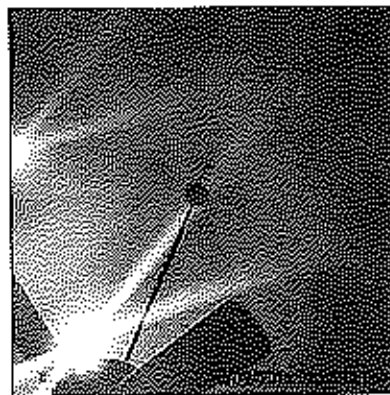
Signs of organic growth are present on cathedral ceiling in the Office. The underlying cause is excessive moisture due to the relative humidity at the top of the room versus the Attic space. I noted excessive condensation around ductwork and AC unit in Attic. I recommend you clean ceiling with appropriate chemicals and consult with an HVAC specialist to examine ductwork and coils on unit in Attic. Also, improving ventilation in attic would help and leaving the fan on in room while away to circulate air.

I did not inspect, test or determine if this growth is or is not a health hazard.

| Project | |
|---|---|
| LABOR AND MATERIALS: To repair office ceiling per described scope of work<br>-Clean, spot prime and paint ceiling in office using one coat of Sherwin Williams ProMar 200 flat to match existing color | 550.00 |

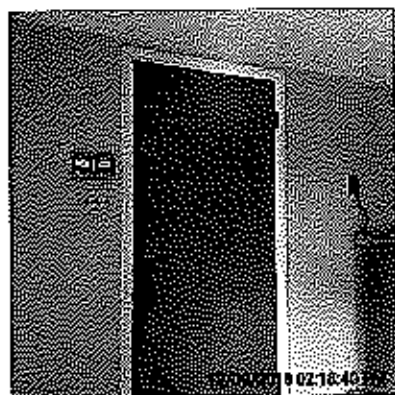
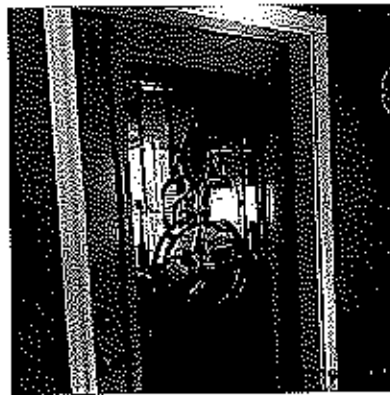
Fire Safety

The occupant doors from inside garage to inside the home are not fire rated door. This means that should a fire occur in garage, the occupant door does not afford protection until fireman arrive. This door should be replaced with a fire rated door.

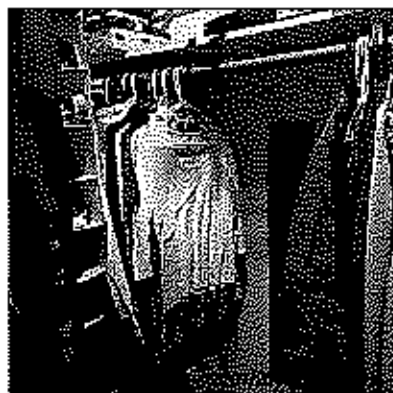
Improper Location

The subpanel cabinet had inadequate working clearance in Master Closet. Modern safety standards require a minimum open space 30 inches in width for a height of 6 feet-6 inches. Minimum clearance in front of the cabinet should be 3 feet. The inspector recommends correction by a qualified contractor.

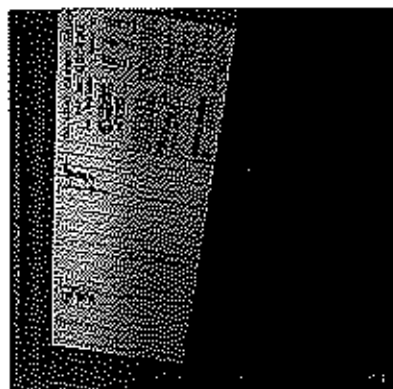
**Missing Labels:** Some labels are present, but are illegible or confusing. I recommend correcting for safety reasons.

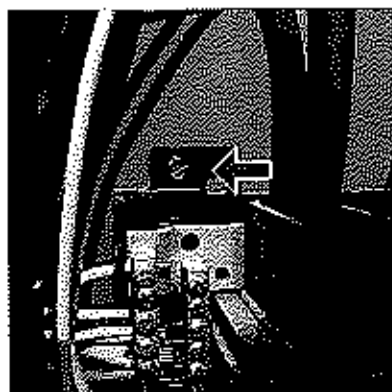
Neutrals and grounds are not separated at sub panel in **Master Bedroom Closet**. In all sub panels, the green bonding screw should be removed and the neutral and grounds should be on separate bus bars. This should be corrected by a licensed electrician.

Green Screw should be removed on sub-panels according to new NEC standards

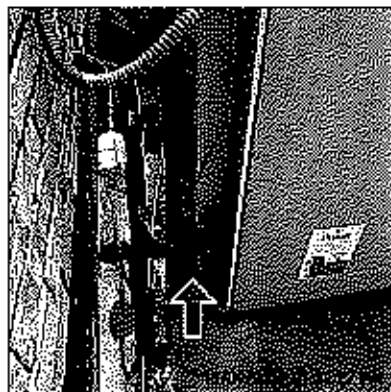
The foam sleeve on suction line is missing foam sleeve in area(s) at outside unit. Missing foam on freon line can cause energy loss and condensation. I recommend service or repair as needed.

| Description | Quant... | P.O. # | Terms |
|---|---|---|---|
| SERVICE CALL: 09/18/2018<br>Selling home - Need to address issues found on inspection<br>Addressed all issues<br>Duct runs - Foiled taped and resealed each duct run with duct sealant - Did not notice it leaking anymore<br>Wrapped suction line and taped on Main system<br>Blew drains on Library unit - Checked for proper drainage | | | |

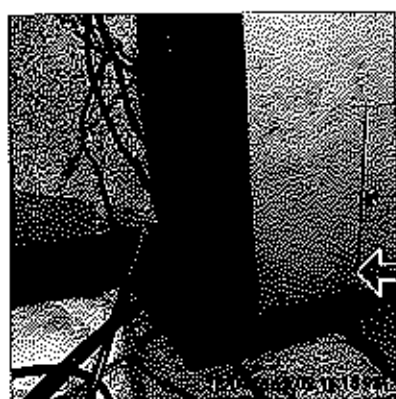
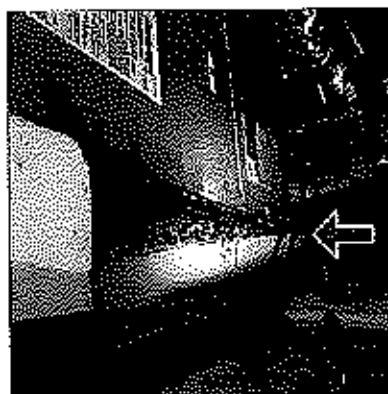
Organic growth noted on Air Handler in attic above Office. These are signs of age and moisture perhaps due to condensation in attic during the summer. This excessive moisture in attic could eventually lead to structural problems if not corrected. Recommend consulting HVAC expert for possible solutions and routine servicing of equipment.

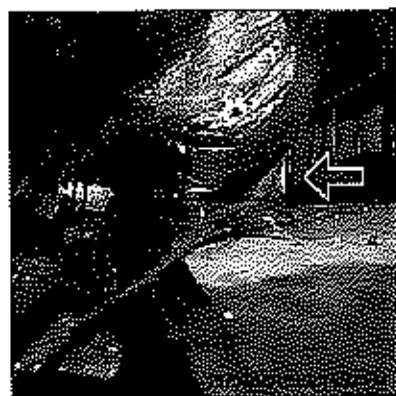
**Air Leaks at Ductwork.** Recommend resealing duct connections over Addition with putty or special tape to prevent energy loss.

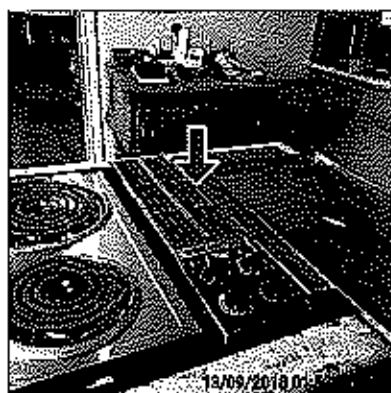
Kitchen

The range exhaust fan did not work when tested. I recommend repair or replace as needed.

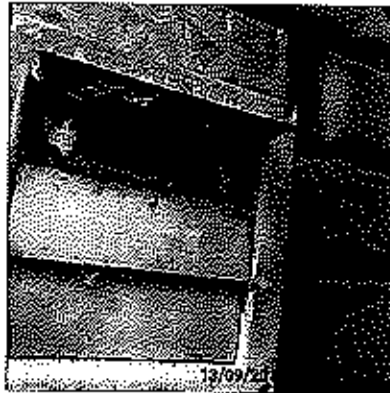
The dryer vent can trap lint at bends. Vent pipes should be cleaned to avoid a fire hazard.
