Subject: Structural Foundation Inspection Report (Level B)
Slab Foundation
3085 N FM 1752, Savoy, TX 75479

3085 N FM 1752, SAVOY, TX 75479

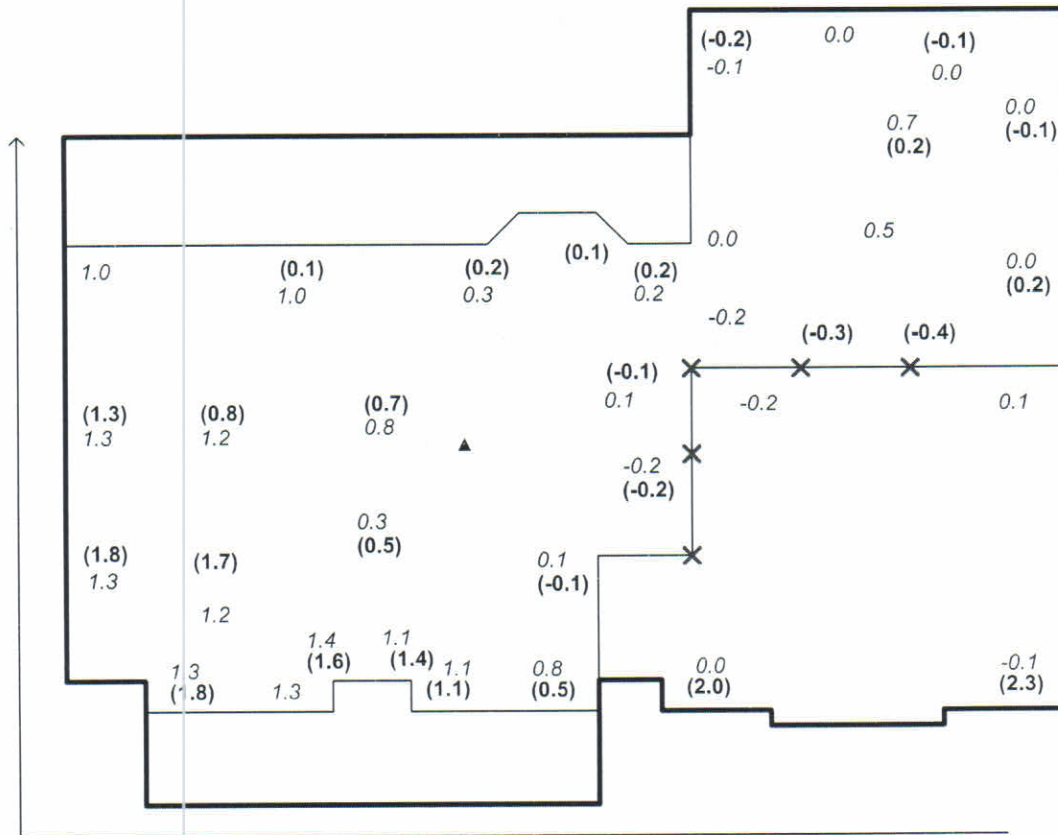
LIMITED REPAIR PLAN

The home has performed well since the drainage and pier work was installed. The damage (wall cracks and brick cracks) has not worsened and in our opinion no additional repairs are recommended at this time.

Based on our visual observations of the structure and our review of the elevation map, it is our opinion that the structure is experiencing seasonal movement and the foundation is performing as intended.

HOMEOWNER INSTALLED
FRENCH DRAIN

NO FOUNDATION REPAIRS NEEDED

We do not recommend foundation repairs at this time. This does not rule out the possibility of needing a foundation repair plan in the future should damages or foundation movement worsen. Re-evaluation of the structure in the future may be prudent.
