HOME INSPECTION REPORT

414 Windmill Rd., Burnett, TX

Inspection Date:
July 2, 2019

Report Number:
190702-3456

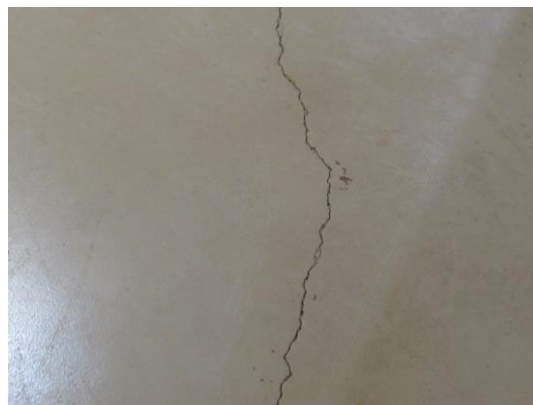
Some cracking was seen in the stained concrete floors in the home. These cracks appeared to be normal shrinkage/settlement cracks and are considered primarily cosmetic in nature.

Example of cracks seen in exposed concrete floors

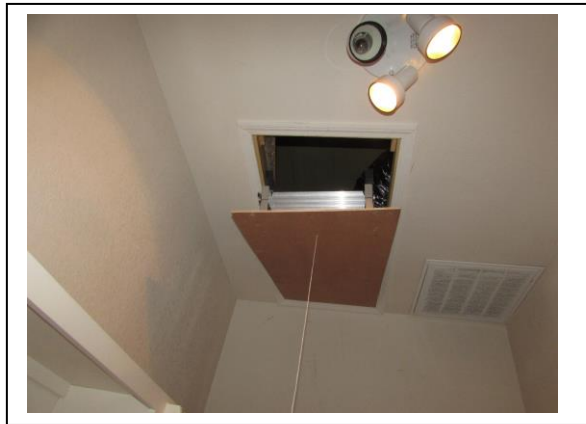
The attic access cover to the right-side attic would not close completely and repairs/improvements will be needed.

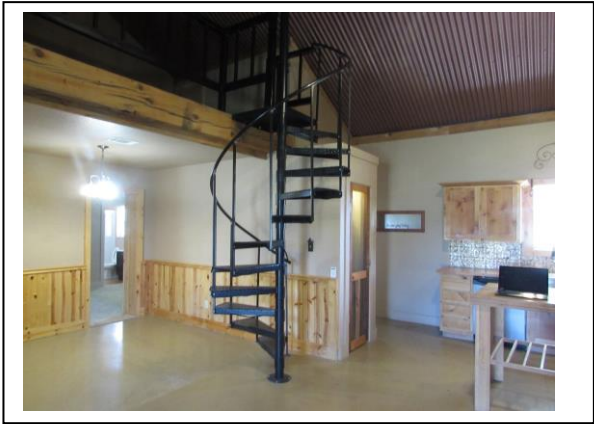
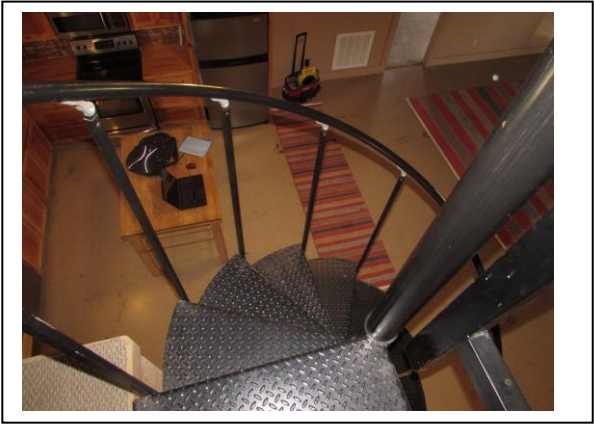
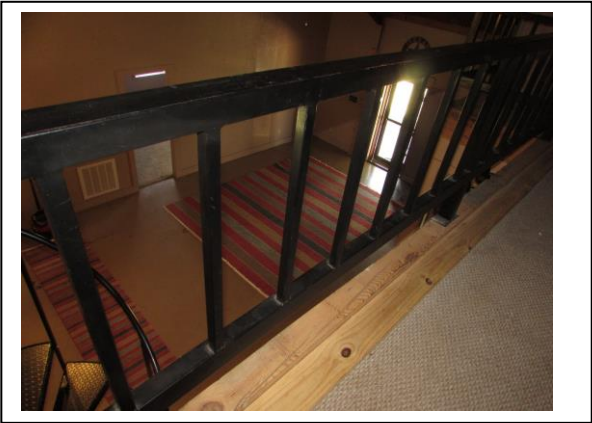
The spiral stairs appeared to be in good condition. However, the stairs are not in compliance with current standards.

Under today's standards, the spacing between the vertical railings for the handrail should be no wider than 4". Currently, the spacing is wide enough for a small child to slip through. The spacing between the railings for the upper landing should also be no wider than 4".

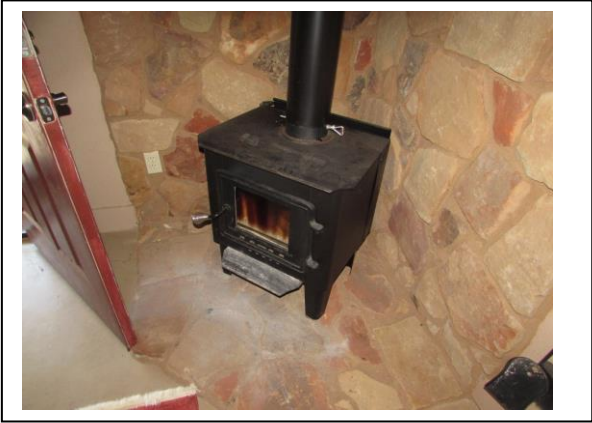
The wood-burning stove appeared to be in fair condition. The electric fan for the stove was working properly.

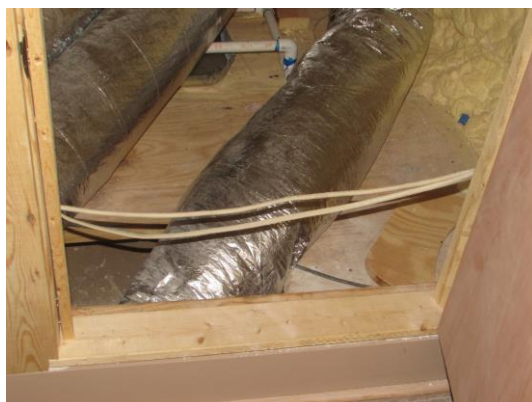
Distribution wiring was obstructing access to the front left-side attic space. This is considered a safety hazard and this wiring should be re-routed.

Distribution wiring obstructing access to the front left-side attic should be re-located

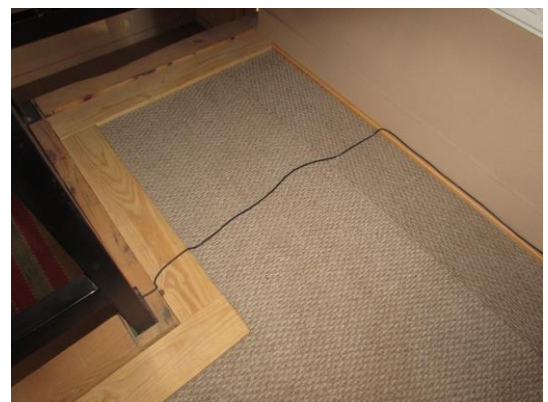
An extension cord plugged into an outlet on the front wall of the upper landing is being used to provide power to the tract lighting in the living room area. This cord is stapled to the floor in the upper landing. This is also a safety issue and, if the tract lighting is a permanent fixture, it should be permanently wired with the wiring running through the walls or placed in proper conduit.

Cord running across flooring in upper landing is considered a safety hazard

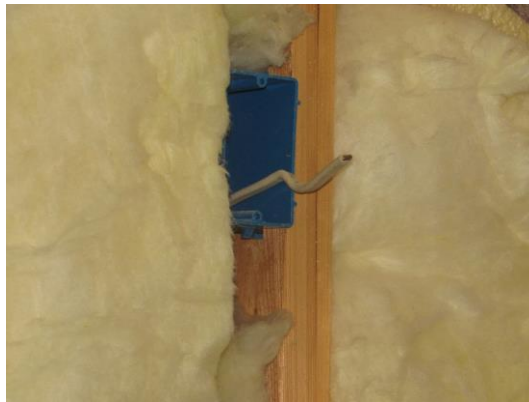
An open junction box with exposed wire ends was seen in the right-side attic space. The wire ends should be capped and sealed in the junction box with a proper faceplate.

Open junction box and exposed wire ends seen in right-side attic.

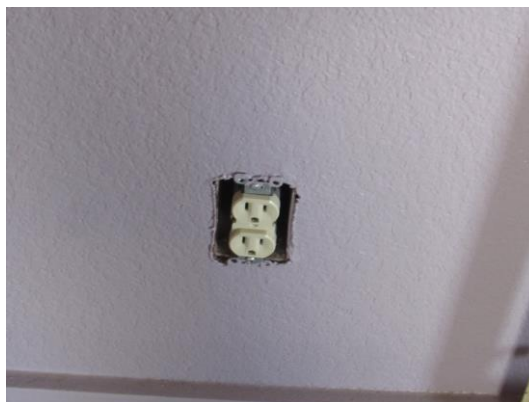
Missing face plates noted on outlets in the master bedroom should be replaced.

Example of missing faceplates noted on outlets in master bedroom

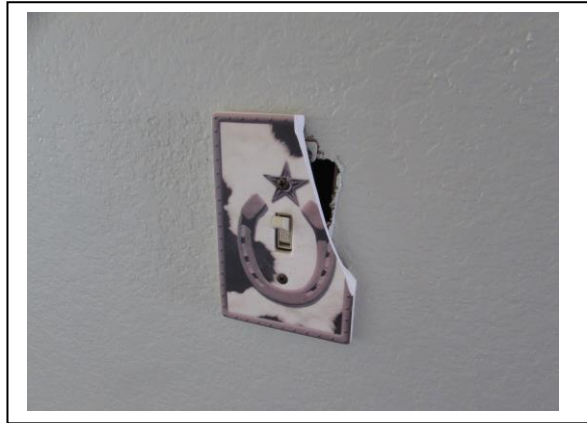
For improved safety, a damaged faceplate noted on a switch in the master bathroom should be replaced.

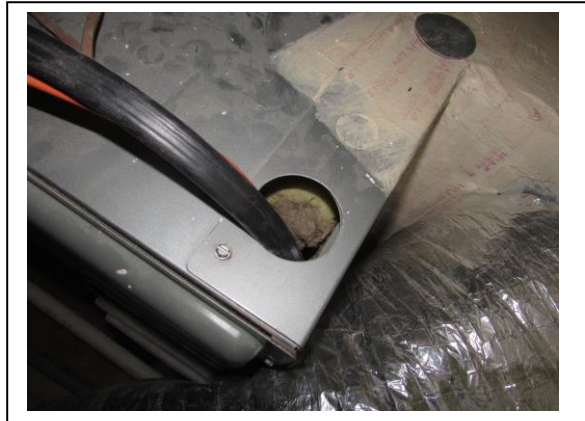
If the heating equipment has not been serviced during the past year, having the heating equipment serviced by a licensed HVAC specialist is recommended. The power line to heating unit #2 is susceptible to damage by the sharp edges of the heater housing. A rubber or plastic grommet should be installed over the opening for the power line to protect it from damage.

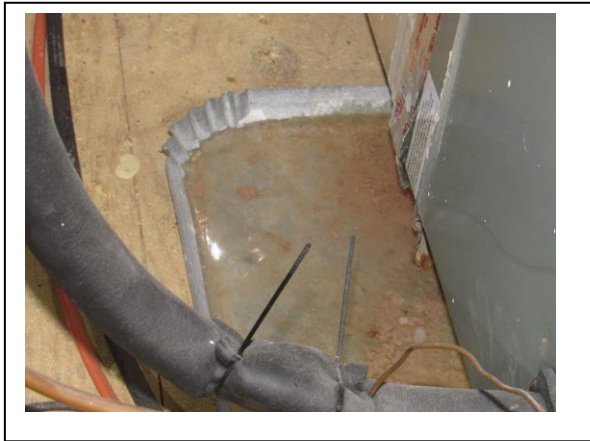
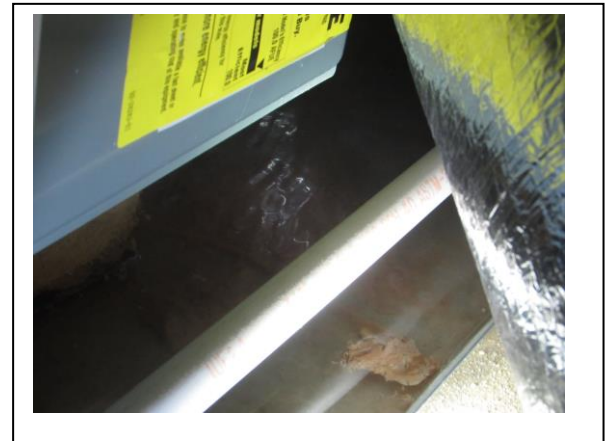
Condensation was seen collecting in the safety condensation drain pan under the evaporator coil in the front left attic. This is an indication that the main condensation drain line is clogged and in need of cleaning. However, the drain lines for both safety condensation drain pans are improperly plumbed. The safety drain lines have been plumbed into the main drain lines. This negates the purpose for the safety drain lines. The safety drain lines should be kept separate from the main drain lines and should exit the structure at a conspicuous point, such as above a window, so that condensation draining from the safety drain lines can be seen.

Condensation was seen collecting in the safety drain pan for the evaporator coil unit in the front left-side attic

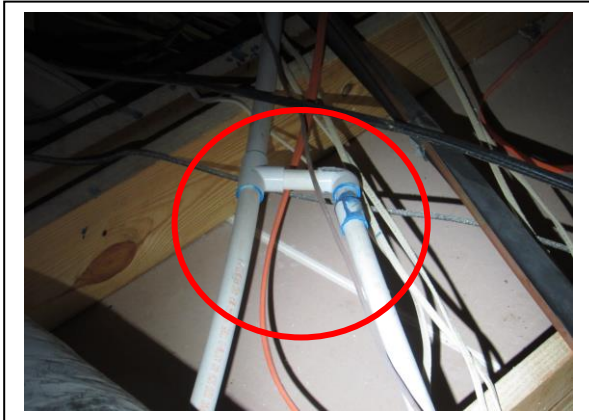
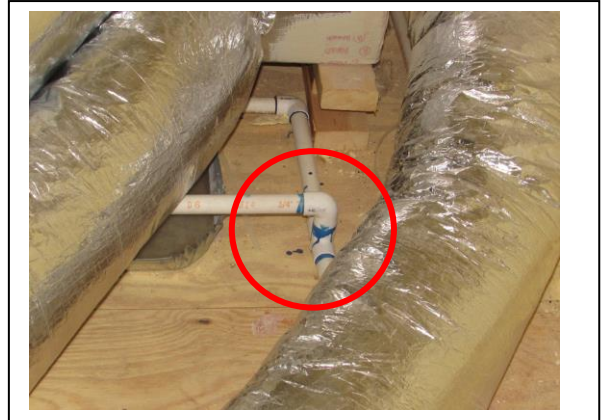
The safety drain lines for the safety condensation drain pans have been plumbed into the main drain lines. This should be corrected

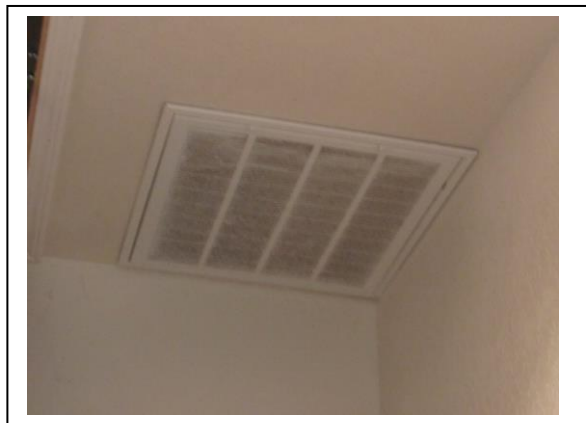
The intake vent for the HVAC equipment located in the right-side attic is located in the master closet. This is not good location for the intake vent. However, a vent has been installed through the wall of the closet to the living room to provide better circulation of air to the intake vent. Ideally, the intake vent would be located in a common area such as a hallway. The filter for this intake vent is very dirty and needs replacing.

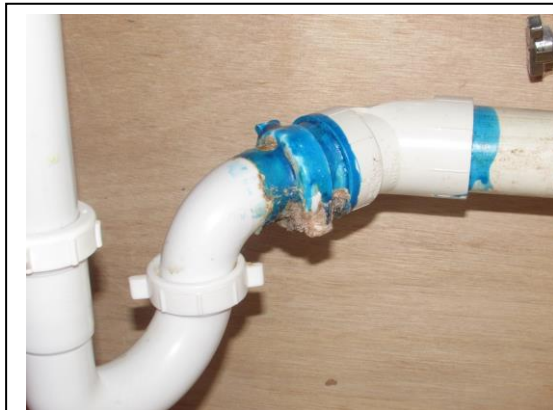
The drain lines for the sink in the bathroom for the front suite and for the front sink in the master bathroom were leaking and will need repairs.

Drain line for sink in the bathroom for the front suite is leaking

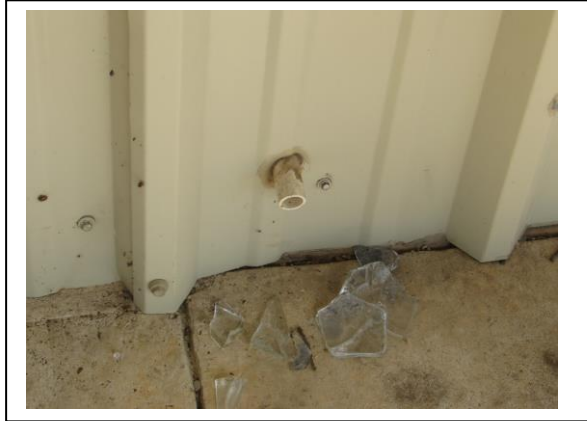
For improved safety, an elbow fitting should be installed on the TPR (Temperature/Pressure Release) valve where it exits the structure through the back wall. This will direct hot water/steam that may be released by the valve downwards towards the concrete porch.

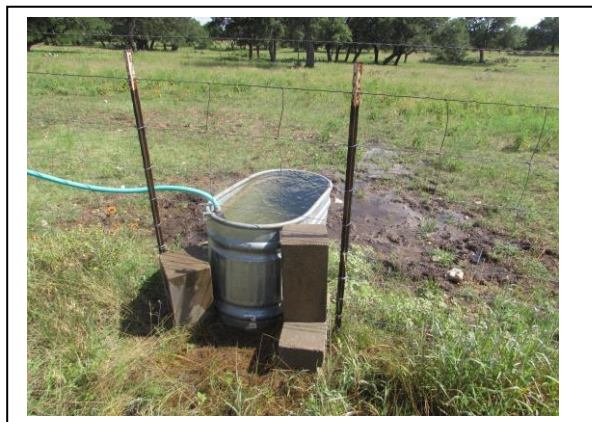
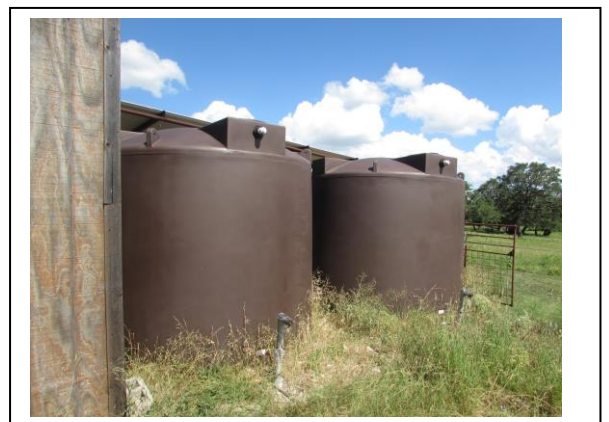
The cut-off float for the watering trough next to the stables is leaking and should be repaired or replaced.

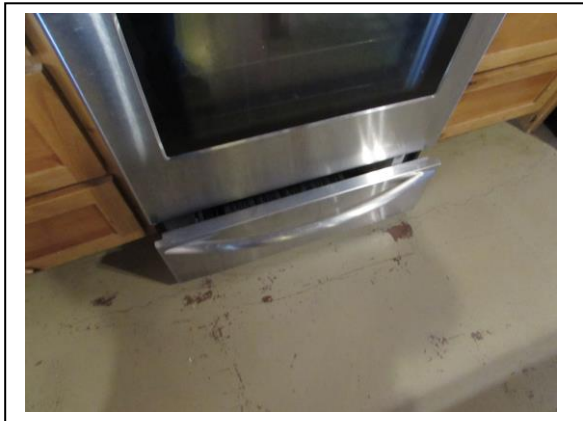
<i>Comments:</i>
RANGE
Energy source: Electricity
Overall, the range performed as intended and appeared to be in fair condition.
The lower storage drawer would not close completely. Repairs/adjustments should be made as needed.
For improved safety, installing an anti-tip device is recommended. This will prevent the range from tipping when weight is applied to the open oven door or an extended oven shelf. |

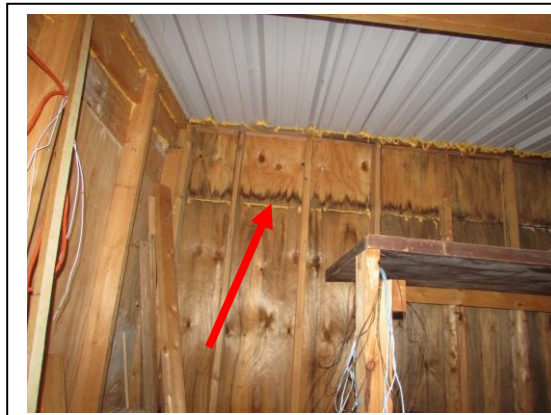
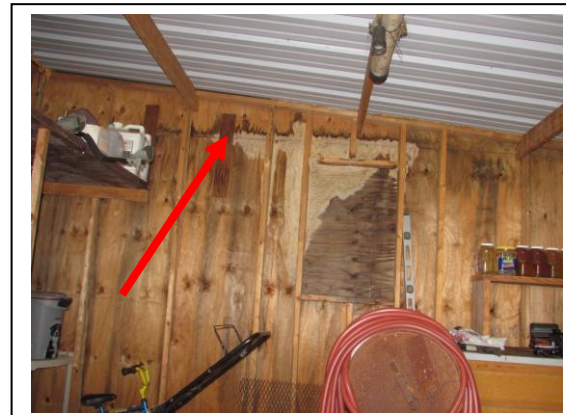
<i>Comments:</i>
Water stains were seen on the interior walls of the tack room. The leaks appeared to be along the upper seams in the siding. Repairs/improvements are recommended. Some moisture damage was also seen along the lower edges of the siding for the tack room. Repairs/improvements should be made as needed to prevent further damage. |

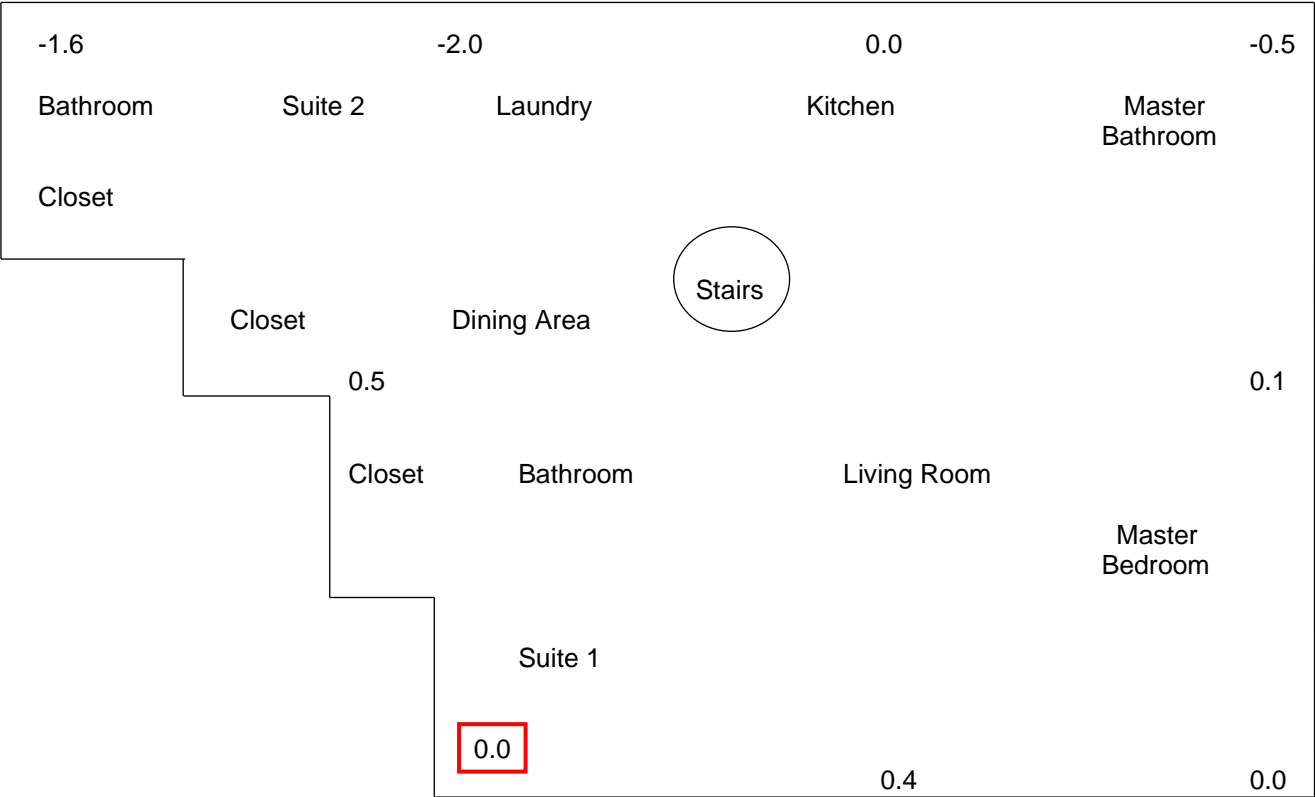
Foundation Level Survey

In this Inspectors opinion, the foundation is performing as intended. However, a foundation levelness survey found the variance in the levelness of the foundation to be above normal parameters for a foundation of this size. This is not uncommon for Barndominium construction. No other significant problems were observed.

The following foundation levelness survey is measured to the nearest 1/10th inch. All readings are the variance from the 0.0 in the read box. The survey showed the variances in the levelness of the foundation to be larger than normal parameters for a house of this size. The drawing is not to scale but is a reasonable facsimile. The drawing should only be used as a reference tool:
