## PROPERTY INSPECTION REPORT

**Concerning:** 1115 Oak Ridge, Blanco, TX  
(Address or Other Identification of Inspected Property)

**By:** Corey Hebert, Lic #20229 01/25/2017  
(Name and License Number of Inspector) (Date)

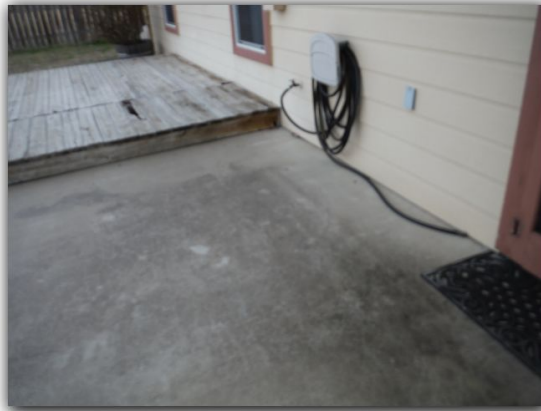
Could not properly inspect the foundation walls because the decking.

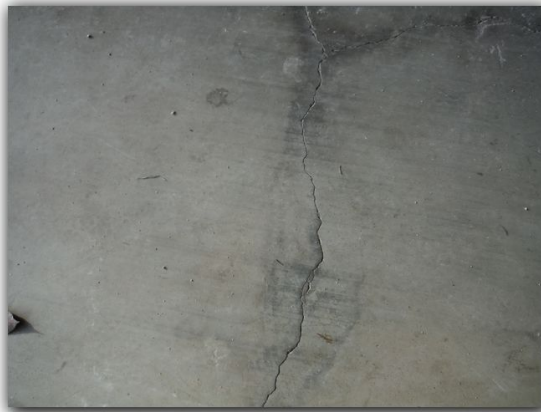
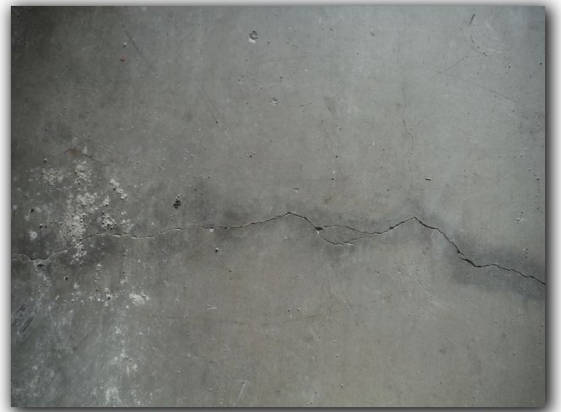
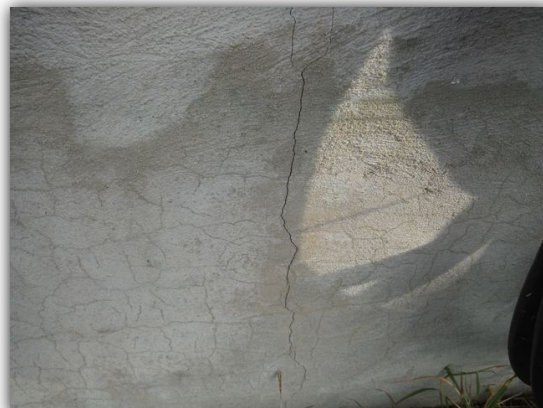
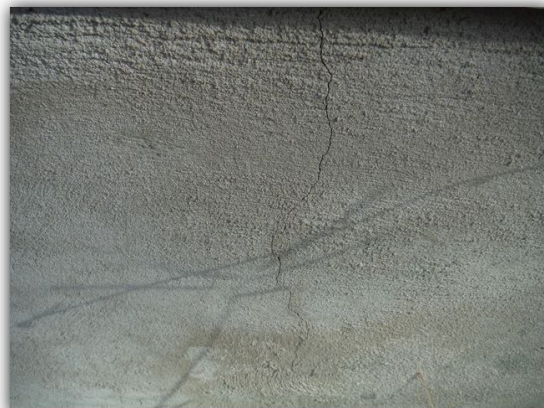
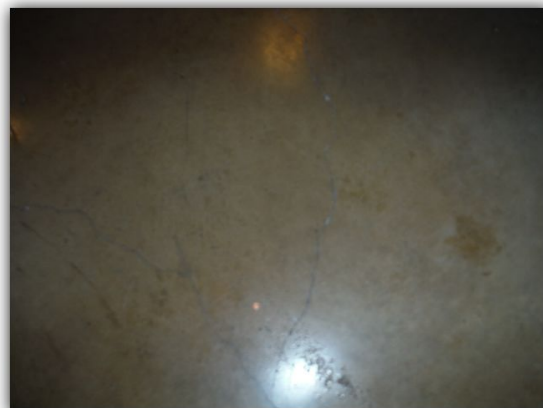
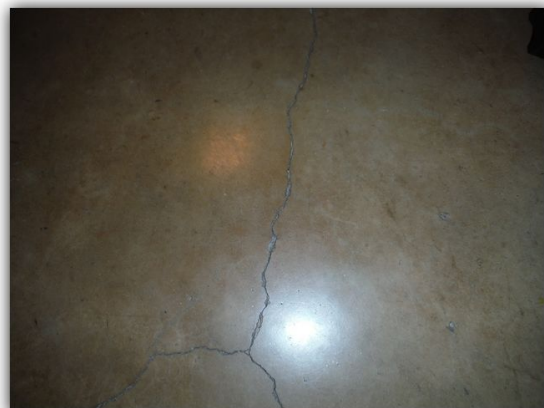
Cracks in wall(s) and/or ceiling, Cracks in exposed concrete floors, Cracks in the slab/plaster coat.

Structural movement and/or settling noted; however, the foundation is supporting the structure at this time.

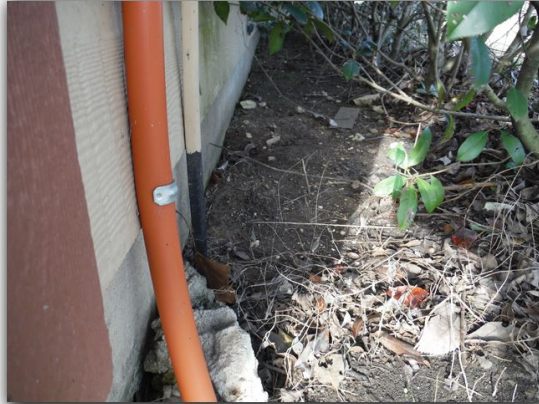
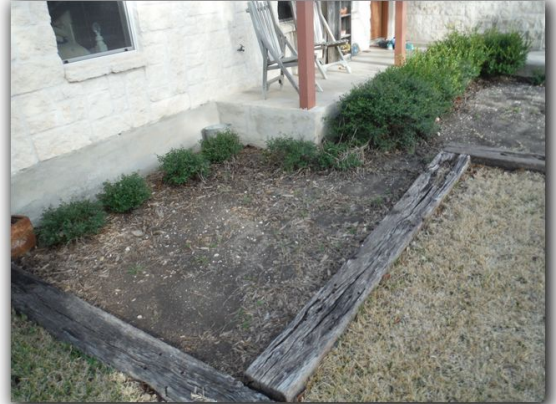
Possible ponding next to foundation at right side and front.

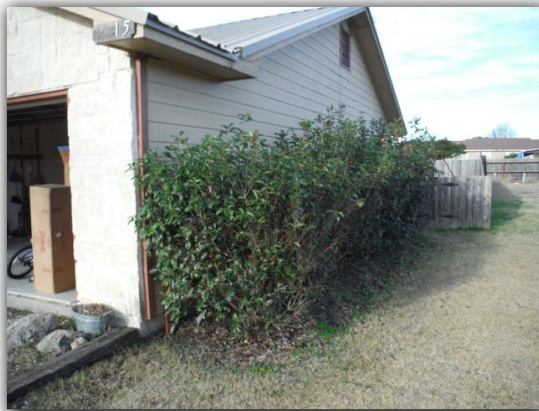
Foliage to close to structure.

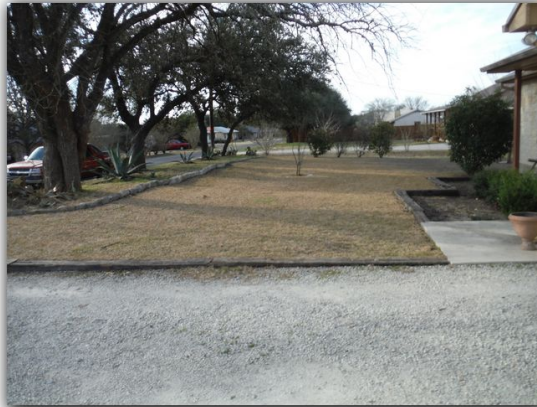
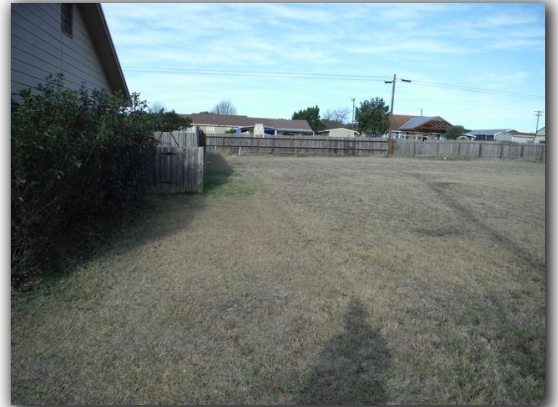
There appears to be improper grading and drainage of the property at front and right side. The property should be graded so that surface water will drain away from foundation walls at a minimum slope of 6" within 10'. Lot drainage should divert to the street as to not create a hazard on the property. (IRC R401.3)

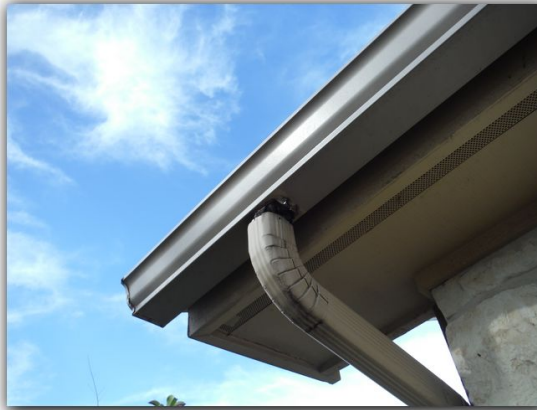
Gutters downspout not properly attached at front.

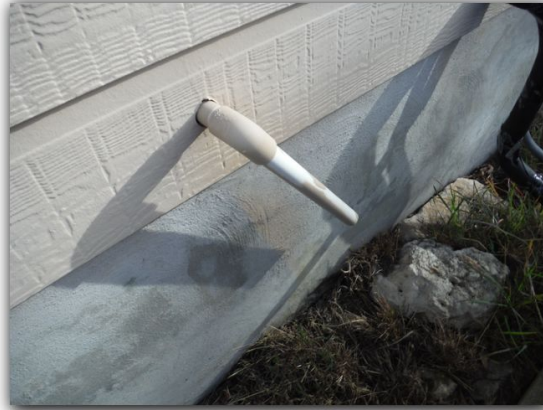
The main condensation drain line for the A/C system drains at the foundation wall. This is not recommend and should be directed at least five feet from the structure or re-routed into the plumbing system.

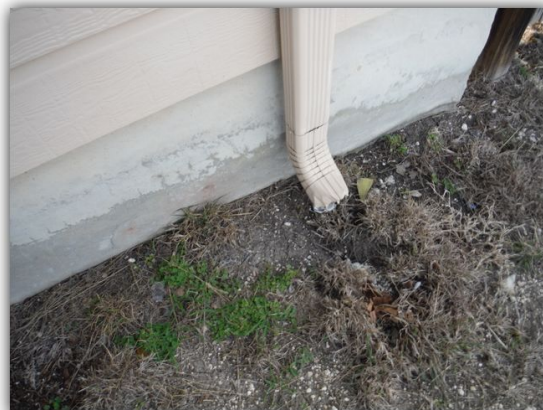
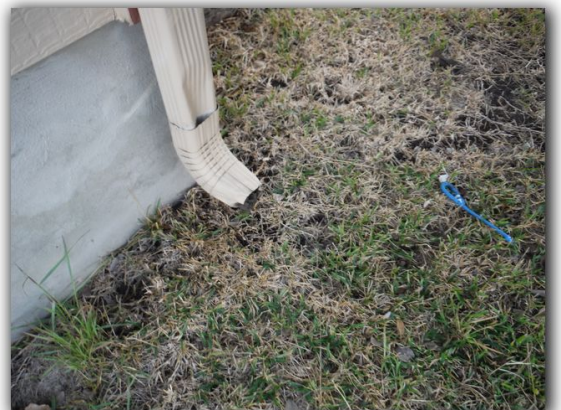
Splash blocks or drains are required to be installed at all gutter downspout ends to avoid soil erosion, water ponding and to discharge roof drainage a minimum of 5' away from foundation walls (IRC R801.3)

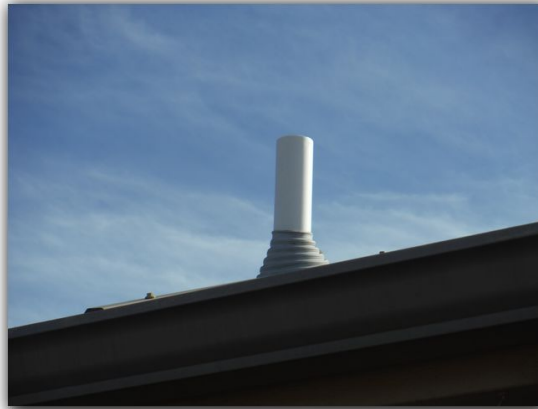
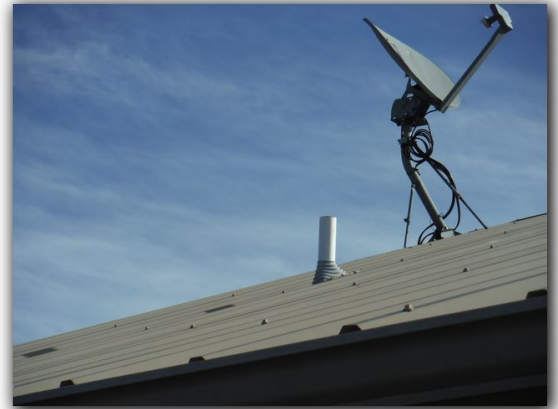
All roof penetrations are required to be painted to prevent deterioration from UV and weather exposure.

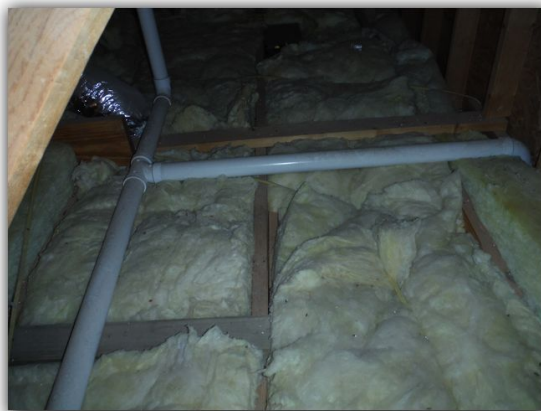
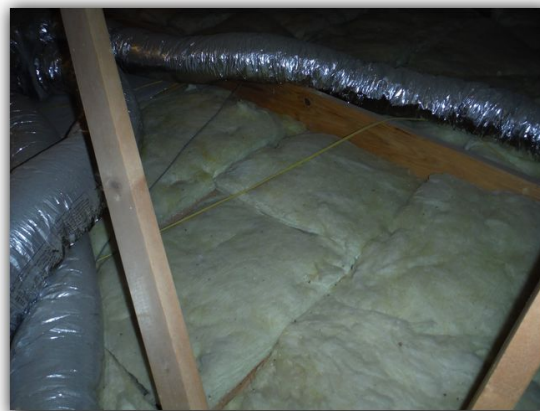
Attic insulation is not the proper thickness in one or more locations and is required to be a minimum thickness throughout the attic of at least R-26 or 8.75" (IRC Table N1102.1)

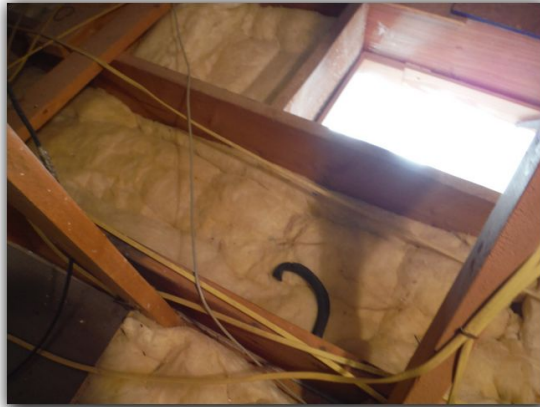
Wiring unprotected/unsecured within 6 feet of opening. This is a safety hazard. Recommend repair.

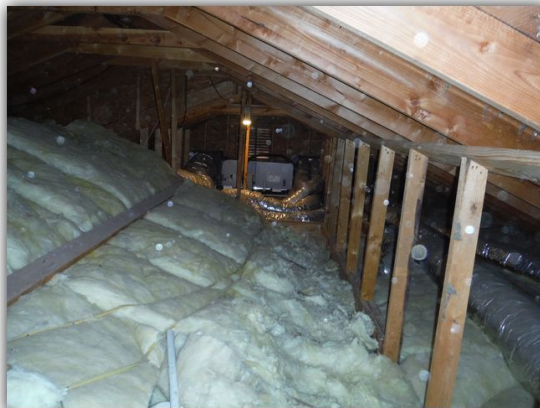
All equipment should be located no more than 20' from the access opening measured along the centerline of the floor. Access and flooring is required to be unobstructed and solid, with a minimum width of 24" from the access opening to all equipment and be a minimum of 30" wide and deep at all areas of the equipment that need servicing (IRC M1305.1.3)

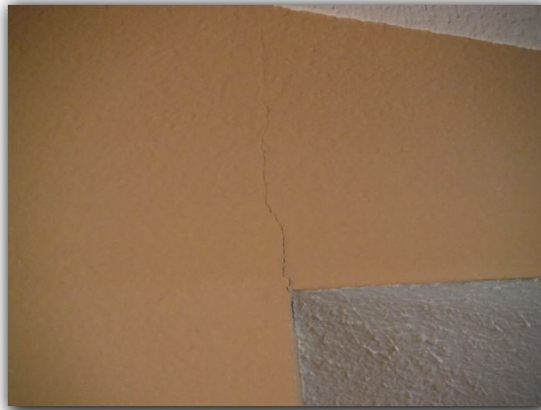
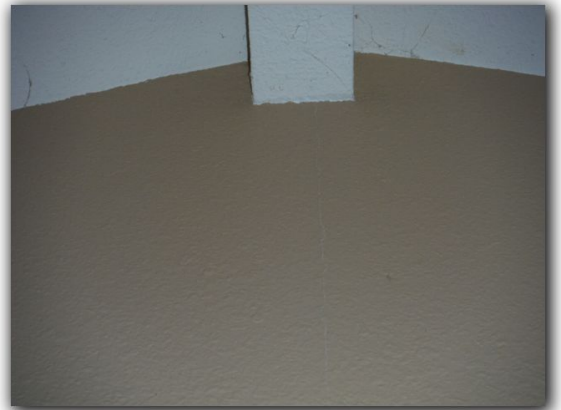
Cracks noted at living room.

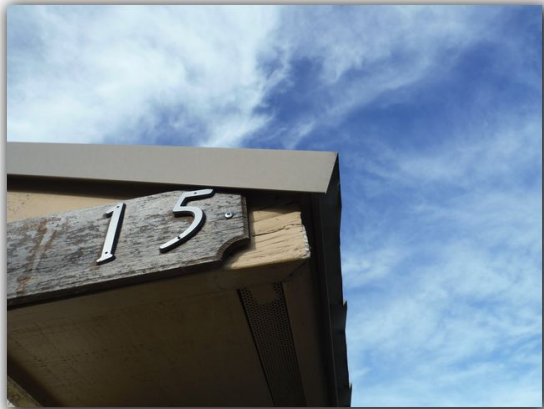
Fascia boards are water damaged at front right.

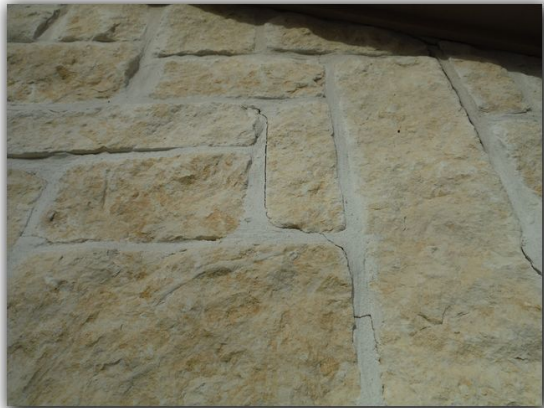
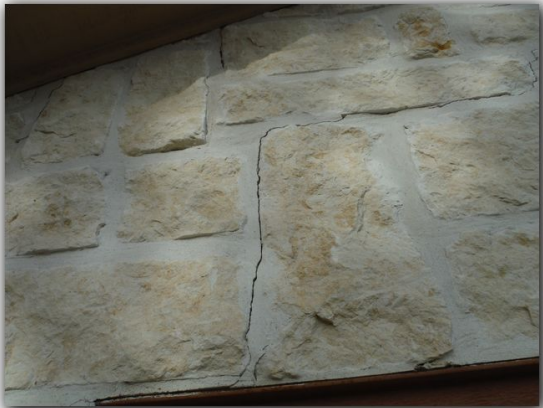
Mortar is separated at garage.

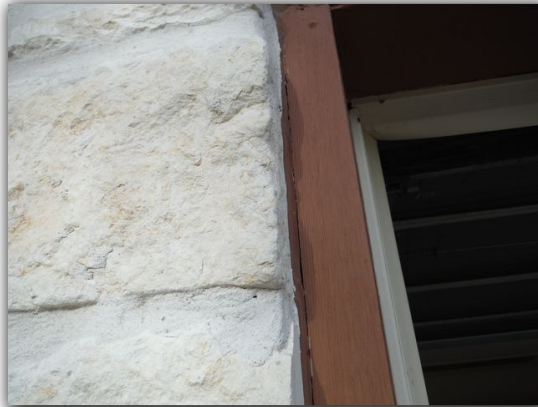
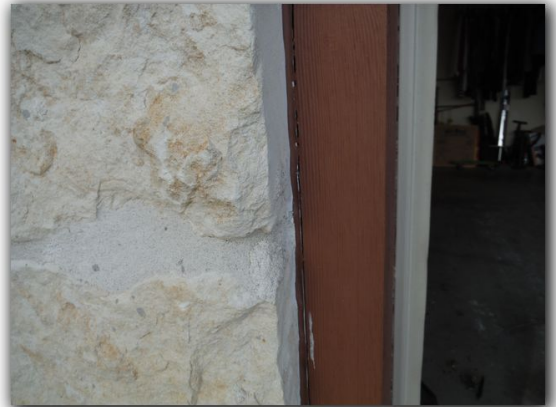
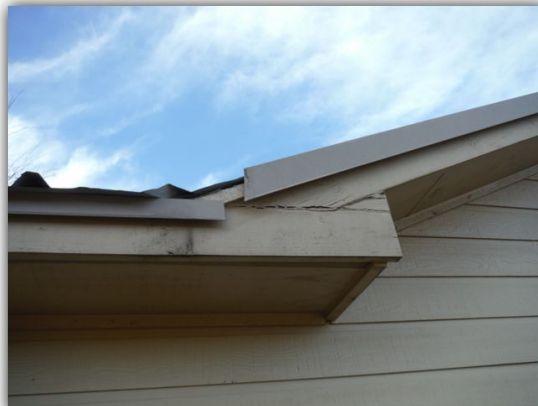
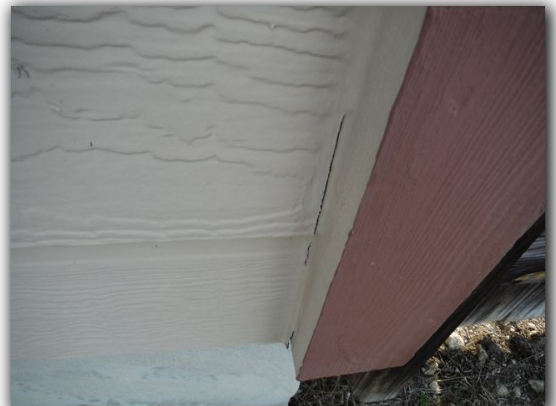
Caulking/sealant is separated or missing in some areas.

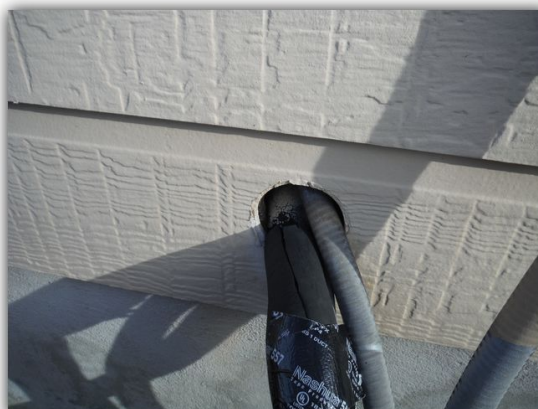
Recommend sealing gaps around compressor lines where they exit structure to reduce possibility of moisture/insect intrusion and associated damages.

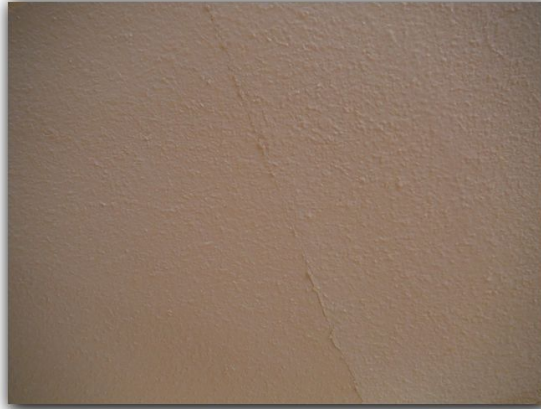
Ceiling crack at dinning room.

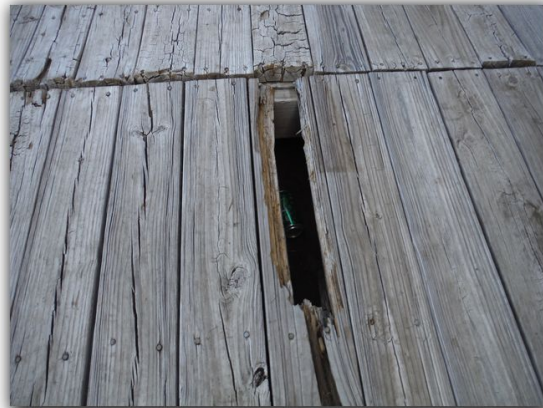
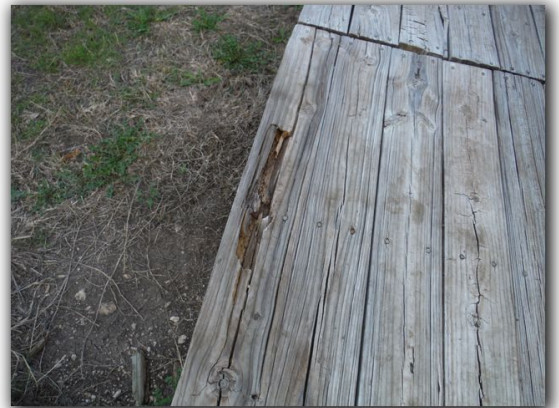
Wood members have damage.

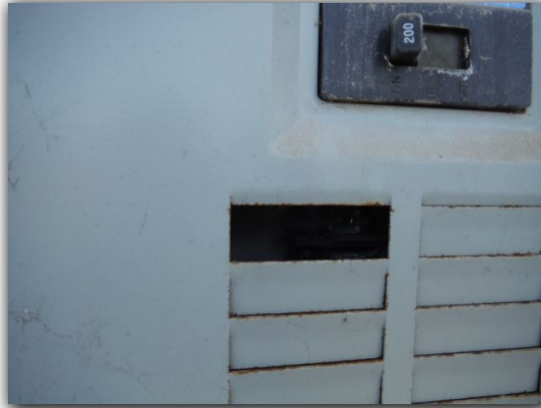
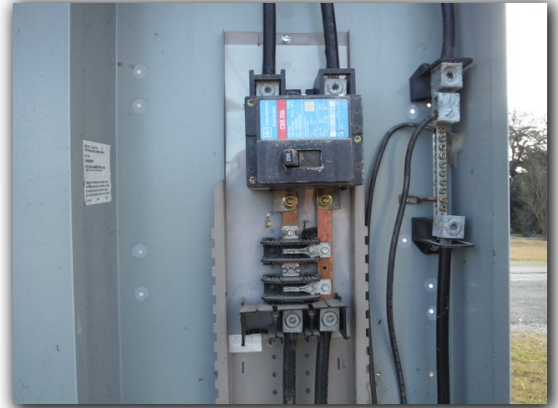
Missing knock out.

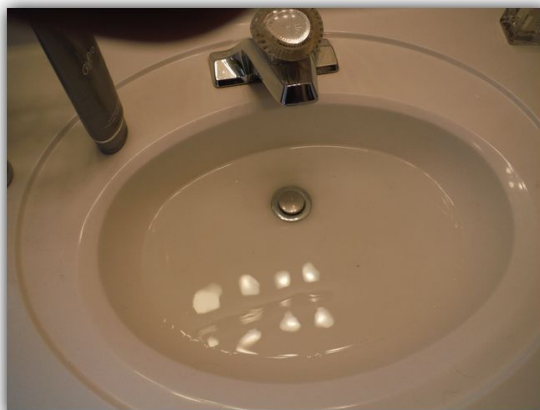
Slow drain at master sink.

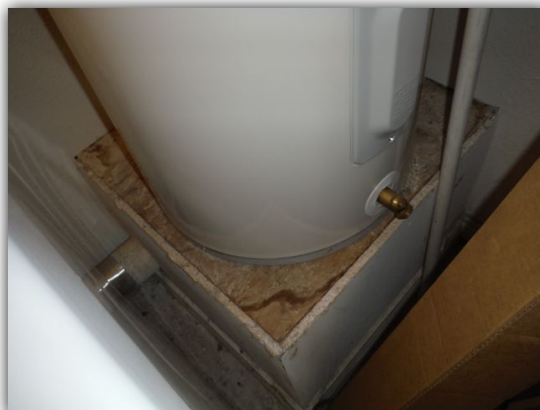
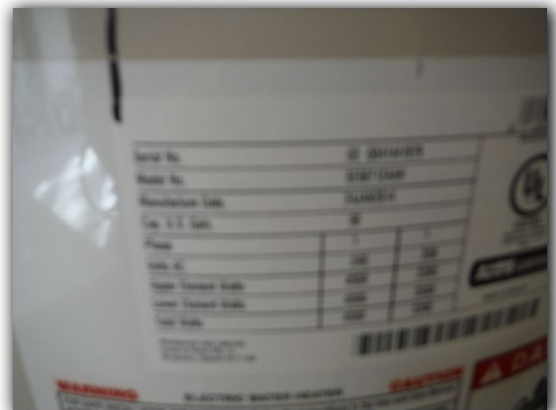
Unit has no drain pan and/or drain line installed under the unit.

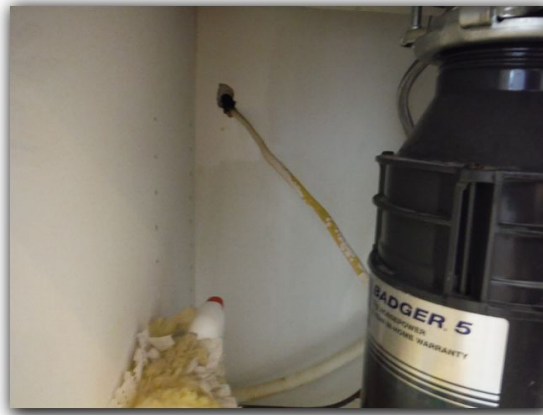
Unit is hardwired.

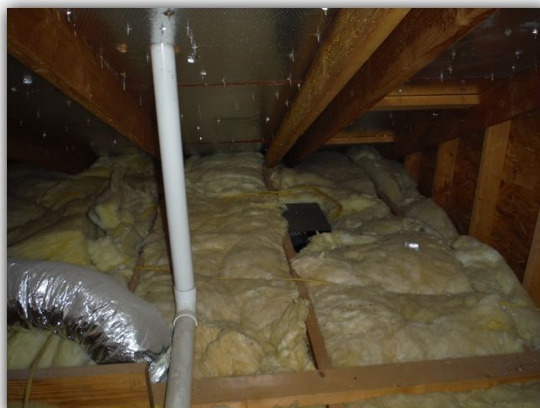
Exhaust fans terminate into attic area. All exhaust fans should terminate to the exterior of the dwelling.
