## Preliminary Arborist Report

To: James MacKay  
Site: 14012 41st Ave NE, Seattle, WA 98125  
Re: Tree Inventory and Assessment for Development  
Date: January 29, 2021  
Project Arborist: Andrea Starbird,  
ISA Certified Arborist #PN-9084A  
Connor McDermott,  
ISA Certified Arborist #PN-8704A  
ISA Qualified Tree Risk Assessor  
Attached: Table of Trees  
Tree Site Map

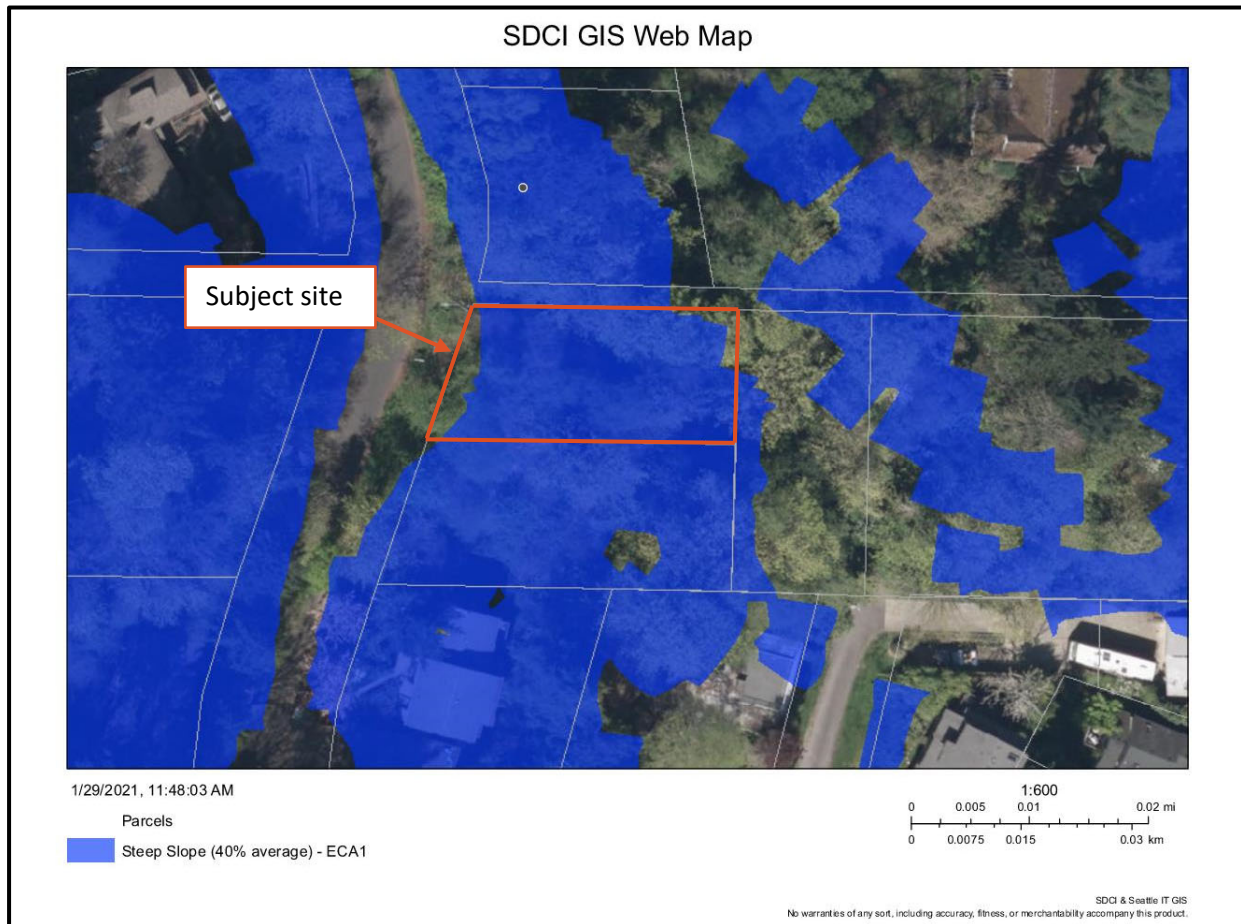
The 8,216 square foot site fronts 41st Ave NE in the Cedar Park neighborhood of Seattle. The Seattle Department of Construction and Inspection (SDCI) GIS map shows a steep slope hazard environmentally critical area (ECA) on site. The site is undeveloped.

Figure 1. Aerial image from SDCI GIS map with Steep Slope (40% average) – ECA1 shown in blue.  
(Accessed 1/29/2021).

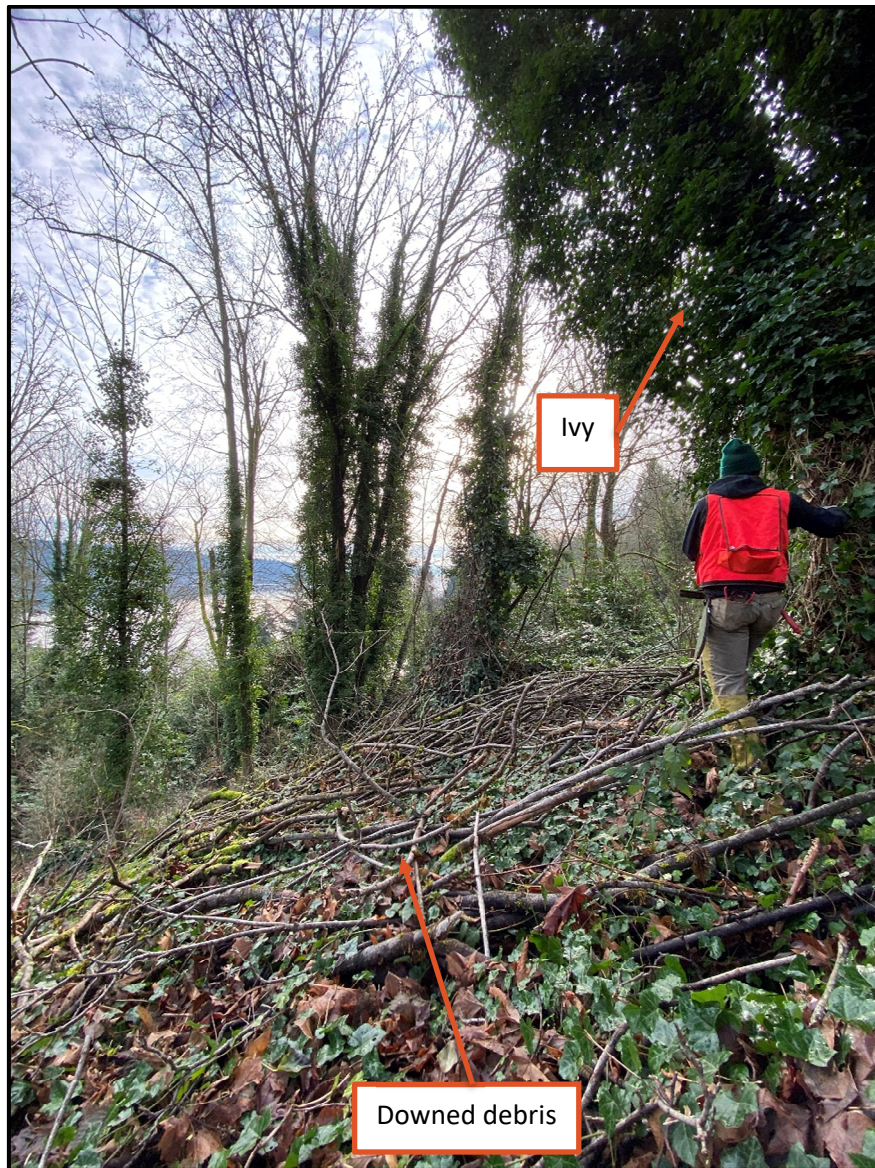
The site is densely vegetated with invasive plant species, including: invasive ivy (*Hedera* sp.) Himalayan blackberry (*Rubus bifrons*), invasive clematis (*Clematis* sp.), and English holly (*Ilex aquifolium*). We observed limited native understory plants with a few low Oregon grapes (*Mahonia nervosa*) and sword ferns (*Polystichum munitum*) throughout. There were multiple tree failures and woody debris from these trees throughout the site.

Photo 1. Site is heavily covered in invasive plant species; pictured here are invasive ivy and blackberry. Several failed trees with scattered woody debris are on site.

- Manage invasive plant species on-site, particularly ivy, and have Tree Solutions Inc. reassess trees planned for retention for health and structural condition.

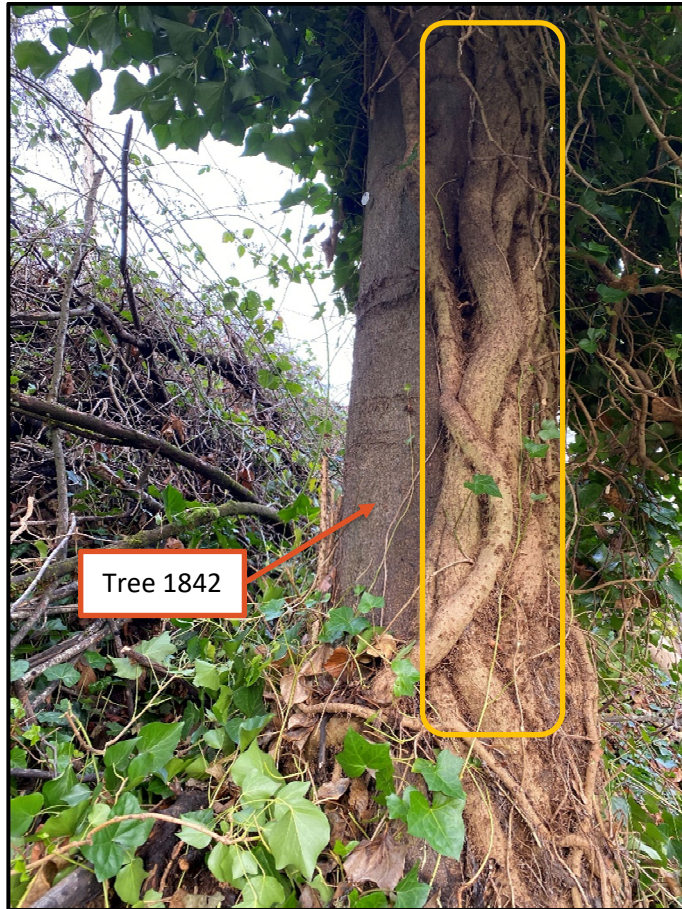
Photo 2. Tree 1842 with extensive ivy stems, outlined in yellow, that limited accurate DSH measurements. Ivy should be removed from trees and reassessed by Tree Solutions.

1842	<i>Acer macrophyllum</i>	Bigleaf maple	28.9	14.5,25	Fair	Fair	13.2	23.2	21.2	31.2	30.0	-	Codominant at base; base obscured; heavy ivy; DSH estimated; swept base
1843	<i>Alnus rubra</i>	Red alder	9.0		Fair	Poor	15.4	15.4	15.4	15.4	Not Exceptional unless in grove	-	Swept base; clematis in canopy and at base
1844	<i>Alnus rubra</i>	Red alder	23.4	18,15	Fair	Poor	23.0	25.0	31.0	26.0	Not Exceptional unless in grove	-	Limited assessment of structure; obscured by ivy; blackberry and clematis at base; previously pruned for power lines; codominant at 1 foot; tear out on western stem; southern stem cracked with saprophytic fungi
A	<i>Alnus rubra</i>	Red alder	15.5		Good	Good	22.6	-	-	-	Not Exceptional unless in grove	-	Obscured by ivy; asymmetrical canopy
B	<i>Acer macrophyllum</i>	Bigleaf maple	40.2	32,13,15,14	Fair	Fair	36.7	-	-	-	30.0	Exceptional	Limited assessment; 4 stems; heavy ivy; obscured at base. Size should be confirmed after ivy is removed.

We recommend removing the ivy from the trunks and around the base of on-site trees and reassessing.

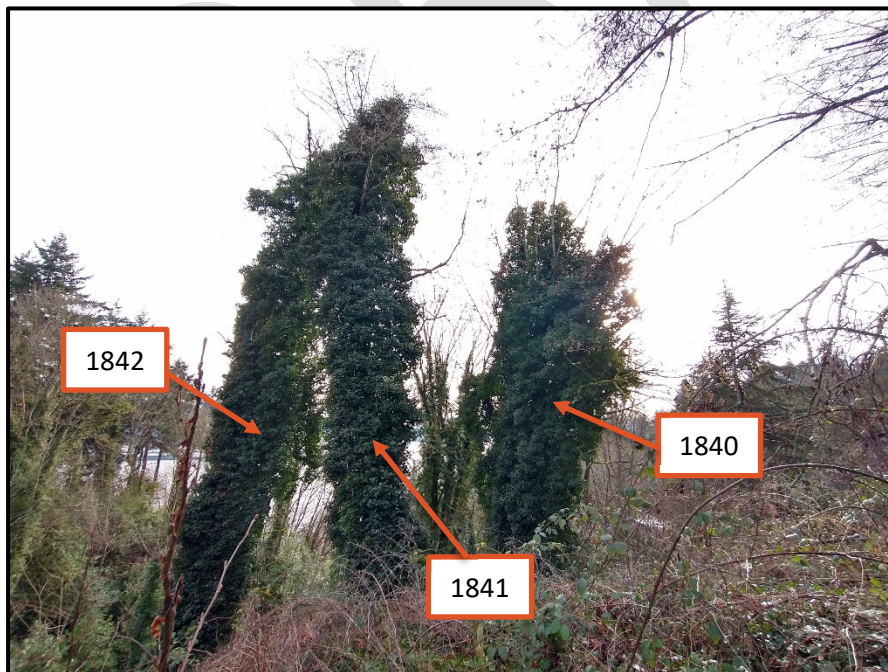
Photo 3. Trees 1840, 1841, and 1842.

Tree 1840 is a bigleaf maple and the only tree of exceptional size on the site. Due to large ivy stems growing on the trunk, we estimated the DSH. The size and condition of this tree should be confirmed after the ivy is removed.

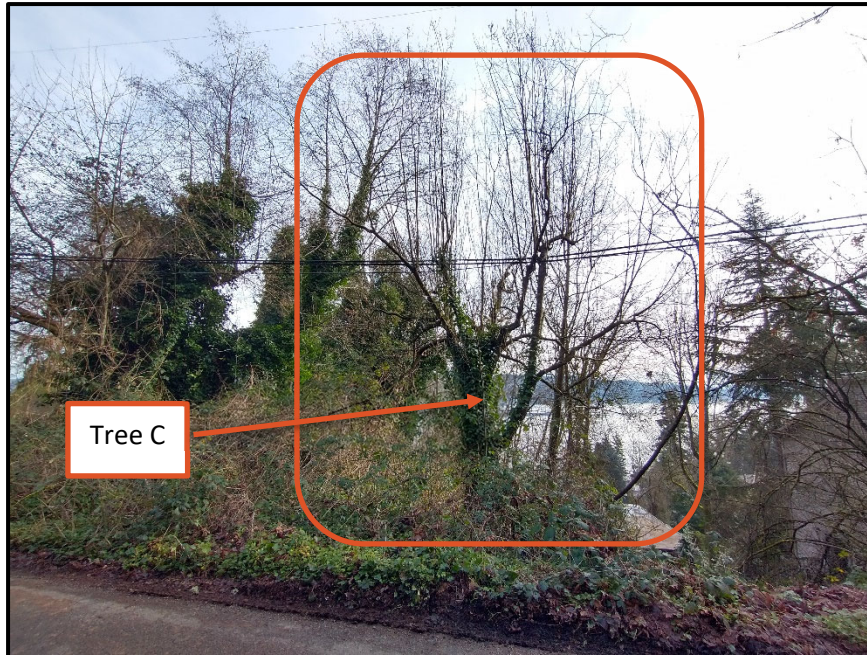
Photo 4. Tree C, outlined in red, within right of way of 141<sup>st</sup> Avenue NE below powerlines.

C	<i>Prunus cerasifera</i>	Cherry plum	16.0		Fair	Poor	18.7	16.7	10.7	16.7	21.0	-	ID should be confirmed when in leaf; phototropic lean to east; heavy ivy; previously topped for utilities; heavy sprouting and regrowth; large trunk wound on south side
