STUCCO INSPECTOR

Stucco Inspection Report

495 Hickory Ridge Rd
Martinsville, VA 24112

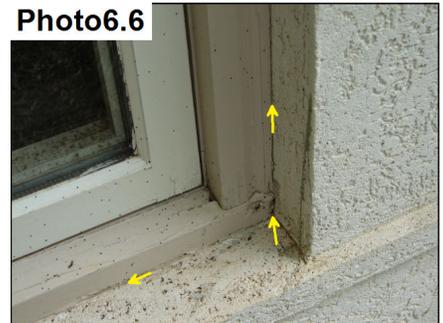
I suggest that window sill be caulked/re-caulked correctly.

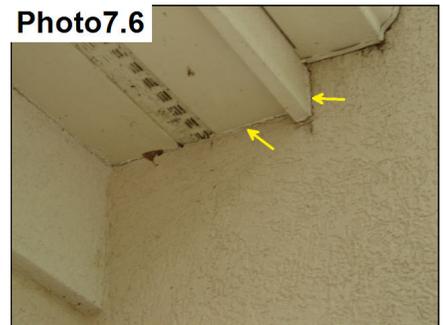
Photo7.6
Soffit/Eaves area needs to be caulked at the stucco.

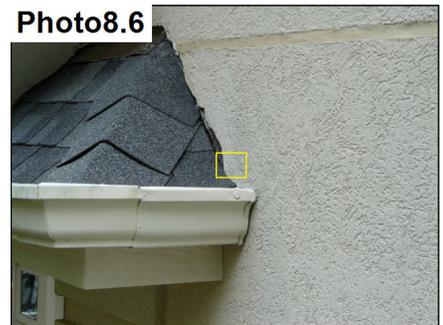
Suggest diverter flashing be installed.

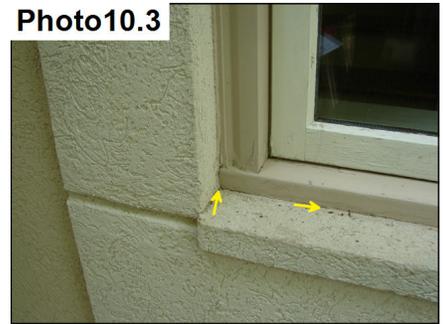
Photo10.3
I suggest that window sill be caulked/re-caulked correctly.

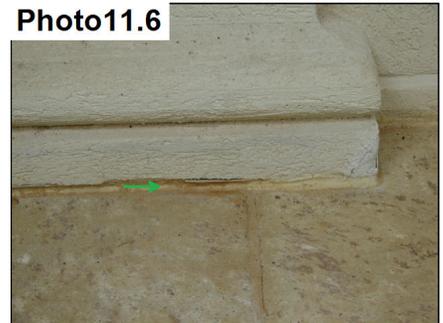
Stucco termination is sealed correctly at the tile.

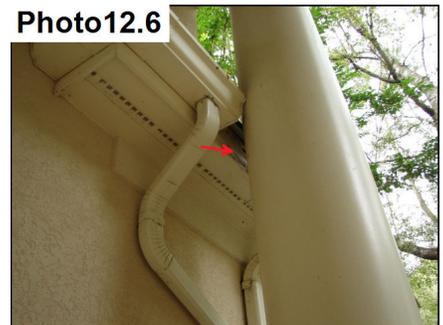
Wood rot is present.

| Grid Location | Item Description | Moisture Readings | Substrate Condition | Observations | Chapter Reference |
|---|---|---|---|---|---|
| I3 | Wood rot | | | External wood rot needs to be repaired. | |

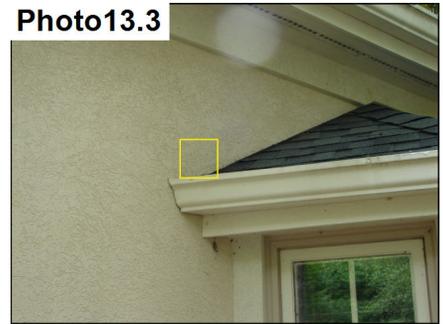
Kickout flashing is missing and needs to be installed.

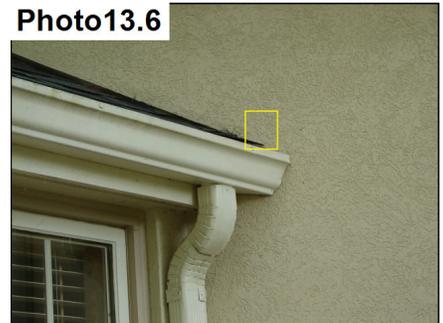
Kickout flashing is missing and needs to be installed.

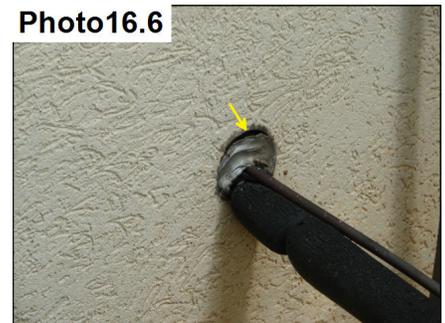
Utility pipe needs to be caulked at the stucco.

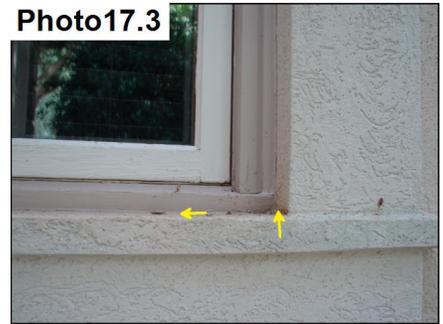
Thin and failing caulk at the window frame, need to re-caulk.

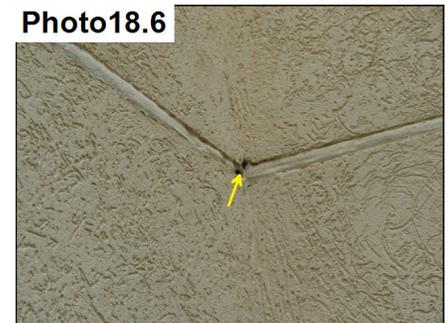
Failed caulk at the joint, need to caulk correctly.

| Grid Location | Item Description | Moisture Readings | Substrate Condition | Observations | Chapter Reference |
|---|---|---|---|---|---|
| H&J 6 | Joint failure | | | Caulk failure at the joint, need to re-caulk correctly. | |

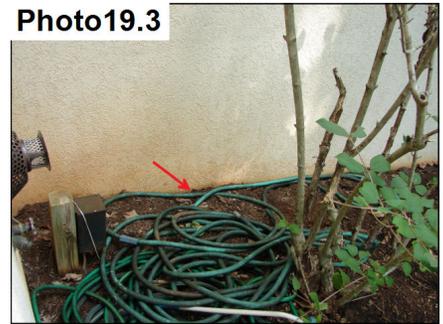
Stucco is below grade, need to bring up above grade.

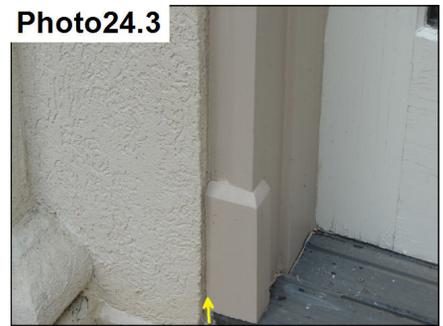
Photo24.3
Thin and failing caulk at the door frame, need to re-caulk.

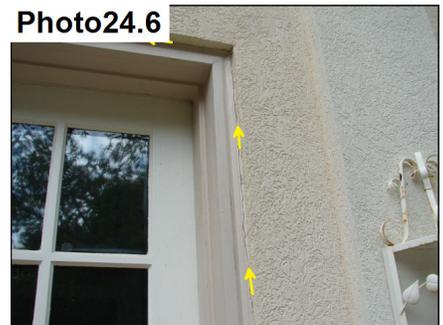
Photo24.6
Thin and failing caulk at the door frame, need to re-caulk.

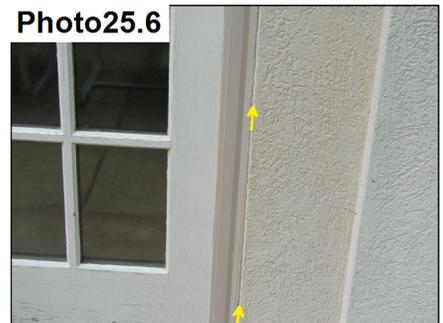
Thin and failing caulk at the door frame, need to re-caulk.

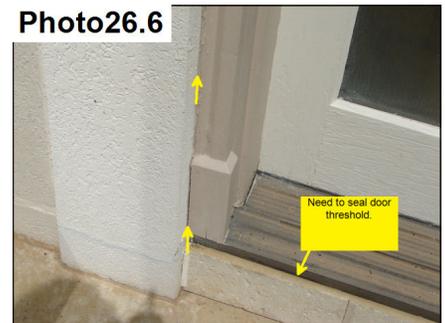
Photo26.6

Thin and failing caulk at the door frame, need to re-caulk.

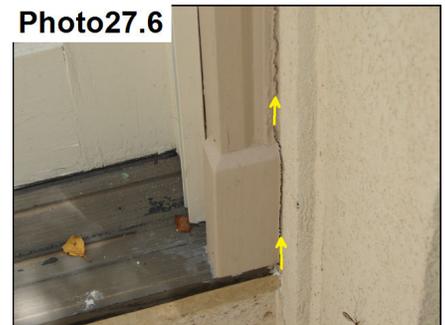
Thin and failing caulk at the door frame, need to re-caulk.

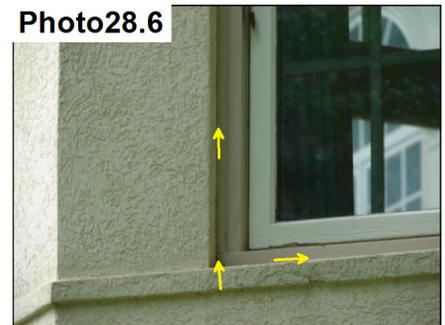
Thin and failing caulk at the window frame, need to re-caulk.

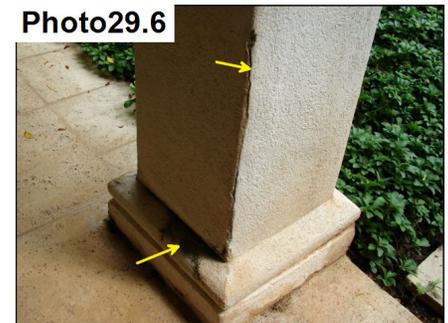
Water entering the stucco between the stucco and concrete.

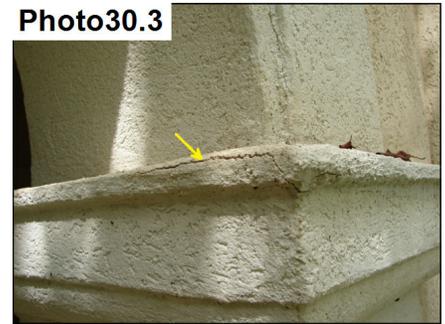
Exposed cracks need to be repaired and or sealed/caulked correctly.

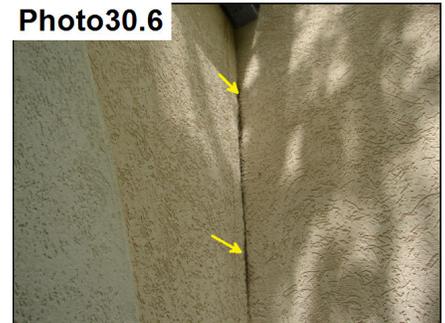
Signs of water entry in the corner at the steps.

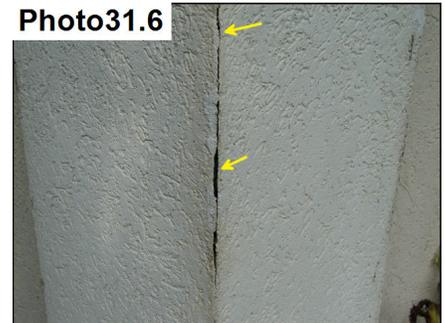
Signs of water entry between the stucco and the concrete construction.

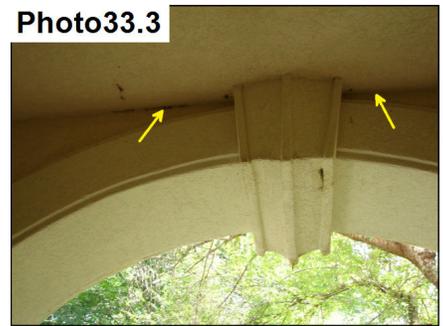
Signs of water entry between the stucco and the concrete construction.

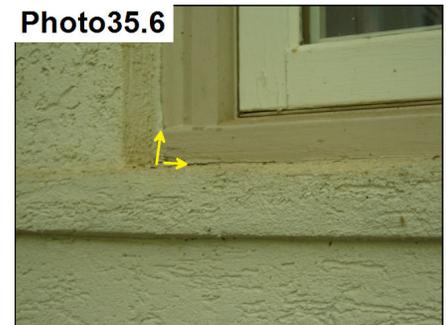
Photo35.6
Thin and failing caulk at the window frame, need to re-caulk.

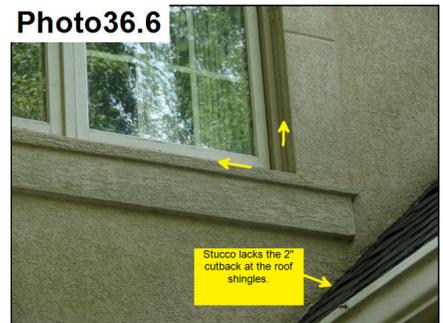
Thin and failing caulk at the window frame, need to re-caulk.

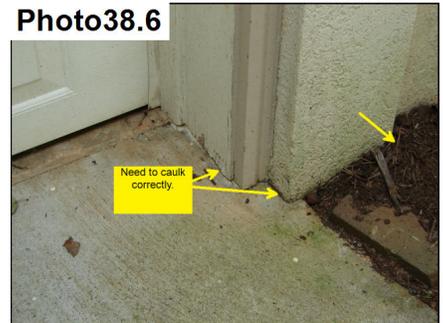
Below grade, need to bring above grade.
