Barry Williams
1701 Cedar Crest Dr, Abilene , Texas

Inspection date
July 23, 2021

Level of inspection
Level I and parts of Level II

Prepared by
Brody Earles CSIA#10109
Shanes Chimney Care LP

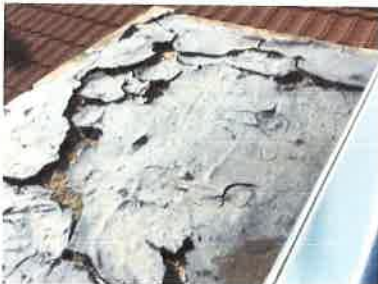
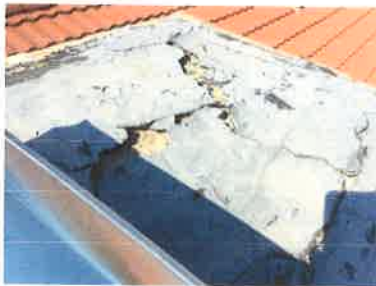
- **Brick / Stone / Chimney walls condition:** Meets industry standards
- **Crown / Wash cap:** Needs attention

This chimney has the presence of roofing tar, a combustible material, as a sealant. This is dangerous as the temperature around the flue could possibly ignite the tar and start a roof fire. Some of that tar has melted and begun running down the inside of the flue.

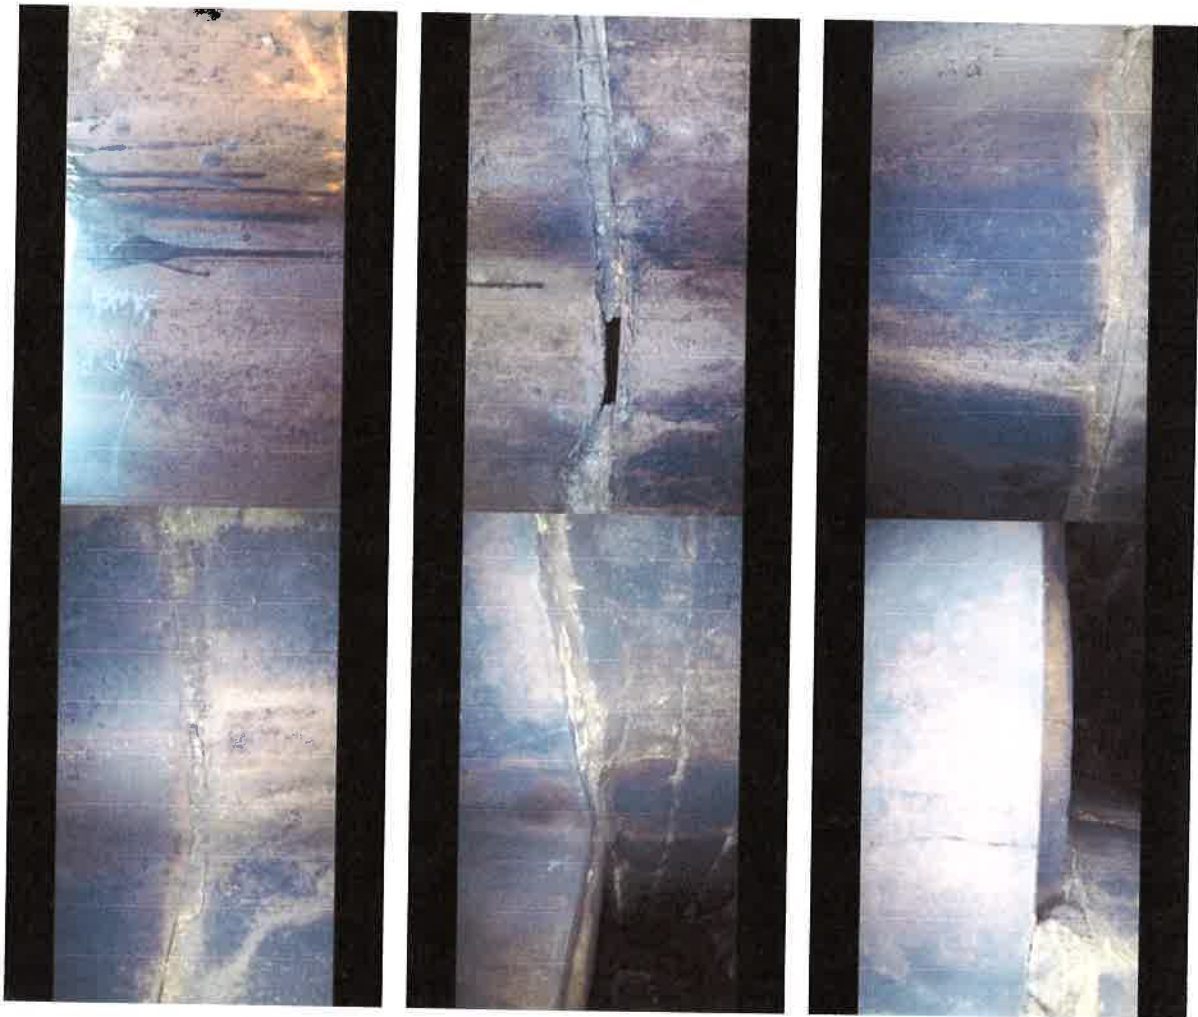
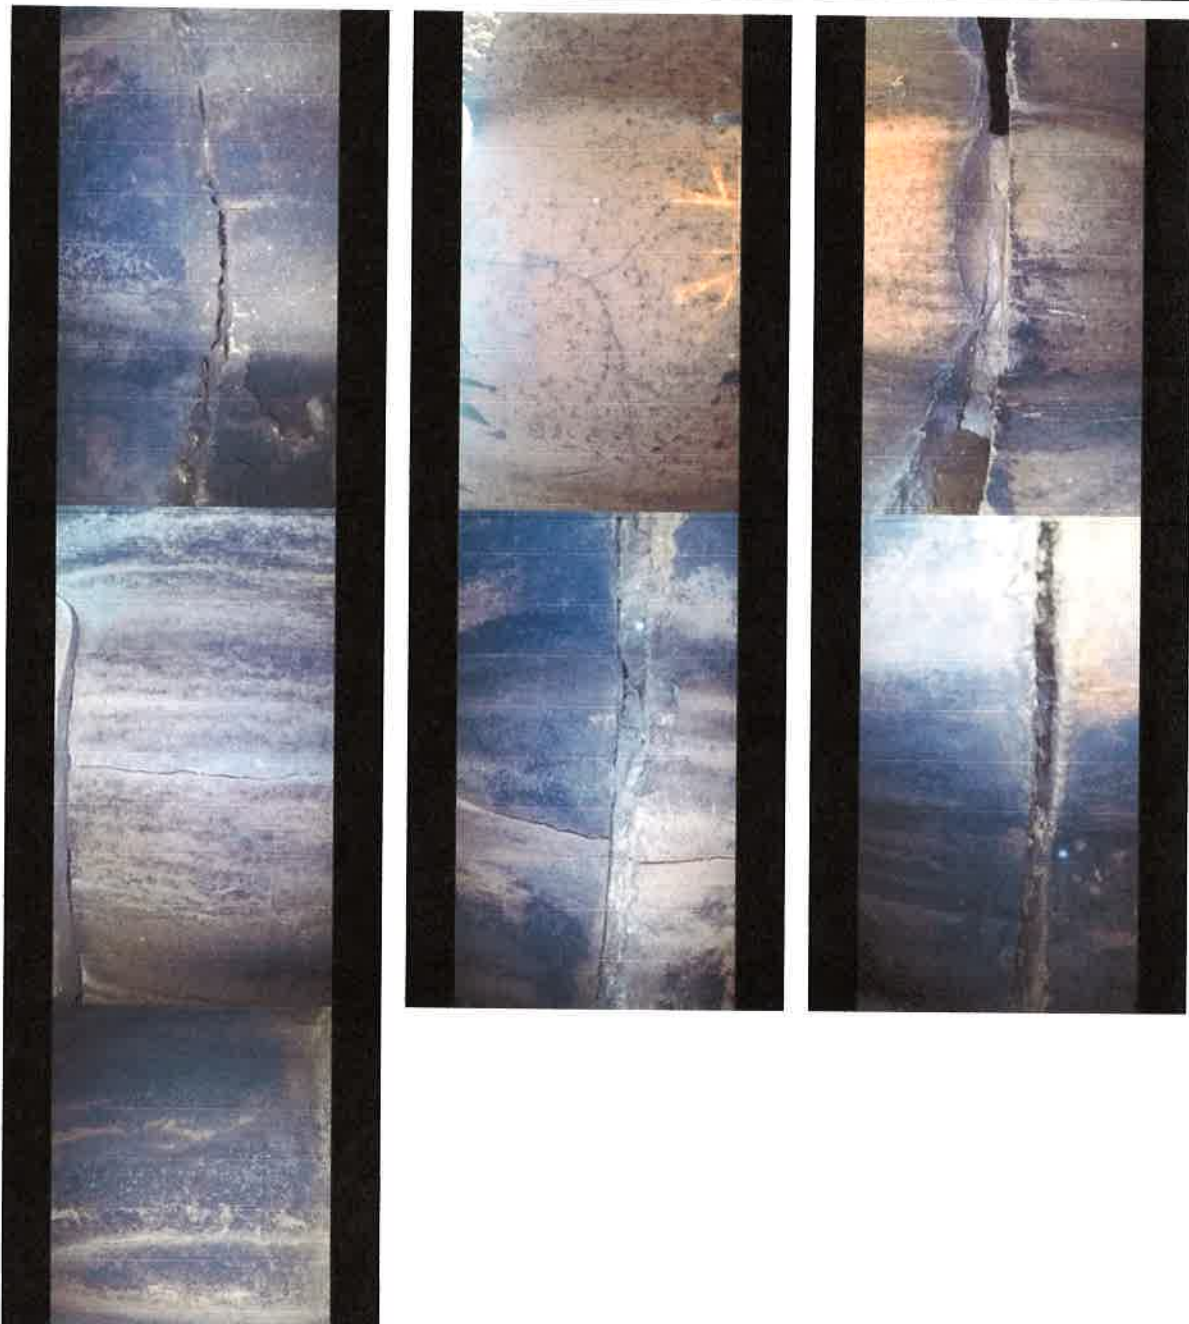
- **Chimney cap / spark guard / Top damper:** Meets industry standards
- **This flue was inspected:** Internal camera inspection system
- **Chimney liner presence, condition regarding readily visible defects, holes, cracks, missing mortar joints, spalling, mortar protrusions, and proper alignment:** Does not meet industry standards

There are tiles that have vertical cracks. Vertical cracks are an indication that there has been a sudden rapid heating of the tile. This rapid heating causes thermal shock to the tile. Thermal shock causes the inside of the tile to heat more rapidly than the exterior of the tile. Heat causes the inside of the tile to expand more rapidly than the exterior of the tile. When this occurs the tile will crack vertically. This flue tile can no longer perform its intended function. The chimney must be relined. 2016 NFPA 211 14.9

The mortar joints between the flue tiles are no longer intact. These missing or deteriorated mortar joints prevent the flue tiles from properly conveying the byproducts of combustion to the exterior of the home.

Flue tiles are required to have space in between them to allow for expansion and prevent cracking.

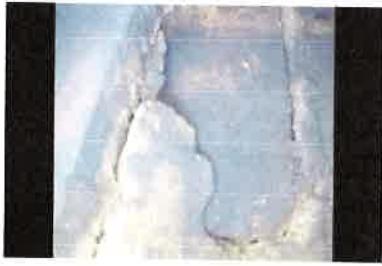
- **Flue tile sealed at smoke chamber:** Does not meet industry standards

The flue tile is not sealed at the top of the smoke chamber. This can allow the byproducts of combustion to go behind the flue tiles and may migrate to areas of the chimney and home not meant to contain them. The potential hazard exists that combustible residue could built up where it cannot be maintained and allow the possibility of a structure fire. This defect could also allow carbon monoxide the enter the home. 2016 NFPA 211 11.2.1.13

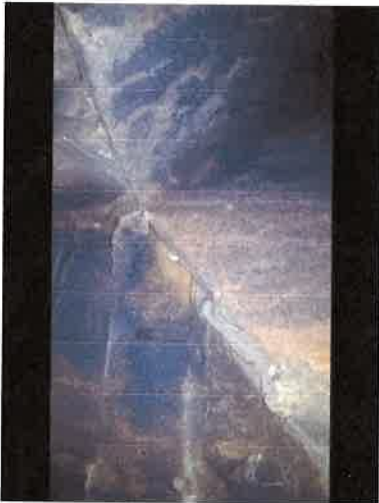
• **Smoke chamber general accessibility, construction, parging and condition:** Does not meet industry standards

The smoke chamber is a crucial part of the fireplace system and is often the most poorly constructed area of the structure. Most structural fires associated with fireplaces originate in this area. It is imperative that this area be completely sealed and parged smooth. 2016 NFPA 211 11.2.1.13 IRC 2006 2111.S

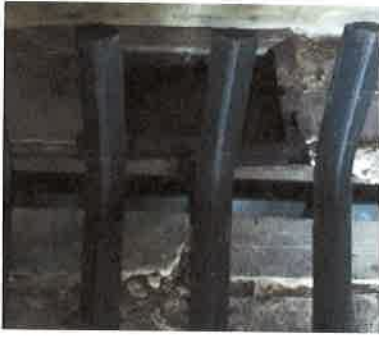
• **Ash dump-door:** Needs attention

The ash dump door is missing and should be replaced or the ash dump sealed off to prevent hot embers or coals to fall into the ash pit

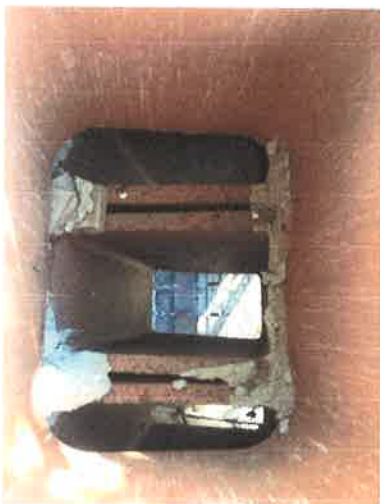
- **Chimney liner presence, condition regarding readily visible defects, holes, cracks, missing mortar joints, spalling, mortar protrusions, and proper alignment:** Needs attention

The mortar joints between the flue tiles are no longer intact. These missing or deteriorated mortar joints prevent the flue tiles from properly conveying the byproducts of combustion to the exterior of the home.

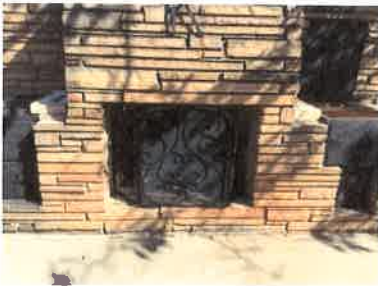
- **Smoke chamber general accessibility, construction, parging and condition:** Needs attention

The smoke chamber is a crucial part of the fireplace system and is often the most poorly constructed area of the structure. Most structural fires associated with fireplaces originate in this area. It is imperative that this area be completely sealed and parged smooth. 2016 NFPA 211 11.2.1.13 IRC 2006 2111.S
