Home Inspection Report

PROPERTY INSPECTED:
2007 Meier Road
Festus, MO 63028

Date of Inspection: 07/30/2020

Inspection No. 55602-3017

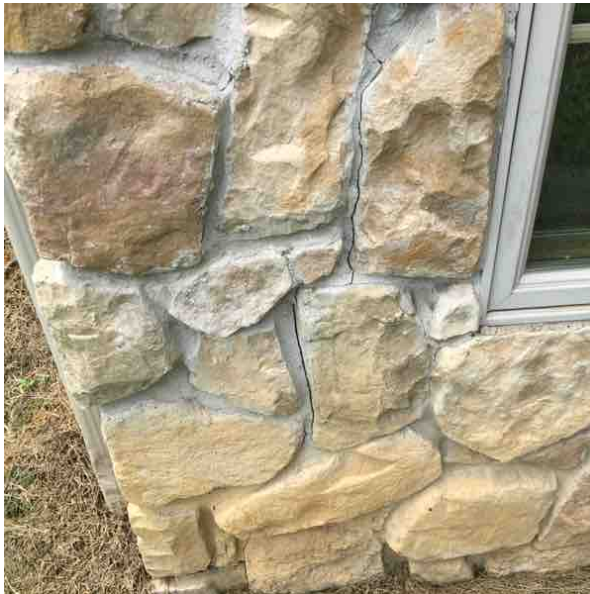
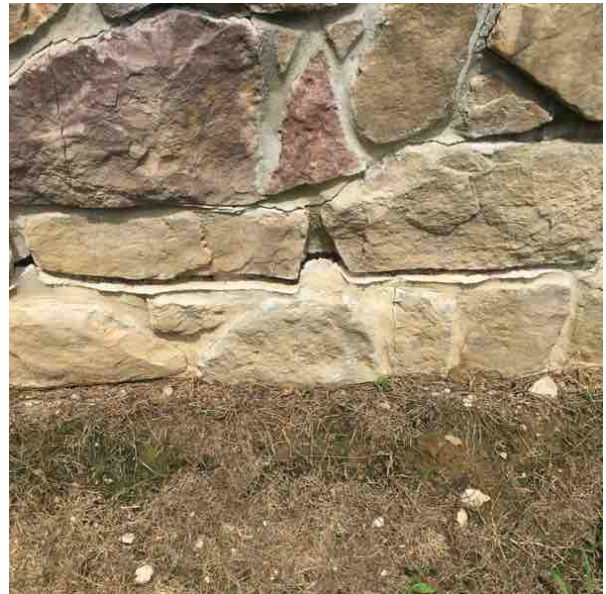
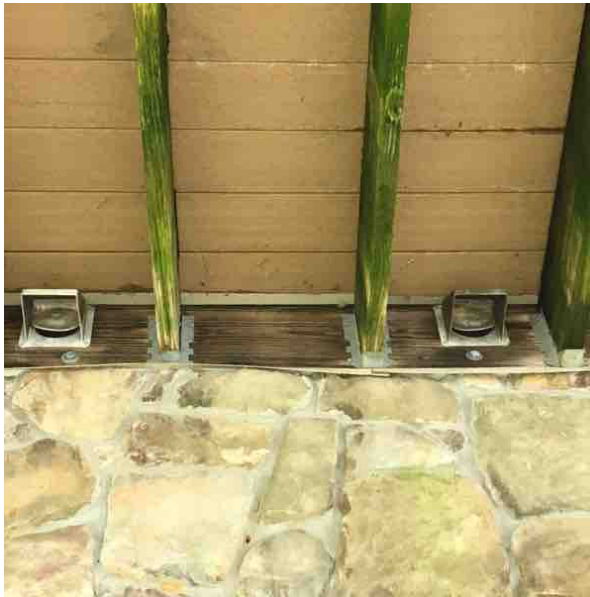
3.3.2 **Damaged/missing mortar joints noted (gaps between the bricks/stone)at select areas, which is common in brick homes and considered routine maintenance. Recommend repair (e.g. spot tuck point) of all areas by a qualified contractor to prevent further deterioration and related damages.**

Observed damaged/ missing exhaust vent cover. Recommend replacement to discourage rodent/ vermin entry.

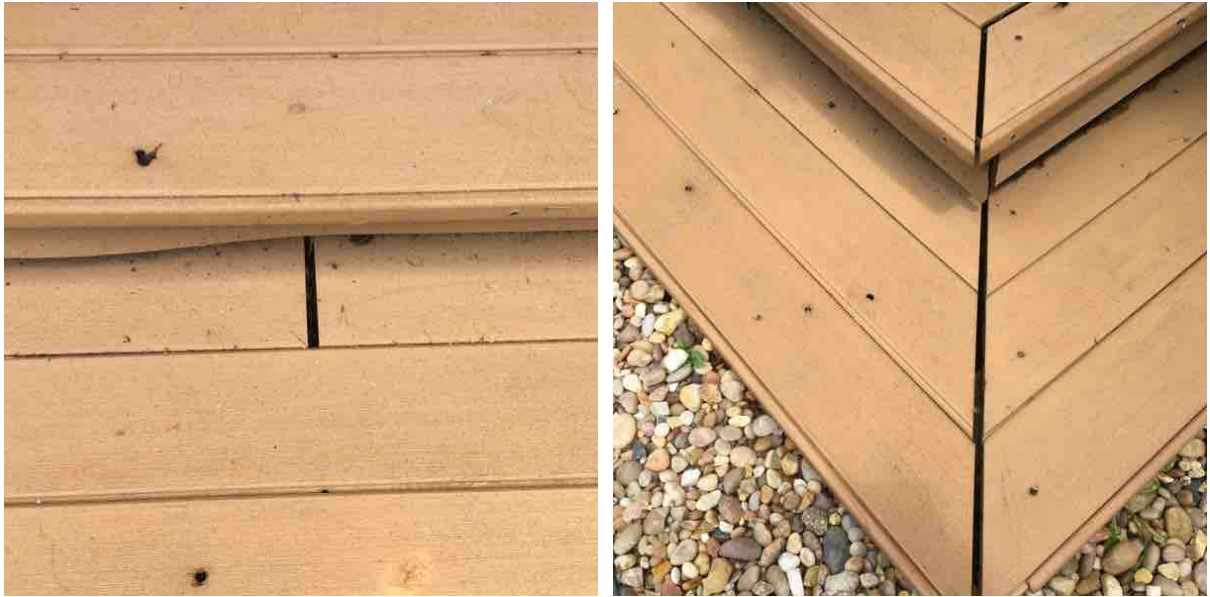
3.9.2 Minor imperfections to the composite decking. Recommend sealing to ensure proper operation and prevent ant moisture related damages.

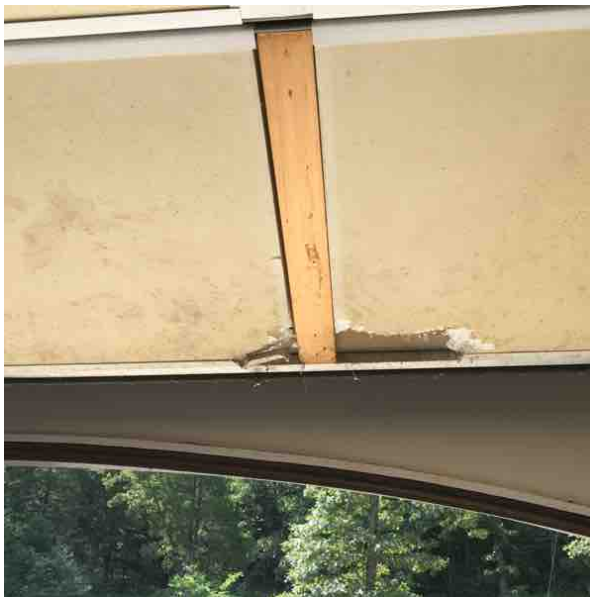
6.3.2 **Minor damage to the foam insulation to the bottom of the door on the right side. Recommend replacing to ensure proper operation.**

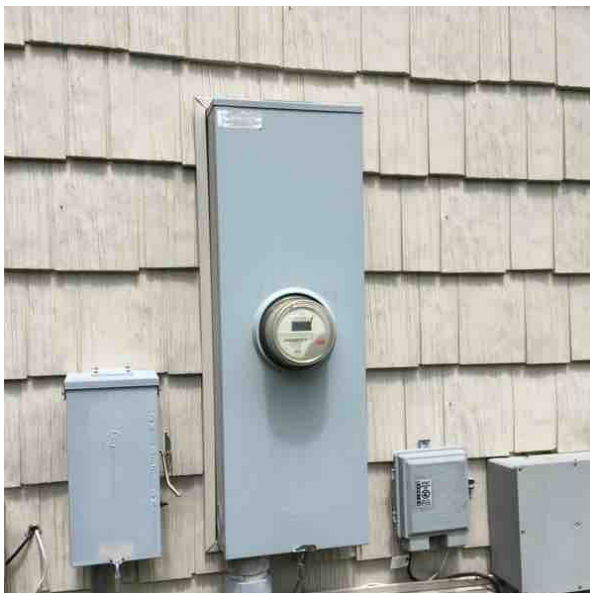
8.2.2 View of the Meter Base

8.2.1 Service entrance was in acceptable condition at the time of inspection. Monitor meter base to ensure it is secure to the home and maintain seal around service entrance wire at the top of the meter and entrance to the home.

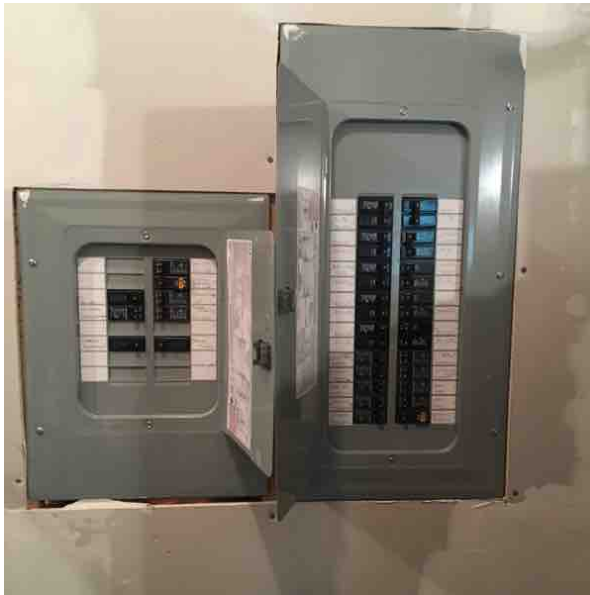
8.3.2 View of Electric Panel

8.3.1 Electric panel was operational at the time of inspection and showed no signs of visible damage.

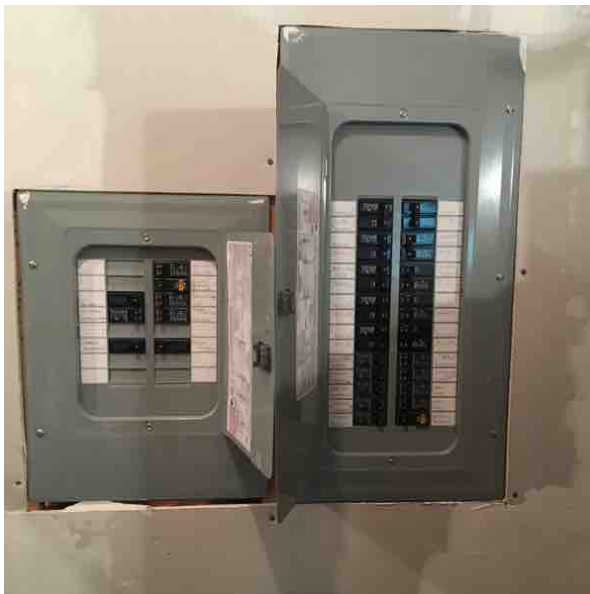
8.4.2 View of sub-panel.

8.4.1 Sub panel was operational at the time of inspection and showed no visible signs of damage.

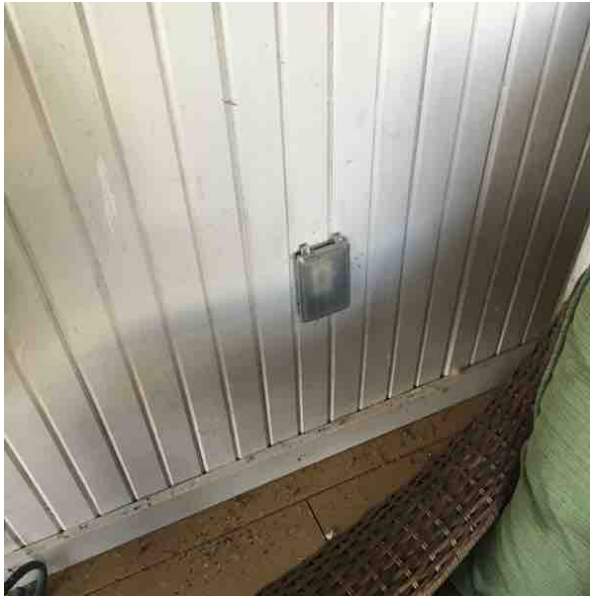
8.6.3 **The GFCI receptacle would not trip and/ or reset when tested on the left side rear on the deck area. Recommend correction by a qualified electrical contractor to ensure proper safety protection.**

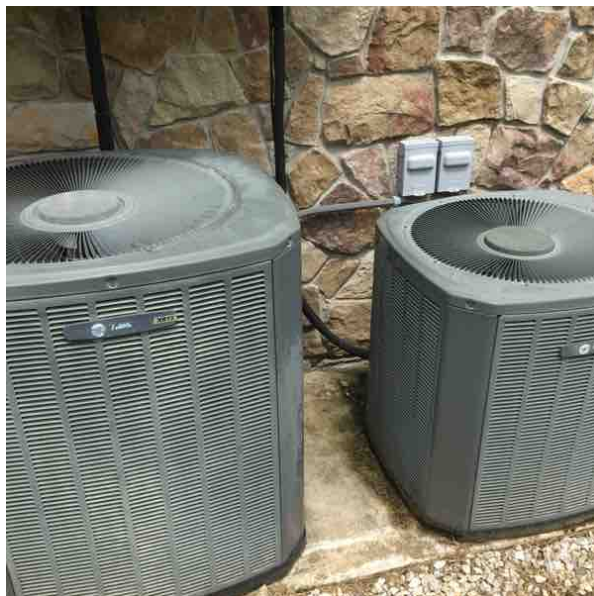
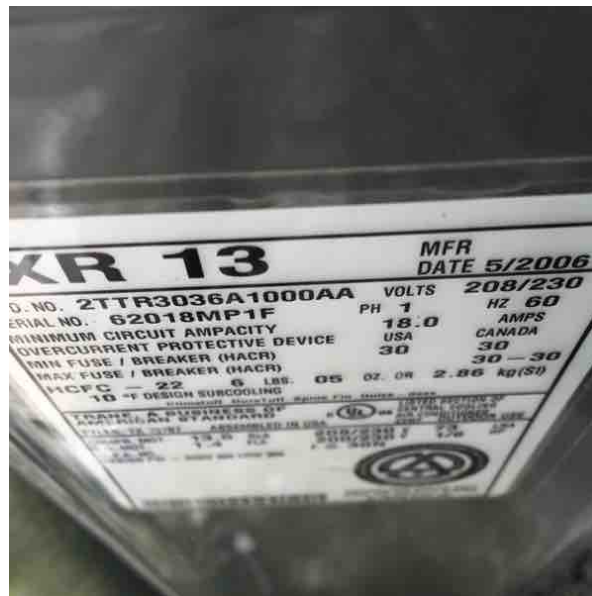
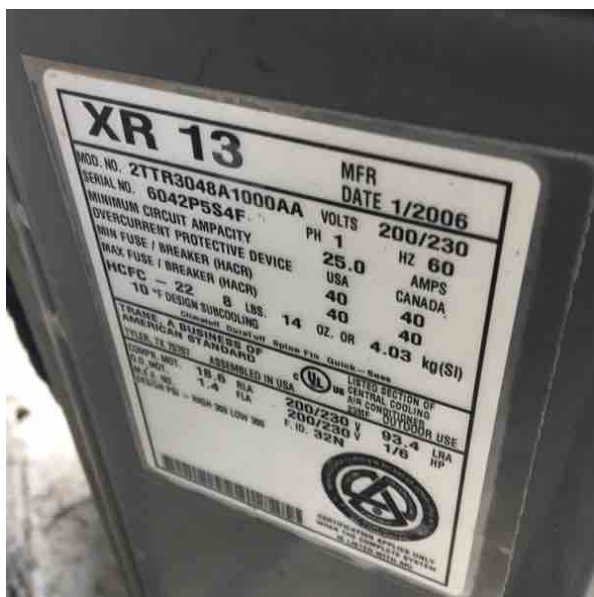
9.4.4 View of the AC unit(s)

9.4.2 Air conditioning system was operating properly at the time of inspection. The temperature differential between the return and supply registers was within acceptable parameters at the time of inspection.

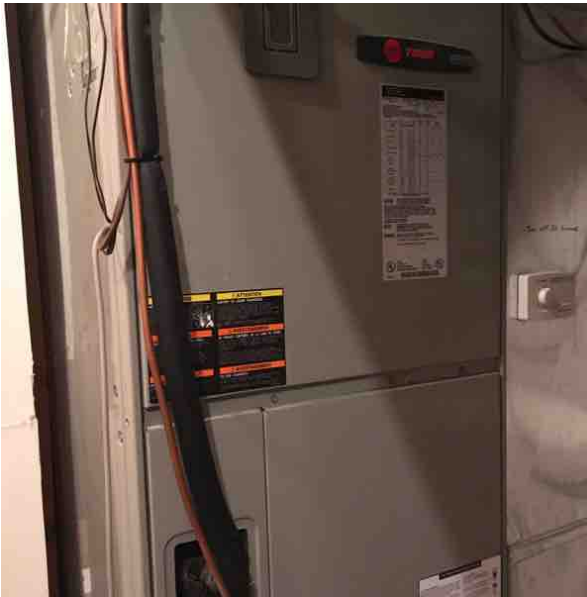
9.5.3 View of Furnace(s)

9.5.1 Furnace was operational at the time of inspection. Recommend annual evaluation and service by a qualified contractor to prolong service life.

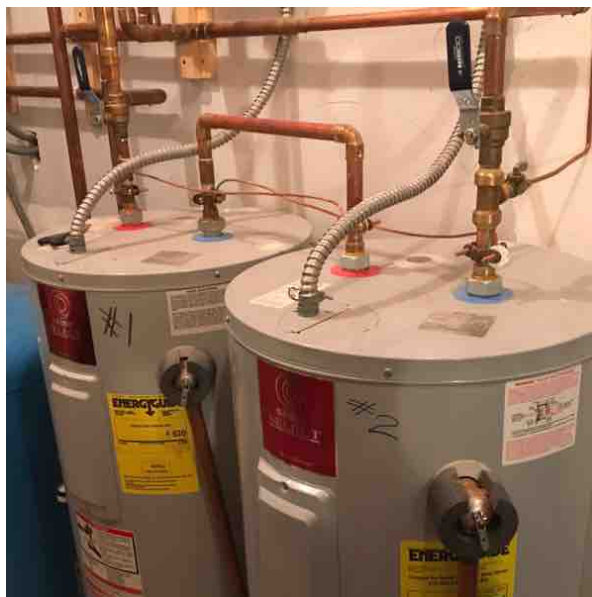
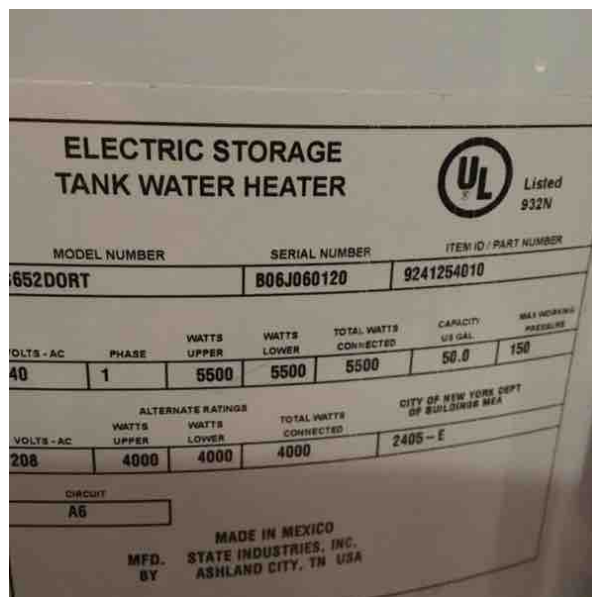
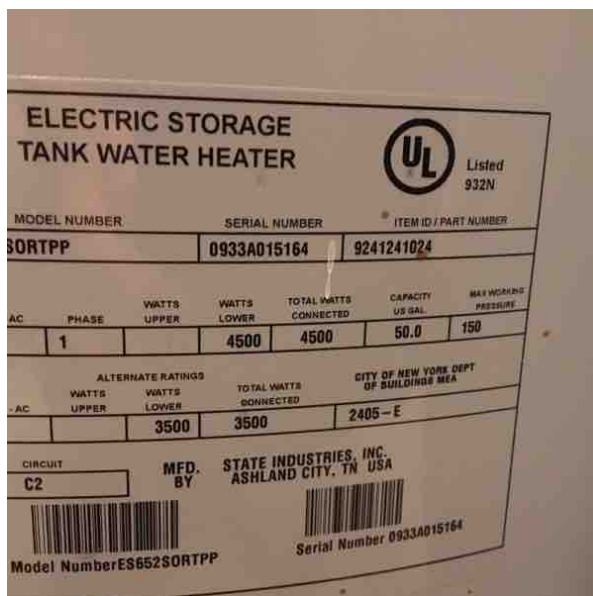
10.5.3 View of Water Heater

10.5.2 Water heater was operational at the time of inspection. Recommend annual maintenance to prolong useful life.

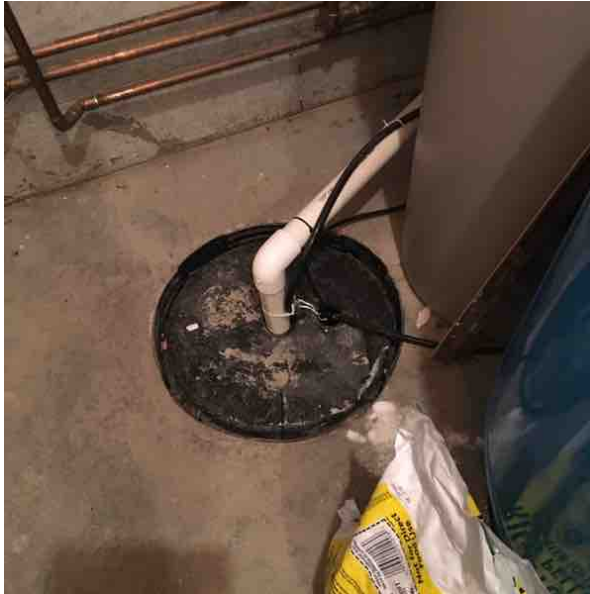
10.11.2 View of Sump Pump

10.11.1 Sump pump was tested and was operational at the time of inspection. Recommend periodic evaluation annually to ensure proper operation.

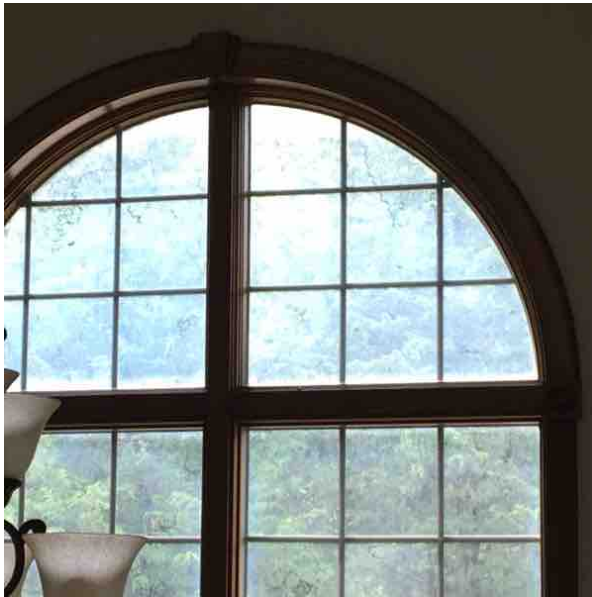
11.4.3 Failed window pane seals noted at (front above entry door) Recommend a qualified contractor repair as needed to limit fogging and staining of the window. Often when failed seals are detected in some windows it is possible that additional windows may have failed seals that could not be detected at the time of inspection or may fail in the near future. For this reason it is advised that all windows be evaluated regularly for failed seals and monitor windows for future performance.

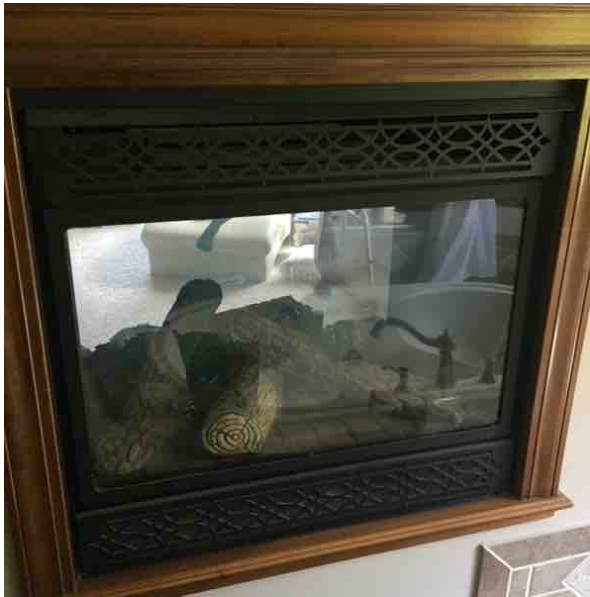
12.2.2 View of gas logs.

12.2.1 Gas log unit was operational at the time of inspection.
