Hansen Home  
Inspections

# Home Inspection Report

407 High Crossing Road, Smithville, TX 78957

Thursday, May 6, 2021

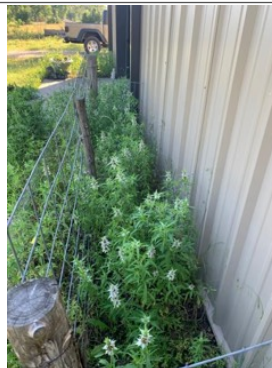
Not all the foundation walls were visible as grading is high.

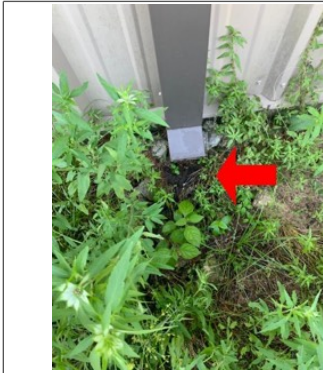
Splash blocks or extensions are recommended for downspouts.

All downspouts should have a splash block or extension installed to help direct storm water away from the foundation.

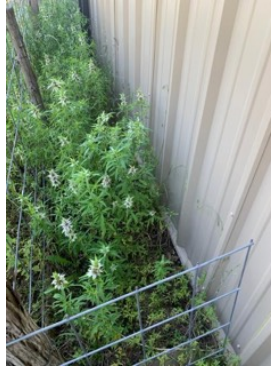
Grading up to the wall on the left side.

The grading should be improved to promote the flow of storm water away from the house. This can usually be accomplished by the addition or removal of top soil. The ground should slope away from the house at a rate of one inch per foot for at least the first ten feet. Ideally, at least eight (8) inches of clearance should be maintained between soil level and the top of the foundation walls. Grading all the way up to the wall increases the risk of water damage, and is conducive for pests.

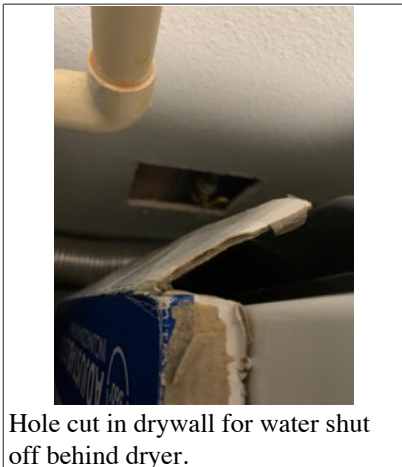
Hole cut in drywall for water shut off behind dryer.

The hole cut behind the dryer for the water shut off should be repaired to reduce the risk of pest penetration.

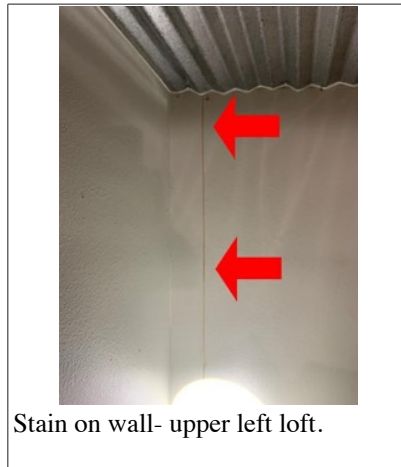
Stain on wall- upper left loft.

*Comments:* There is a stain on the wall in the upper left loft. The cause should be investigated, and minor cleaning/painting is recommended.

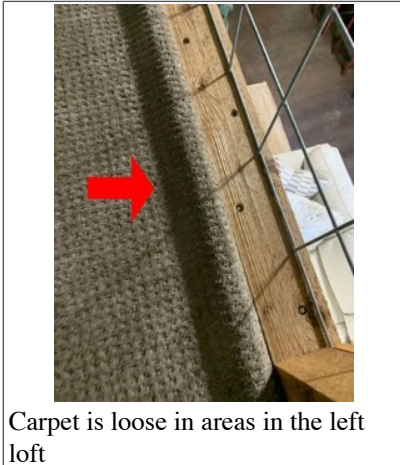
Carpet is loose in areas in the left loft

*Comments:* Loose carpet in the left loft should be re-secured.

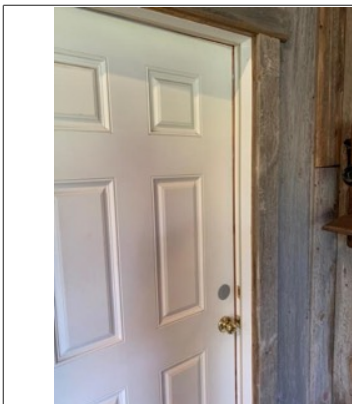
Laundry room door needs adjustment/trimming.

*Comments:* Doors for the laundry room and shop area closet should be trimmed or adjusted as necessary to work properly.

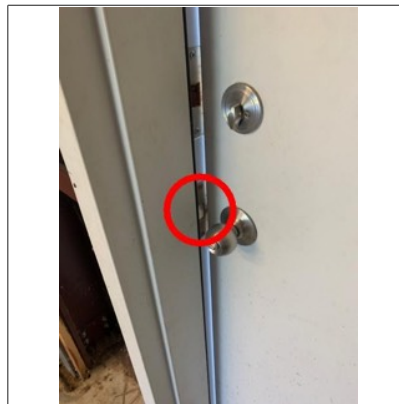
Right exterior shop door needs adjustment to latch.

The right exterior door needs adjustment to latch.

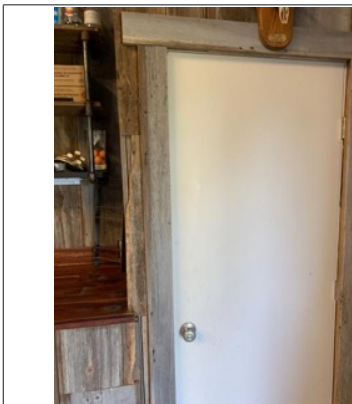
Closet door in shop needs adjustment/trimming.

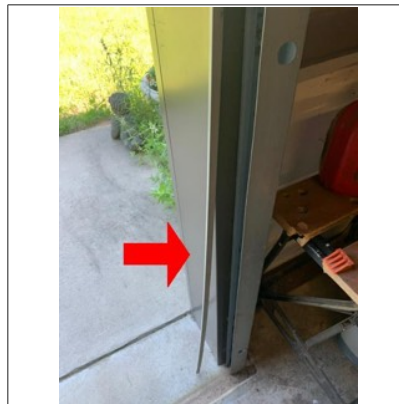
Loose weather stripping on overhead door.

Loose weather stripping on the left overhead garage door should be re-secured.

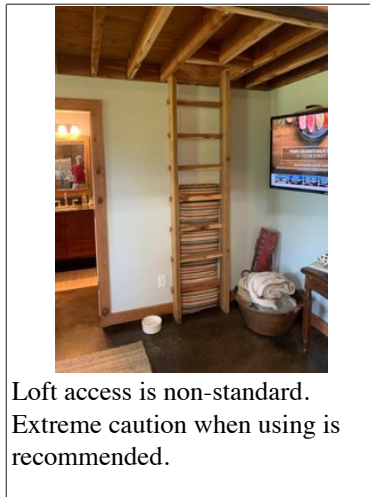
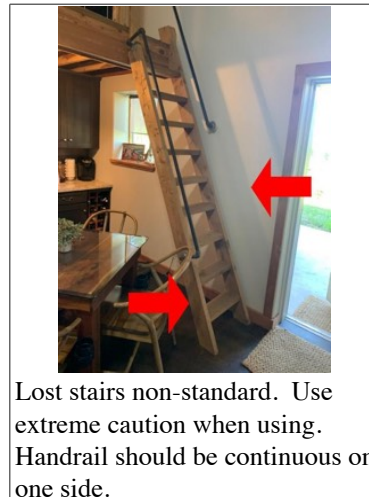
*Comments:* The stairways are steep, with non-standard treads. It may not be practical to change this condition. Extreme care should be taken when using these stairways/ladder. Carelessness could lead to an accident. These types of stairways are not recommended as the only means by which to get from one floor to another in case of a fire.

The stairway handrail does not run continuous from the bottom of the stairwell to the top of the stairwell so to cover all of the steps (treads). Under current building standards all handrails for the stairway should run continuous for the full length of the flight. The handrail should start directly above the lowest step and run continuously to end directly above the top step.

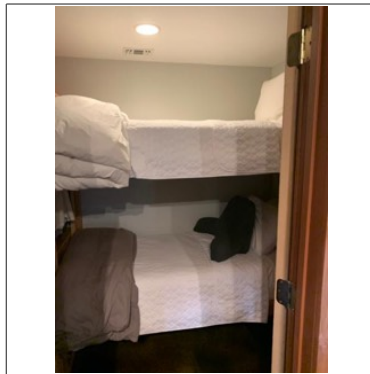
Bedrooms/loft have no emergency exits.

*Comments:* **The areas used as bedrooms, and the loft do not have emergency exits. These areas should not be used for sleeping until windows are added that are at least 24 inches tall by 20 inches wide for safety. Sleeping areas without an emergency exit are extremely dangerous in the event of a fire or other emergency.**

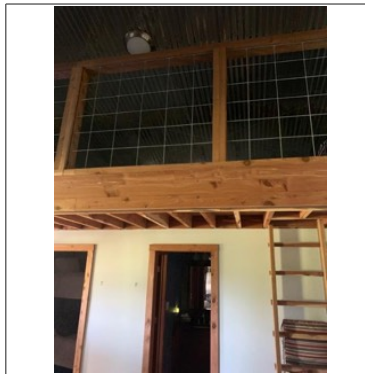
No emergency exit for lofts.

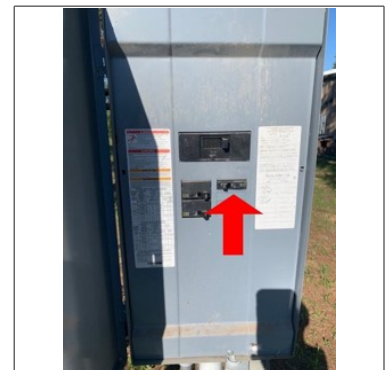
Not all breakers are labeled at service panel.

*Comments:* **All breakers should be labeled for safety.**

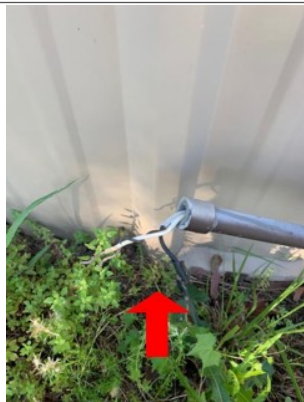
Abandoned wires in conduit at the rear of the building.

*Comments:* Abandoned wiring should be removed or appropriately terminated at the rear exterior.

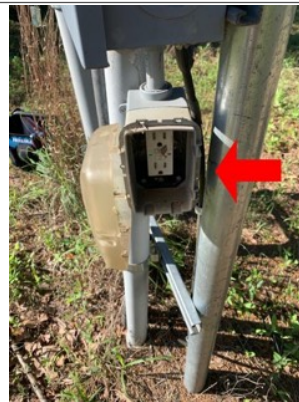
Outlet under the service panel needs to be better secured.

The outlet under the service panel is loose, and should be re-secured. Loose interior outlets should also be re-secured.

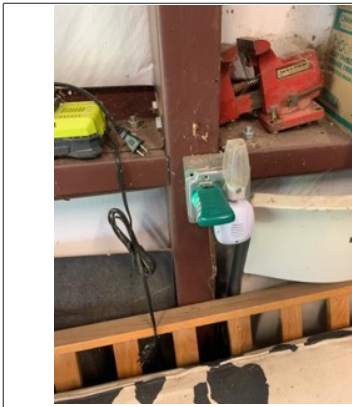
Shop and laundry room outlets are not GFCI protected.

The installation of a ground fault circuit interrupter (GFCI's) by a qualified service professional is recommended in the shop area, the laundry room, and for the exterior building outlets. A ground fault circuit interrupter (GFCI) offers protection from shock or electrocution.

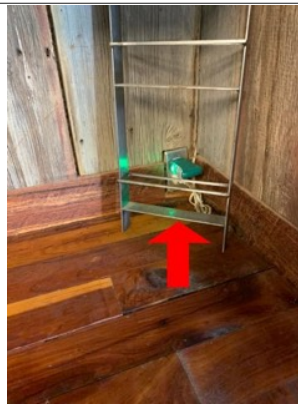
Sink area outlet in shop is not GFCI protected.

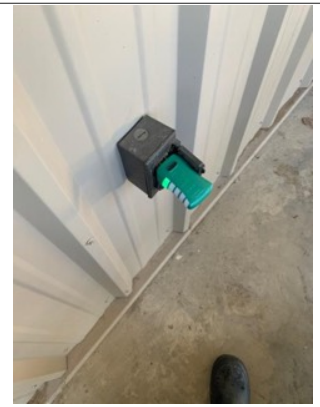
Outside outlets are not GFCI protected.

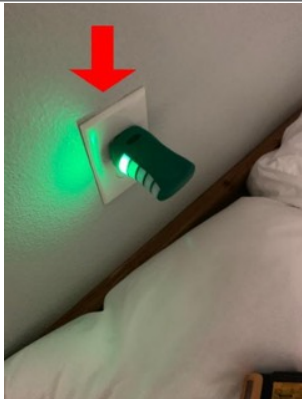
Outlet loose in the wall in left loft.

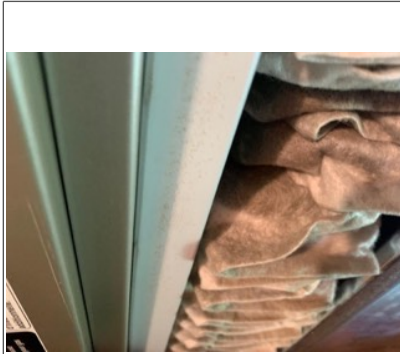
Air filter for system needs to be changed.

*Comments:* The air filter was dirty, and should be replaced. Recommend a qualified service professional perform a service on the unit to ensure maintenance is up-to-date.

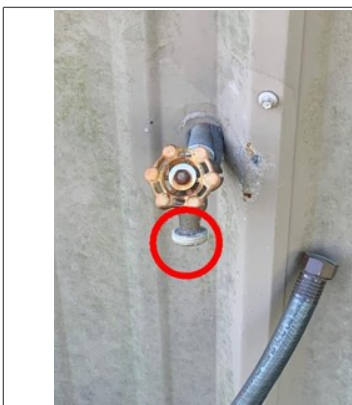
Anti-siphon devices are recommended for the hose bibs.

Anti-siphon devices should be installed on the exterior hose bibs to help protect the water supply.

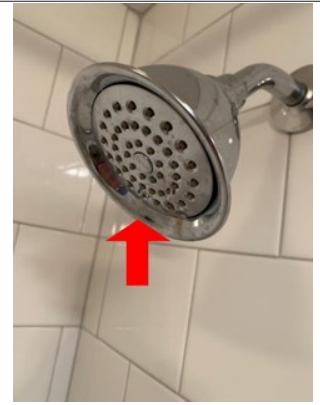
Left side shower is leaking.

The left side shower valve is leaking and should be repaired by a qualified service professional.

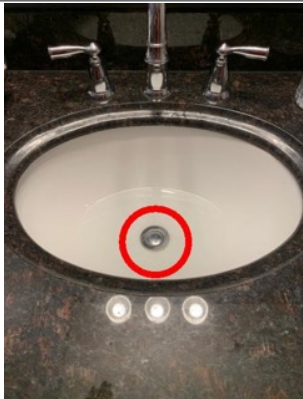
Left side bathroom sink stopper does not hold water.

*Comments:* The drain stop for the left side bathroom sink does not hold water, and should be repaired.

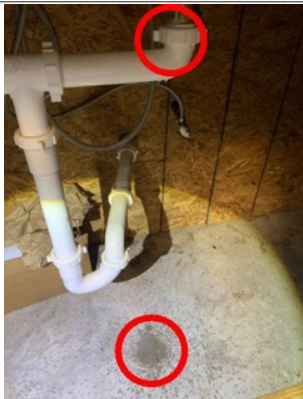
Waste pipe is leaking under shop sink.

*Comments:* The waste piping is leaking under the shop sink and is in need of repair by a qualified service professional.

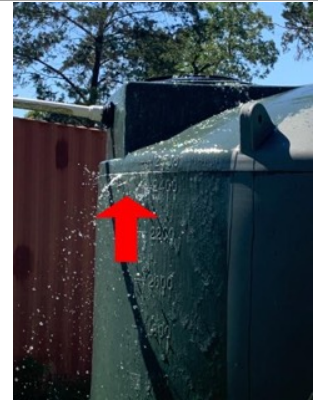
Overflow at storage tank.

*Comments:* **Water was overflowing from the storage tank during operation. This condition should be investigated and repaired by a qualified service professional.**
