# WOOD DESTROYING PESTS AND ORGANISMS INSPECTION REPORT

Building No. 12032	Street HUTTO ROAD	City PENN VALLEY	Zip 95946	Date of Inspection 5/23/2022	Number of Pages 4
<b>THOMAS TERMITE CONTROL, INC.</b> <b>13827 FAMILY CIRCLE</b> <b>GRASS VALLEY CA 95945</b> <b>Tel (530)273-7468</b> <b>bugdude58@gmail.com</b>				Report # : 20673 Registration # : PR-3900 Escrow # : N/A <input type="checkbox"/> CORRECTED REPORT	
Ordered by: TERESA DIETRICH goldcountryranches@gmail.com PENN VALLEY, CA. 95946		Property Owner and/or Party of Interest: DR. JEFF BOSSHARD, TRUSTEE P.O. BOX 606 (831-818-9806) FREDOM, CA. 95019 jeffbosshard@gmail.com		Report sent to: SAME	
COMPLETE REPORT <input checked="" type="checkbox"/> LIMITED REPORT <input type="checkbox"/> SUPPLEMENTAL REPORT <input type="checkbox"/> REINSPECTION REPORT <input type="checkbox"/>					
GENERAL DESCRIPTION: ONE DOUBLE WIDE MODULAR HOME				Inspection Tag Posted:	
				Other Tags Posted:	
An inspection has been made of the structure(s) shown on the diagram in accordance with the Structural Pest Control Act. Detached porches, detached steps, detached decks and any other structures not on the diagram were not inspected.

# THOMAS TERMITE CONT

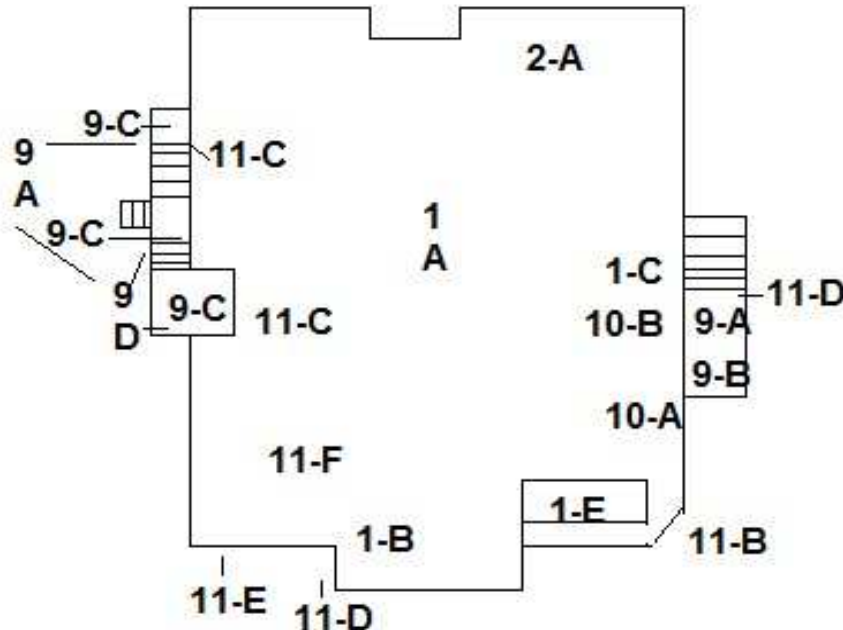
**Diagram Not To Scale**

01A: FINDING: There is a vapor barrier on subfloor so same is inaccessible for inspection due to vapor barrier.

01B: FINDING: We noted cardboard in subarea, same showed old signs of subterranean termites, owner should remove all cardboard as infestation can occur on a daily basis.(S2)

01C: FINDING: Vapor barrier is torn open at the subfloor, same shows discoloration to what appears to be subfloor and possibly a metal pan in this area, we could not determine, refer to other trades.(FI)

01D: FINDING: Some earthwood contacts were noted at the piers. Concrete piers are at grade footings with pad on top.

01E: FINDING: There is inaccessible area, which has a storage platform, same is inaccessible for inspection. RECOMMENDATIONS: Open this area up, further inspect. NOTE: FURTHER INSPECTIONS COULD REVEAL FURTHER CONDITIONS.(FI)

02A: FINDING: Master bathroom stall shower is fiberglass, sheetrock on bedroom wall opposite shower is discolored, refer to other trades. Appears to have a leak at the fixture.

02B: FINDING: Hallway bathroom tub enclosure is fiberglass, fixtures are apart and do not work at this time, owner should refer to other trades to correct.(S2)

09A: FINDING: Decking shows fungus damage and surface fungus.  
RECOMMENDATIONS: Remove all decking, further inspect pressure treated framing, replace with new decking.(S1)

09B: FINDING: Rails are falling off and have fungus damage.  
RECOMMENDATIONS: Remove fungus damaged areas, replace with new material, owner should resecure rails and maintain.(S1)

09C: FINDING: Fungus damage was noted to decking at the pressure treated joists.  
RECOMMENDATIONS: Remove fungus damaged rails, replace with new material.(S1)

09D: FINDING: Joist is broken and show fungus damage.  
RECOMMENDATIONS: Remove fungus damaged areas, replace with new material.(S1)

09E: FINDING: End of four by twelve shows fungus damage.  
RECOMMENDATIONS: Cut back four by twelve to good material, splice in with new material.(S1)

OTHER:  
10A: FINDING: Discoloration was noted under the kitchen sink area to sheetrock, owner should refer to other trades.(S2)

10B: FINDING: Water stains were noted with damage at the wall at kitchen cabinet, hot water heater area cabinet shows damage also.  
RECOMMENDATIONS: Remove all damaged areas, replace with new material.(S1)

11B: FINDING: Trim shows damage at the siding and blocking.  
RECOMMENDATIONS: Remove damaged areas, replace with new material.(S1)

11C: FINDING: Door frame is badly weathered, cracked and split, owner should maintain and replace as decay occurs.(S2)

11D: FINDIGN: Facia shows damage.  
RECOMMENDATIONS: Remove damaged facia, replace with new material.(S1)

11E: FINDING: There is wood pecker damage at the eaves, holes were noted, owner should try and keep wood peckers away and keep all holes sealed up.(S2)

11F: FINDING: Barge rafter needs attention, owner should maintain and replace as decay occurs.(S2)

RECOMMENDATIONS: Remove soil and further inspect. NOTE: FURTHER INSPECTIONS COULD REVEAL FURTHER CONDITIONS.(FI)

RECOMMENDATIONS: Owner should refer to other trades to open this area up to determine if there is a leak and correct leak if so. NOTE: FURTHER INSPECTIONS COULD REVEAL FURTHER CONDITIONS.(FI)
