# THOMAS REAL ESTATE INSPECTIONS, Inc. INSPECTION SERVICES Inc.

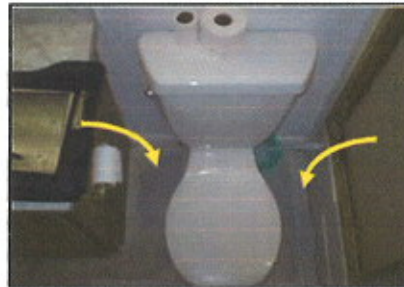
GFCI reset for the sink outlet is located in the upper half bathroom. Staining is noted to the floor covering around the toilet & in front of the tub. Unable to determine source of water. Lifting is noted to the floor covering along the front of the tub. Recommend keeping all seams & edges around the tub/shower caulked/ sealed.

Staining is noted to the floor covering around the toilet & in front of the tub.

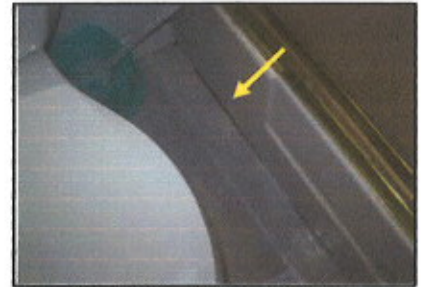
Lifting is noted to the floor covering along the front of the tub.

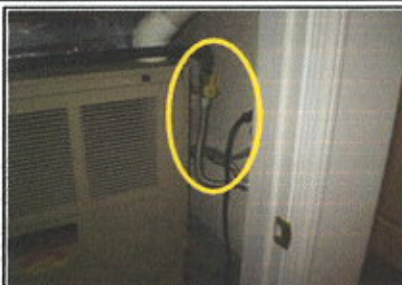
Older heating/Air conditioning equipment noted has exceeded their expected life. Did not locate the LP gas conversion sticker on the furnace. Conversion is required by the manufacturer. Sediment trap is not installed on the furnace gas supply connector as required by the manufacturer. Missing sediment trap & missing LP conversion may void a manufacturer's or home warranty. 20 amp breakers noted at for the AC condenser disconnect are within the manufacturers recommendations stated on the unit. Unable to verify if the opening in the closet wall behind the furnace is providing sufficient make-up air for the furnace. Recommend installation of a louvered door for the furnace closet.

Sediment trap is not installed on the furnace gas supply connector.

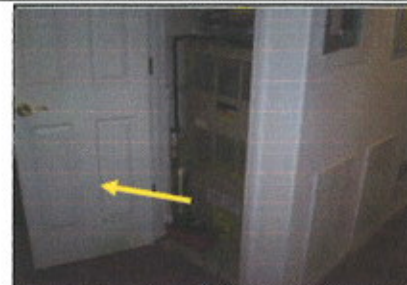
Recommend installation of a louvered door for the furnace closet.

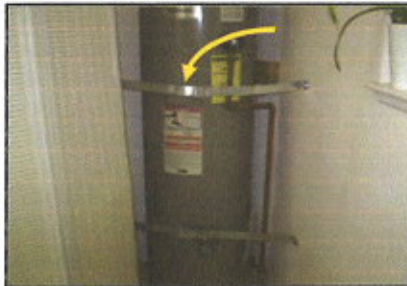
**EQ strapping is loose, not securing the water heater from movement.**

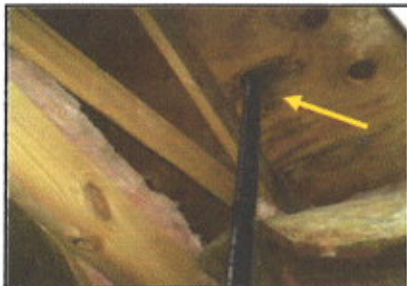
Staining is noted to the framing at the upper plumbing vent pipe entry through the roofing. Sealant/patching is noted on the roof at the vent pipe. Master bathroom exhaust fan is discharged towards the eave vent, not to the eave vent. Moisture buildup & black staining is noted to the attic framing at the master bathroom exhaust discharge. Recommend correcting the exhaust to terminate to the building exterior.

Staining is noted at the upper plumbing vent pipe entry through the roofing.

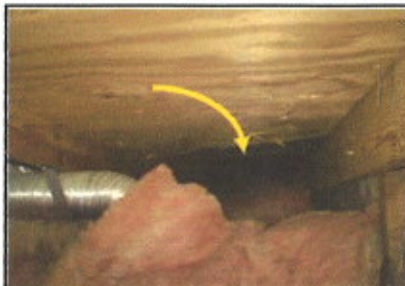
Moisture buildup & black staining is noted at the master bathroom exhaust discharge.
