THOMAS REAL ESTATE
Inspections, Inc.
Inspection Report
(530) 268 - 3452

HOME INSPECTION REPORT

Inspection Address: **10438 Lazy Valley Rd. Penn Valley, Ca.**

Date of Inspection: **12/20/2021**

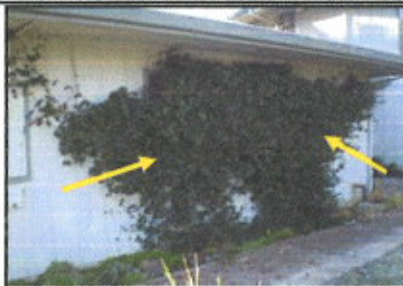
Vegetation noted contacting the house may accelerate wear, trap moisture, & allow an entry point for pests. Recommend keeping vegetation trimmed off & away from the house.

Recommend keeping vegetation trimmed off & away from the house.

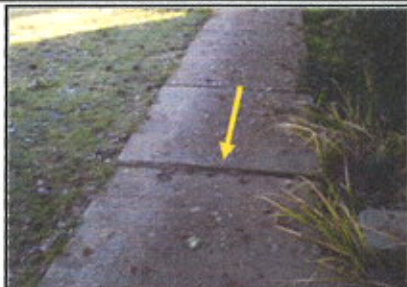
Uneven surfaces & uplifting edges are noted at walkways around the house.Patios **N/A**

Uplifted edges are noted in the front walkway.

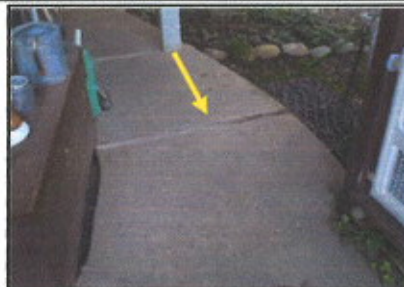
Uplifted edges are noted in the side walkway.

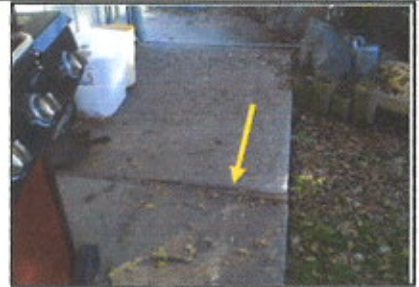
Uplifted edges are noted in the rear walkway.

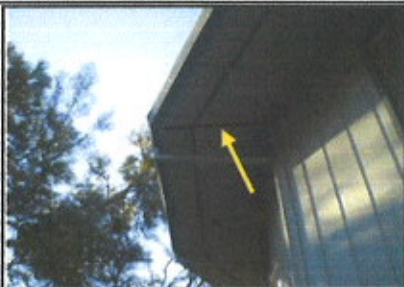
Loose trim material is noted under the eave soffits around the house.

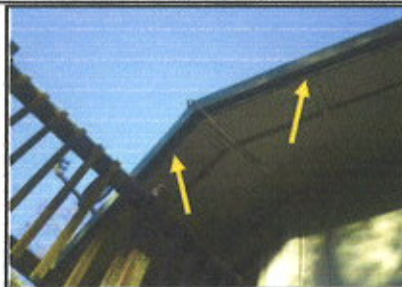
Wood pecker wear is noted along the upper eaves/soffits.

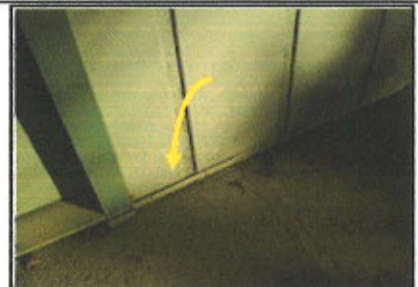
Loose trim material is noted under the eave soffits around the house. Wood pecker wear is noted along the upper eaves/soffits. Wear is noted to the bottom edges of the siding around the house. Pan flashing on the rear of the garage has been installed incorrectly over the siding vs. under the siding as instructed. Unsealed flashing will allow water to trap against the siding behind the flashing. Recommend keeping the flashing caulked/sealed. All exterior exposed seams & edges in siding & along trim are recommended to be caulked/ sealed to help prevent water entry behind & into material. Recommend annual check of the exterior caulking & re-apply as needed.

Unsealed pan flashing will allow water to trap behind the flashing.

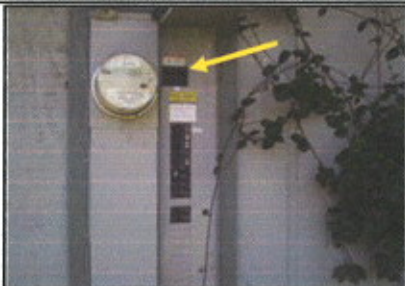
Panel breakers are not labeled - identification is recommended for safety & convenience. Generator hook-up is noted. Generators, equipment, & systems are not tested or operated.

House main electrical service entrance & disconnect breaker.

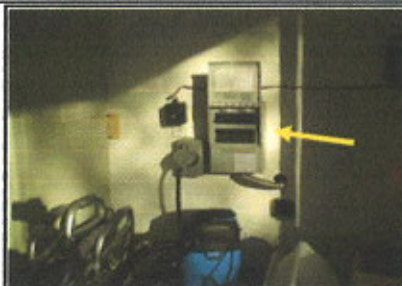
Generator equipment & systems are not operated or tested.

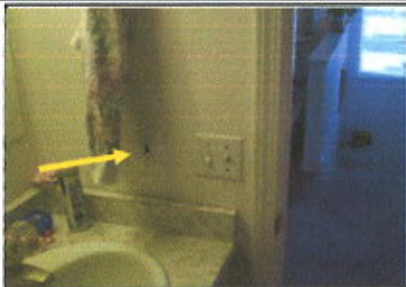
GFCI reset for the exterior & bathrooms outlets in in the upper half bathroom.

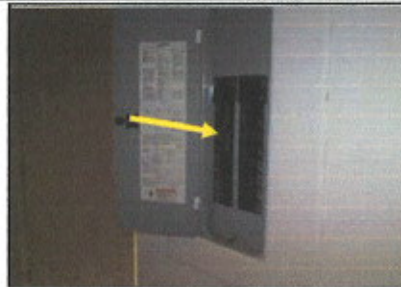
Electrical sub panel is located in the lower bedrooms hallway.
