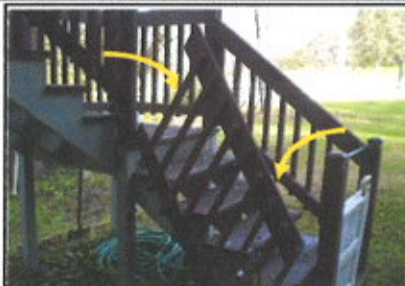
Openings between the step rises exceed 4 " recommended maximum. Step openings are insufficient for infants & toddlers. Recommend upgrading the step rise openings to a 4" maximum. Deterioration is noted to the deck & deck steps railings & posts material. Loose balusters are noted. Bottom steps railing is detached from the posts. Deck steps hand rails are not continuous graspable from top to bottom - hazard. Fungus & deterioration is noted to the framing under the decking.

Bottom steps railing is detached from the post.

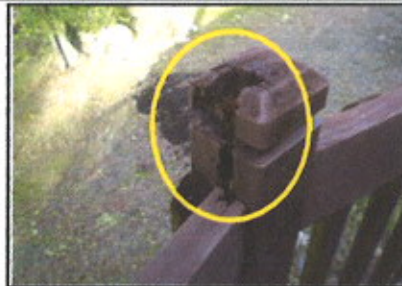
Deterioration is noted to the deck & deck steps railings & posts material.

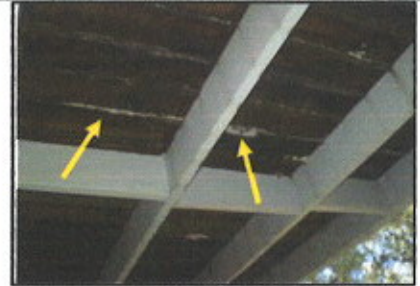
Fungus & deterioration is noted to the framing under the decking.

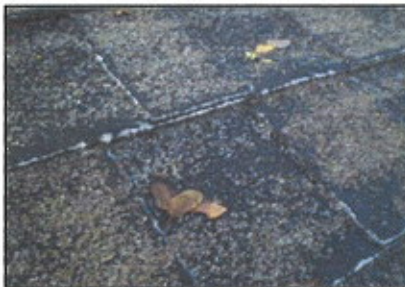
Roofing shingles are reaching their expected life.

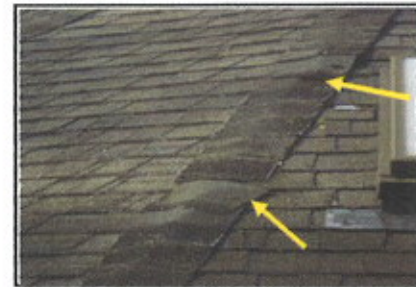
Loose & missing shingles are noted.

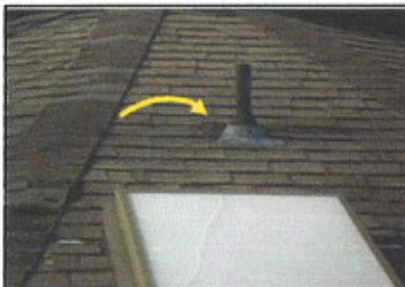
Staining/water entry is noted at the upper plumbing vent pipe roof penetration.

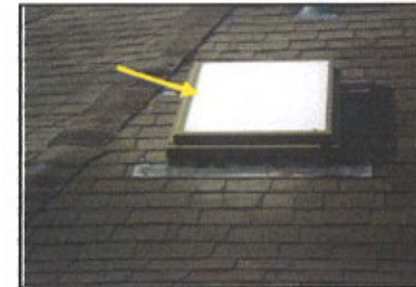
Master bedroom skylight cover is cracked.

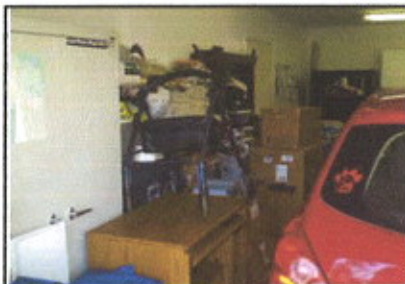
Limited garage access was noted.

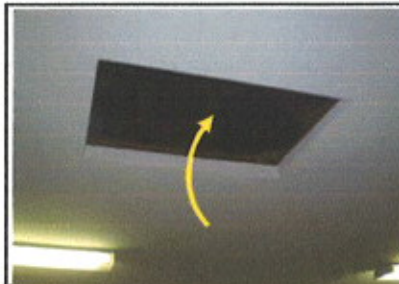
Attic access opening in the garage ceiling reduces the garage to house fire protection.

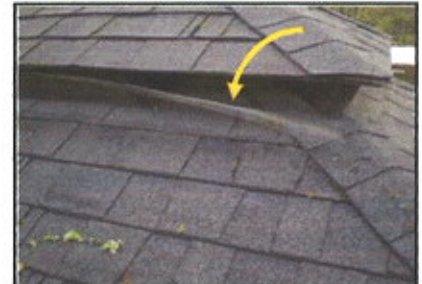
Loose vent screen at the roof cupola over the garage may allow animal entry into the garage attic.

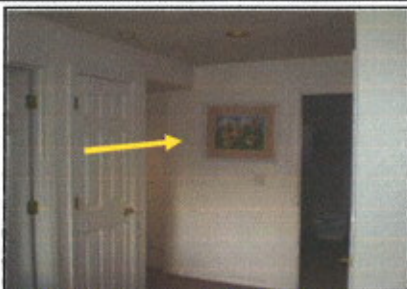
CO detector is missing for the lower floor/bedrooms.

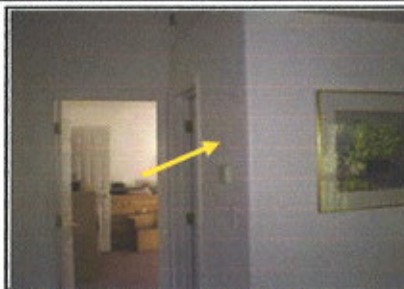
CO detector is missing for the upper floor/bedroom.

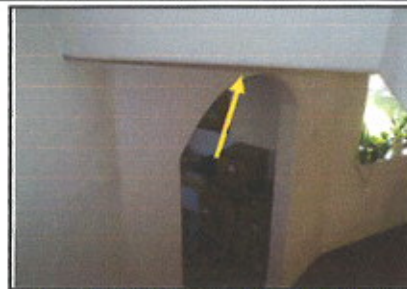
Low head clearance is noted at the bottom of the stairs.

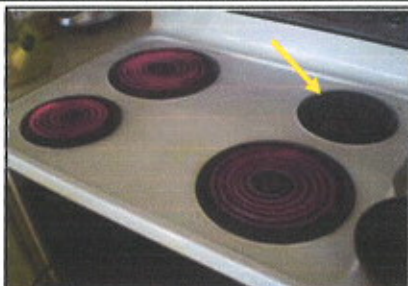
Stove right rear burner did not heat.

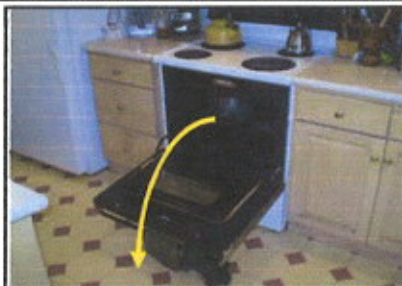
Anti-tip bracket is not installed for the oven/ stove.

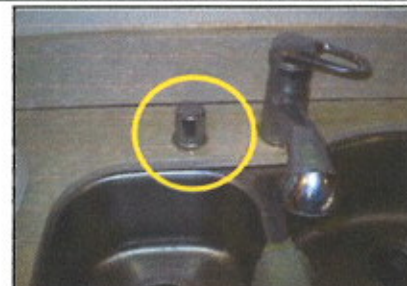
Water noted discharging out of the air gap device indicates debris in the dishwasher drain line hose.

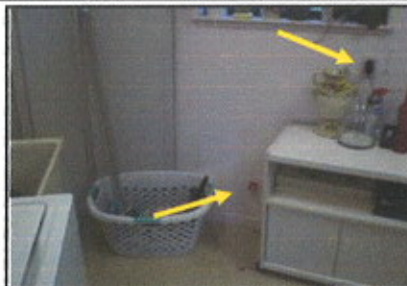
Wall outlets located within 6 ft of the laundry sink are not GFCI protected.

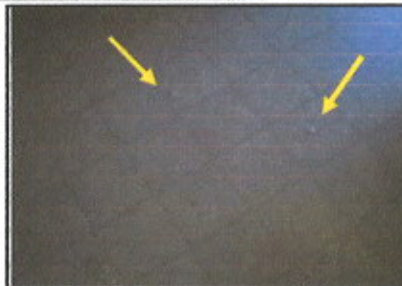
Dimples/bumps are noted in the flooring under the vinyl covering?

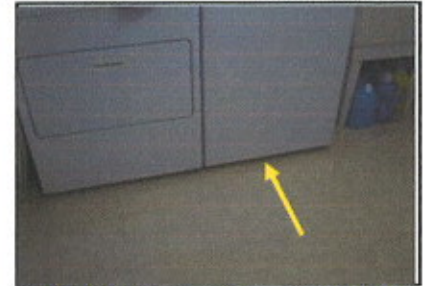
Drain/ catch pan is recommended under interior installed washers.

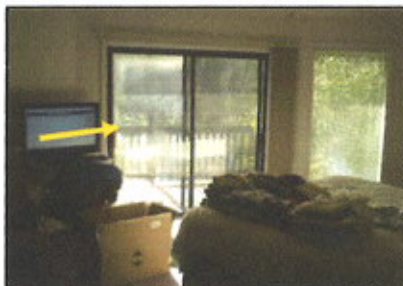
Master bedroom - failed thermo seal/fogging is noted in the slider door.

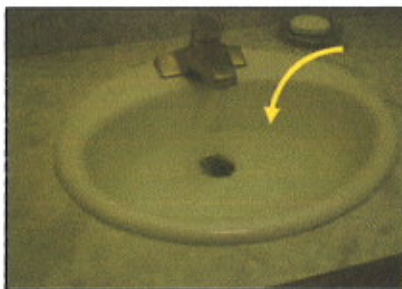
Right sink was slow to drain.

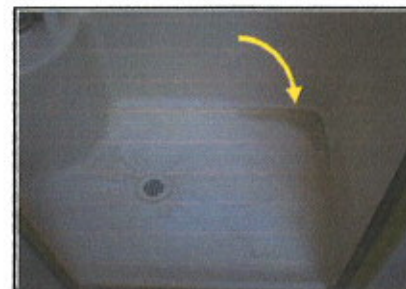
Water ponds in the right rear corner of the shower pan.
