Inspection Report

Property Address:
3033 McGregor Ln
Dripping Springs TX 78620

CODE 3 Property Inspections. PLLC

PROPERTY INSPECTION REPORT FORM

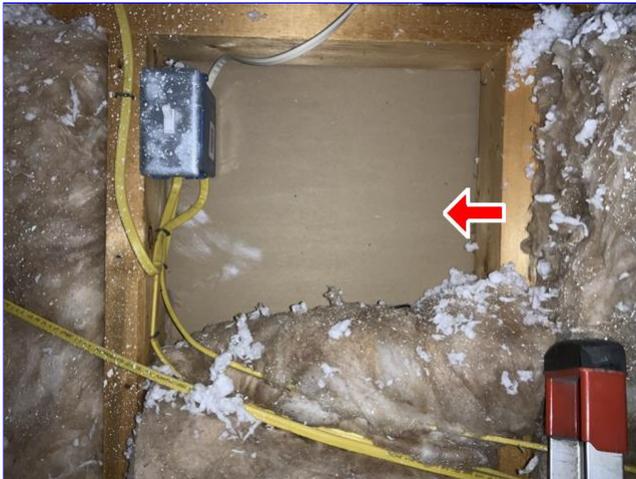
D. Item 1(Picture)

(1) Some of the bat insulation on the vertical faces in the attic has fallen down and needs to be reattached.

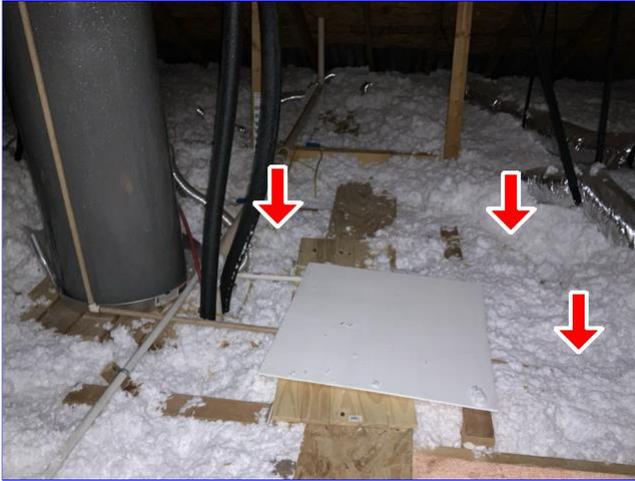
D. Item 2(Picture)

(2) The insulation in the attic has been disturbed/moved, it should be re-distributed in some areas to achieve a uniform depth.

- Depths of fiberglass insulation that will maintain an R value of 30 (depending on % glazing and manufacturer) will improve heating and cooling characteristics and reduce utility costs. For reference, this is equivalent to a depth of loose or bat fiberglass insulation of 10 to 12 inches depending on the manufacturer. Inadequate insulation will result in greater heat and cooling

losses in my opinion. Energy companies are now recommending 18 inches of insulation to reach R-38.

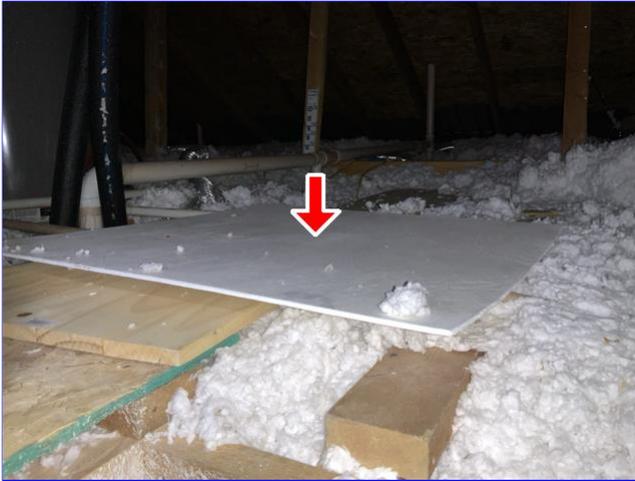
D. Item 3(Picture)

(3) Attic scuttle access door is uninsulated, this can allow conditioned air to escape into the attic and/or allow radiant heat from the attic to enter the living space below.

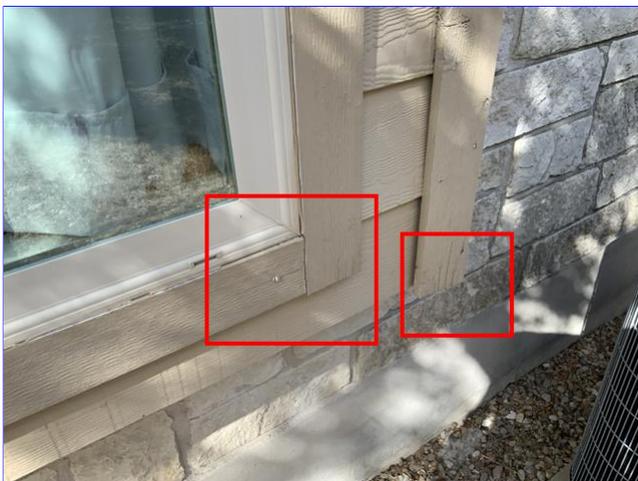
E. Item 1(Picture)

(1) There are some areas of the exterior trim and/or siding that needs repair, painting and/or staining to prevent moisture damage. This is located on the primary bathroom window.

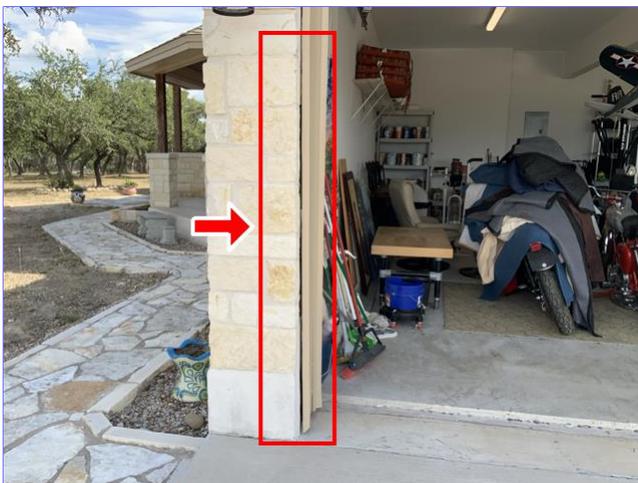
E. Item 2(Picture)

(2) Caulk and seal all gaps, cracks, and openings. There are various areas around the house that need sealing. Seal all trim boards along the vehicle garage doors.

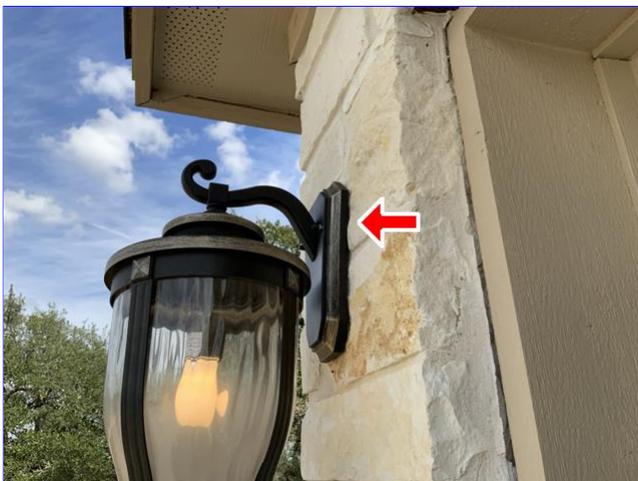
E. Item 3(Picture)

(3) Wall mounted boxes / fixtures on exterior cladding should be sealed at the top and half way down each side. The bottom of the boxes shall not be sealed. This will allow water to run down the sides and out the bottom.

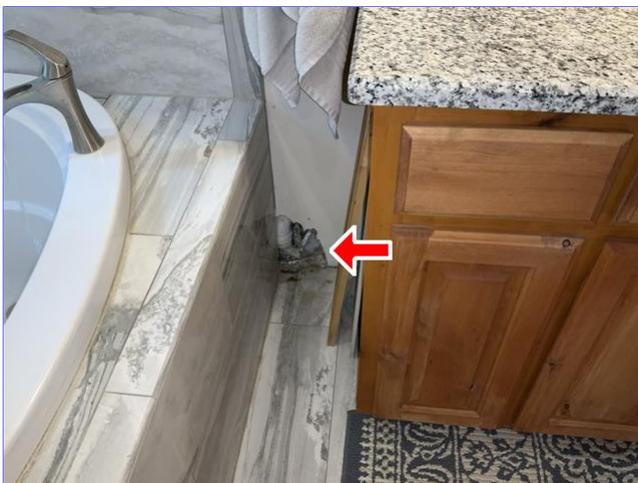
E. Item 4(Picture)

(4) Missing a small section of the drywall, located in the primary bathroom between the bathtub and the sink cabinets, recommend repair.

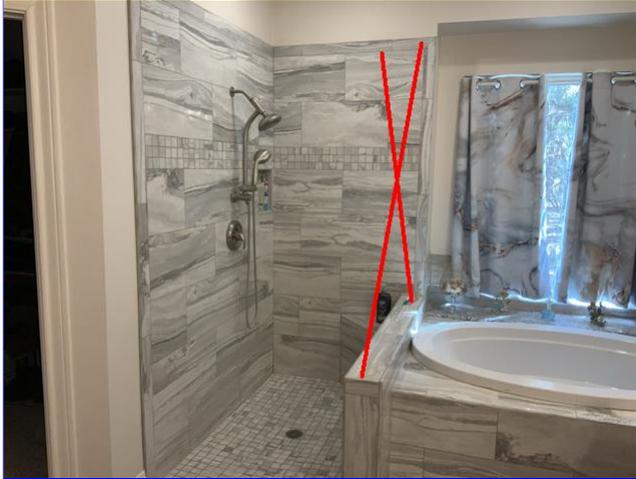
E. Item 5(Picture)

(5) Missing glass wall that separates the shower from the bathtub, recommend asking the seller for more information.

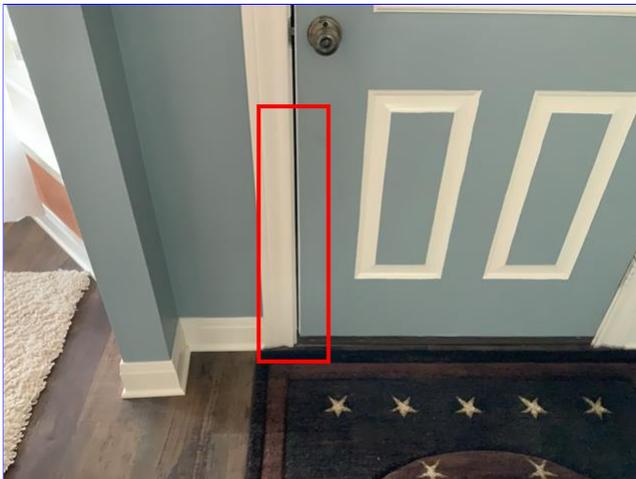
G. Item 1(Picture)

(1) Weather stripping on the front entry and side pedestrian garage door are not sealed, daylight can be seen in several places. Weather stripping that does not seal can lead to moisture intrusion, a lack of energy efficiency and provides access for insect intrusion.

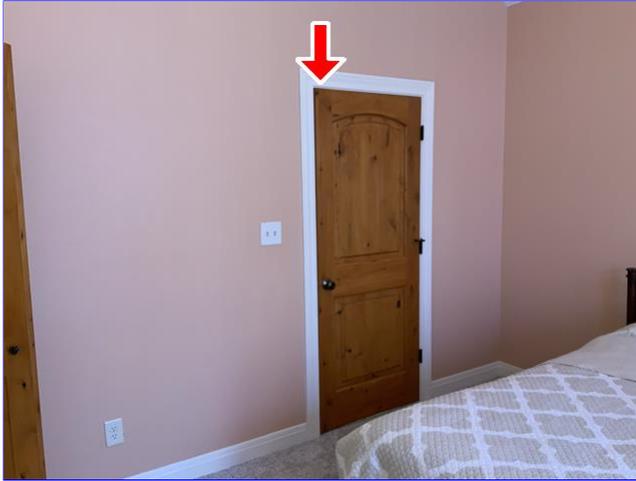
G. Item 2(Picture)

(2) The primary bedroom door makes contact with the frame, recommend adjusting the door as needed for a smooth operation.

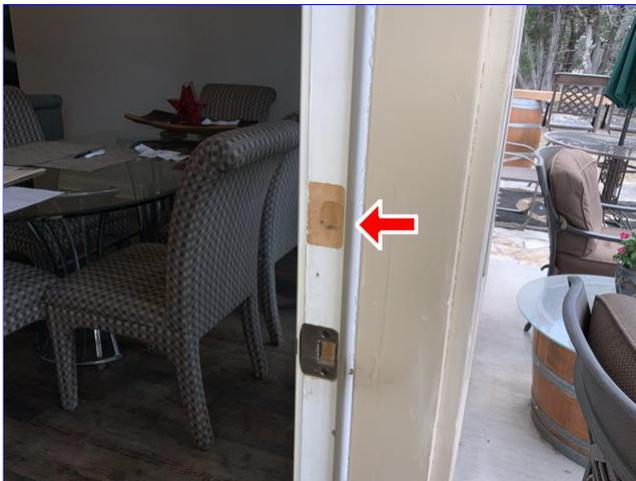
G. Item 3(Picture)

(4) Missing the strike plate to the rear patio deadbolt.

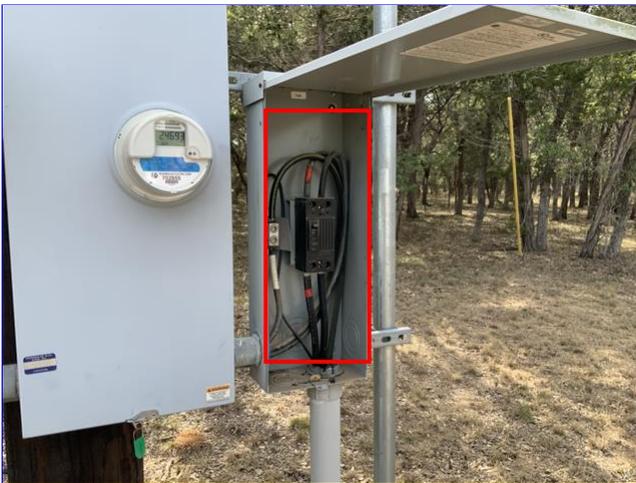
A. Item 2(Picture)

(2) Missing the dead front cover plate to the right electrical panel. This panel is located next to the main service meter.

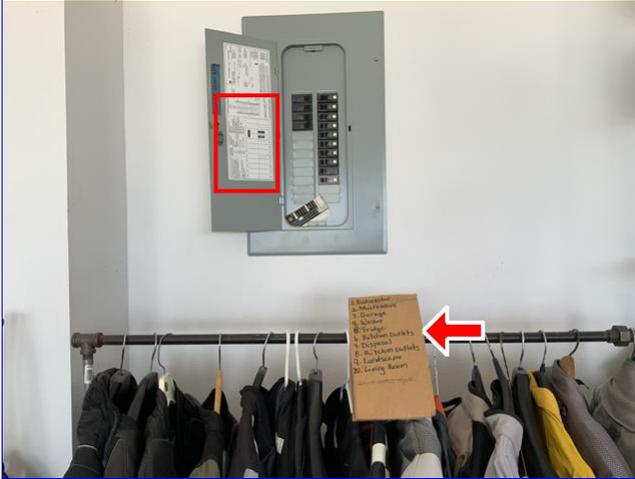
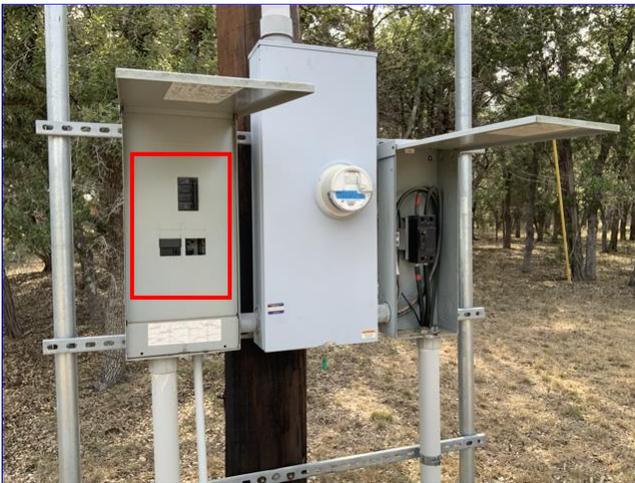
(3) Labeling of overcurrent protective devices with generic or missing terms such as General lighting and receptacles is not specific enough to identify which currents are involved. Under current electrical standards, All circuits and circuit modifications shall be legibly identified as to their clear, evident and specific purpose. The identification must include sufficient detail to allow each circuit to be distinguished from all others and the identification must be on a circuit directory located on the face or inside of the door of a panel box. Recommend that a qualified electrician re-inspect, label and verify the appropriateness of existing over current protection for all branch circuits. The absence of labels makes repair of circuits dangerous and can result in a shock hazard for repair personnel.

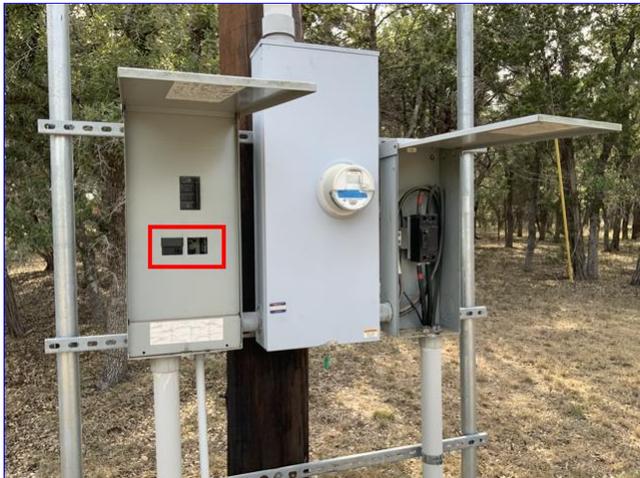
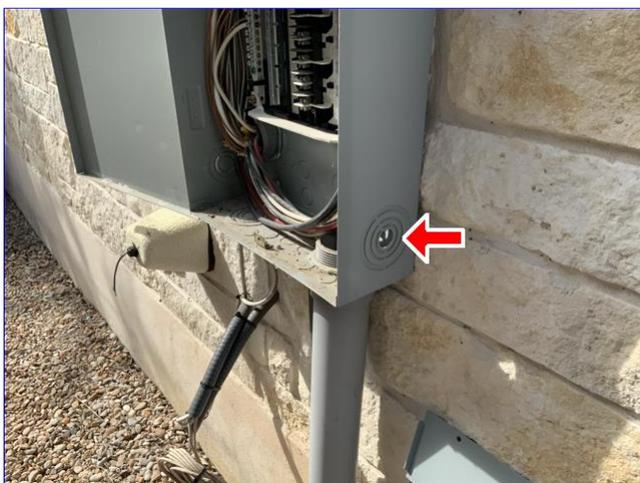
(5) There are knockouts missing on the dead front cover in the main electrical panel. This will allow moisture to enter the panel and represents a potential shock hazard.

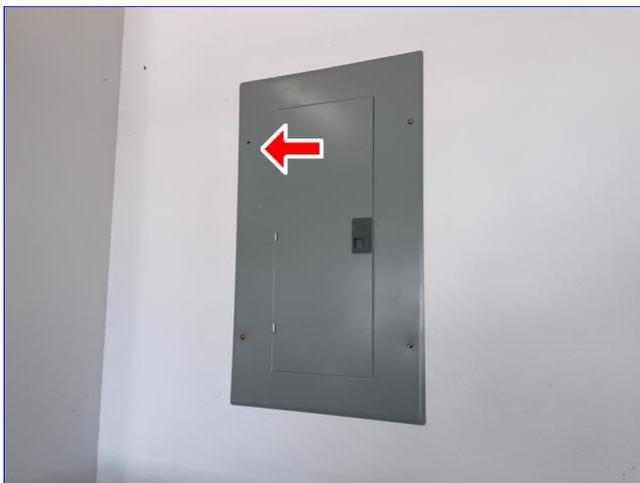
A. Item 7(Picture)

(6) The sub-panel(s) dead front cover is missing screws.

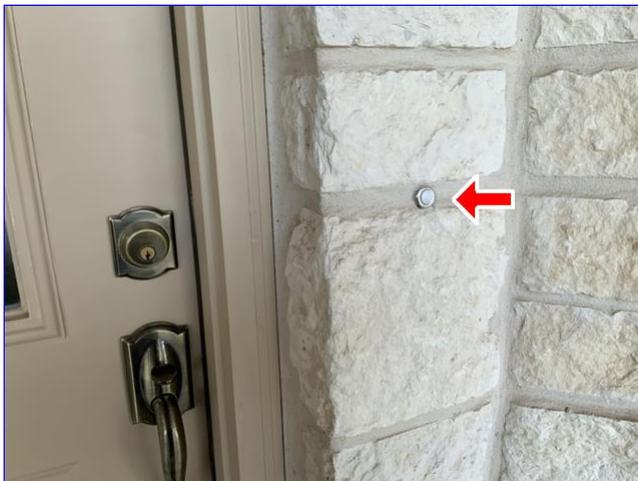
B. Item 1(Picture)

(1) The doorbell is inoperable.

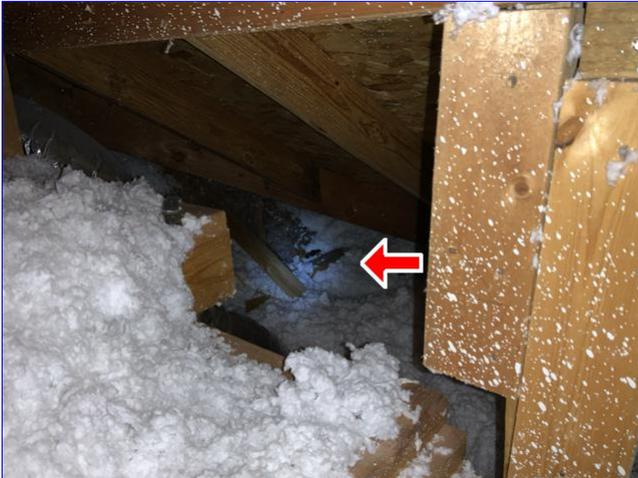
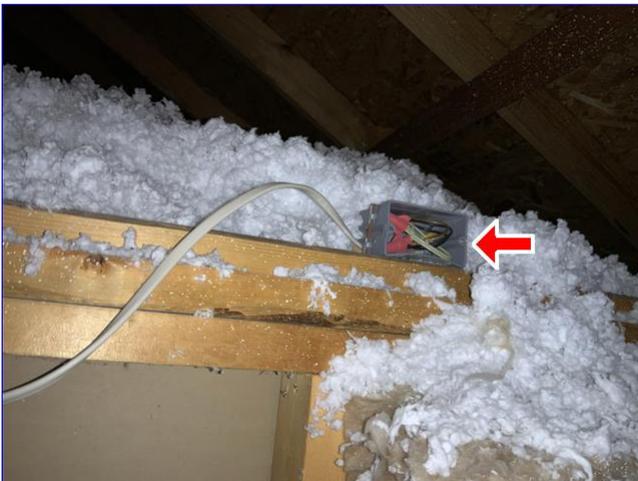
(2) Wire splices observed inside the attic over the laundry room area, recommend installing the wires in an approved junction box with a cover plate.

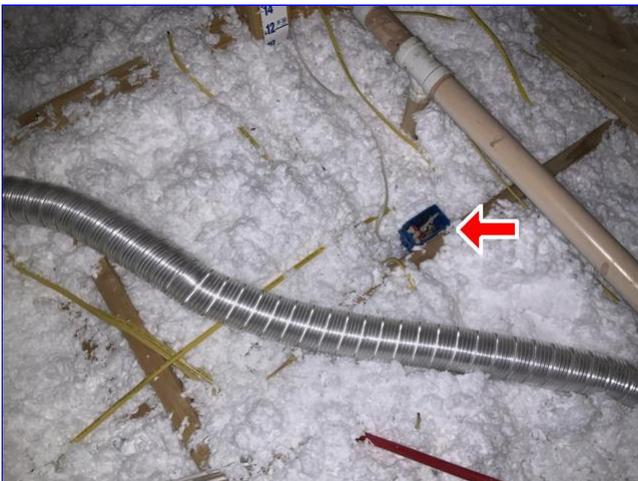
B. Item 4(Picture)

(3) Electrical cover plate(s) observed to be loose, cracked, damaged and/or missing and should be repaired to avoid the risk of shock and/or fire.

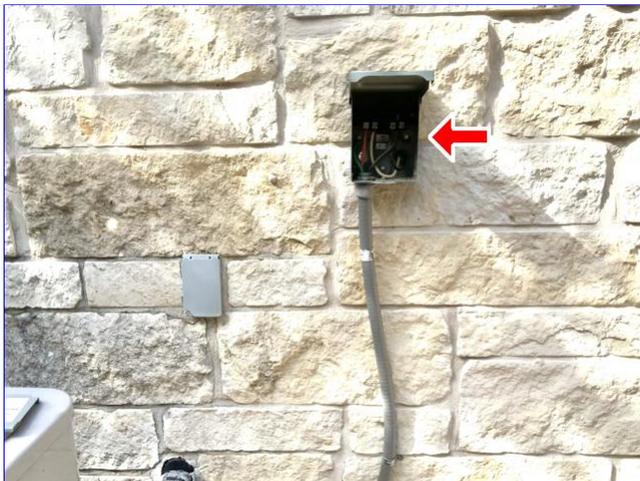
B. Item 5(Picture)

(4) The load and line wires inside the AC compressor's emergency disconnect box are reversed, recommend a licensed electrician for further evaluations.

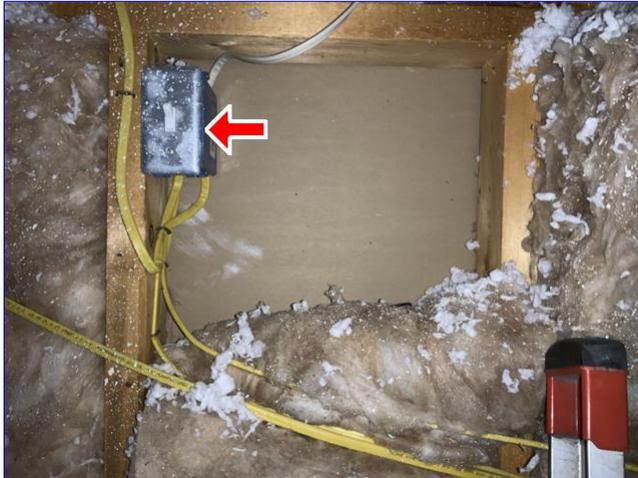
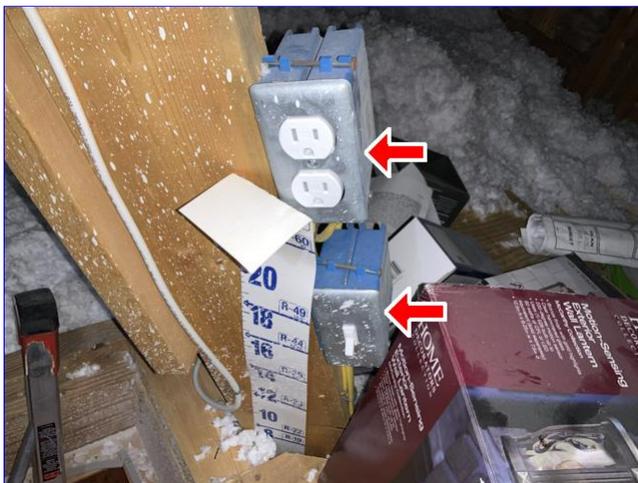
(6) Missing the bonding wire/clips to the metal cover plates located in the attic, recommend swapping with plastic cover plates.

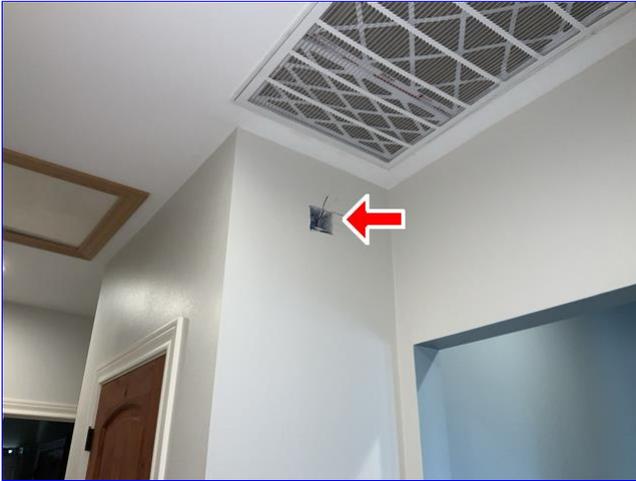
B. Item 8(Picture)

(9) Exposed electrical wires, recommend installing wire nuts over the wires and placing wires inside the box with a cover plate. This is located in the hall way above the the thermostat.

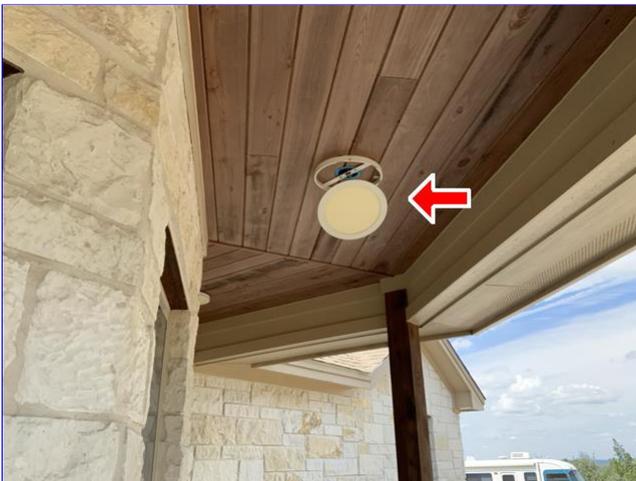
B. Item 9(Picture)

(12) Loose light fixture located at the front porch, recommend repair.

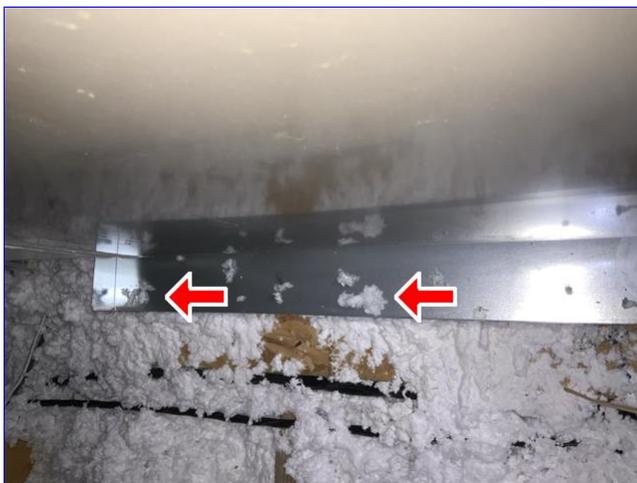
B. Item 1(Picture)

(2) The auxiliary/secondary condensate pan for the A/C unit in the attic has debris in it and needs to be cleaned to prevent clogging of the drain in case of an emergency.

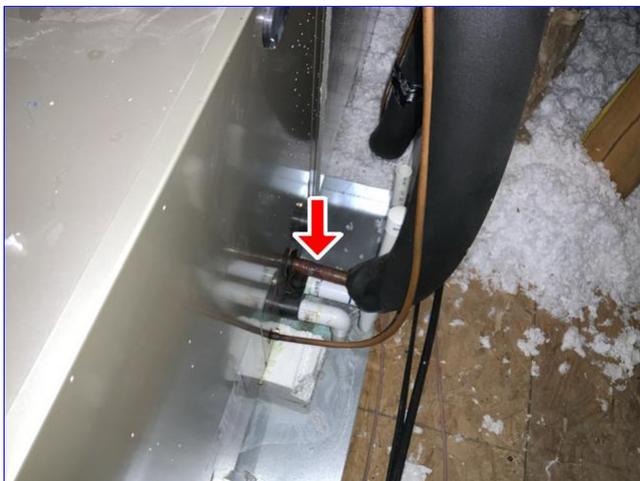
B. Item 2(Picture)

(3) Insulation is missing/damaged on the large refrigerant line located in the attic, this may allow condensation to drip on to the ceiling below and/or affect the performance of the HVAC unit.

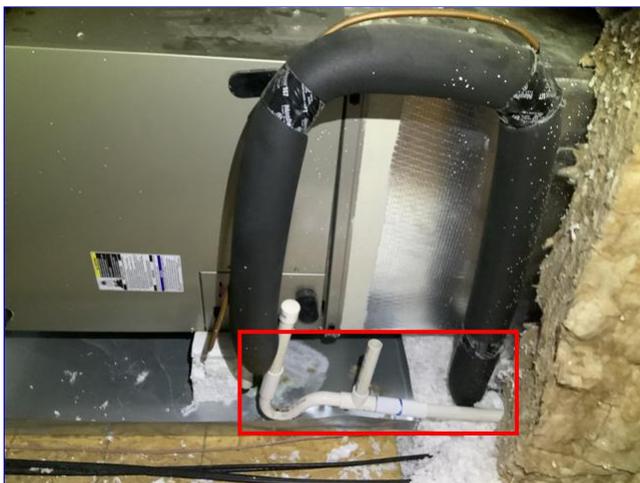
B. Item 3(Picture)

(4) Insulation is needed on the first 8 feet of the exposed primary condensate drain line to the evaporator coil. Uninsulated lines will permit condensate to form and introduce moisture to the ceiling structure.

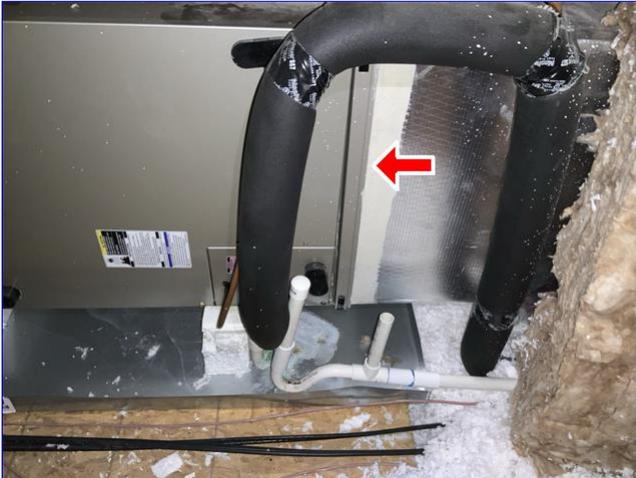
B. Item 4(Picture)

(5) Air was observed to be escaping from the HVAC system and into the unconditioned space, recommend sealing.

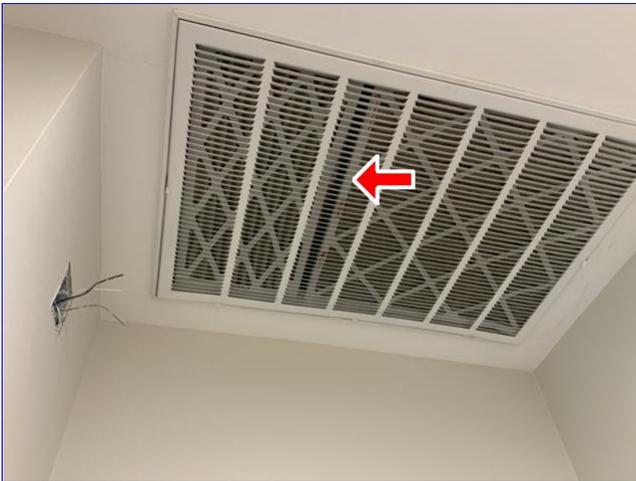
C. Item 1(Picture)

(1) Two separate air filter were observed in the hall ceiling return vent, this gap allows dirt/debris to bypass the filters and collect on the evaporator coils. Recommend installing the correct size filter.

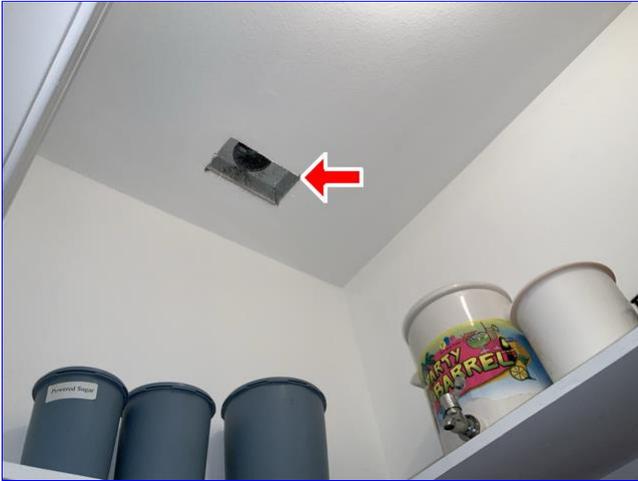
C. Item 2(Picture)

(2) Missing a supply register located in the kitchen pantry closet.

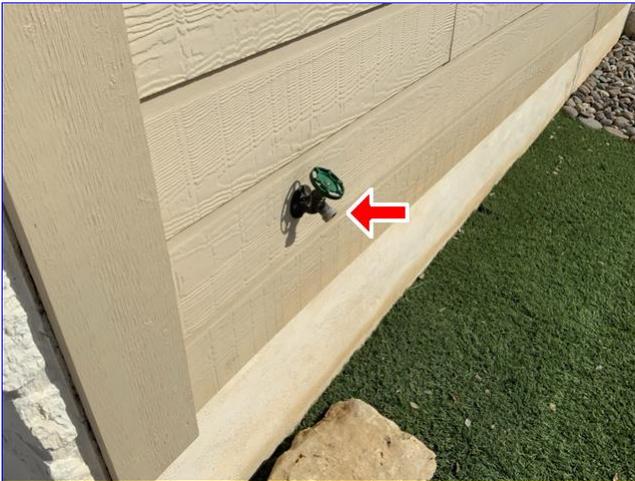
A. Item 1(Picture)

(1) Back-flow devices, anti-siphon devices, or air gaps are missing at the flow end of fixtures, i.e. exterior hose bibs

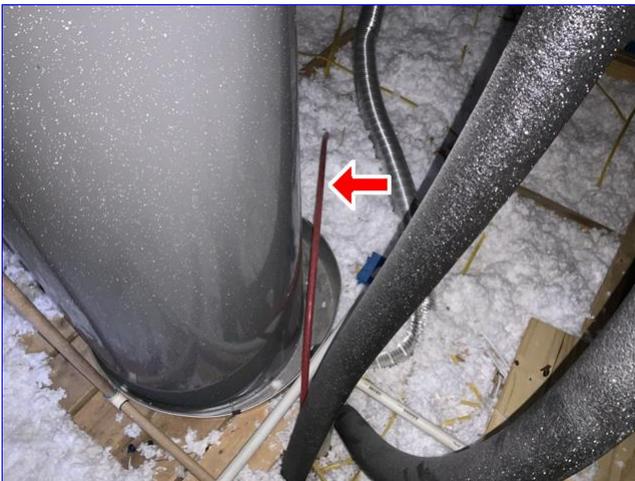
A. Item 2(Picture)

(2) The water pipes in the attic are not protected against freezing. Unprotected water pipes can freeze, burst and cause damage to the structure. Extended freezes are rare in this area but when they do happen serious damage can result to the ceiling below.

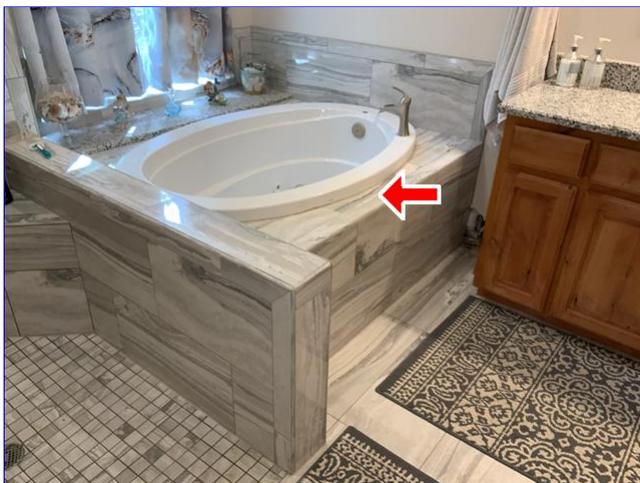
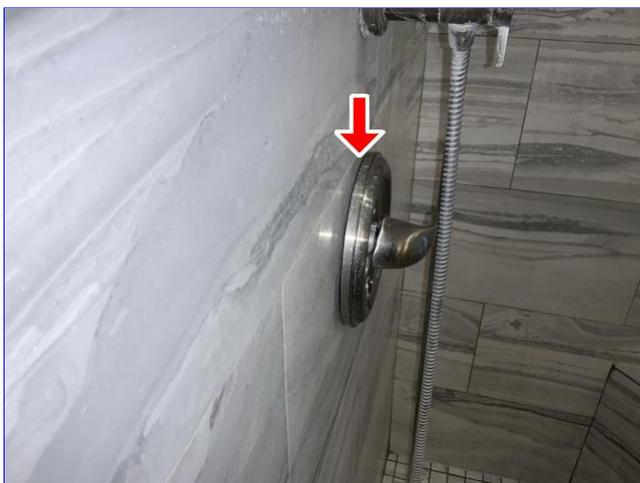
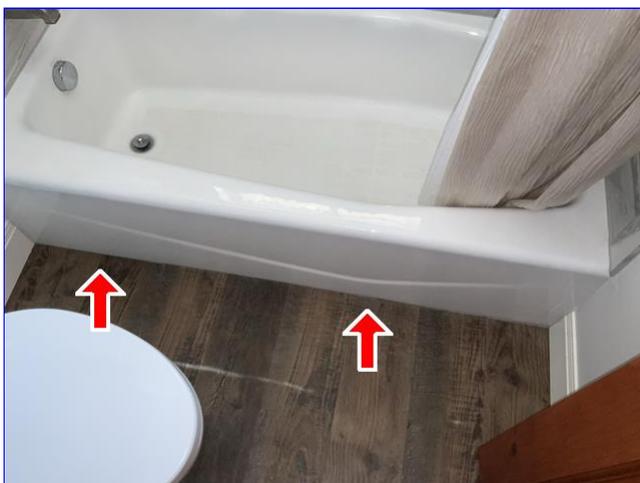
(3) The shower/bathtub located in the primary bathroom and hall bathroom has missing / loose caulk / grout. Recommend repairing to prevent water from entering the wall cavity.

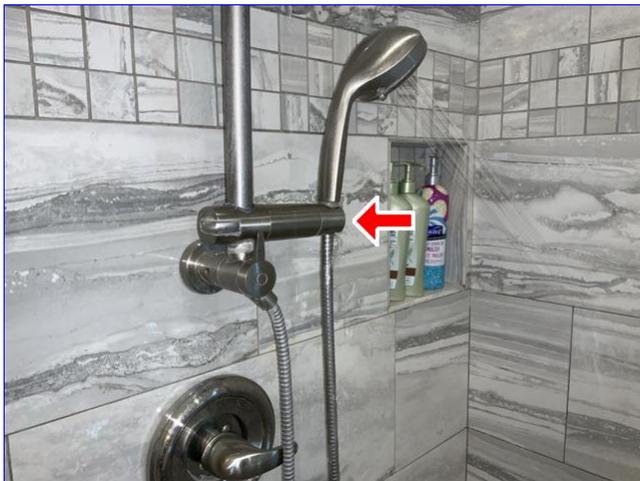
A. Item 6(Picture)

(4) Water leak detected at the primary shower head (hand wand), recommend repair.

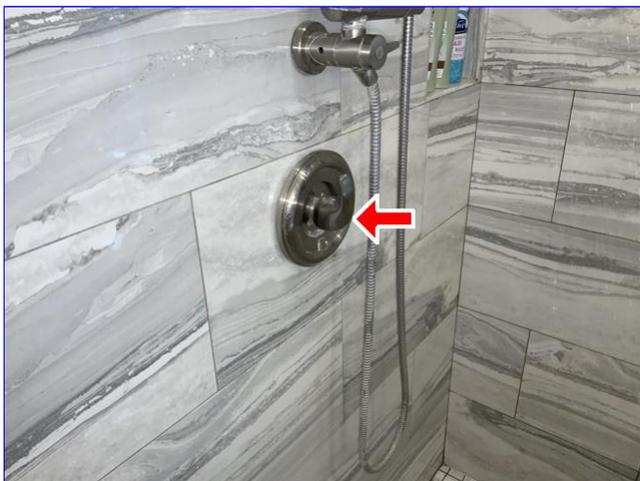
A. Item 7(Picture)

(5) The mechanical stop to the primary shower faucet handle is damaged/broken. This damaged stop allows the handle to spin in a 360 degrees. Recommend a licensed plumber for further evaluations and repairs.

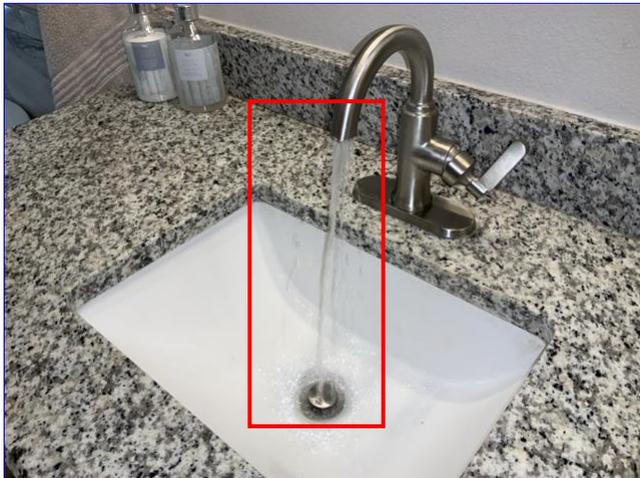
A. Item 8(Picture)

(6) Several faucets throughout the house (i.e. kitchen, bathroom sinks and bathtub/shower...) have the hot and cold orientation reversed, recommend a licensed plumber for further evaluations.

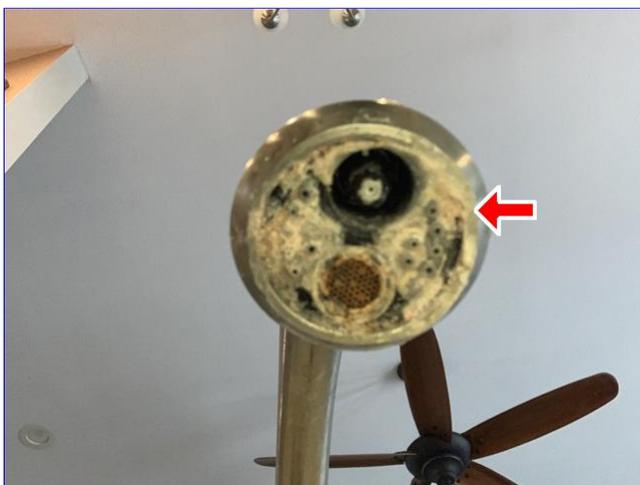
(7) Several aerators at the faucets are partially clogged/ has an erratic spray pattern, recommend cleaning.

A. Item 9(Picture) Kitchen faucet

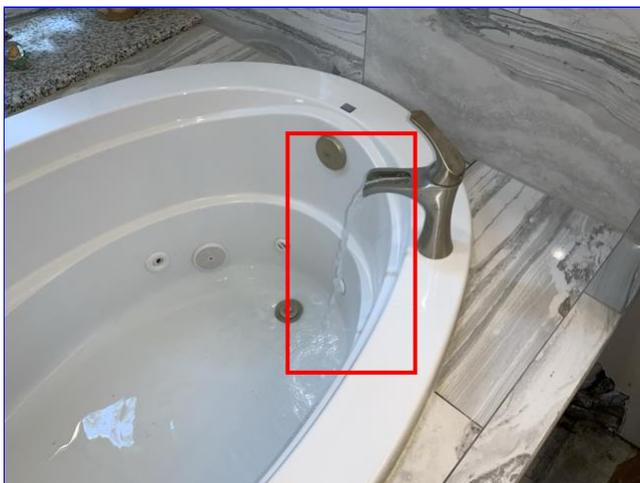
A. Item 10(Picture)

(8) Low water pressure was observed at the primary bathtub, this takes a long time to fill the bathtub with water. Recommend a licensed plumber for further evaluations.

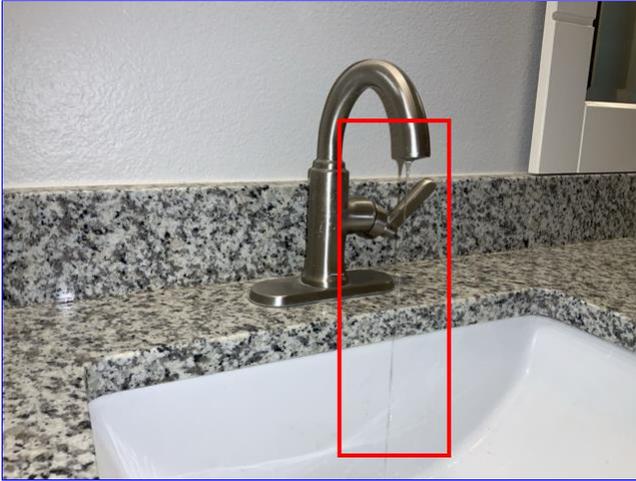
A. Item 11(Picture)

(9) Little to no water flow observed to the left hall bathroom sink, recommend a licensed plumber for further evaluations.

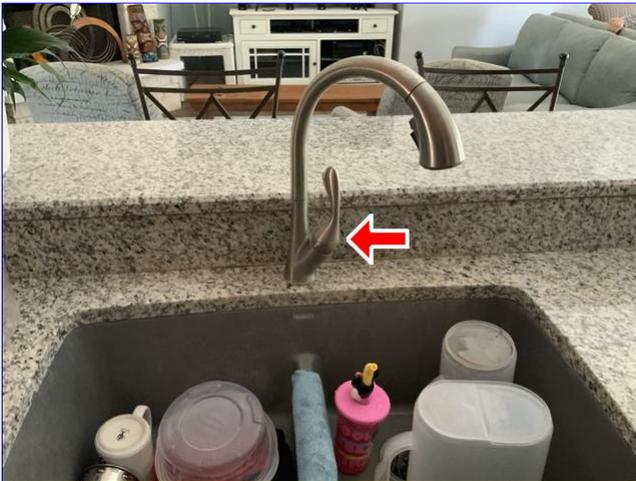
A. Item 12(Picture)

(10) The kitchen faucet is loosely mounted to the countertop, recommend repair.

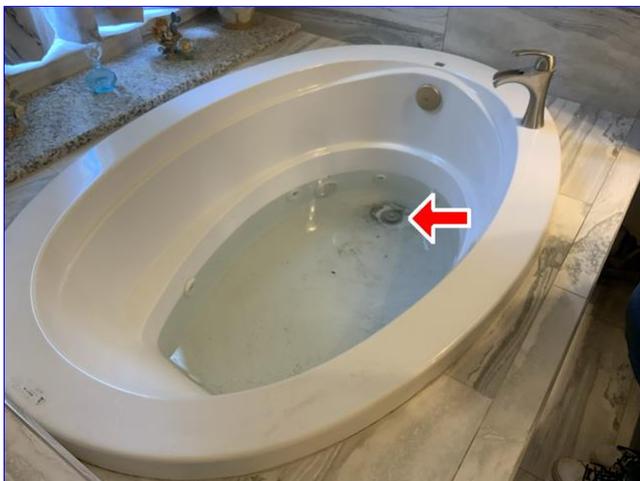
B. Item 1(Picture)

(1) Slow drain observed in the primary bathtub. A properly constructed and properly functioning bathtub/shower and/or sink(s) should drain virtually all water (with the exception of minimal amounts that remain due to the surface tension of the water).

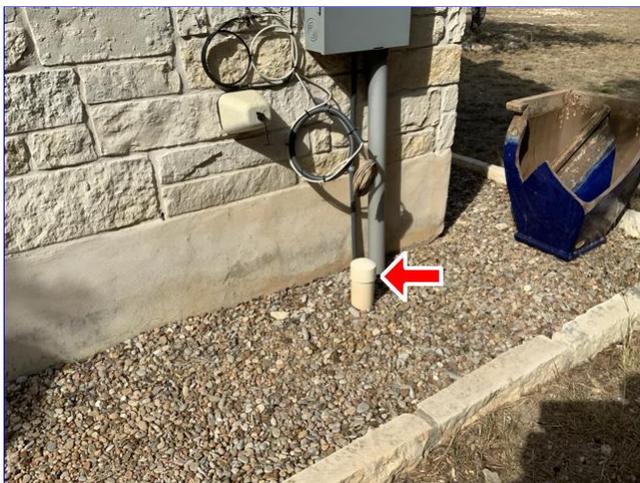
B. Item 2(Picture)

(2) The sewer clean out does not have a removable cap, recommend a licensed plumber for further evaluations. This is located on the front right corner of the house.

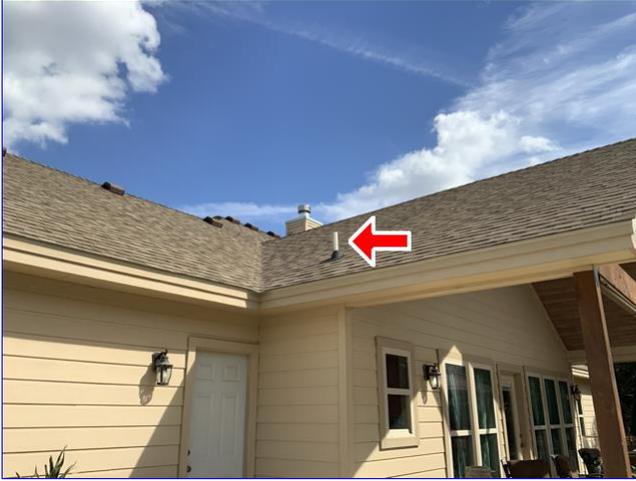
B. Item 3(Picture)

(3) The plumbing vent pipes located on the roof top are not painted. Painting helps protect them against ultra violet/sun damage.

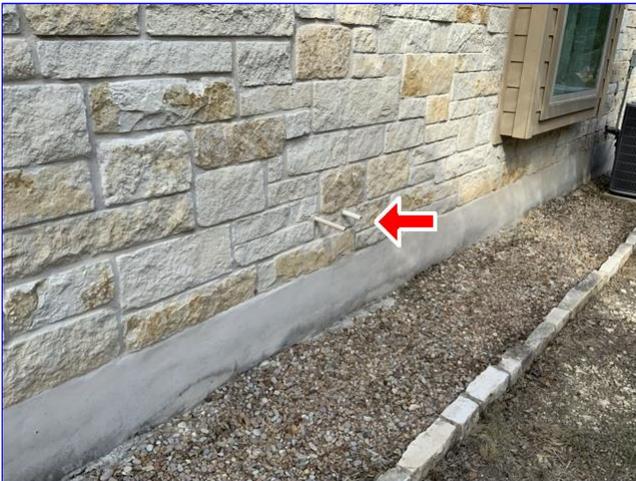
C. Item 1(Picture)

(1) The drain lines for the temperature pressure relief line and the water heater drain pan that are located on the right side of the house are not fully trimmed out and need to have CPVC 90 degrees elbows installed.

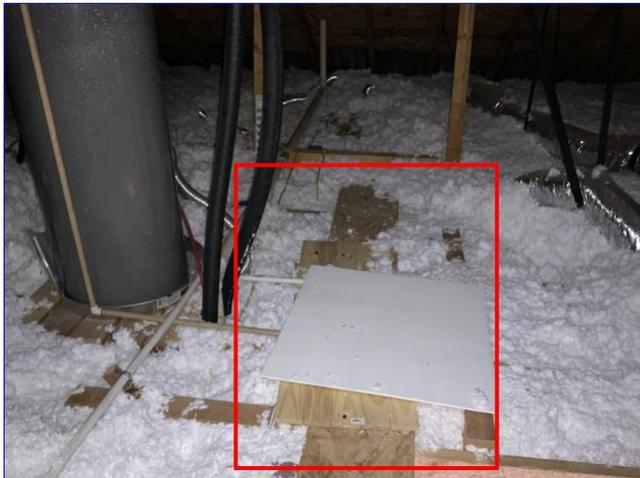
C. Item 2(Picture)

(2) Inadequate access to the water heater system that would allow access for equipment inspection, service, repair or replacement, it must have a 24-inch-wide solid floor from the entrance to the appliance, and must have a 30 X 30-inch level platform for service access.

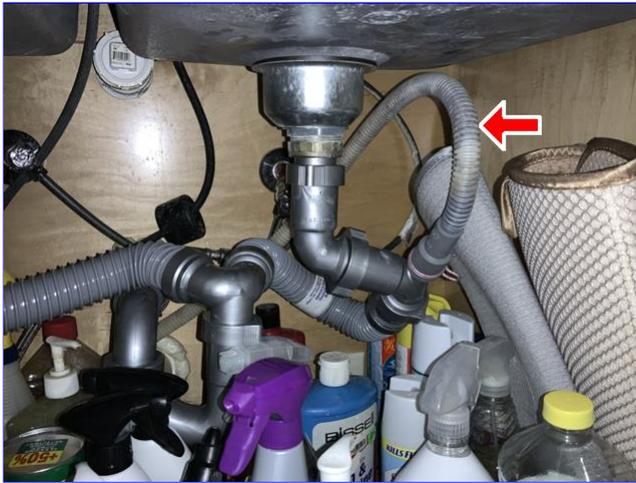
A. Item 1(Picture)

A visible backflow device was not found while inspecting the dishwasher. It is possible that the dishwasher may have an internal device but a second device either a High Loop or a mechanical backflow device should be installed. These devices lessen the chance of non-potable water backing up from the sink and entering the dishwasher and the water supply or contaminating the clean items in the washer. The high loop should attach to the underside of the countertop.

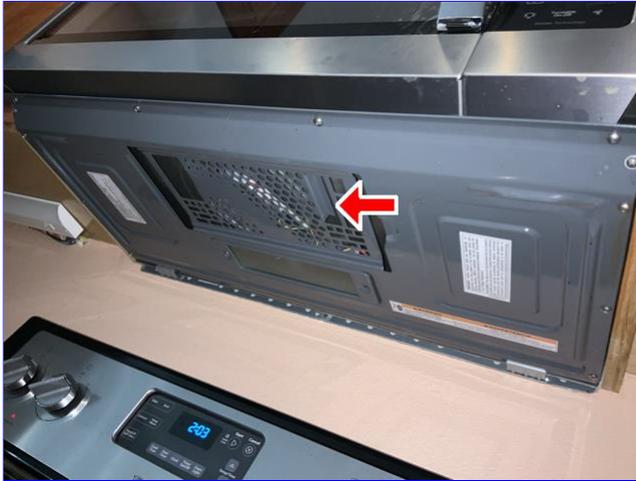
C. Item 1(Picture)

The exhaust filter on the range hood is missing. This allows particles to collect in the flue and presents a potential fire hazard.

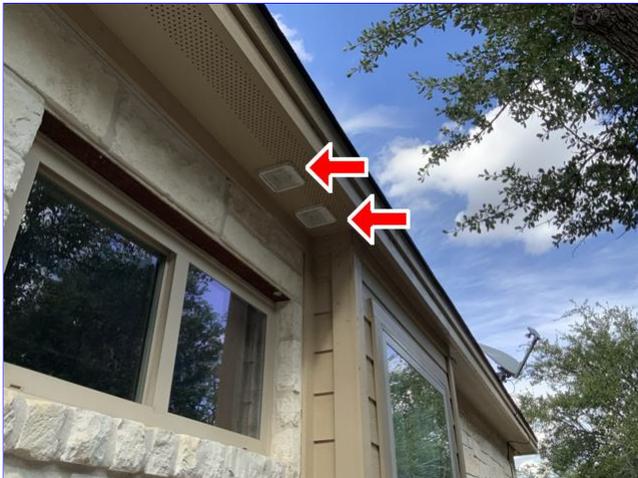
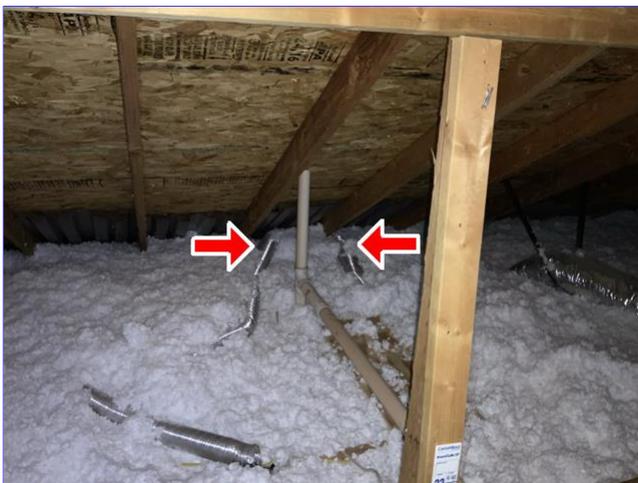
(1) The bath exhaust vents terminate to the attic soffit. Exhaust to the soffit can cause moisture from the vents to be pulled back into the attic. All bath vents should terminate through the roof structure.

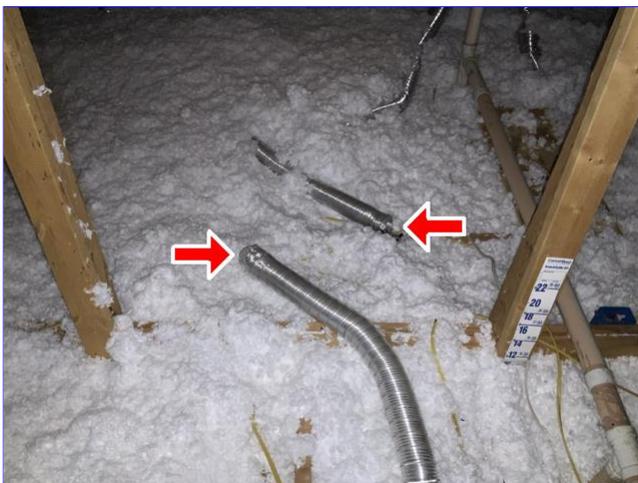
F. Item 3(Picture)

(2) Flex duct located in the attic has separated into two pieces, recommend repair.

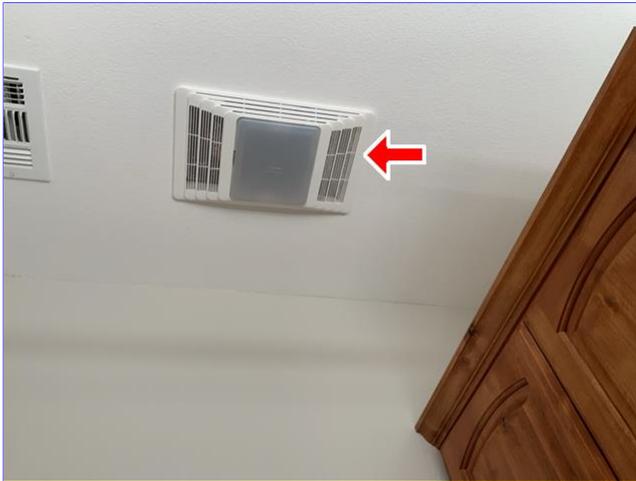
F. Item 4(Picture)

(3) The mechanical exhaust system located in the hall bathroom is loud during the start up, recommend cleaning the system first.

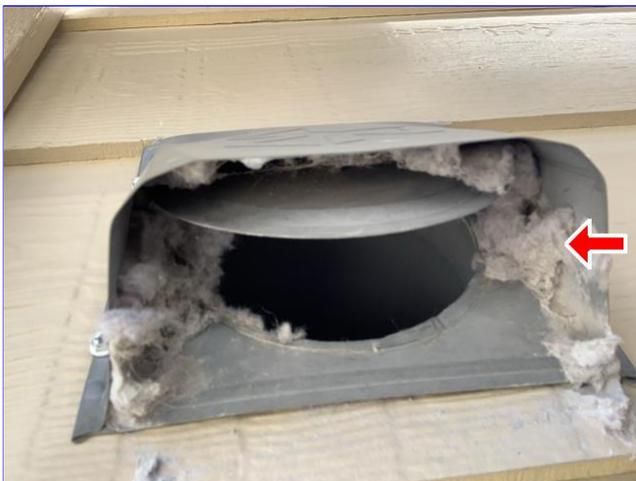
H. Item 1(Picture)

Lint was observed in the dryer vent system, this is a fire hazard and causes the dryer to operate inefficiently, recommend cleaning prior to use.
