GEOTECHNICAL CONSULTANTS, INC.
11918 Warfield Drive, San Antonio, Texas 78216
Office (210) 344-8144 Fax (210) 349-6151
Toll Free: 1-888-525-7955
e-mail: geotechnical@sbcglobal.net

April 12, 2022

Subject: Report of Structural Evaluation
Home at 1104 Turncreek Lane
Schertz, Texas
TBPE Registration: F-409
Project Number: 22220

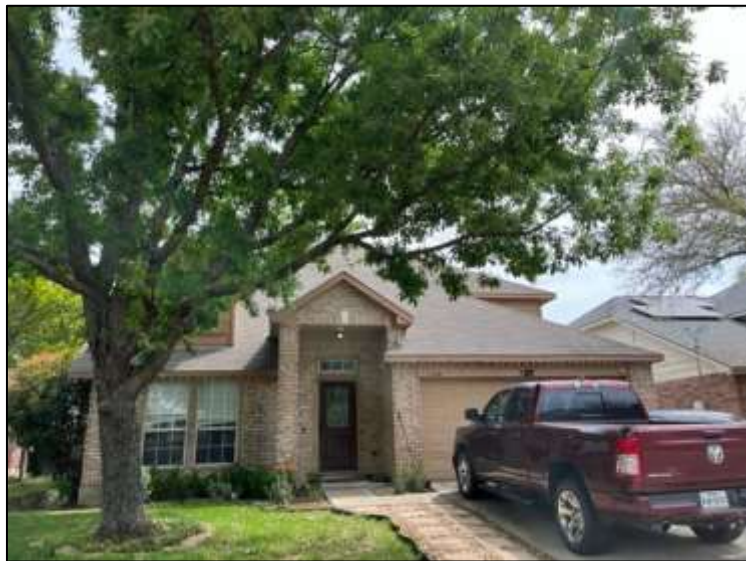
Photograph #1 – Front view of the house.
