# INSPECTION REPORTS

Job Site Address: 15771 SW OBERST LN

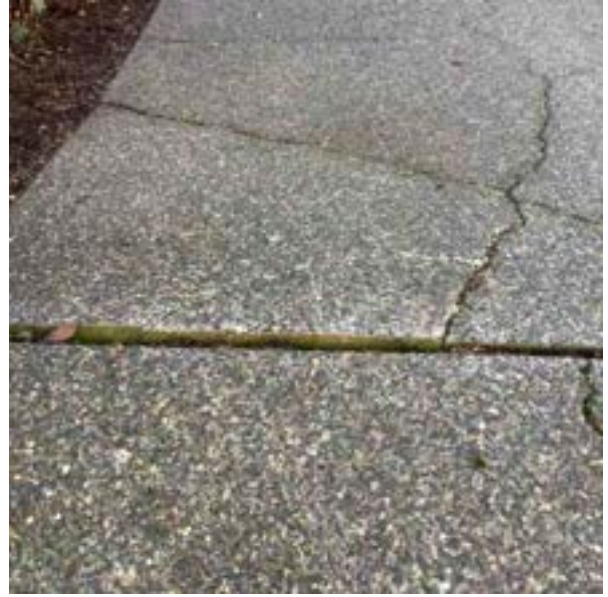
2.5.2 Driveway has settled to the point that it poses a trip hazard. Further evaluation and correction of all issues found is advised.

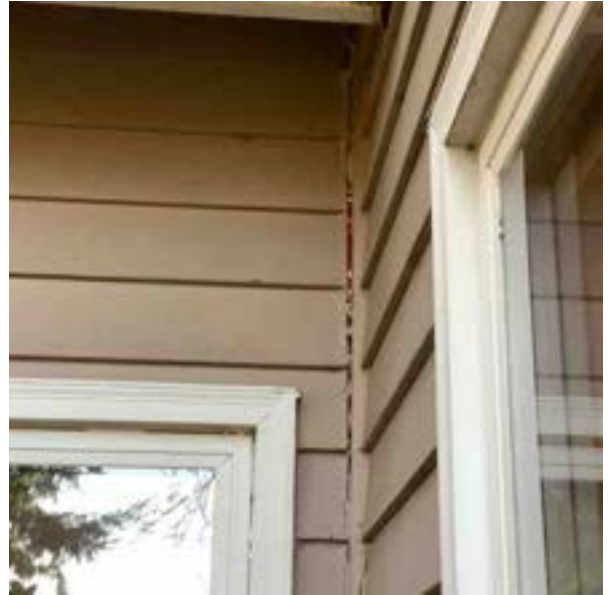
- Exterior Left
- den

3.2.1 Separation noted at a joint in exterior wall and crack noted at interior wall in the west room off of the den indicates settling has occurred. Evaluation and correction of all issues. Found advised.

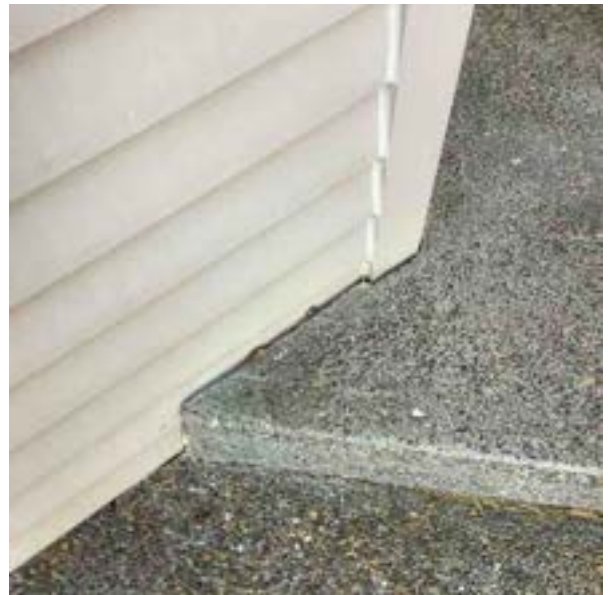
3.4.3 Concrete is touching the wooden siding. This can lead to moisture intrusion issues. Unsure if hidden damage exists. Further evaluation and correction of all issues found advised. **(Exterior Front)**

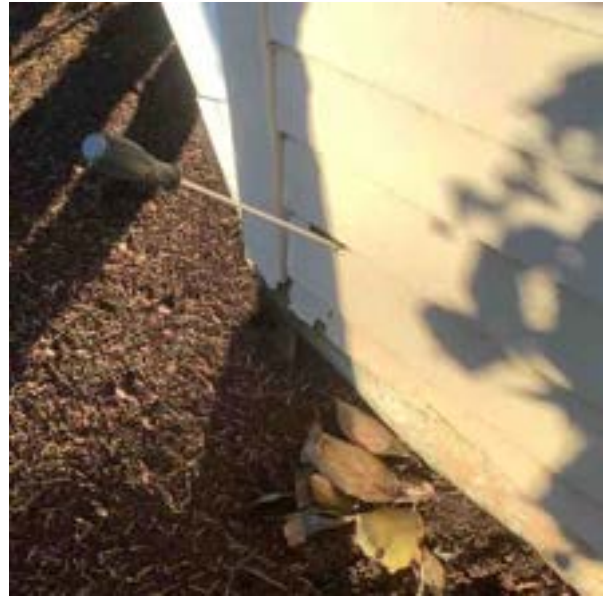
3.4.4 Rot in siding. Unable to determine extent of damage. Further evaluation and correction of all issues found is advised. **(Exterior Front)**

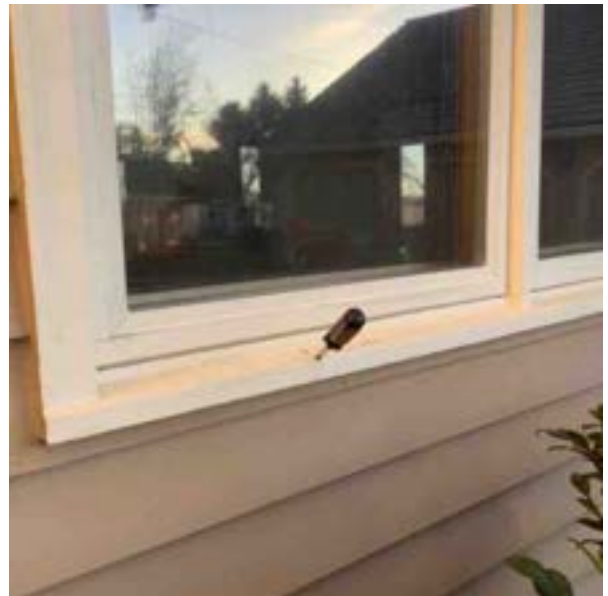
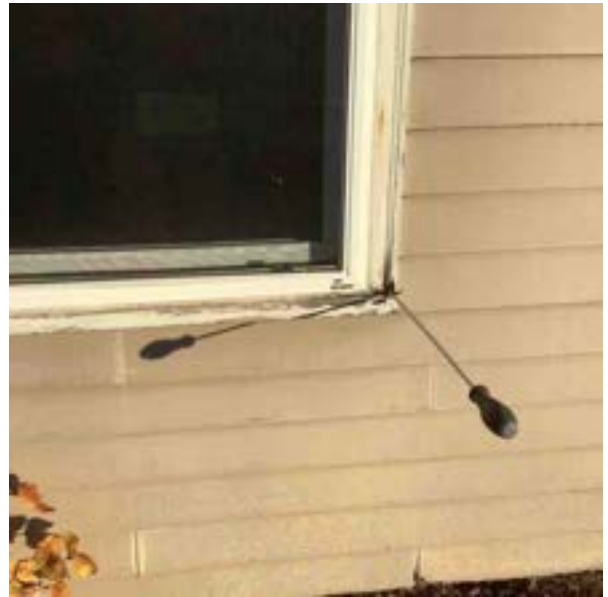
3.6.1 Rot in trim around the house. Mostly at the front. Unable to determine extent of damage. Further evaluation and correction of all issues found is advised.

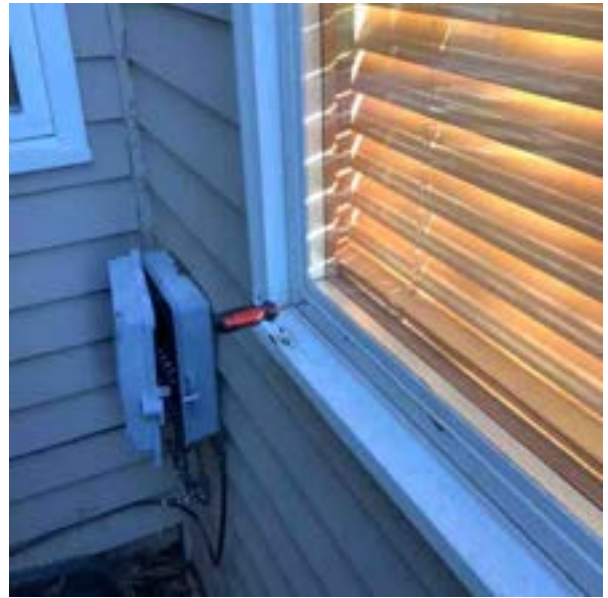
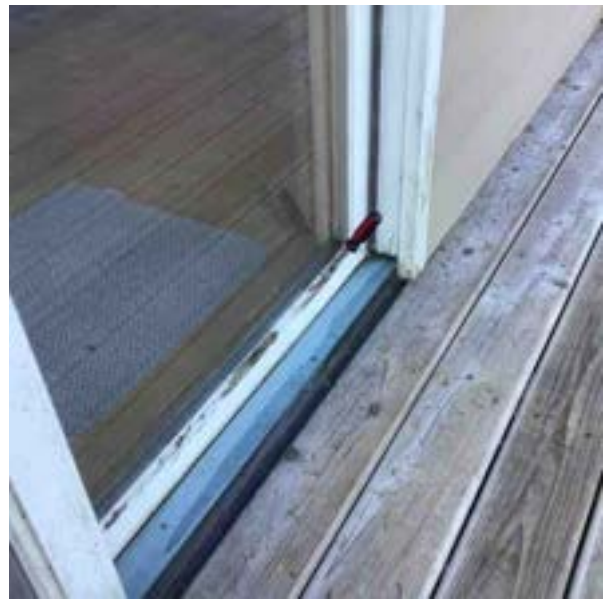
3.7.4 These types of wood windows and sliding doors from this time period are known to have issues with rot, wear and separation of joints. Some windows have issues and rot was found. Further evaluation of ALL windows and correction of all issues found is advised.

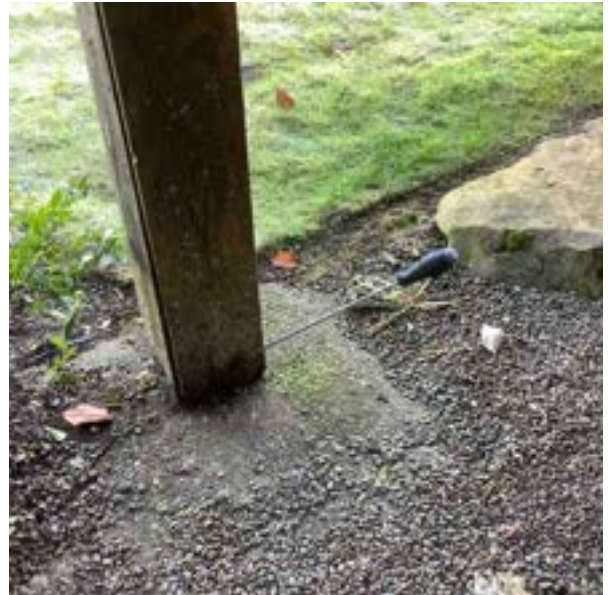
3.10.6 Rot was found in posts. Unable to determine extent of damage. Further evaluation and correction of all issues found is advised. **(Exterior Back)**

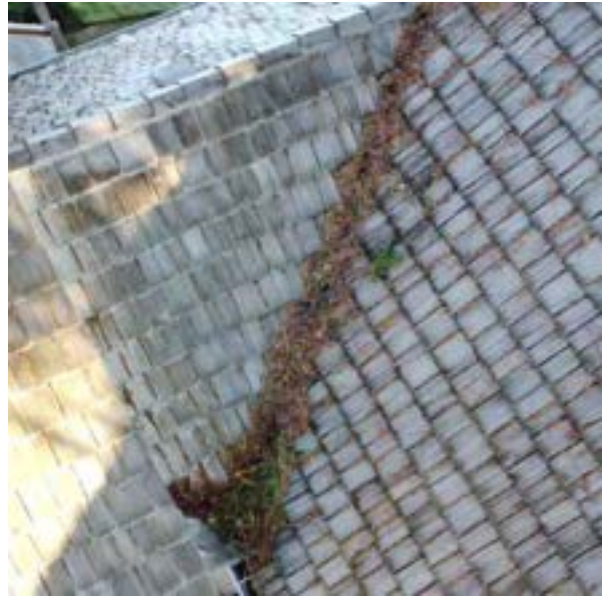
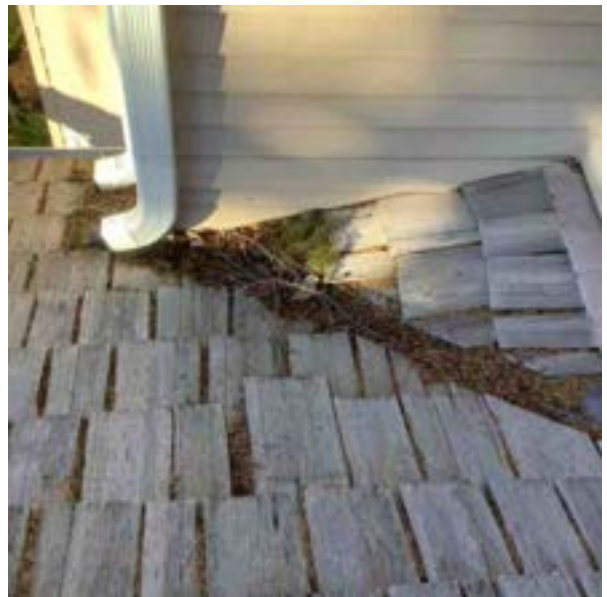
4.2.4 Keep roof cleaned of moss and tree debris to allow water to more easily flow off and into the gutters and to extend the life of the roof. Evaluation and correction of all issues found advised.

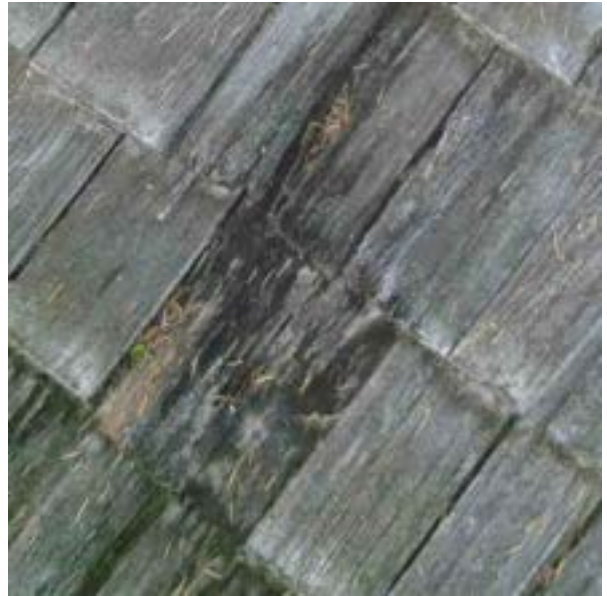
4.4.2 There are lifting staples, moss, and some rotted shakes noted. Further evaluation of the entire roofing system and correction of all issues found is advised.

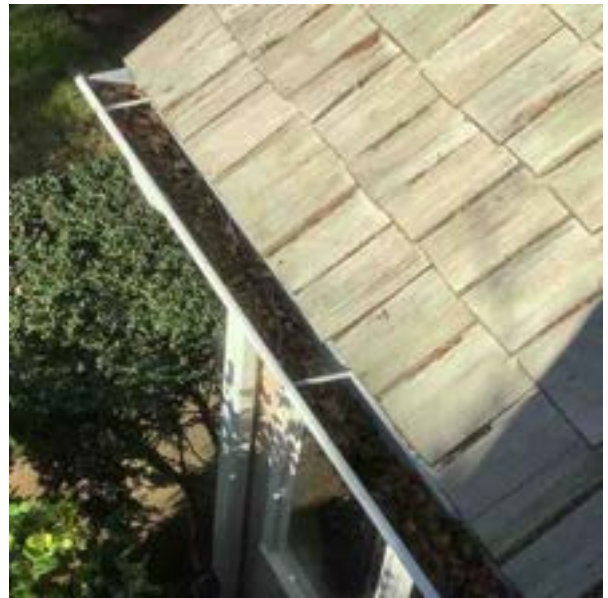
4.6.3 Gutters could use cleaning to facilitate water drainage towards downspouts. Further evaluation and correction of all issues found is advised.

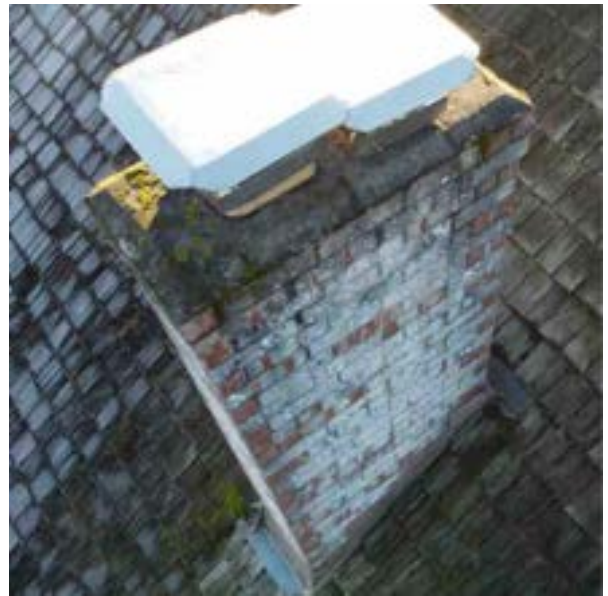
4.7.2 Typical chimney cap cracks and moss noted. Further evaluation and correction of all issues found is advised.

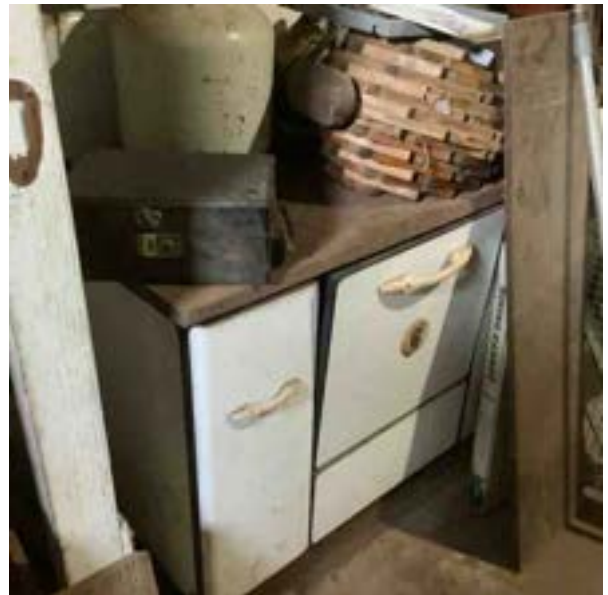
5.1.3 Old wood burning stove is venting into the attic. Stove does not appear to meet state standards and has not been used in quite some time. Further evaluation and correction is advised. (**Attic Garage**)

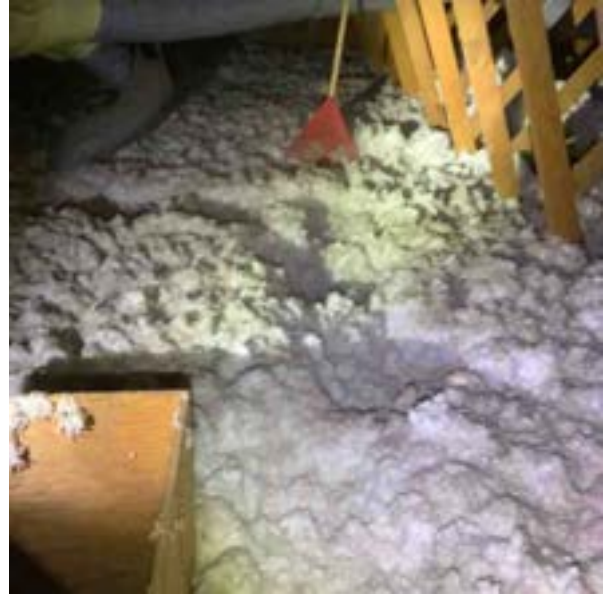
5.3.3 Insulation level has been compacted in several places; this can reduce its effectiveness. Further evaluation and correction of all issues found is advised. **(Attic: Upper)**

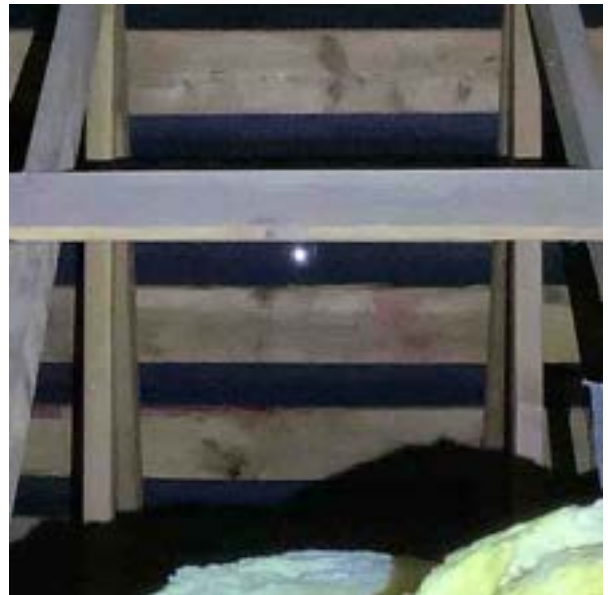
5.6.3 Light was visible around the chimney, which is not unusual, but there is also light visible in other areas where it shouldn't be visible. A bucket with water in it, evidently from a roof leak was noted. Further evaluation and correction of all issues found advised.

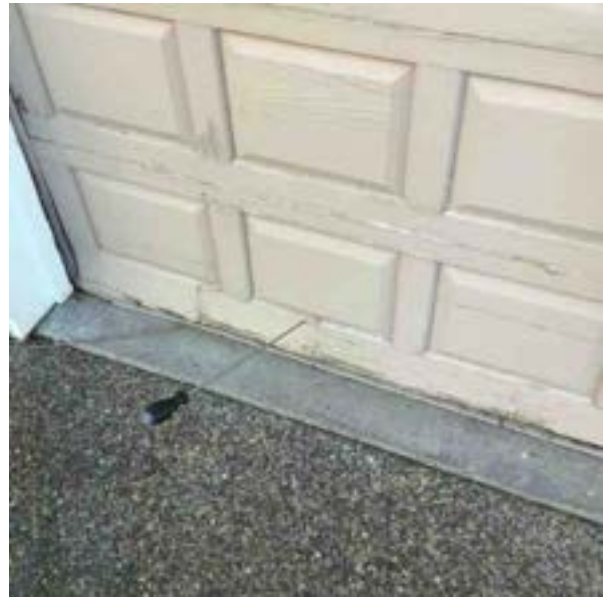
6.4.5 The garage doors have rot. Further evaluation and correction of all issues found is advised.

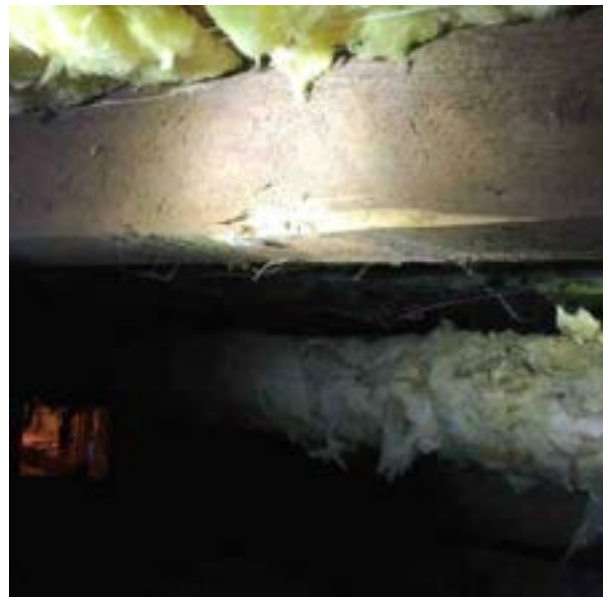
7.3.2 Evidence of old wood destroying insect activity and surface damage noted along a few beams. Find out from seller if the house has been exterminated/evaluated. If not, further evaluation and correction of all issues found is advised. **(Original CrawlSpace)**

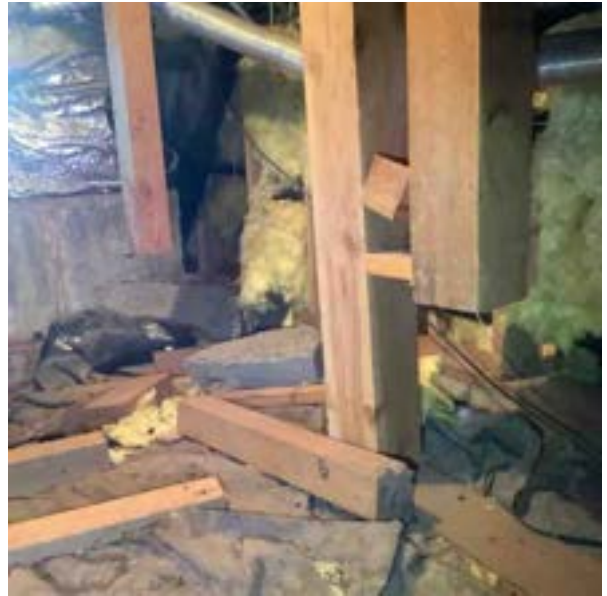
7.3.3 Extensive sub-structure repairs noted in the crawlspace and possible incorrect pillar supports. Obtain all documentation from the seller regarding all work done in the crawlspace for warranty purposes. If concerned further evaluation and correction is advised. **(Original Crawlspace)**

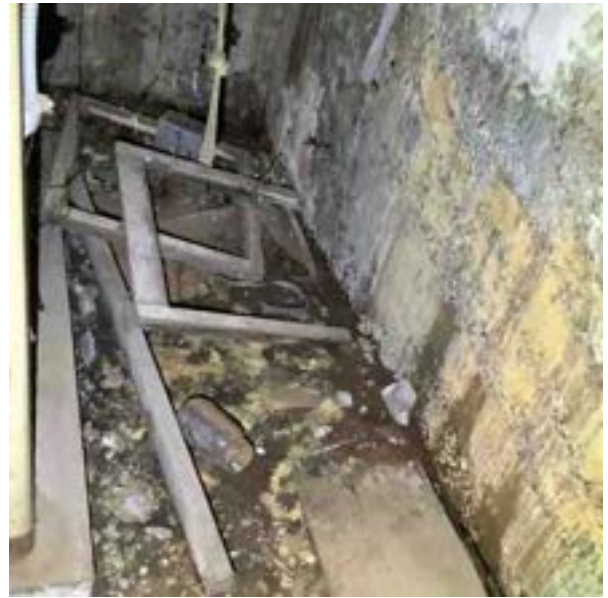
8.3.1 Cellulose debris was noted in the crawlspace. Removal of all cellulose (loose wood, wood or cardboard forms, plants, or any other debris) large enough to be picked up by a standard garden rake is advised to reduce the chance of infestation by wood destroying insects.

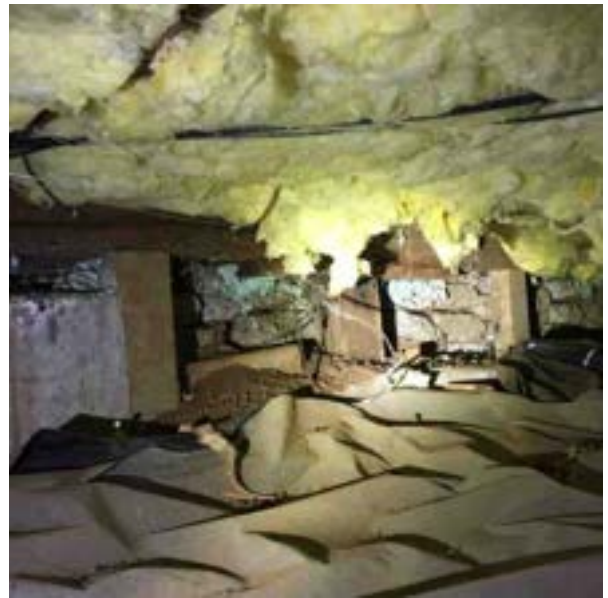
8.3.2 Earth to wood contact noted at the west crawlspace. Further evaluation and correction of all issues found is advised. **(Original Crawlspace)**

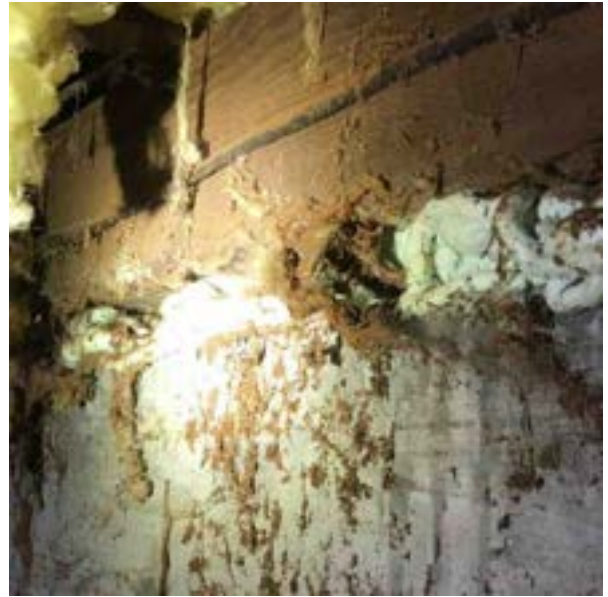
8.3.3 Possible Frass from wood destroying insects noted. Unable to determine if activity is current or damage has occurred. Further evaluation and correction of all issues found is advised.

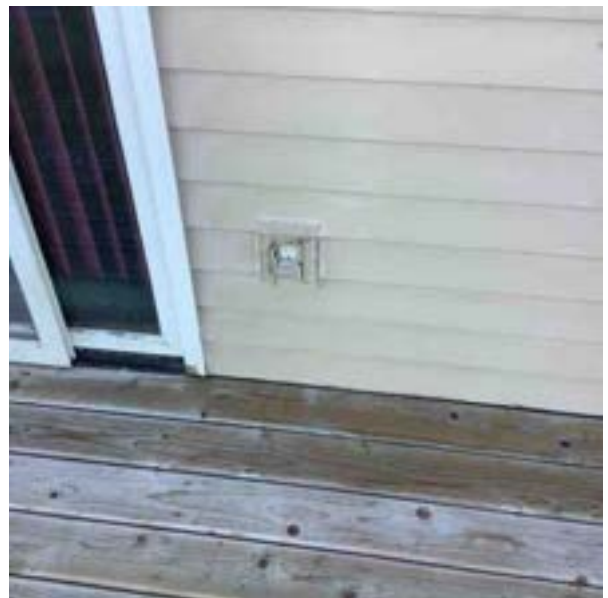
9.7.4 All outdoor receptacles should have approved covers for safety. Correction advised. **(Exterior Front)**

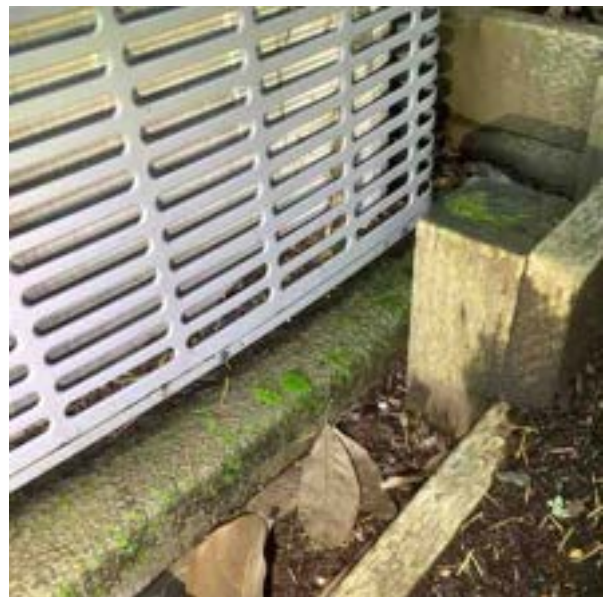
10.5.6 System is dirt and there is earth up against the unit. Further evaluation and correction of all issues found is advised. **(Exterior Left)**

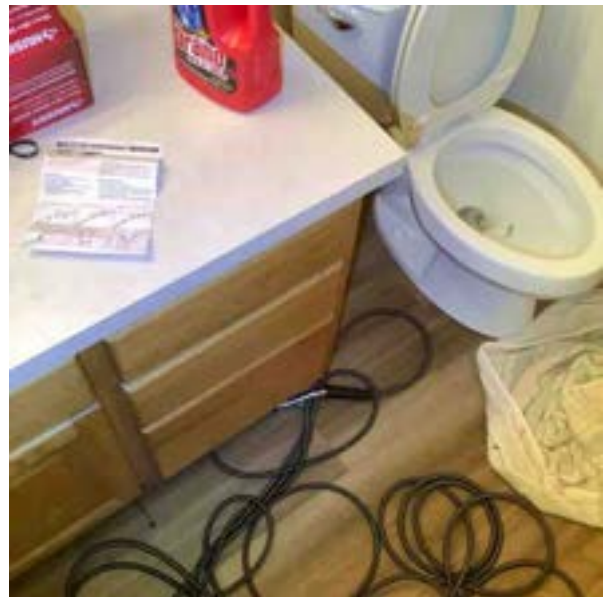
11.8.2 Toilet appears to be clogged. There is Drano and toilet snake near fixture too. Further evaluation and correction of all issues found is advised. **(Basement bathroom)**

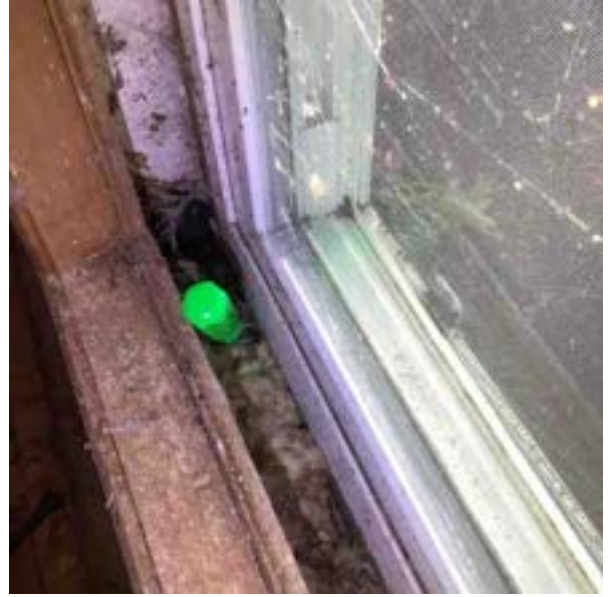
12.5.5 Rot found in sill. Unable to determine extent of damage. Further evaluation and correction of all issues is advised. **(Garage)**

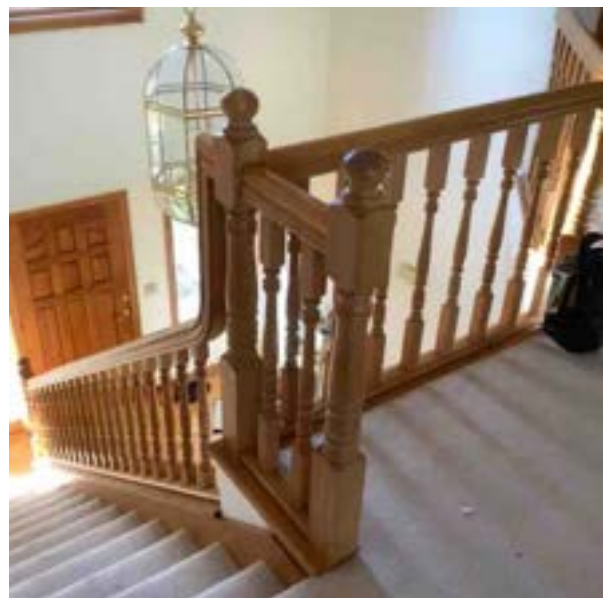
12.8.4 Handrail is loose. Further evaluation and correction of all issues found is advised.

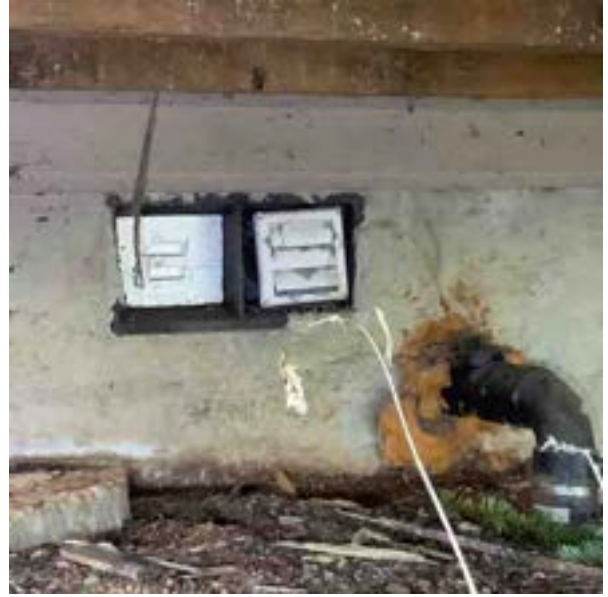
14.10.2 The dryer vent cover has quite a bit of lint caught in it and is blowing into the crawlspace. Further evaluation and correction of all issues found is advised. **(Crawlspace)**

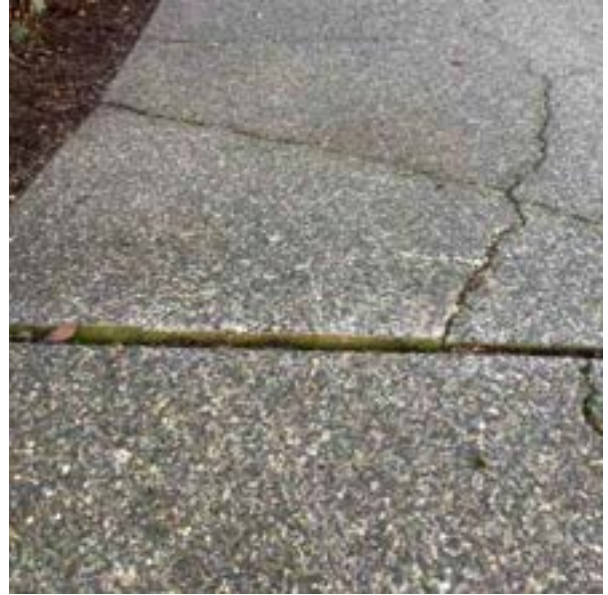
**2.5.2 Driveway has settled to the point that it poses a trip hazard. Further evaluation and correction of all issues found is advised.**

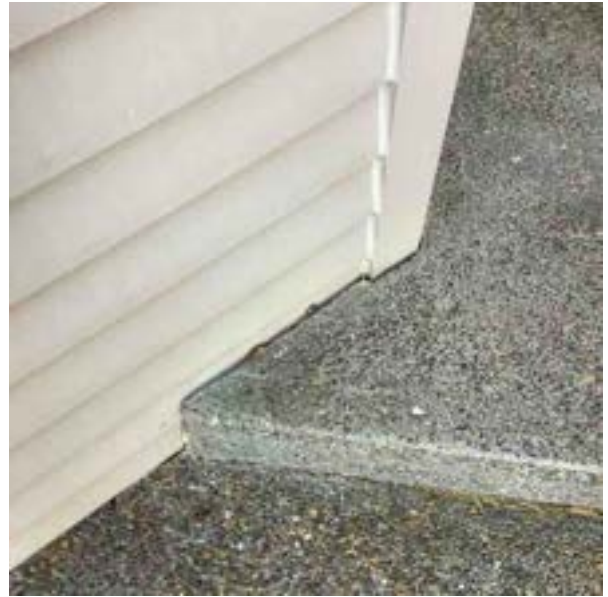
**3.4.3 Concrete is touching the wooden siding. This can lead to moisture intrusion issues. Unsure if hidden damage exists. Further evaluation and correction of all issues found advised. (Exterior Front)**

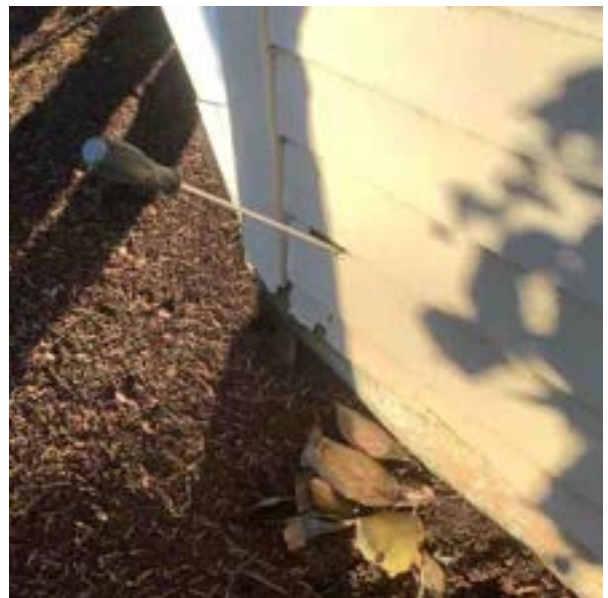
**3.4.4 Rot in siding. Unable to determine extent of damage. Further evaluation and correction of all issues found is advised. (Exterior Front)**

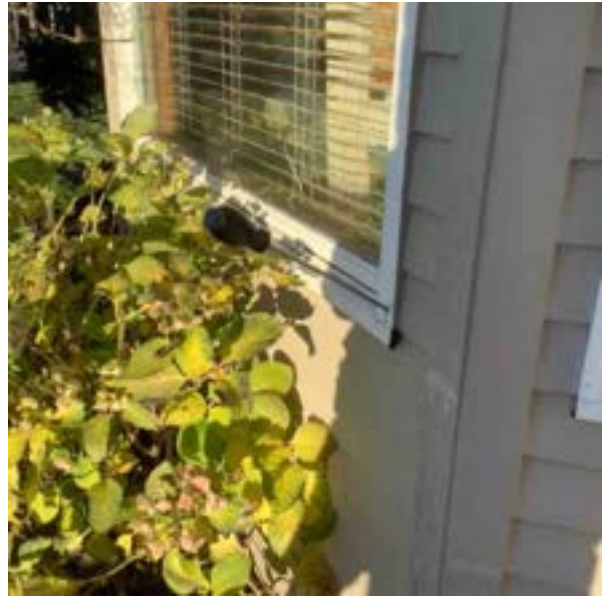
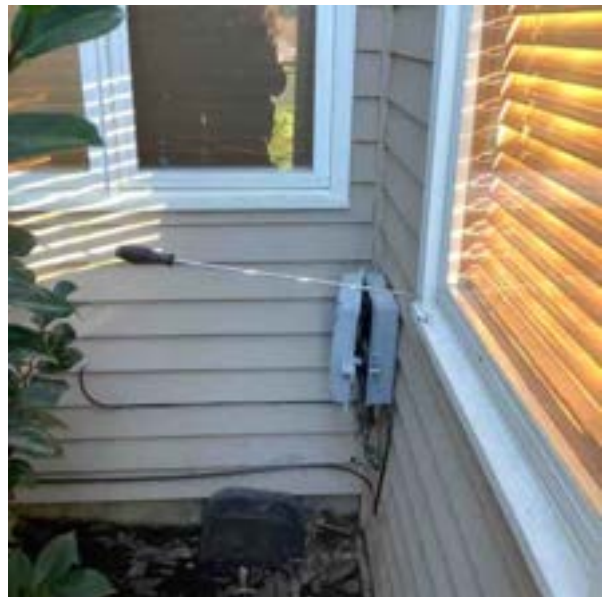
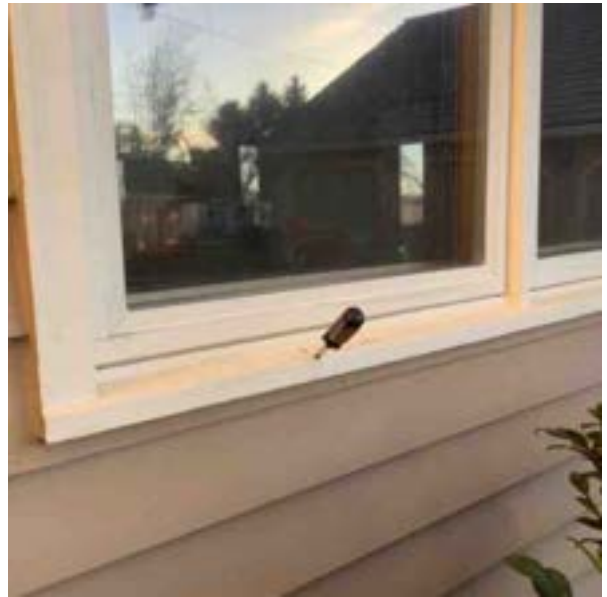
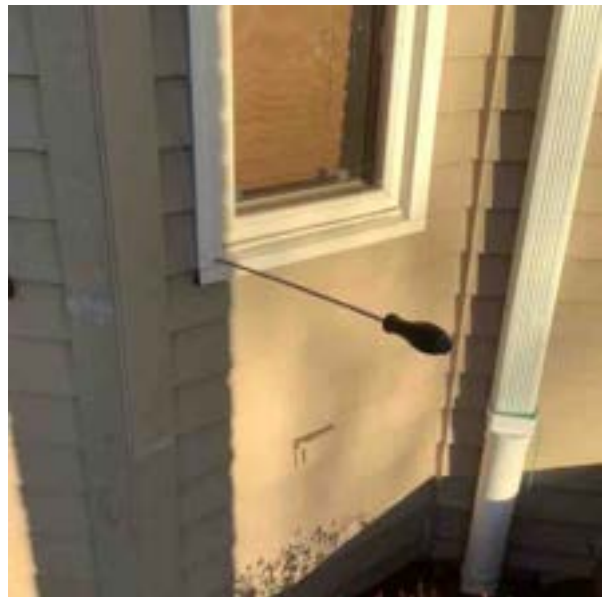
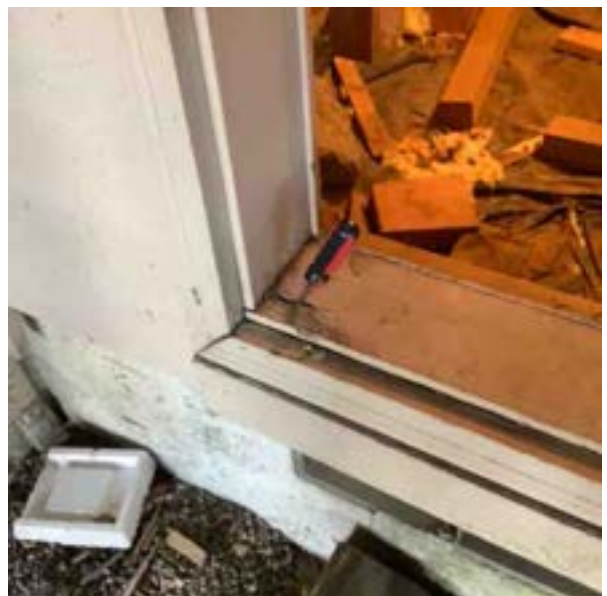
**3.6.1 Rot in trim around the house. Mostly at the front. Unable to determine extent of damage. Further evaluation and correction of all issues found is advised.**

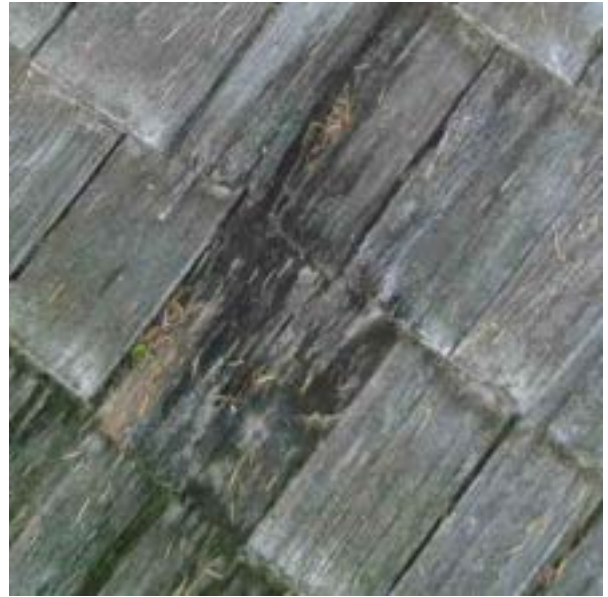
4.4.2 There are lifting staples, moss, and some rotted shakes noted. Further evaluation of the entire roofing system and correction of all issues found is advised.

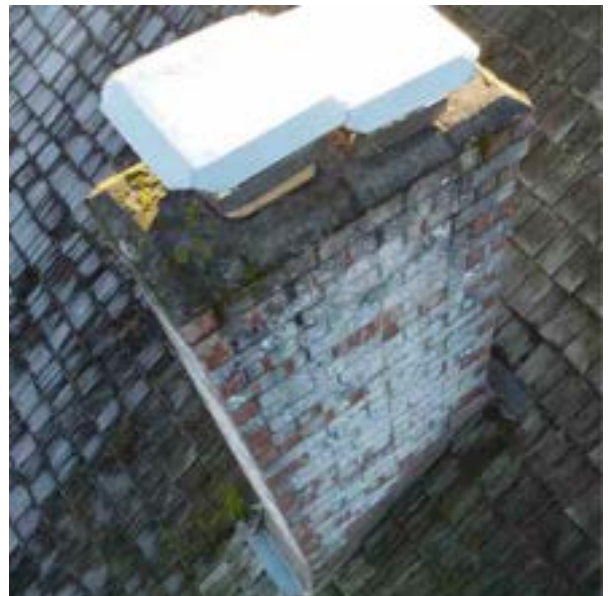
4.7.2 **Typical chimney cap cracks and moss noted. Further evaluation and correction of all issues found is advised.**

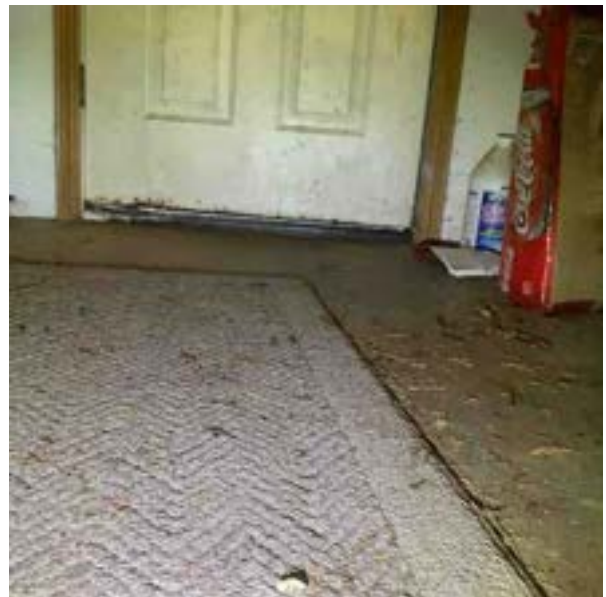
6.3.2 **Weather strip is damaged or missing around door to the outside. Further evaluation and correction of all issues found is advised. (Garage)**

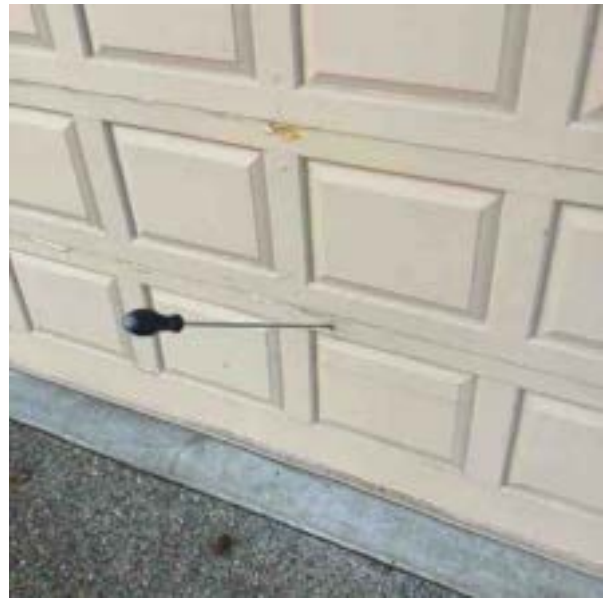
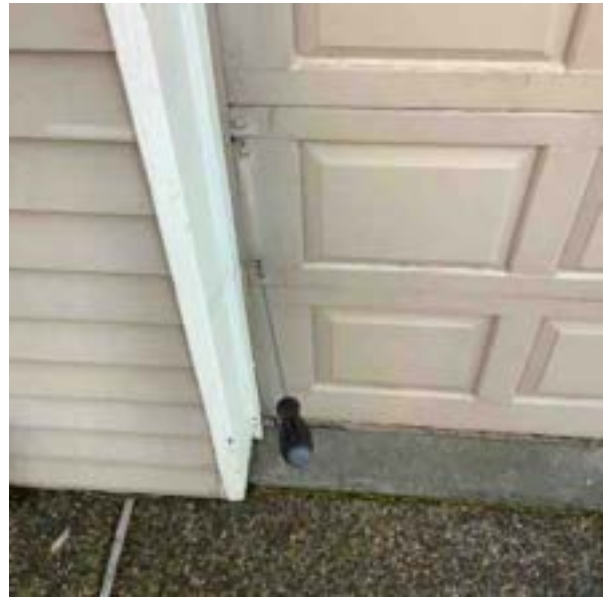
6.4.5 **The garage doors have rot. Further evaluation and correction of all issues found is advised.**

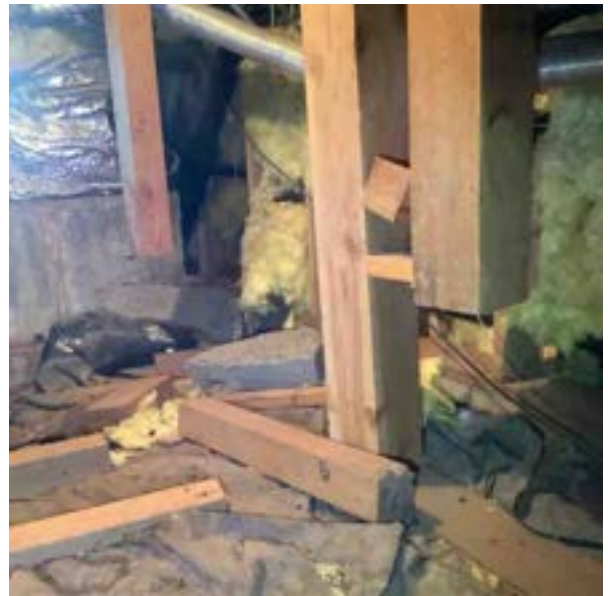
**7.3.3 Extensive sub-structure repairs noted in the crawlspace and possible incorrect pillar supports. Obtain all documentation from the seller regarding all work done in the crawlspace for warranty purposes. If concerned further evaluation and correction is advised. (Original Crawlspace)**

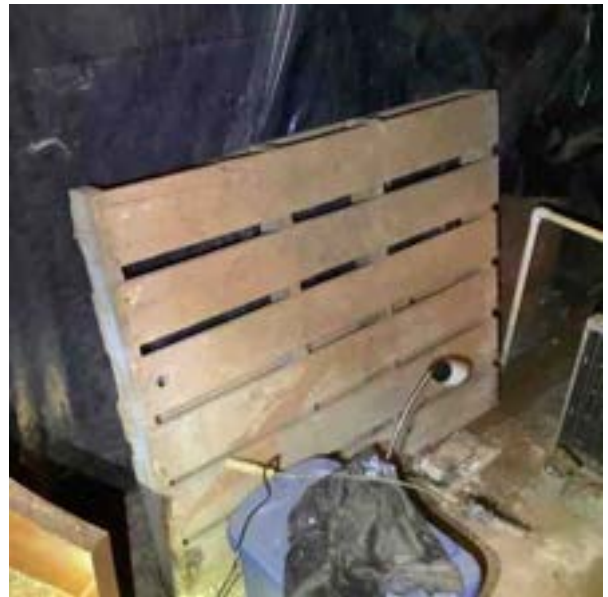
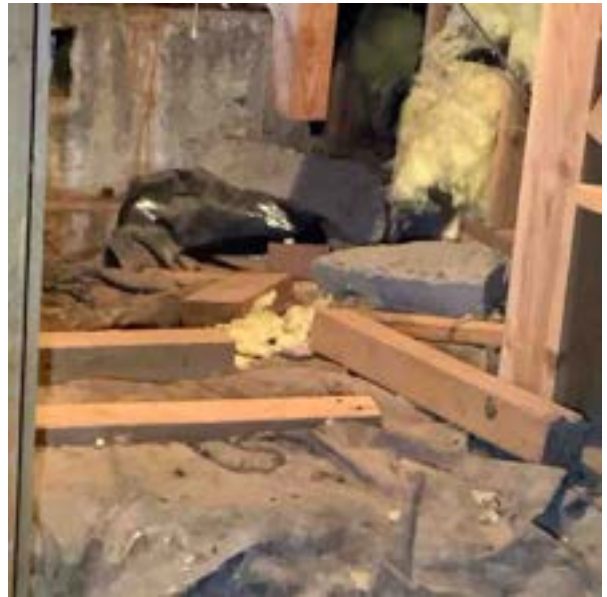
8.3.1 Cellulose debris was noted in the crawlspace. Removal of all cellulose (loose wood, wood or cardboard forms, plants, or any other debris) large enough to be picked up by a standard garden rake is advised to reduce the chance of infestation by wood destroying insects.

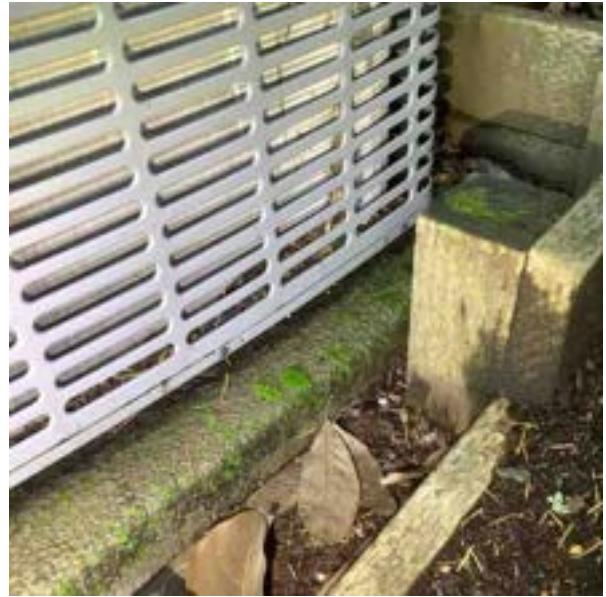
10.5.6 System is dirt and there is earth up against the unit. Further evaluation and correction of all issues found is advised. (Exterior Left)

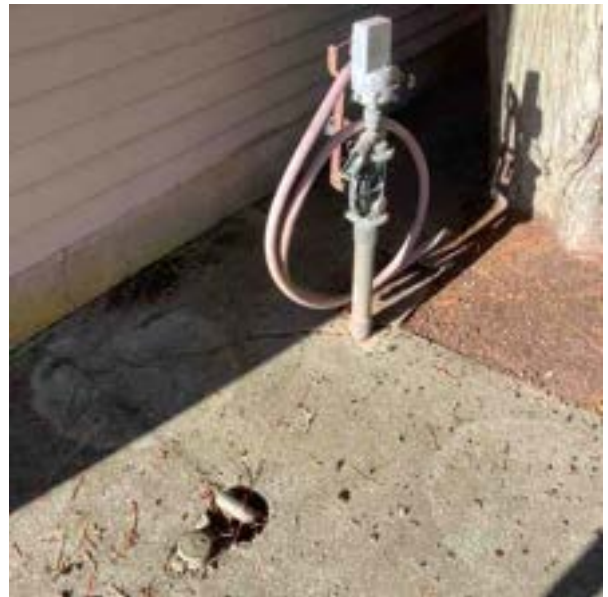
10.10.2 **Behind the garage, there is what appears to be a fuel pump and underground storage tank. Ask the sellers about this. Further evaluation and correction of all issues found advised.**

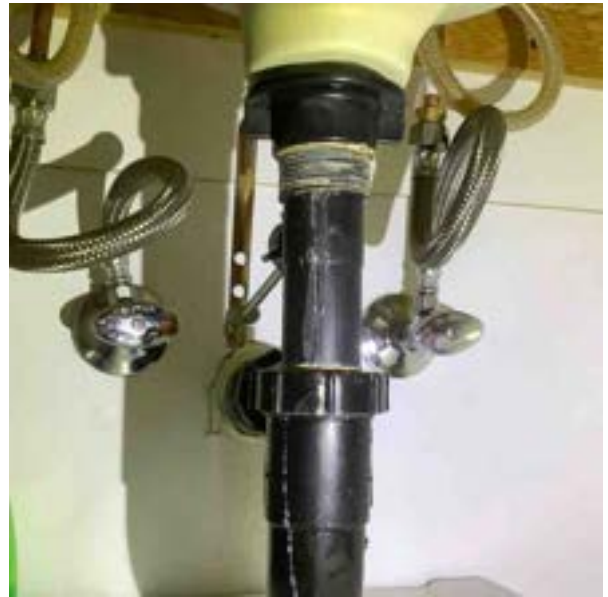
Evidence of previous leaking noted under the sink but no leaking was noted at this time. **(Primary Bathroom)**

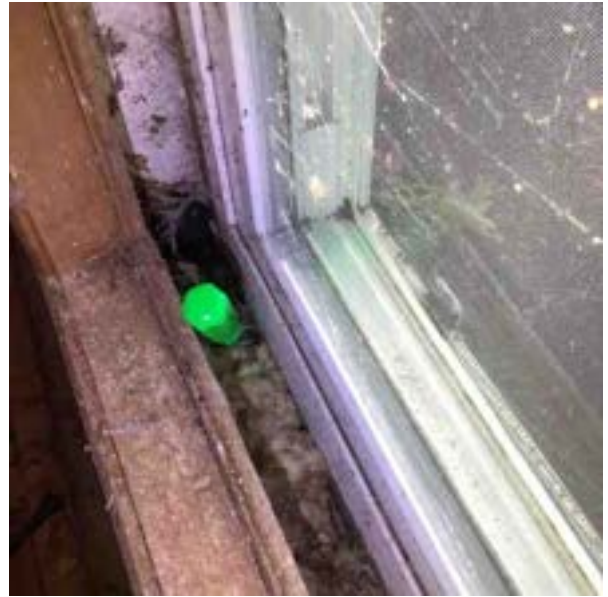
12.5.5 Rot found in sill. Unable to determine extent of damage. Further evaluation and correction of all issues is advised. (Garage)

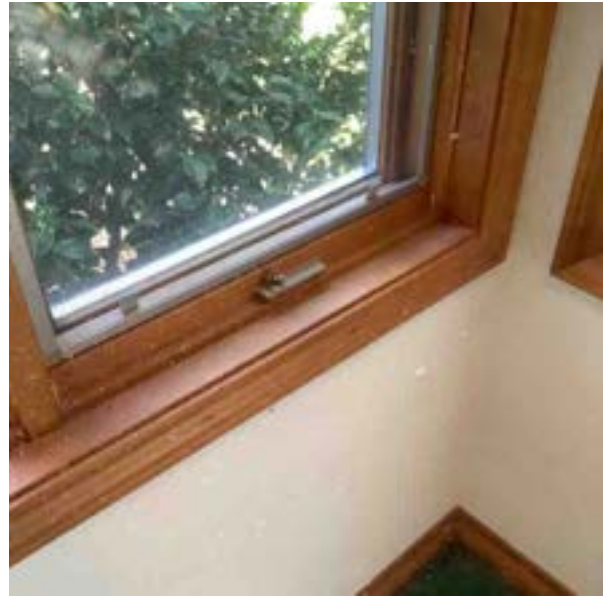
12.5.7 Crank handle(s) missing, unable to test window. Further evaluation and correction of all issues found is advised. **(1st floor SW bedroom)**

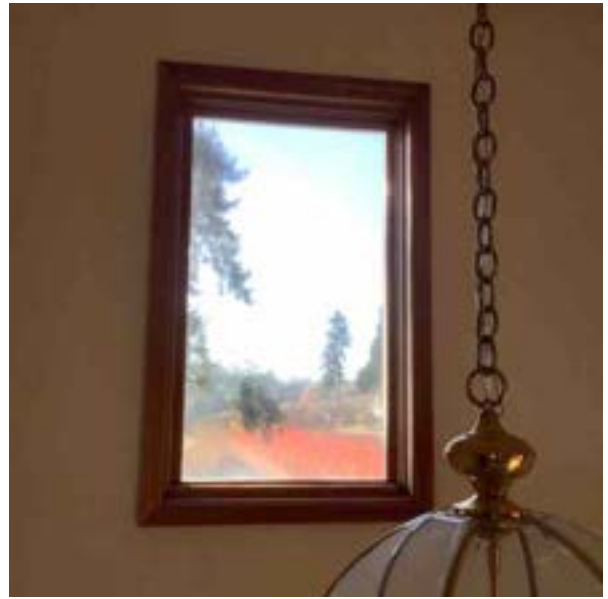
- Basement Family Room
- Entry

12.5.8 **Thermopane seals are broken causing moisture staining/discoloration between the panes of glass. Replacement/repair may be desirable but this is a cosmetic issue and will not cause damage.**

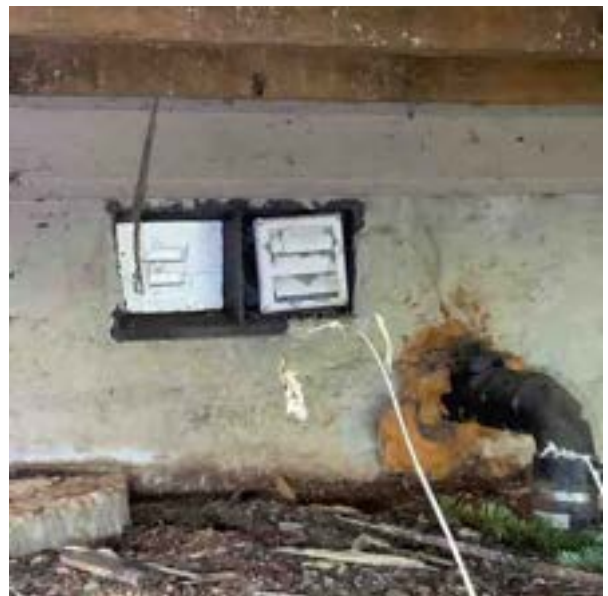
14.10.2 **The dryer vent cover has quite a bit of lint caught in it and is blowing into the crawlspace. Further evaluation and correction of all issues found is advised. (Crawlspace)**
