## Existing System Evaluation Report for Onsite Wastewater Systems

**Home Repairs following January 2015 Inspection**  
29759 Bellfountain Road, Corvallis, OR 97333

Inspection Address: 29759 Bellfountain Rd., Corvallis, OR

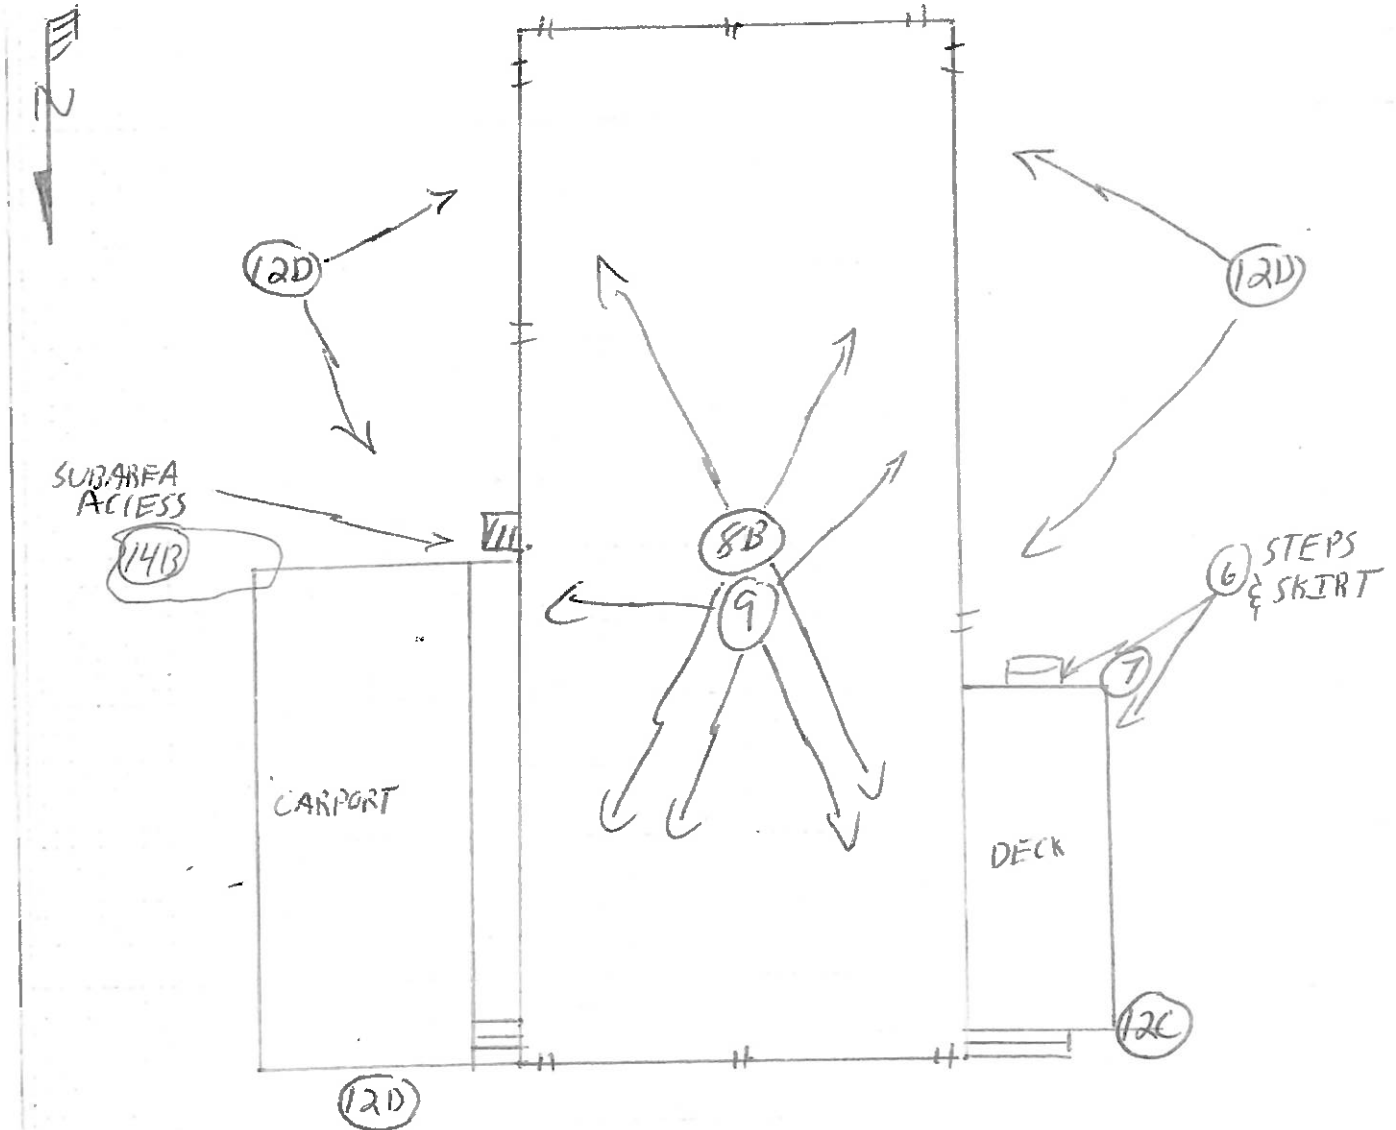
## REFERENCE SKETCH

| ID # | YES | EXTERIOR |
|---|---|---|
| 6 | X | Damage noted at deck: <input type="checkbox"/> decking <input type="checkbox"/> beams <input type="checkbox"/> posts <input type="checkbox"/> joists <input type="checkbox"/> railing <input checked="" type="checkbox"/> steps <input checked="" type="checkbox"/> skirt |

| ID # | YES | EXTERIOR |
|---|---|---|
| 12C | X | Downspouts are <input type="checkbox"/> disconnected <input type="checkbox"/> missing <input type="checkbox"/> damaged <input checked="" type="checkbox"/> disconnected from buried drain. |
| 12D | X | Gutters are <input type="checkbox"/> damaged <input type="checkbox"/> deteriorated <input checked="" type="checkbox"/> debris-filled <input checked="" type="checkbox"/> over-flowing <input type="checkbox"/> missing. |
| 8B | X | Vapor barrier (soil cover) is damaged. |

| ID # | YES | DESCRIPTION |
|---|---|---|
| 6 | X | Replace all damaged/deteriorated members with new material of comparable size and strength. Use |
| 7 | X | Provide 6 inches between non-pressure-treated wood and soil or replace with pressure treated material. |
| 8B | X | Replace all vapor barrier (as per number 8, above). |
| 12C | X | <input checked="" type="checkbox"/> Repair <input type="checkbox"/> replace <input type="checkbox"/> install new <input type="checkbox"/> add additional downspouts, as needed |
| 12D | X | <input type="checkbox"/> Repair <input type="checkbox"/> replace <input checked="" type="checkbox"/> remove debris <input checked="" type="checkbox"/> reposition <input type="checkbox"/> install additional gutters. |
