8527 STAYTON RD

TURNER, OR

Home

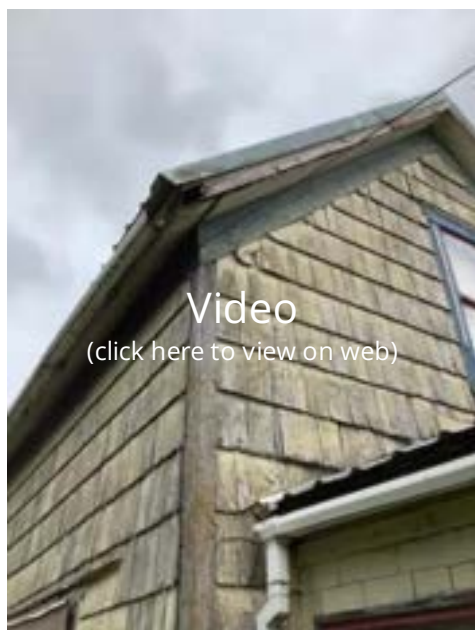
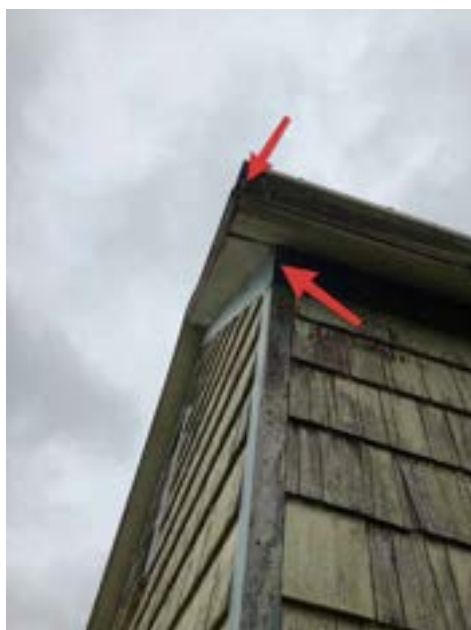
Fascia/Eave Wood Rot (Representative Picture)

Contact a qualified roofing professional.

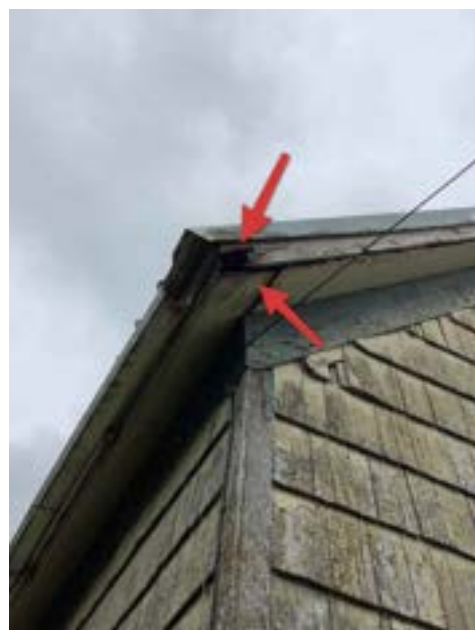
Fascia/Eave Wood Rot (Representative Picture)

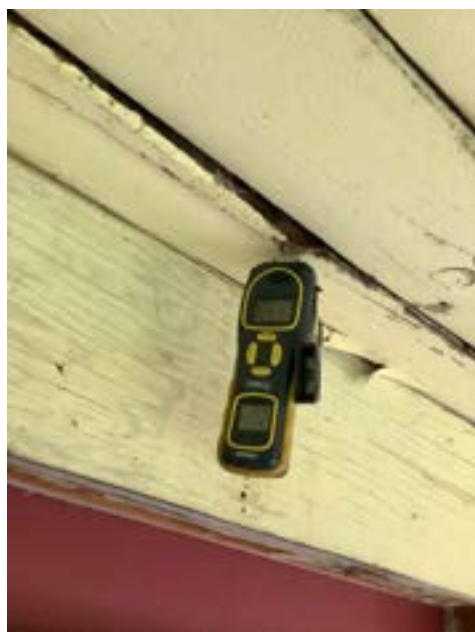
Fascia/Eave Wood Rot (Representative Picture)

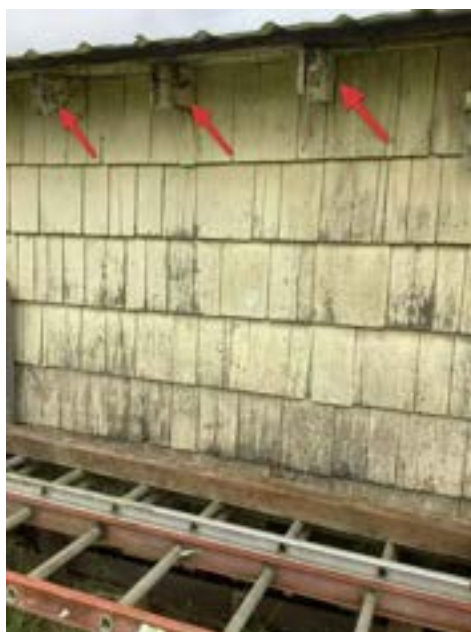
Rafter Wood Rot (Representative Picture)

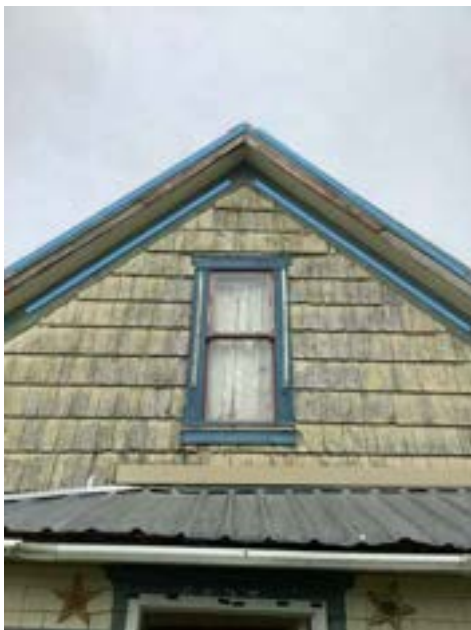
Fascia/Eave Paint Deteriorating
(Representative Picture)

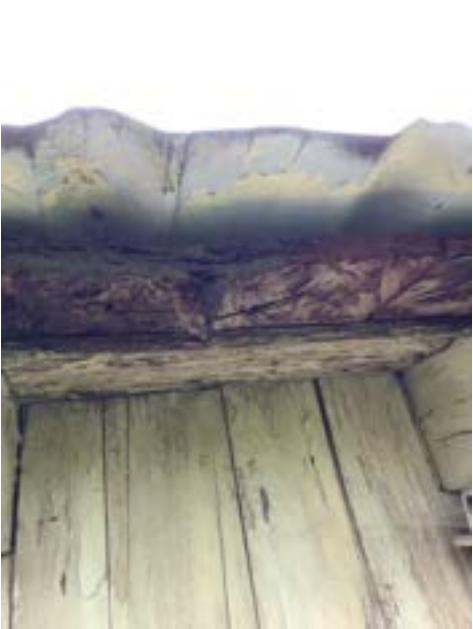
Roof Decking Wood Rot
(Representative Picture)

Contact a qualified roofing professional.

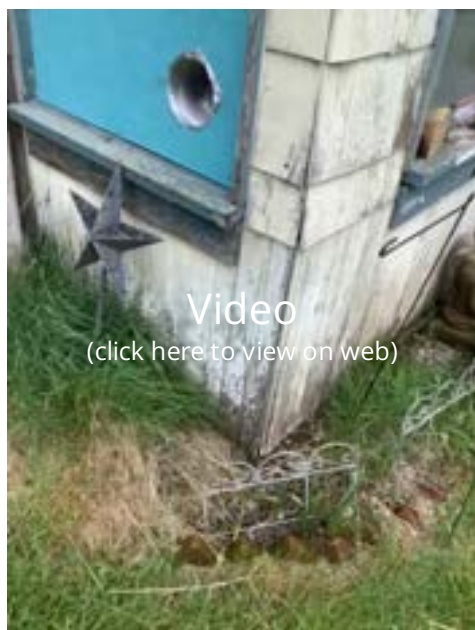
Siding/Trim Wood Rot (Representative Picture)

Contact a qualified siding specialist.

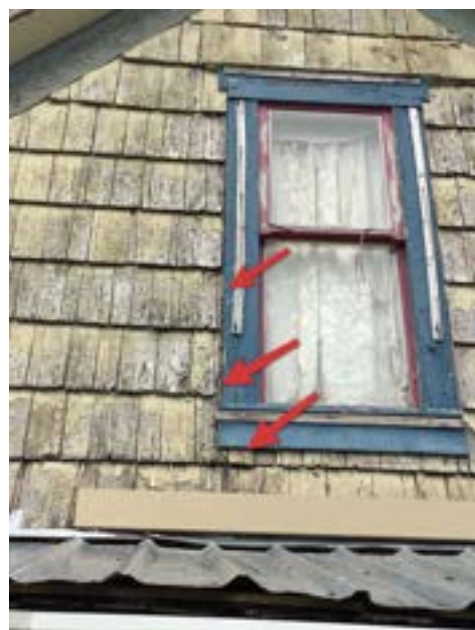
Siding/Trim Wood Rot (Representative Picture)

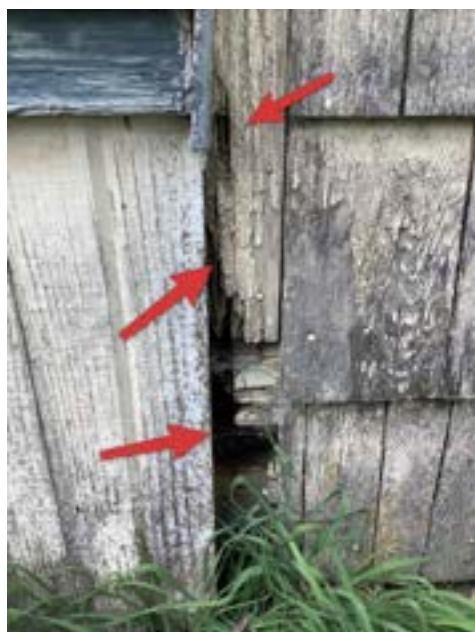
Siding/Trim Wood Rot (Representative Picture)

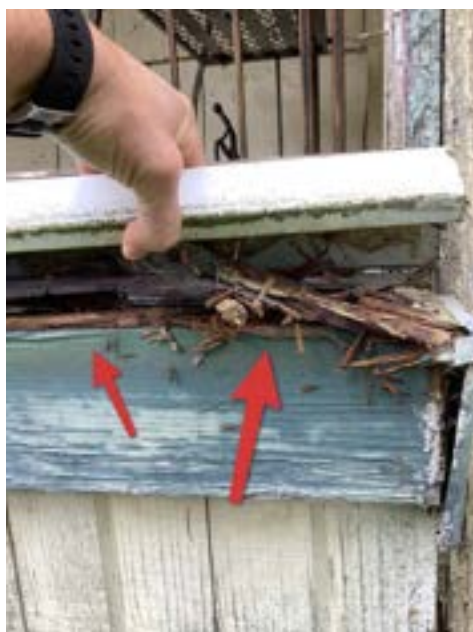
Siding/Trim Wood Rot (Representative Picture)

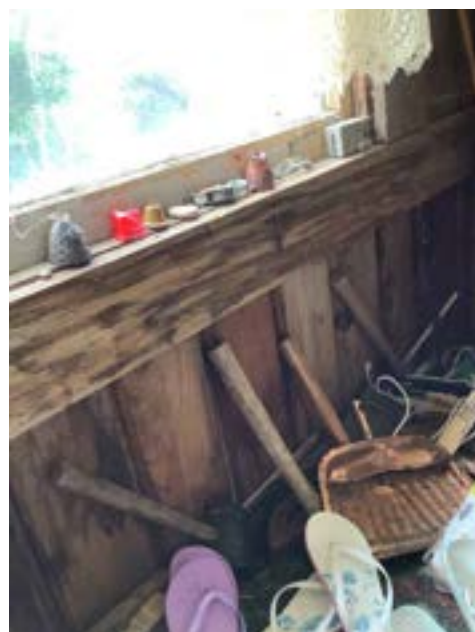
Siding/Trim Wood Rot (Representative Picture)

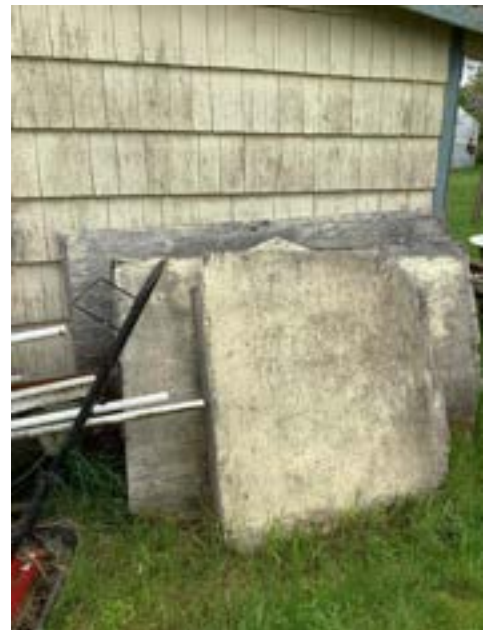
Wood in Contact With Siding - Side B

Recommended DIY Project

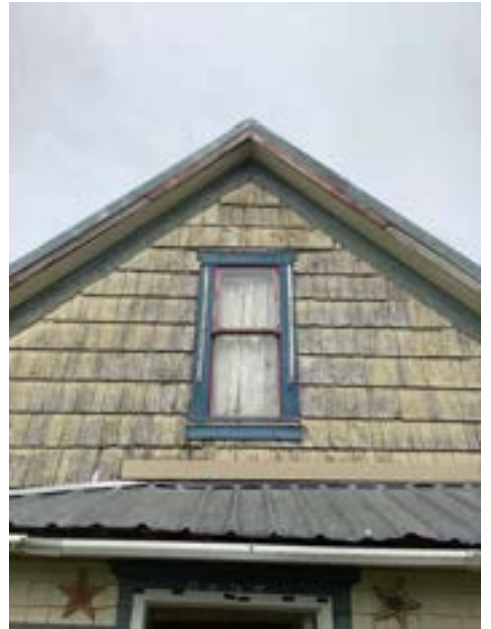
Siding/Trim Paint Deteriorating
(Representative Picture)

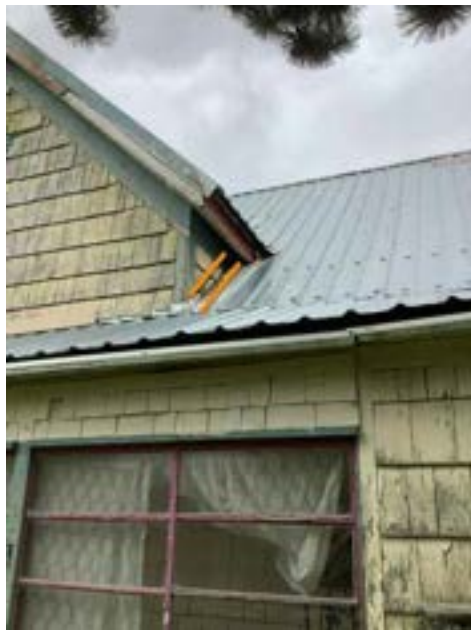
Siding in Contact With Roof
(Representative Picture)

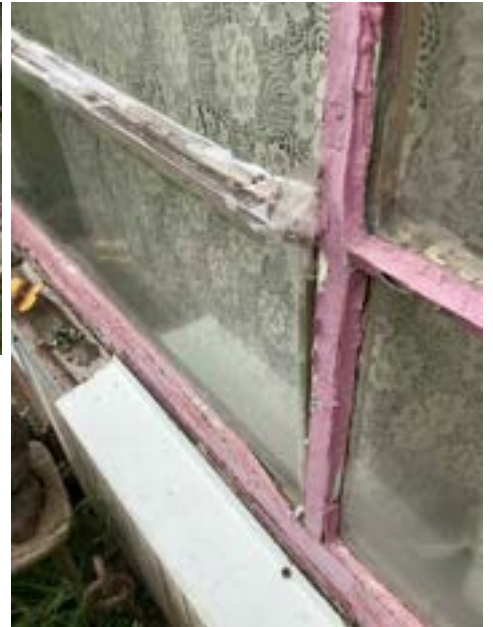
Window Trim/Frame Wood Rot
(Representative Picture)

Contact a qualified window repair/installation contractor.

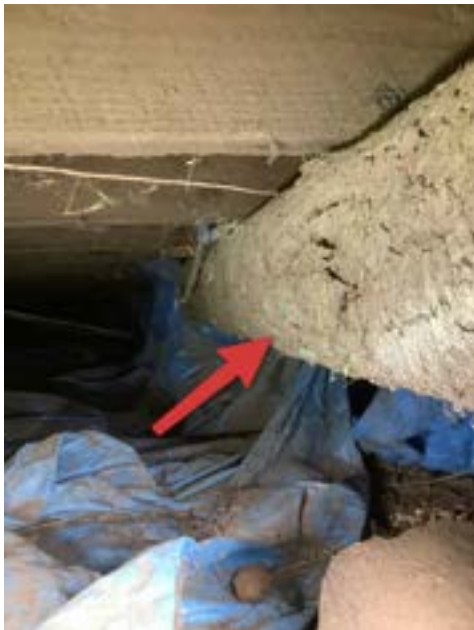
Sub-Floor Structure Wood Rot/Damage - Crawl Space (Representative Picture)

Contact a qualified structural engineer.

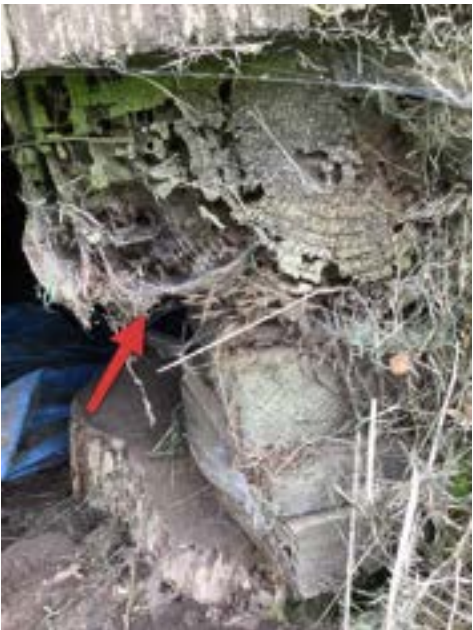
Sub-Floor Structure Wood Rot/Damage - Crawl Space (Representative Picture)

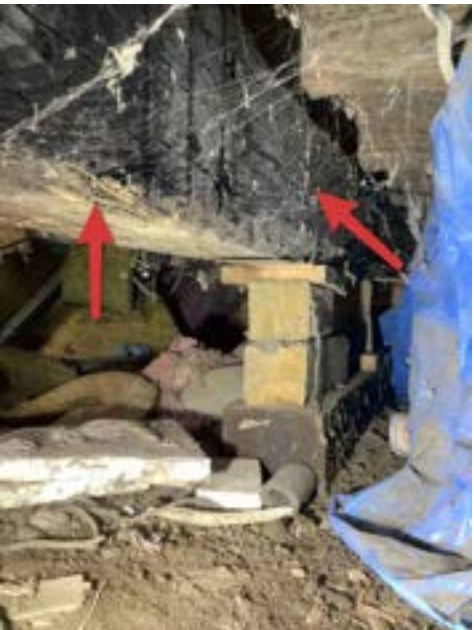
Sub-Floor Structure Wood Rot/Damage - Crawl Space (Representative Picture)

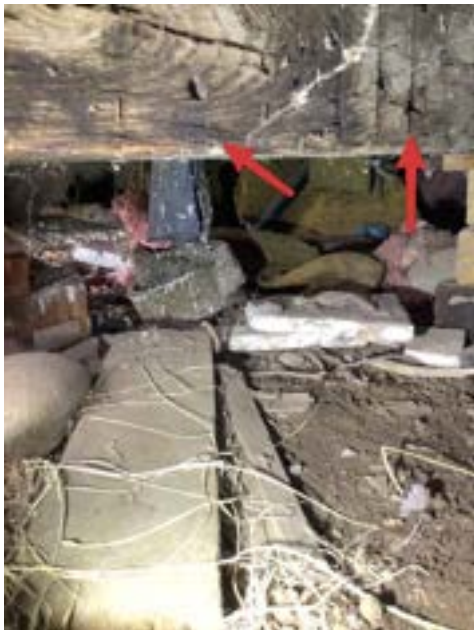
Sub-Floor Structure Wood Rot/Damage - Crawl Space (Representative Picture)

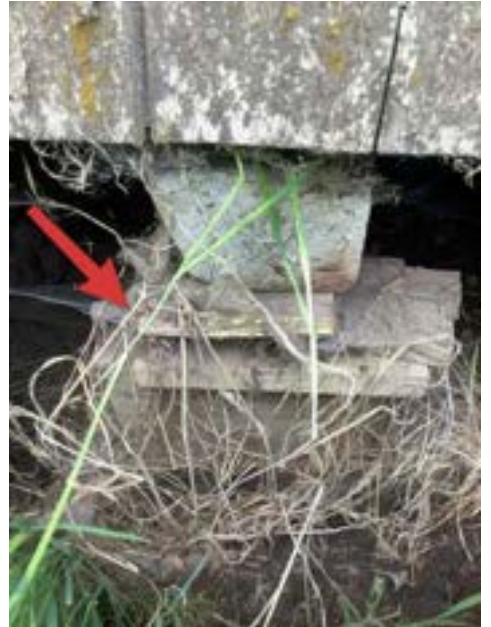
Floor Structure Improperly Braced - Crawl Space (Representative Picture)

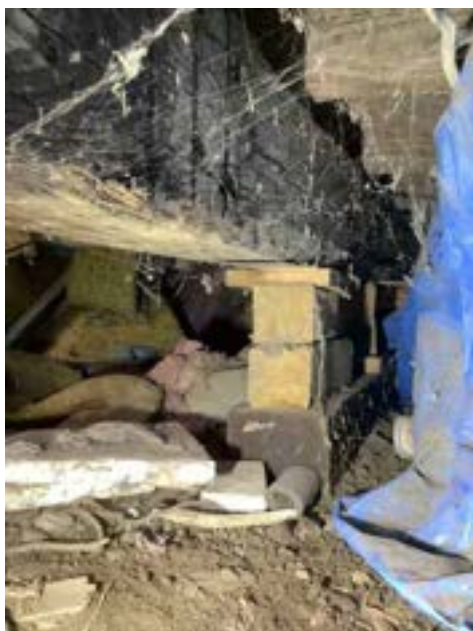
Due to the presence of obstructions and possible instability of the sub-floor structure within the crawl space the inspector was unable to evaluate the condition of the water supply distribution lines, determine if leaks are present, and/or inspect the associated systems and components.

Limitations/Obstructions - Crawl Space
(Representative Picture)

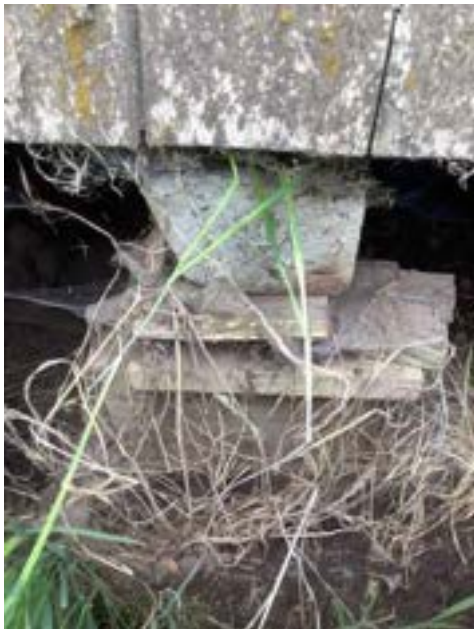
Additionally, due to the presence of obstructions and possible instability of the sub-floor structure within the crawl space the inspector was unable to evaluate the condition of the drain/waste piping, determine if leaks are present, and/or inspect the associated systems and components.

Limitations/Obstructions - Crawl Space
(Representative Picture)

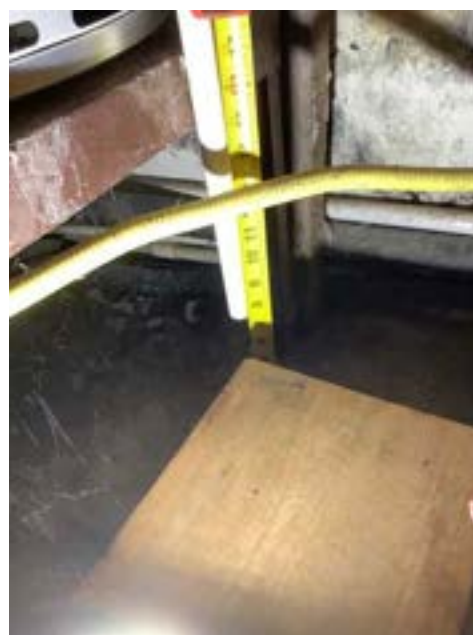
Incorrect Length of TPR Valve Piping - Utility Room (First Floor)

Contact a qualified plumbing contractor.

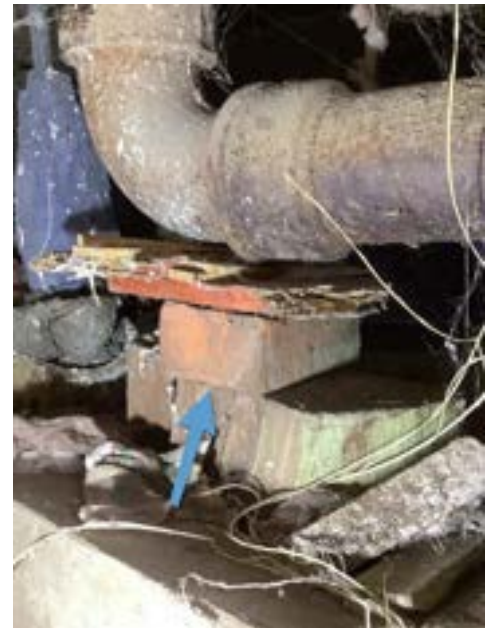
Improperly Supported Drain/Waste Piping - Crawl Space

Contact a qualified plumbing contractor.

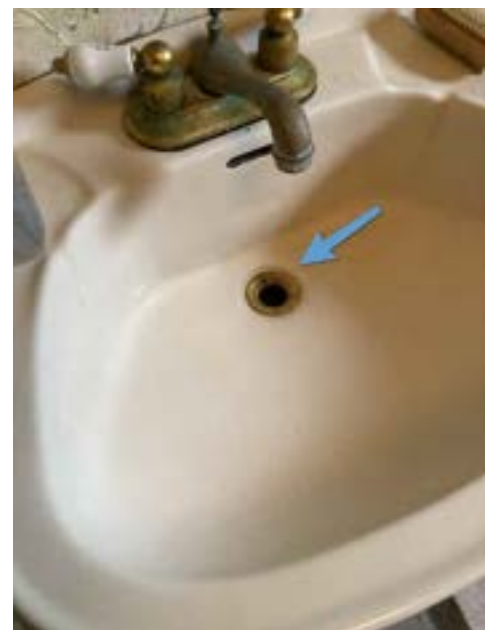
Drain Stop Missing - Full Bathroom (First Floor)

Contact a handyman or DIY project

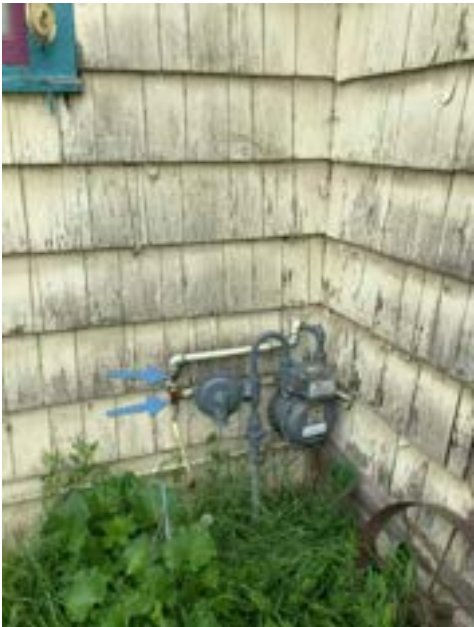
The gas supply line from the meter into the home show signs of corrosion. Over time and with continued exposure to the elements, the corrosion could become more extensive and cause deterioration of the line, resulting in a potential gas leak if left unaddressed. We recommend a qualified individual remove the rust from the line, and the line be repainted to protect against the exterior elements.

Corroded Gas Supply Line - Side B

Recommendation
Contact a qualified professional.

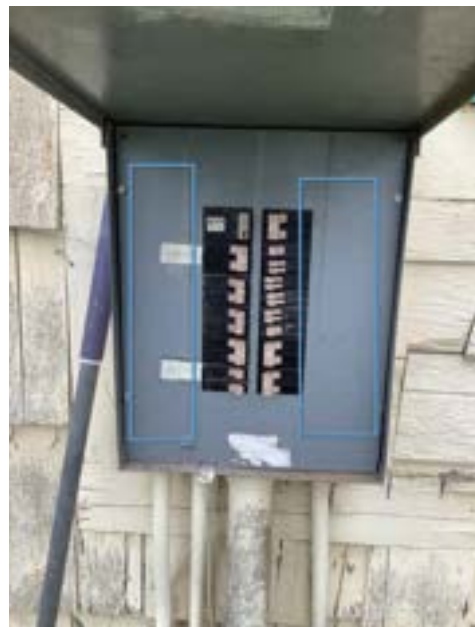
Insufficient Labeling of Electrical Panel - Side B

Contact a qualified electrical contractor.

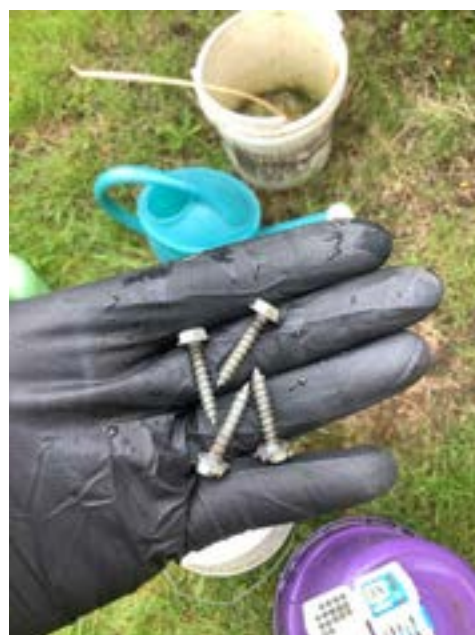
Incorrect Type of Panel Cover Fasteners - Side B

Contact a qualified professional.

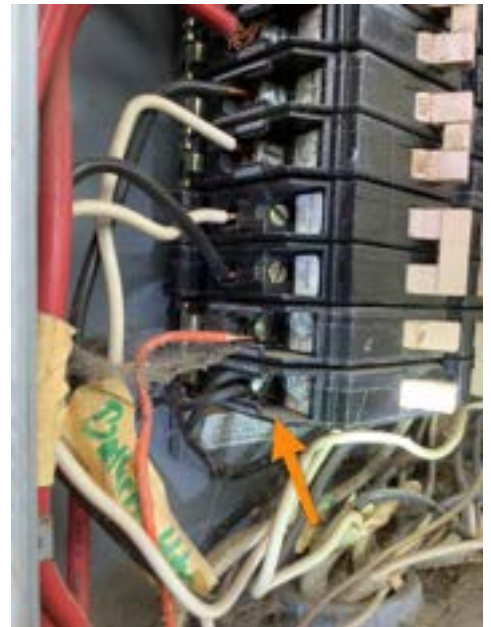
Breaker #23 Incorrectly Wired - Side B

Contact a qualified electrical contractor.

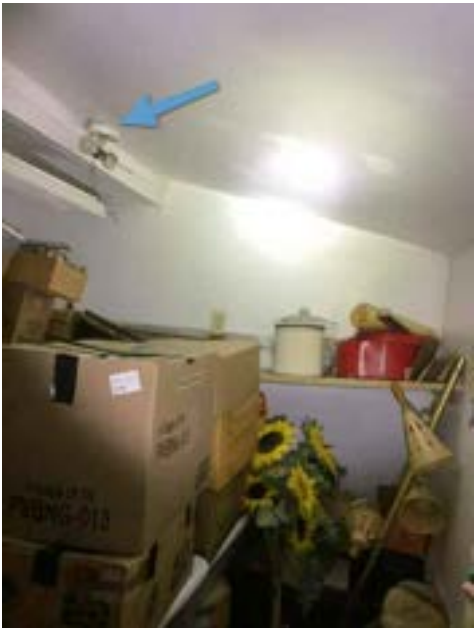
The cover is missing around the light fixture in the storage room within the garage, which could result in damage to the bulbs and/or fixture. A protective cover acts as a barrier from moisture, pests, dust/dirt, etc., and guards the bulbs to prevent breakage/damage. We recommend a knowledgeable/skilled individual install a protective cover around the bulbs.

Light Fixture Cover Missing - Garage

Recommendation
Contact a handyman or DIY project

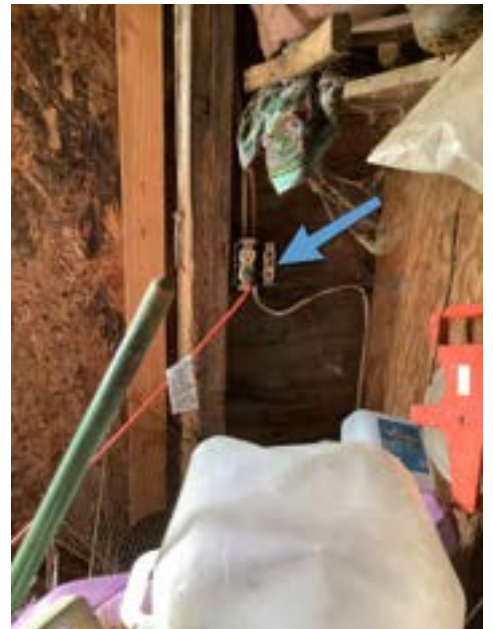
Outlet Cover Plate Missing - Garage

Contact a handyman or DIY project

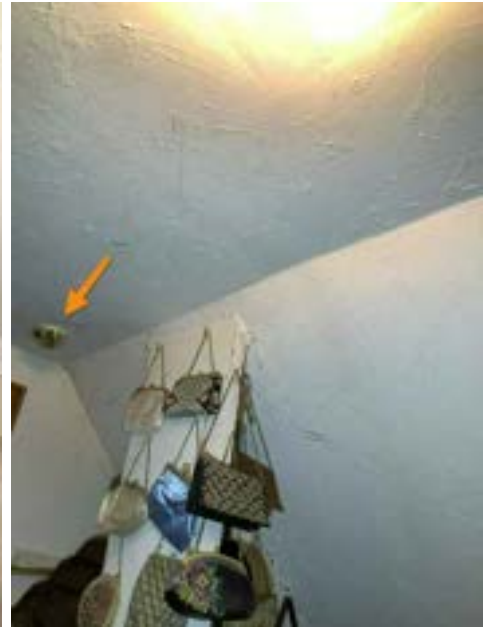
Smoke Detector(s) Damaged (Representative Picture)

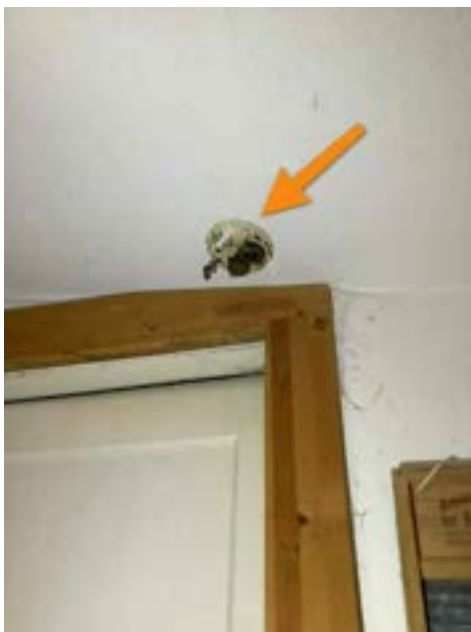
Smoke Detector(s) Damaged (Representative Picture)

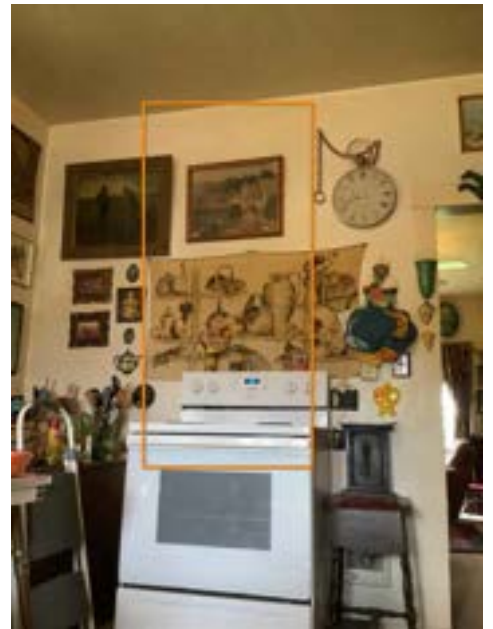
Range/Oven Exhaust System Not Present - Kitchen (First Floor)

Contact a qualified HVAC professional.

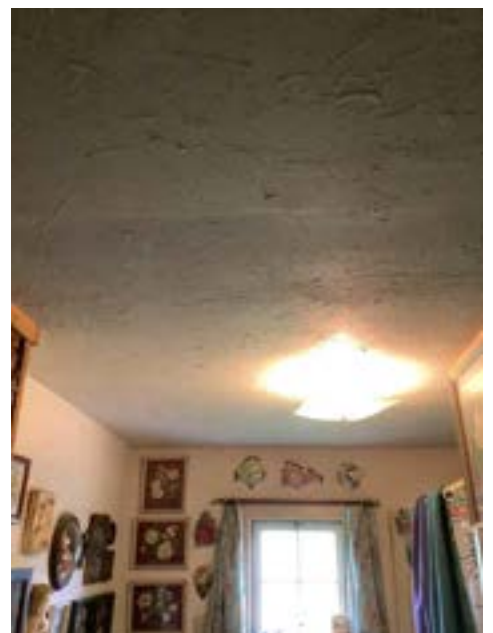
Exhaust System Not Present - Full Bathroom (First Floor)

Contact a qualified general contractor.

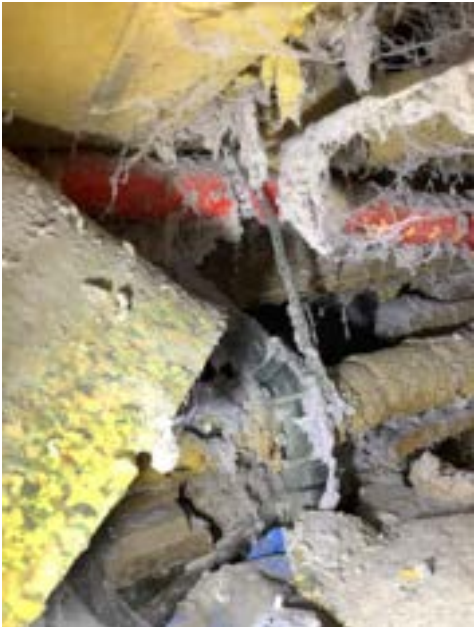
The dryer exhaust is currently venting into the crawl space, near the back side of the home, which can allow for moisture accumulation and possibly create an environment suitable for the development of microbial growth, such as mold. We recommend a licensed contractor evaluate and correct as needed to ensure the dryer exhaust is properly terminating and venting to the exterior of the home.

Dryer Exhaust Improperly Venting - Crawl Space

Recommendation
Contact a qualified general contractor.

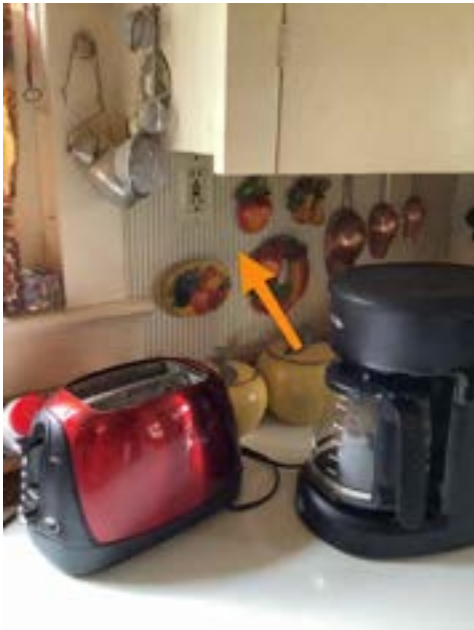
Wallpaper is present in the first floor kitchen. The presence of wallpaper/wall covering(s) prevents the inspector from fully observing/assessing the wall surfaces for possible moisture damage and or cracks within the structure. We recommend either thermal imaging or removal of the wallpaper/wall covering(s), and a re-inspection of the area to ensure no moisture damage is present.

Limitations/Obstructions - Kitchen
(First Floor)

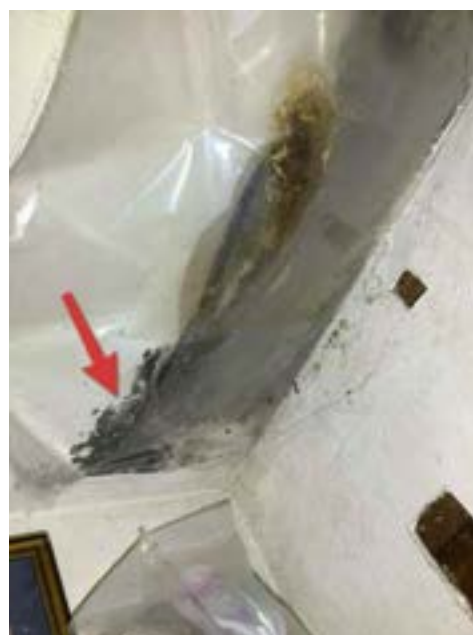
Signs of Possible Microbial Growth - Bedroom (First Floor - On Right)

Contact a qualified mold remediation contractor

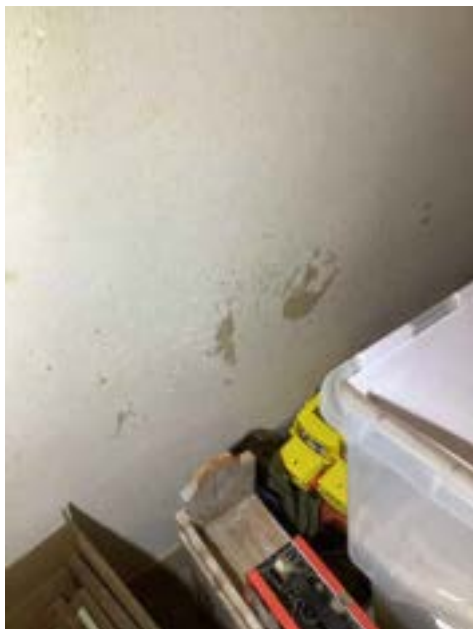
Wall Surface Damage (Representative Picture)

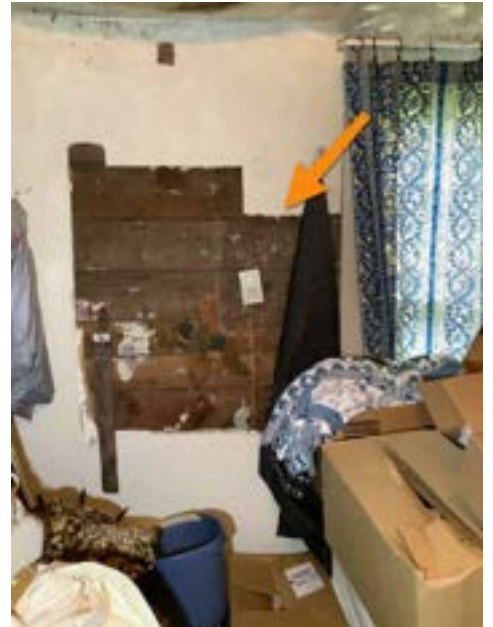
Section of Drywall Missing - Bedroom
(First Floor - On Right)

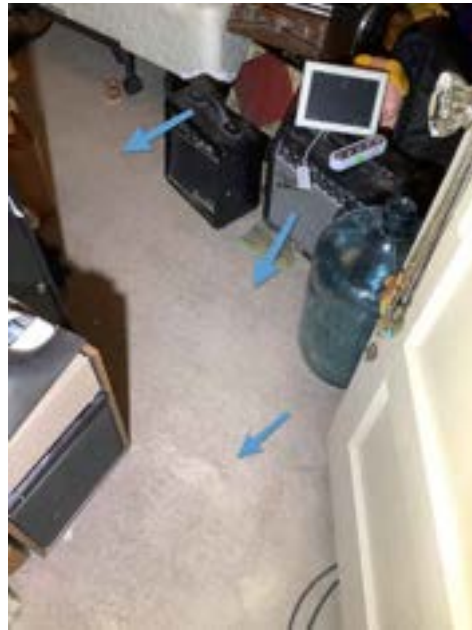
Loose Carpet (Representative Picture)

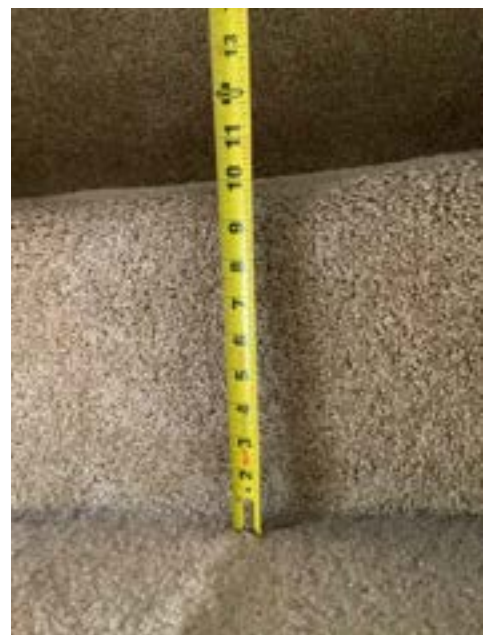
Step Riser(s) Exceed Recommended Height - Stairway (First Floor to Second Floor) (Representative Picture)

Contact a qualified general contractor.

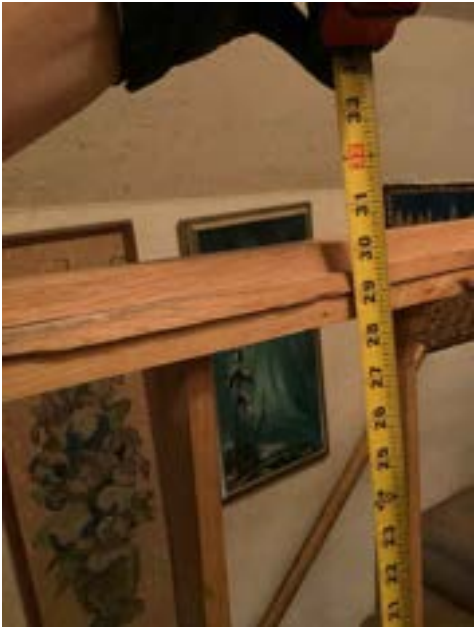
The height of the guardrail along the second floor hallway is insufficient, measuring roughly 30.5 inches. Though this is common for homes of this age, it is recommended that the guardrail height be between 36 to 40 inches tall for safety purposes. Railings provide stability and they also provide a safety function protecting occupants from falling down stairway openings. We recommend a licensed contractor assess and correct/repair as needed.

Insufficient Height of Guardrail -
Hallway (Second Floor)

Recommendation
Contact a qualified general contractor.

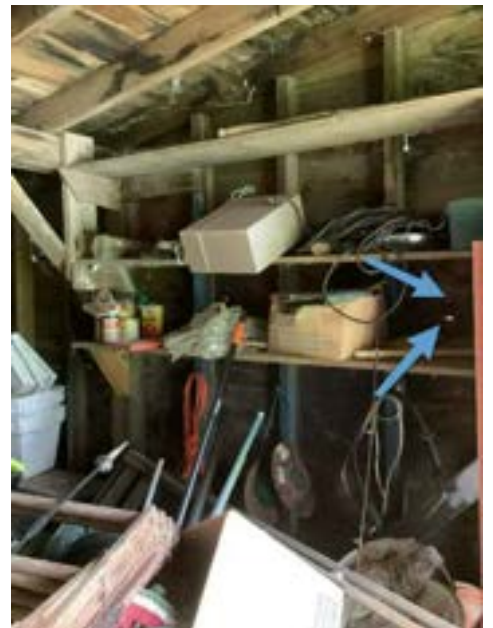
Wall Penetrations - Garage
(Representative Picture)

Contact a handyman or DIY project

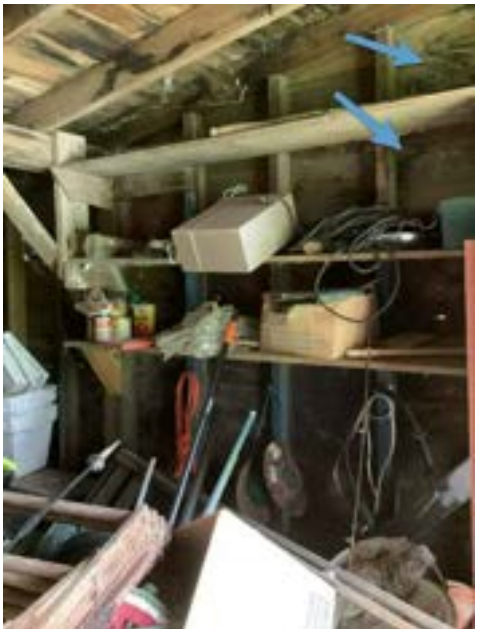
Staining/discoloration was observed on the garage walls in multiple areas throughout; please note, due to limitations present preventing access to the complete garage the inspector was unable to obtain moisture readings in these areas. We recommend further evaluation by a licensed contractor.

Wall Surface Staining/Discoloration - Garage (Representative Picture)

Recommendation
Contact a qualified general contractor.

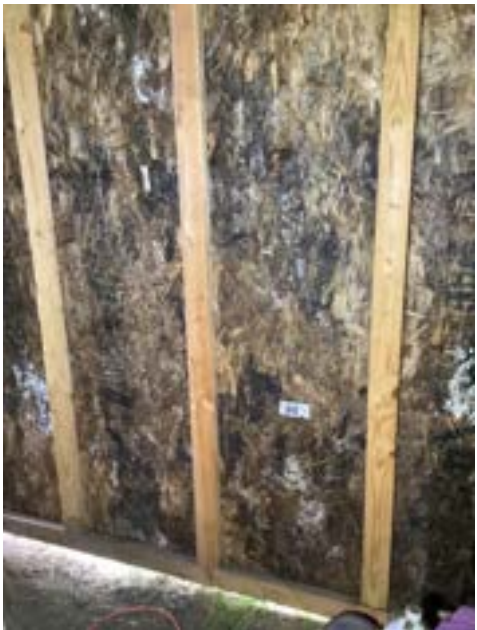
Garage Door Wood Rot - Side B (Representative Picture)

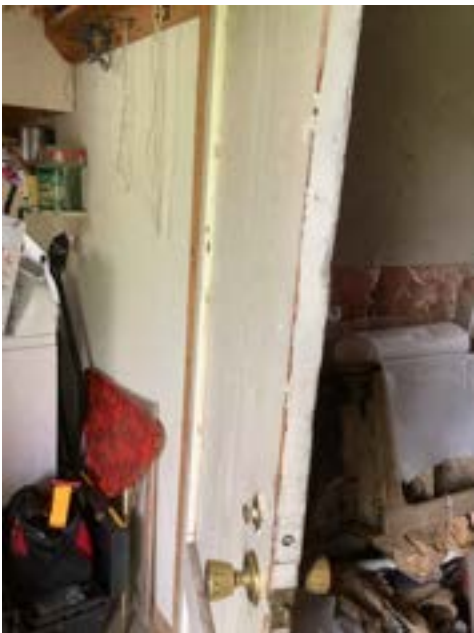
The door from the garage into the home (occupant door) does not meet recommended separation requirements. Doors in firewalls must be at least 1 3/8-inch thick, metal/steel, or a 20-minute fire-rated door, with no penetrations. Should a fire occur within the garage, the occupant door serves as a protective barrier allowing the occupants in the home time to safely exit the structure, while limiting the spread of a fire. We recommend a knowledgeable/skilled individual replace the door with the appropriate fire rated occupant door.

Door Does Not Meet Separation Requirements - Garage

Recommendation
Contact a handyman or DIY project

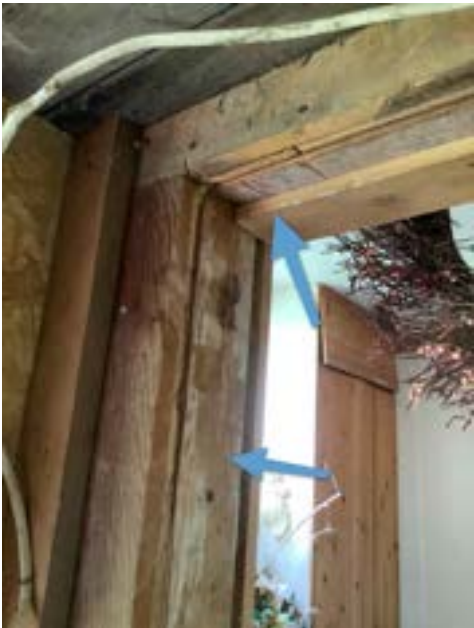
Weather-Stripping Not Present - Garage

Recommendation
Contact a handyman or DIY project

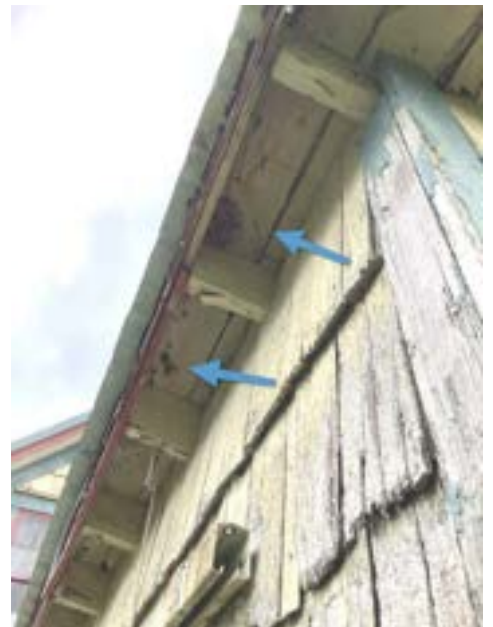
Signs of Wasp Activity (Representative
Picture)

Contact a qualified pest control specialist.

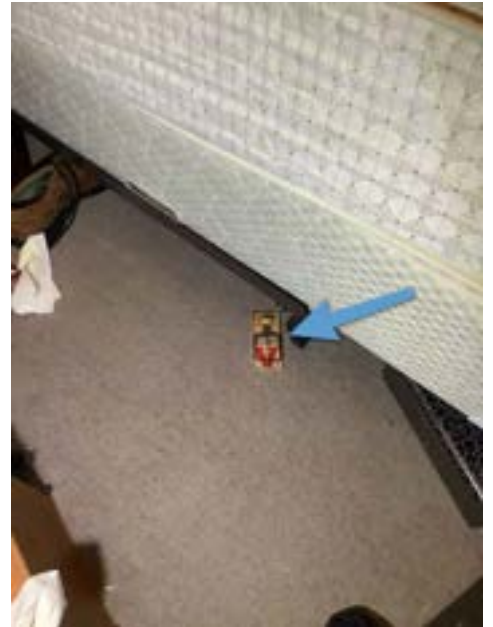
Rodent Mitigation - Bedroom (First Floor - On Right)

Contact a qualified pest control specialist.
