## TPI HOME INSPECTION REPORT

6139 SH 30 Anderson TX 77830

## PROPERTY INSPECTION REPORT

Concerning: 6139 SH 30, Anderson TX 77830

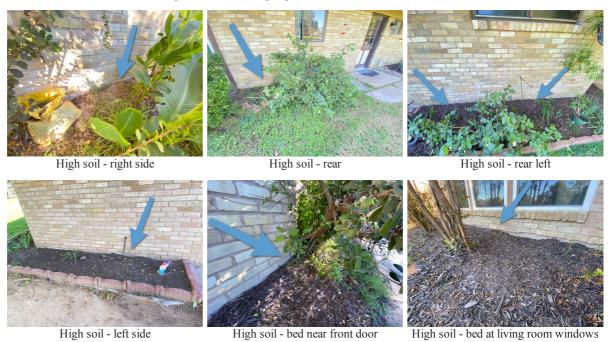
1: Soil level too high at exterior walls Deficient - Maintenance Item

Lower soil to provide adequate clearance from all wall coverings. At least of 4 inches of clearance between soil and siding or masonry wall covering can help prevent water penetration and termite infestation.

Recommendation: Contact a qualified landscaping contractor

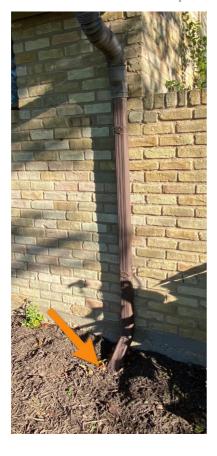
Gutter downspouts should be undamaged and installed so that they direct runoff away from the structure.

Gutter downspout slightly bent, in contact with soil

Recommendation: Contact a qualified gutter contractor

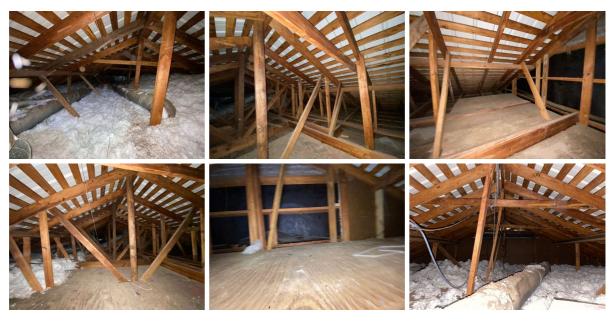
Observations: Floored storage area

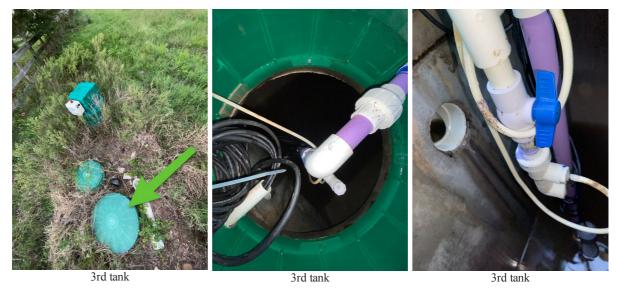
Third Tank: Size Undetermined, Concrete

Primary Treatment Observations: Lids Appear Water Tight, Lids Undamaged, Baffles Installed, Tanks Level -

Tanks appear to be level, no excess moisture or foul odors observed in soil adjacent to tanks. Baffles and clear effluent were observed in the 2nd treatment tank.
