**WESTERN WOOD**

February 27, 2015  
Walker Residence Bridge Inspection  
Fall Creek, Oregon  
WWSI# 157008

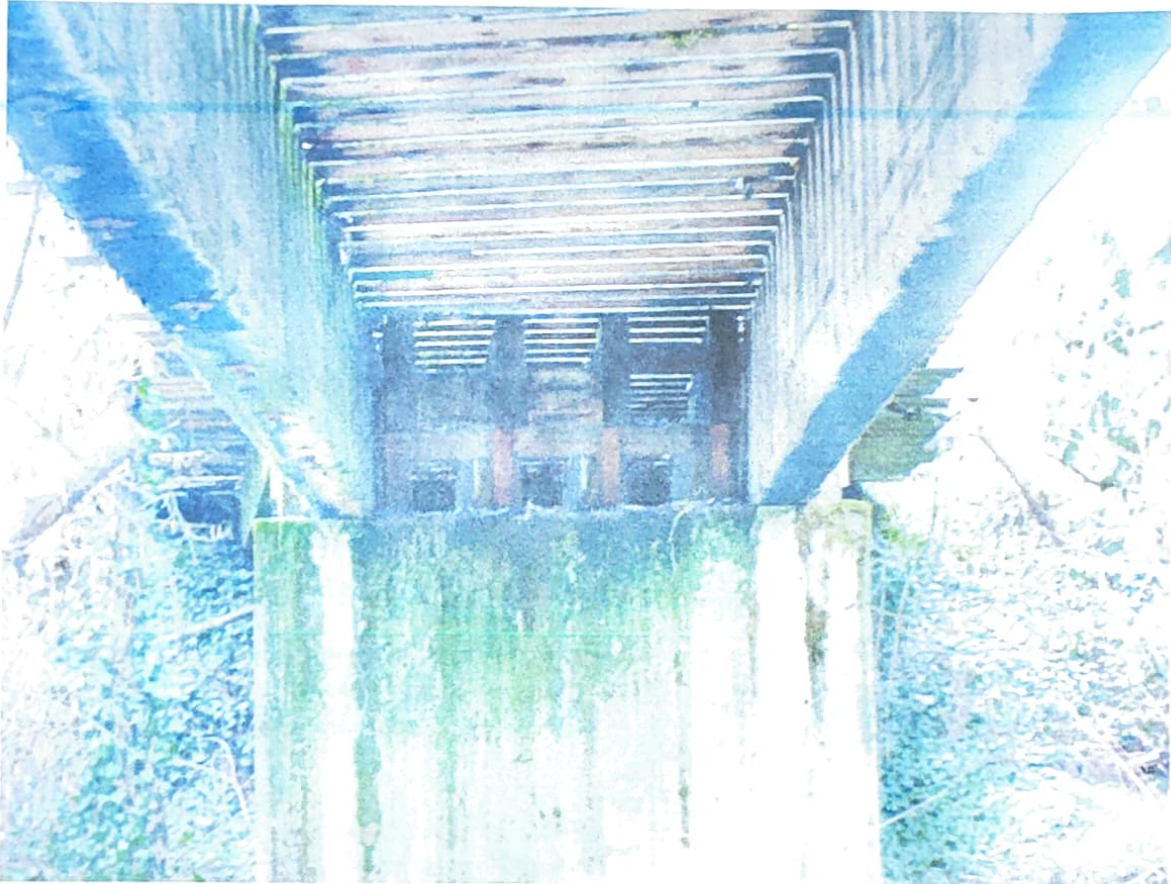
At the main span, the members do not show any signs of decay. The west stringer has a crack in it at about the mid height of the member. An attempt has been made to stitch the member back

together with bolts installed vertically and spaced about 4'-0" on center. These stitch bolts are located across the majority of the span. See photo 1. This bolt pattern is not sufficient to restore the stringer to its original capacity. This stringer has a noticeable sag to it. The sag can be seen by sighting along the soffit and from the top of the bridge. The sag is consistent with the reduced stiffness corresponding to two stringers each 19 1/2" deep. There is no intermediate lateral support for these members. Typically intermediate blocking or diaphragms are installed at 25'-0" on center.

Photo 1 = Stitch bolts on west main span stringer

A load rating analysis was performed for this bridge to determine the capacity of the bridge. This analysis determined that the capacity of the bridge is controlled by the damaged west stringer on the main span. The maximum two axle vehicle weight on this span is limited to 7 tons. The maximum axle weight is limited by the decking which is rated for 4 tons. The deck rating assumes that the vehicle is driven down the center of the bridge so the wheels travel almost directly over the stringers.

The crack in the west main stringer can be repaired by jacking the stringer back into the original position and installing shear dowels to repair the crack. A steel cable post-tensioning system can be designed and installed to restore the carrying capacity of the member. If this member were to

be repaired, the bridge would then be rated for 10 tons on a three axle vehicle such as a small dump truck. The limiting axle weight of 4 tons will still be in effect.

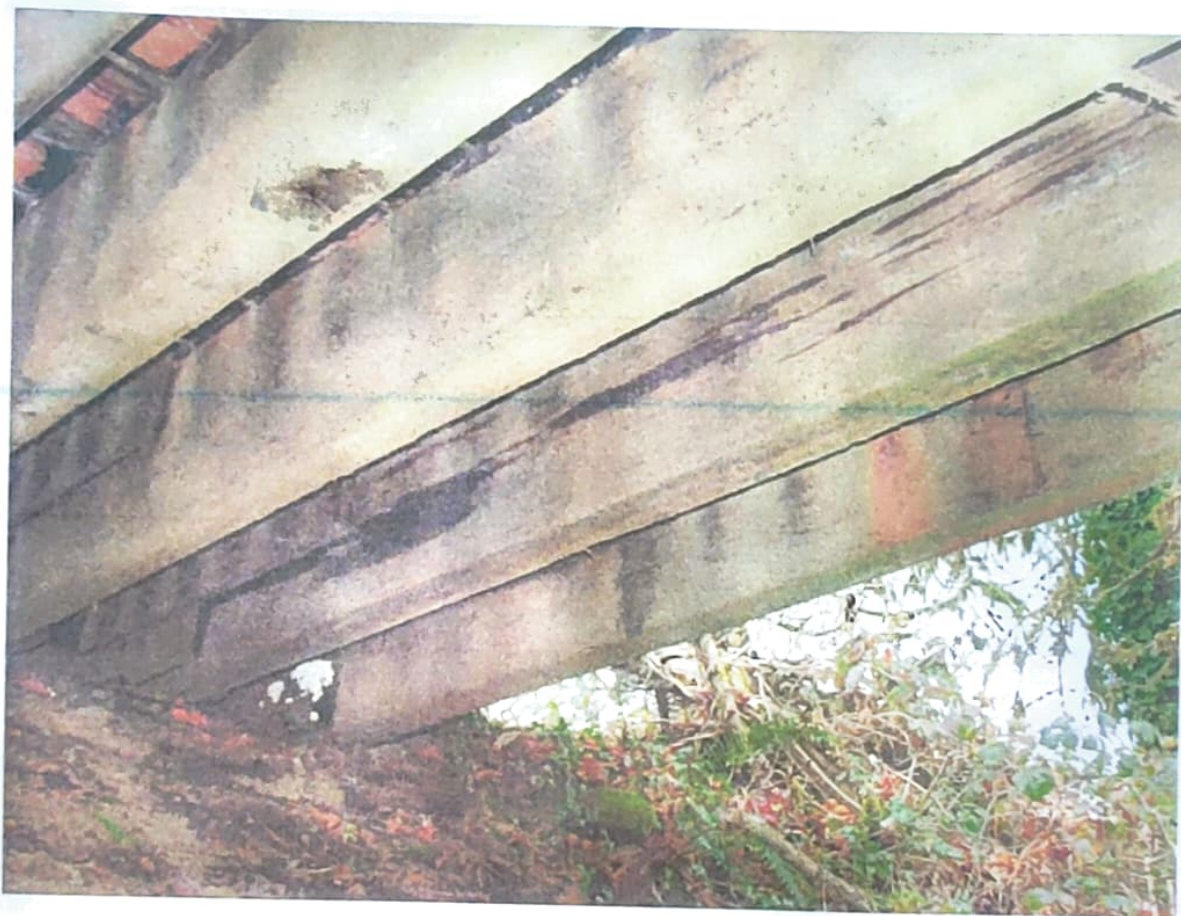
The stringers on the south side span have varying amounts of decay on the tops of the members. I was able to insert my awl about 2" deep in several places. The second stringer from the west side of the bridge has a significant amount of decay at the mid height of the member. This appears to start at the south end of the member and extend about 6 feet. Several of these members have side pieces bolts to the members. This is apparently an attempt to repair the bearing capacity of the members. See photo 2.

Photo 2. The second stringer from the right has an area of decayed wood where the wood is darker. This decay will continue to propagate. Not also the timber side members attached to the second and third stringer from the right.

The timber bridge at 39950 Little Fall Creek Rd. has several areas of degradation such as decay in several of the stringers on the south side span and a crack midheight in the west main span stringer. The decay in the south span stringers is not extensive and does not decrease the bridge rating at this point. However, the decay will propagate over time to the point where it affects the load capacity of the bridge. These stringers should be observed over time and replaced when noticeable deflections of the bridge deck become apparent. There is a significant amount of dirt and debris surrounding the side span stringers at each end of the bridge. I recommend that the ends of the bridge be excavated and pressure treated mudsills and backwalls be installed which will keep dirt and debris from collecting at the bearings.

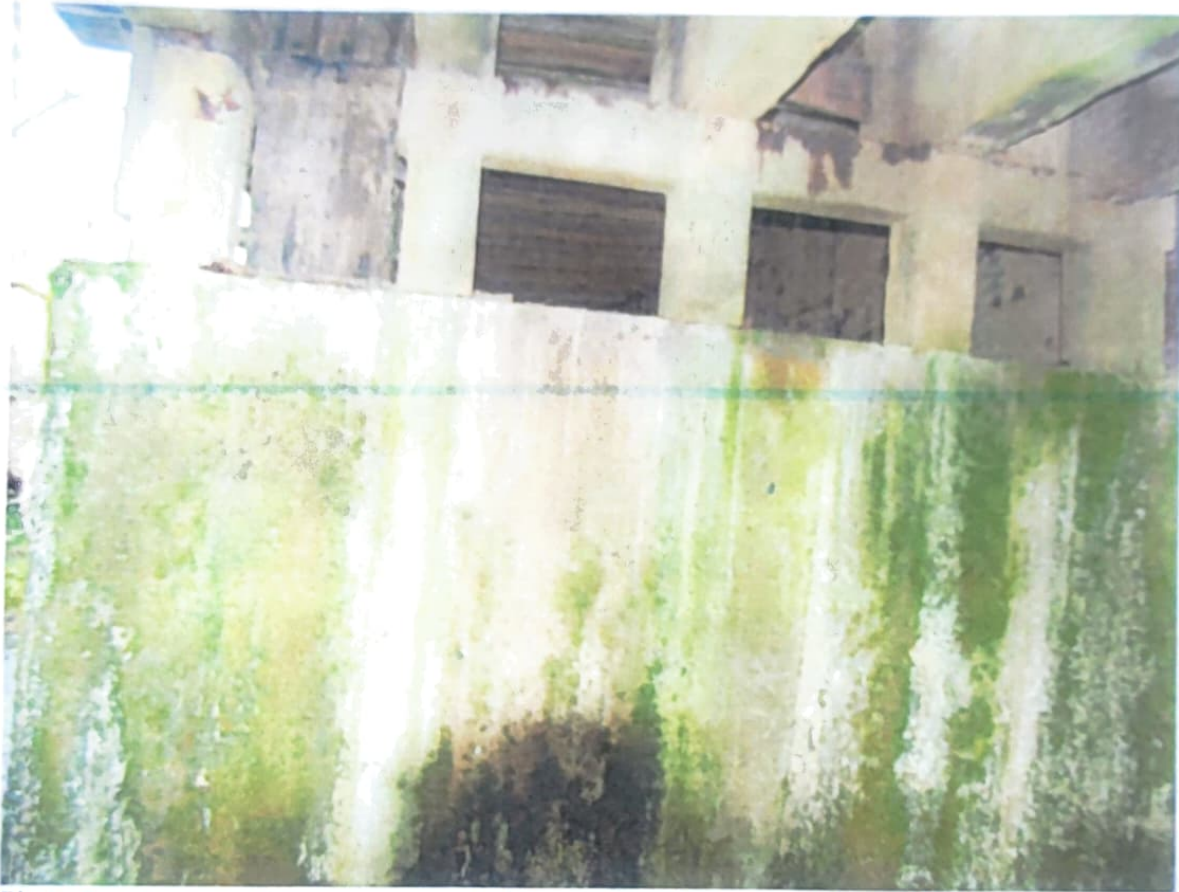
The two main span stringers bear directly on the concrete piers. There is a reinforcing steel bar located on each side of these stringers. The reinforcing bars provide some level of lateral support for the stringers. The stringers from the side spans are supported by a short timber bent made with 6x6s and by a timber block. This bearing conditions does not provide resistance to lateral loads due to wind or wind or seismic ground motion. See photo 3.

Photo 3. side span stringers are supported by small timber bent and timber blocks.

The timber bents between the main stringers at the piers could be made to provide lateral support by installing plywood on both sides. Solid blocking could be installed between the side span stringers to provide lateral support for these members at the bearing.
