Tri State Home Inspections

Home Inspection Report

431

Butterfly Ln

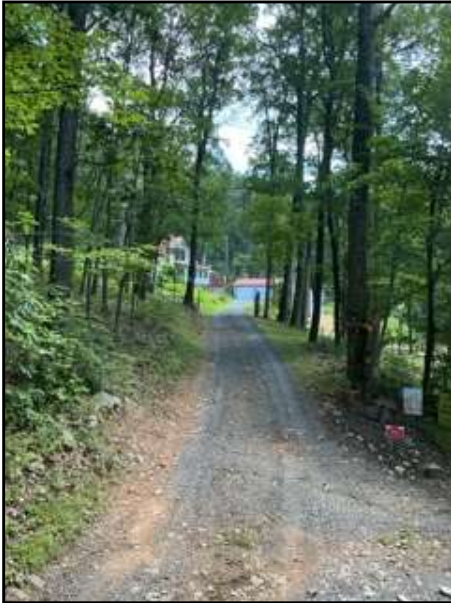
Figure 1-1

Comment 1:
The driveway is satisfactory .

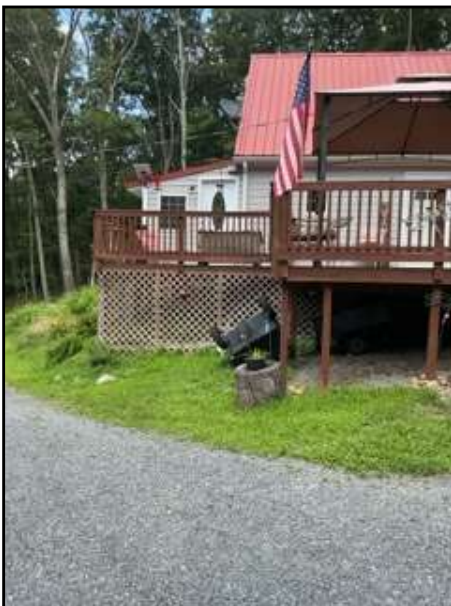
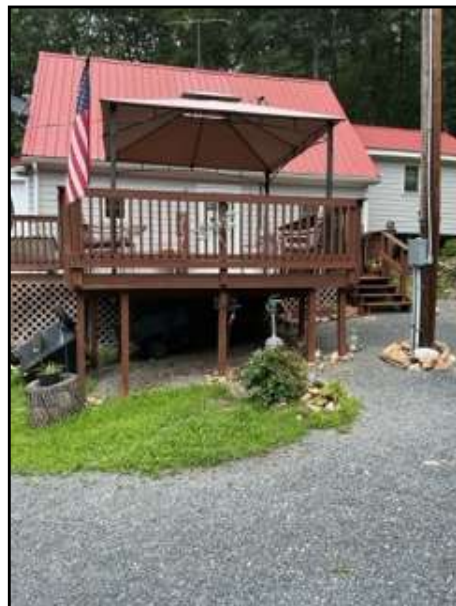
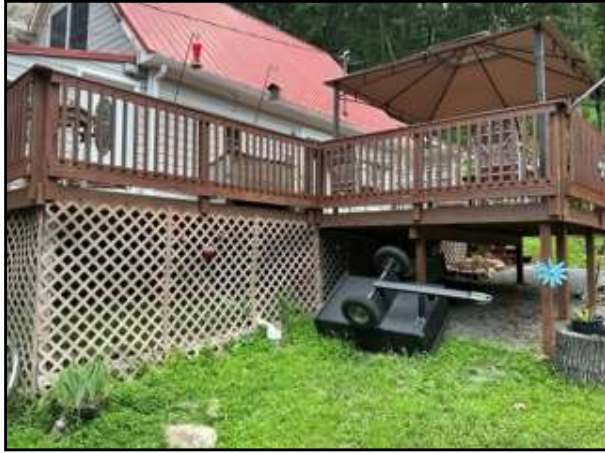
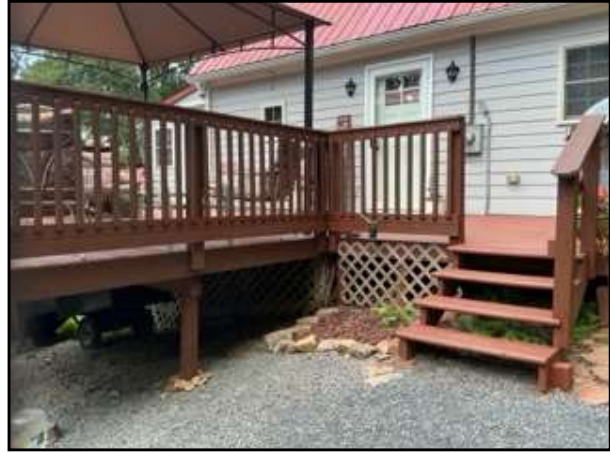
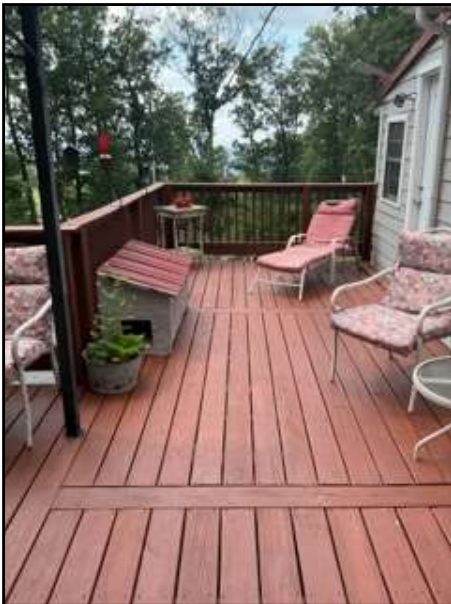
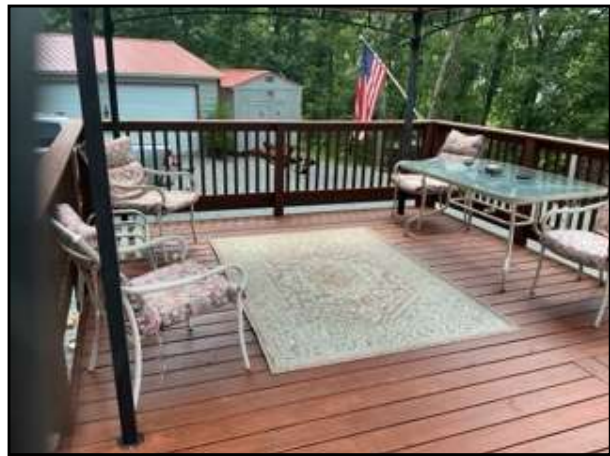
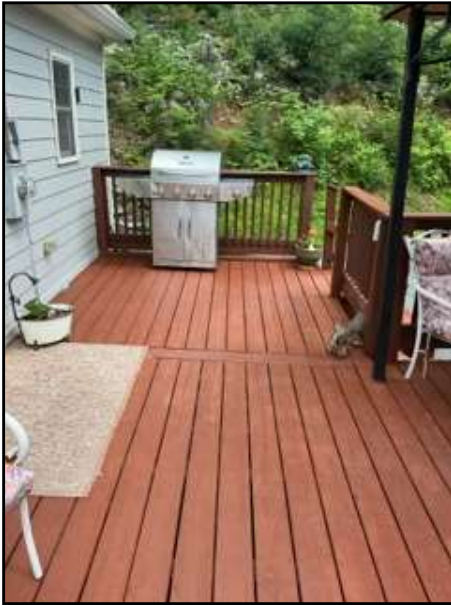
Comment 2:
The deck is satisfactory .

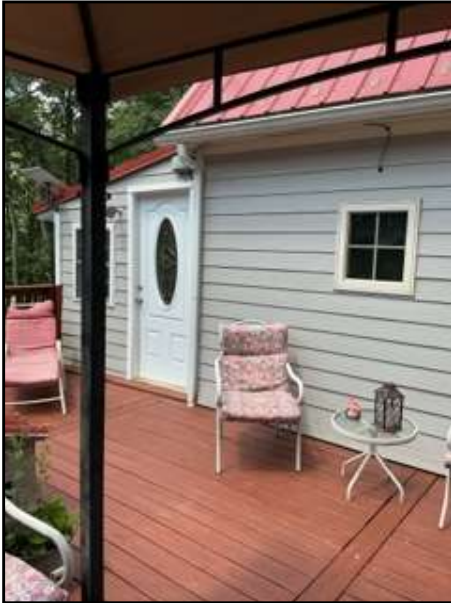
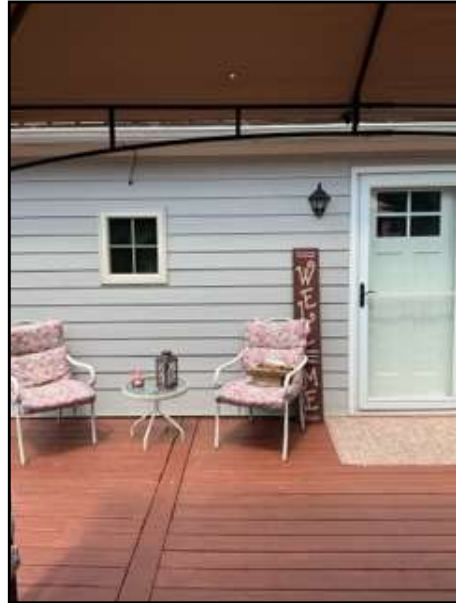
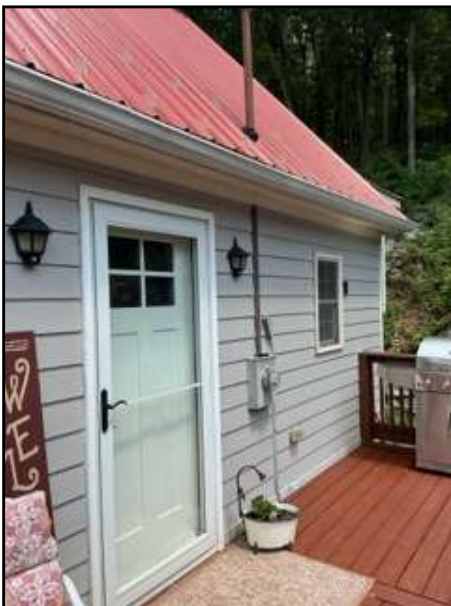
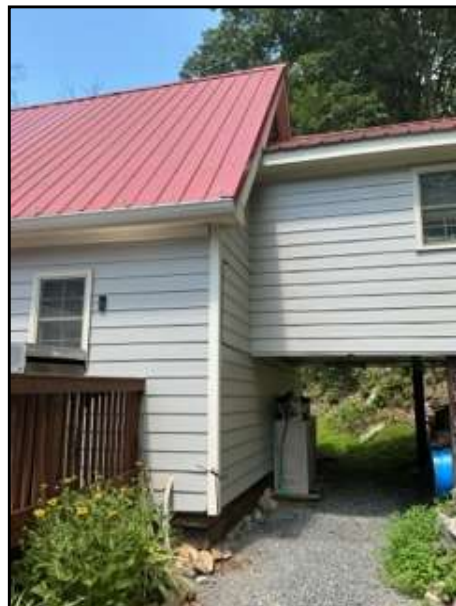
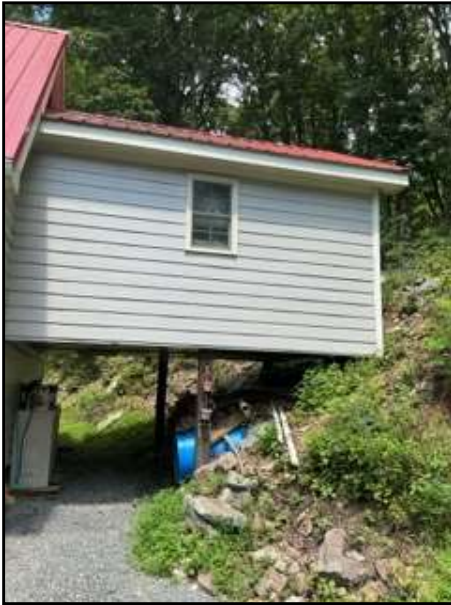
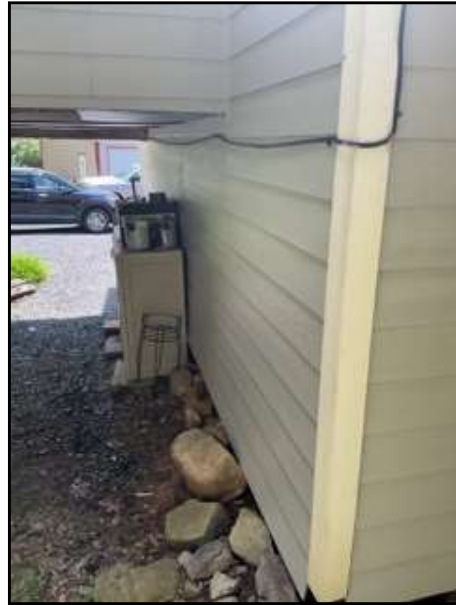
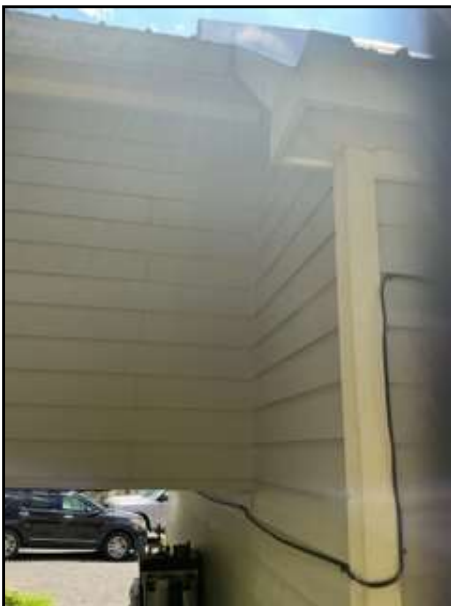
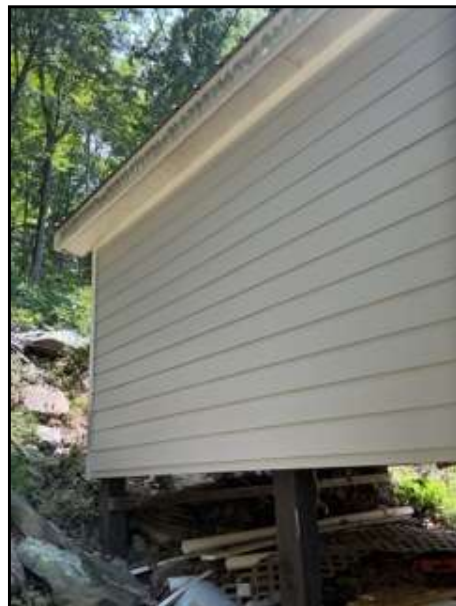
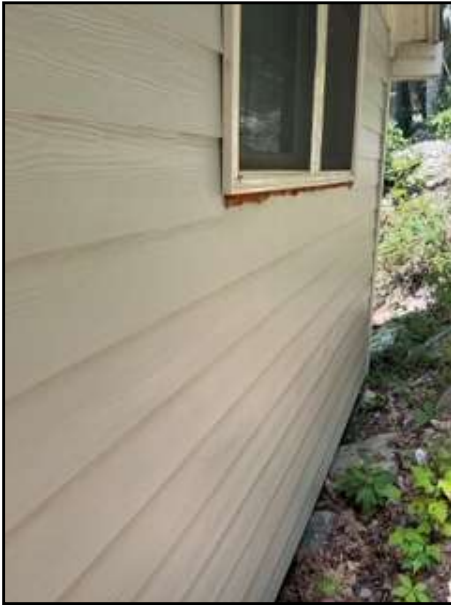
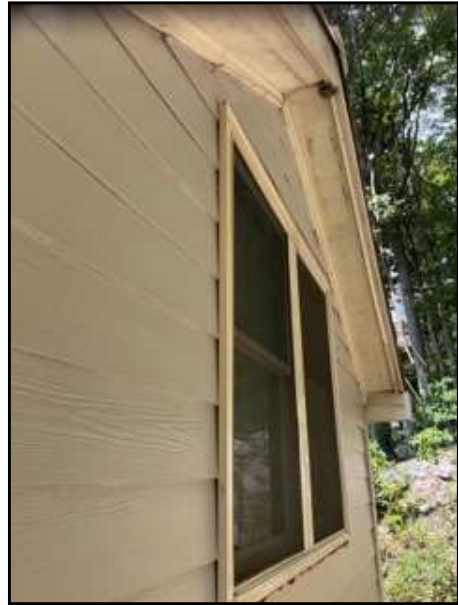
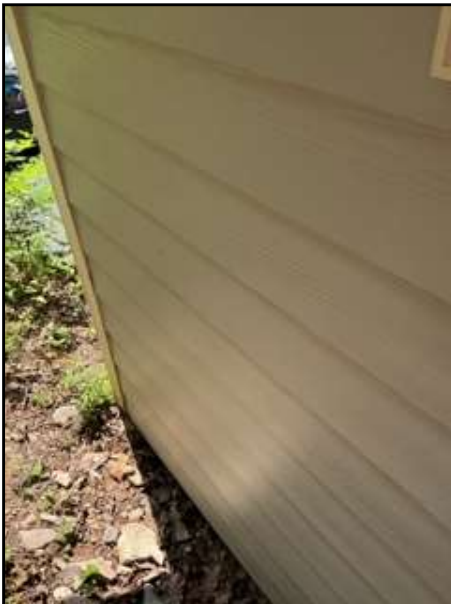
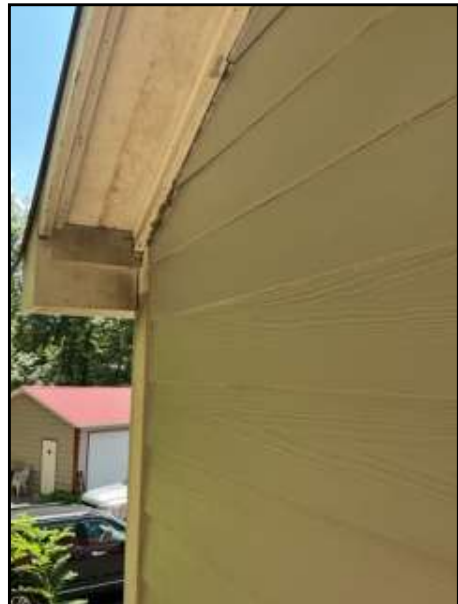
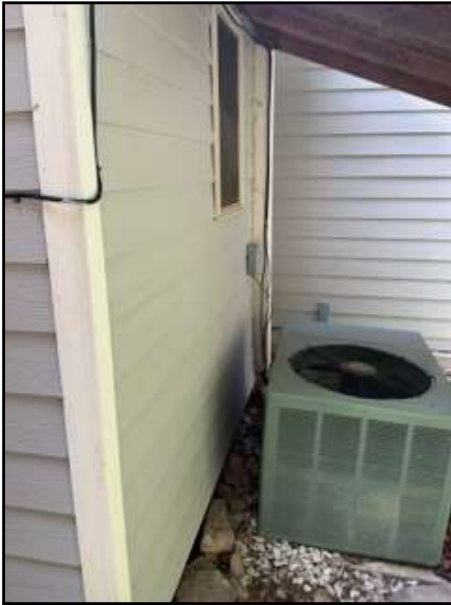
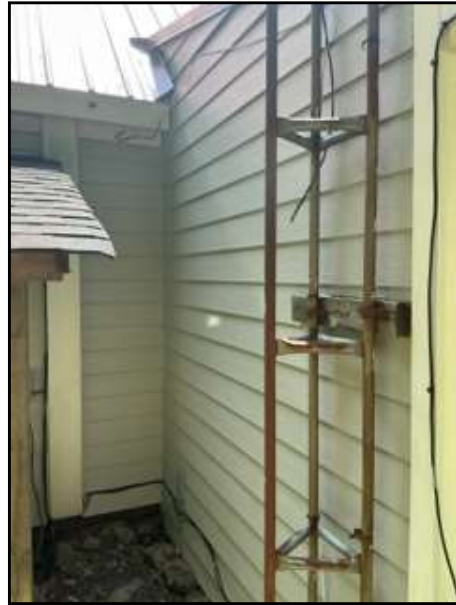
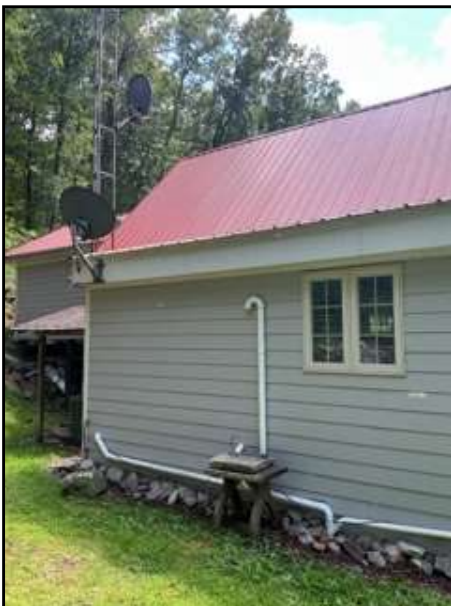
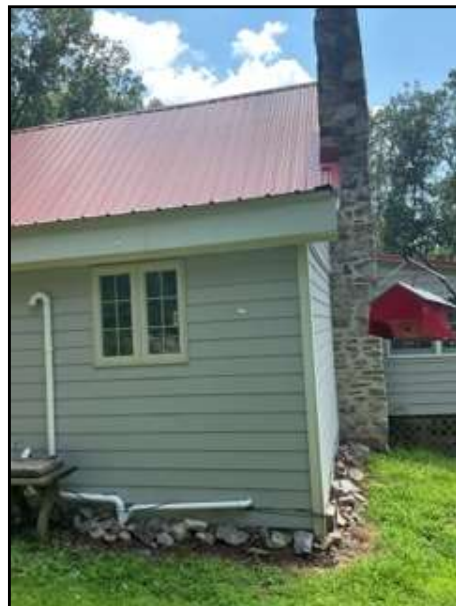
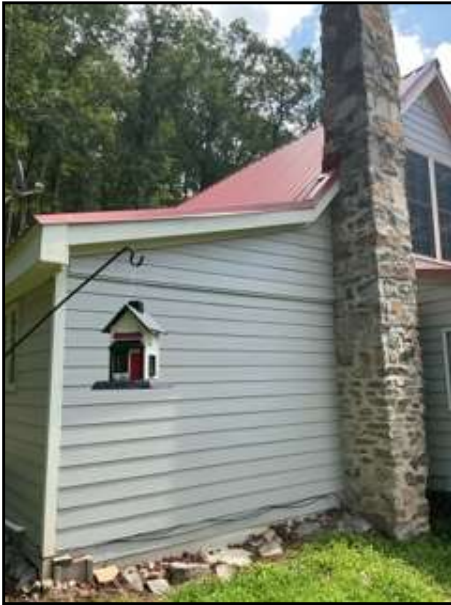
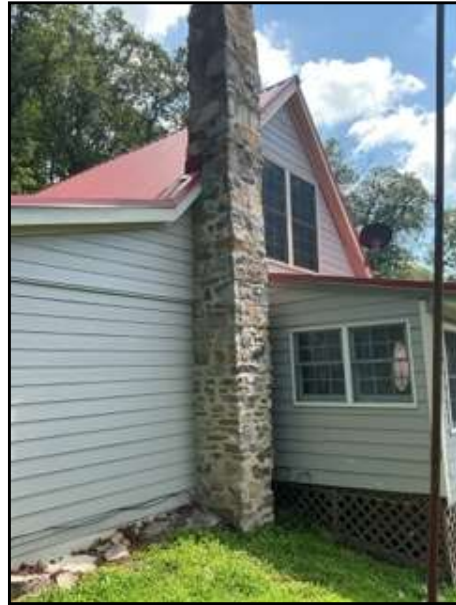
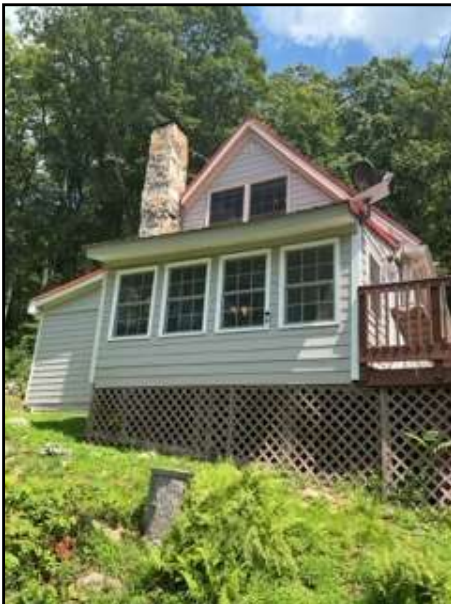
Comment 3:
The exterior siding is satisfactory .

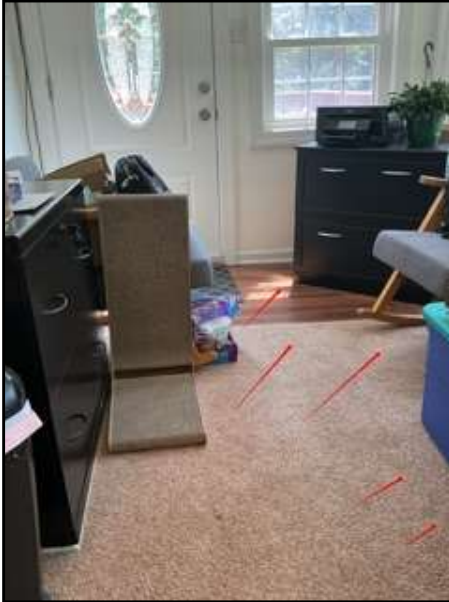
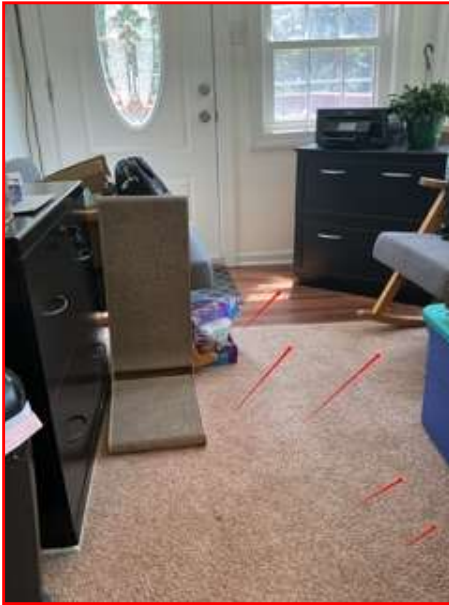
Figure 7-1

The floor in the edition does go down at an angle recommend further evaluation by a licensed professional for further assessment .

4) The floor in the edition does go down at an angle recommend further evaluation by a licensed professional for further assessment .

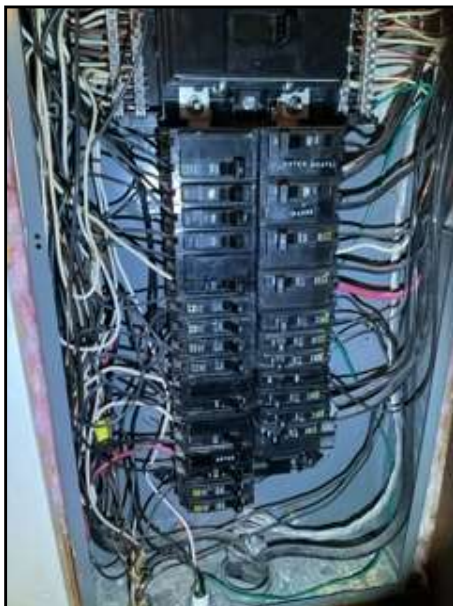
Figure 9-1

The service panel is satisfactory .

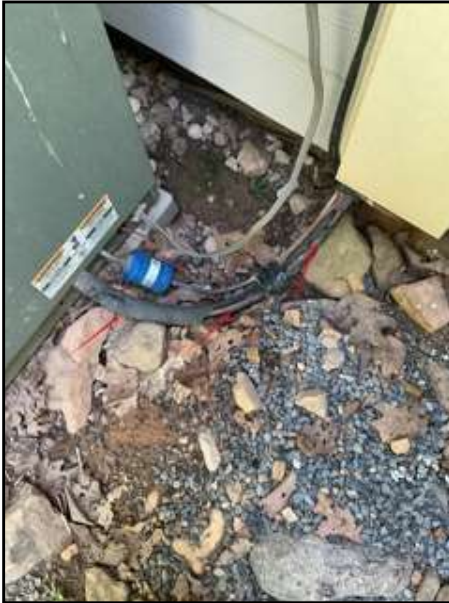
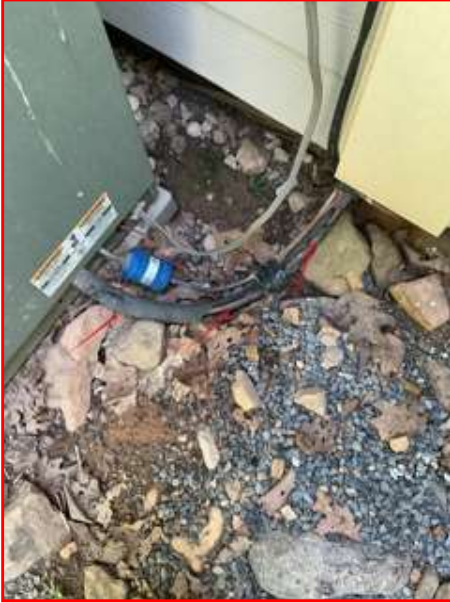
Figure 10-1

The insulation on the ac inlet line is in poor recommend replacing .

6) The insulation on the ac inlet line is in poor recommend replacing .

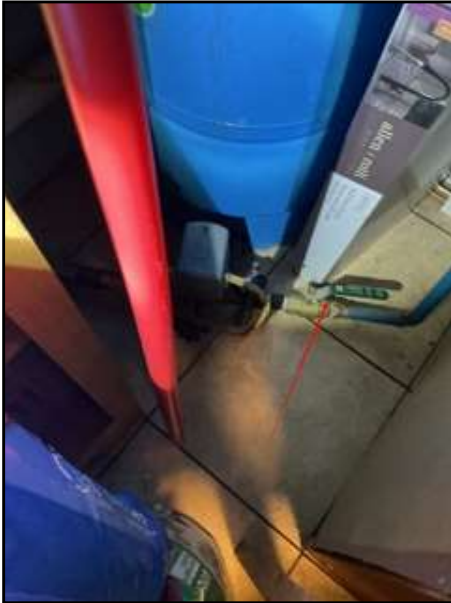
Figure 11-1

The main water shut off is located at the pressure tank .

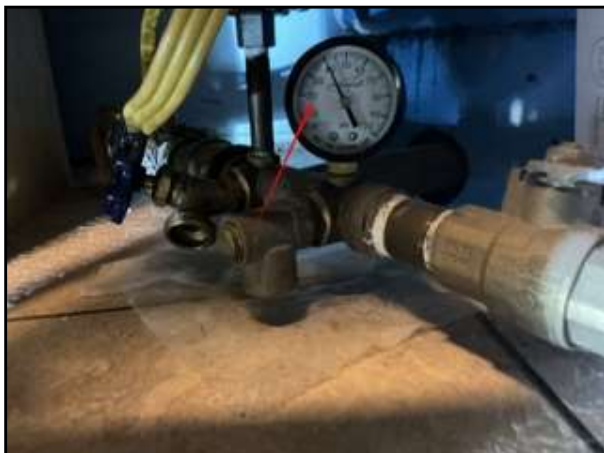
Figure 12-1

The water pressure at the gauge is around 40 psi .

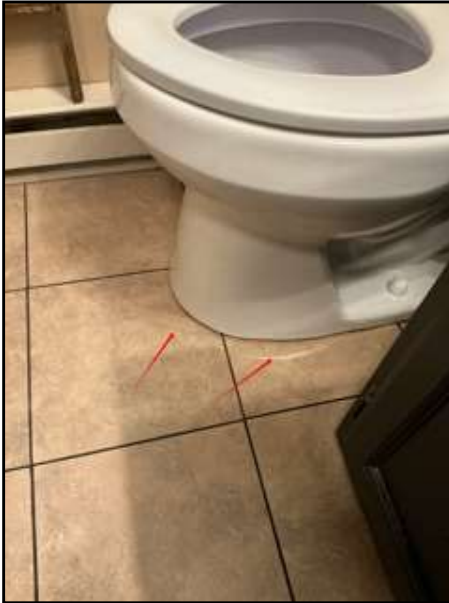
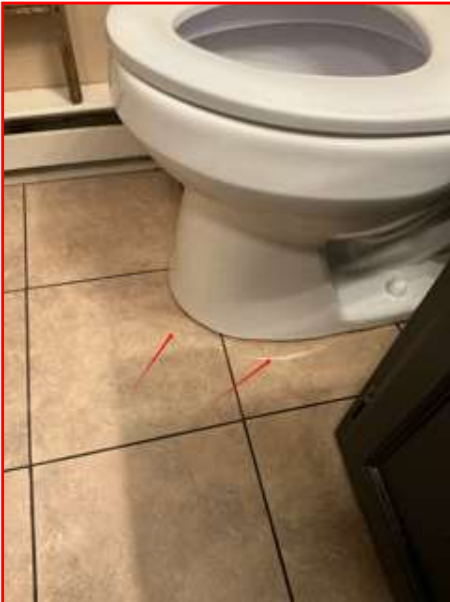
Figure 14-1

The toilet is loose recommend repair .

8) The toilet is loose recommend repair .

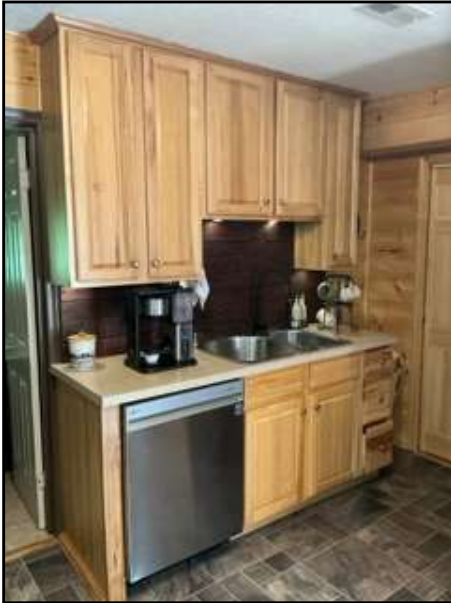
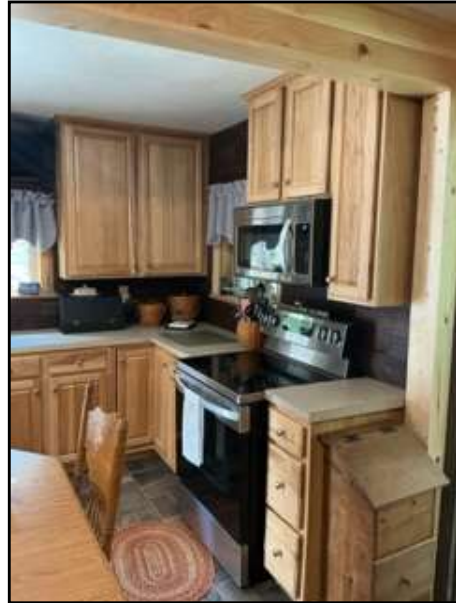
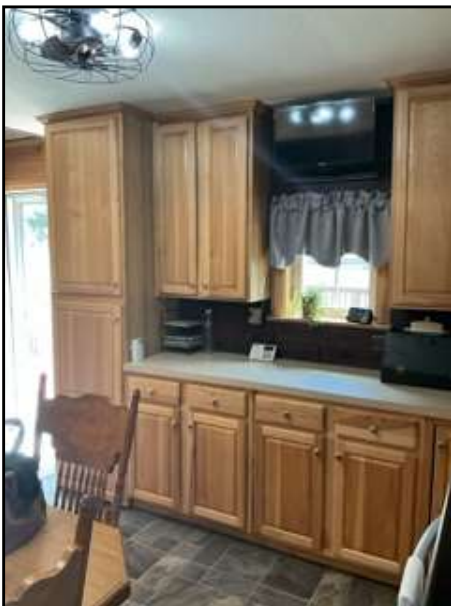
The kitchen cabinets and countertops are satisfactory .

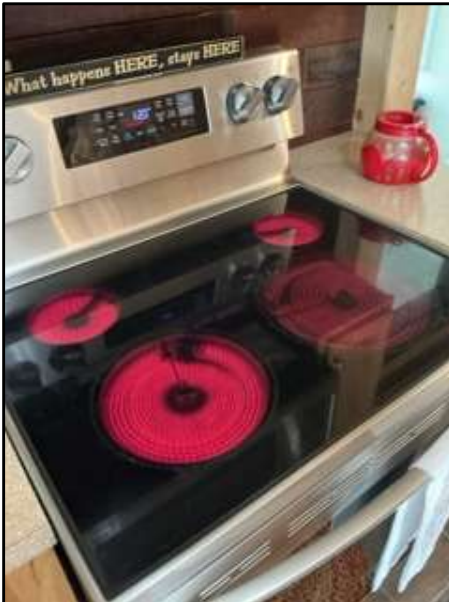
Figure 17-1

Comment 17:
The cooktop and the oven are satisfactory .

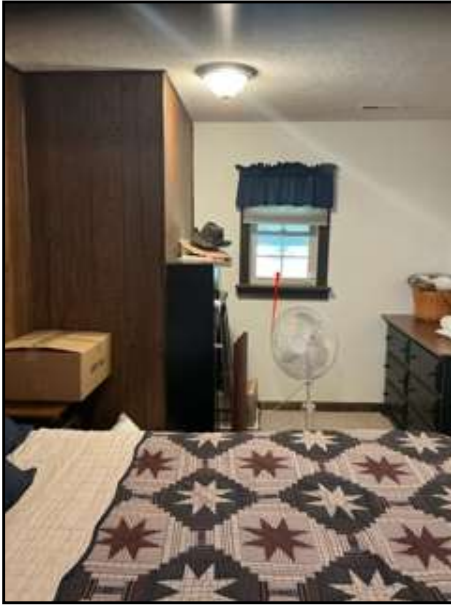
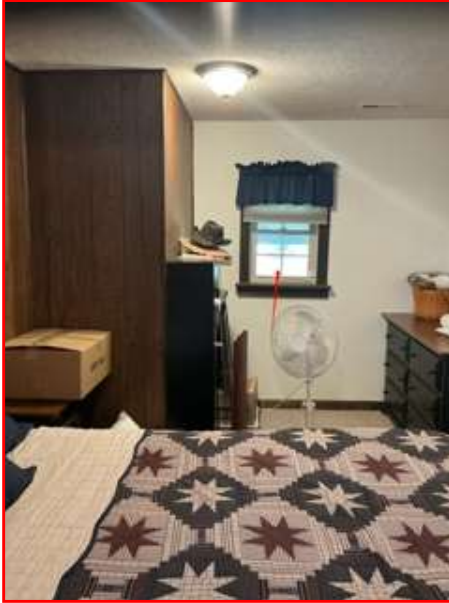
Figure 19-1

The rear master bedroom window will not stay up on its own recommend repair .

10) The rear master bedroom window will not stay up on its own recommend repair .

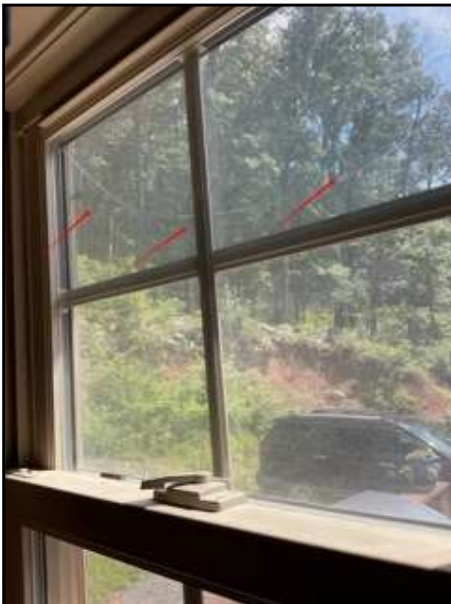
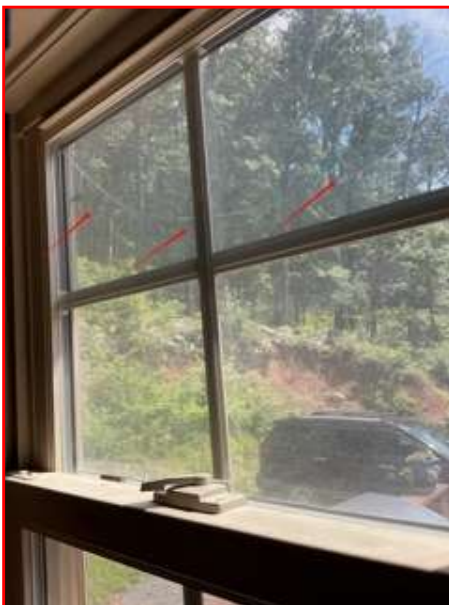
Figure 20-1

The front master bedroom window has a cracked window glass recommend replacing .

11) The front master bedroom window has a cracked window glass recommend replacing .
