# FOLLOW-UP INSPECTION REPAIR REPORT

7207 Laurel Canyon Rd  
07/15/2025

## HOME INSPECTION REPORT - FOLLOW UP 5/26/2025

7207 Laurel Canyon Rd  
Junction City, KS 66441

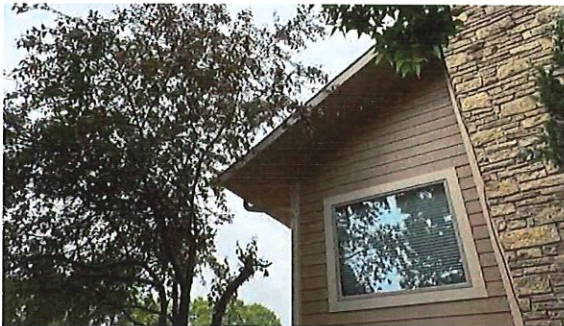
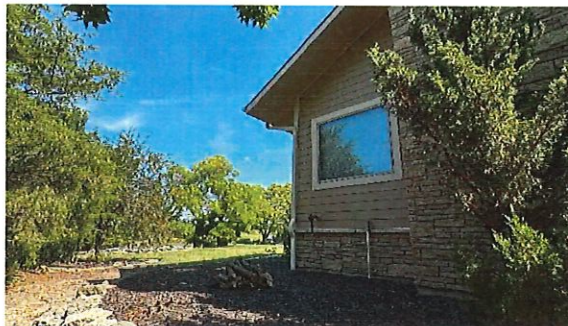
Location  
Exterior Southwest

## 2.7.1 - Grounds: Vegetation Trim Tree Branches

Tree has been removed so branches don't rub on the roof and cause damage when blown in the wind.

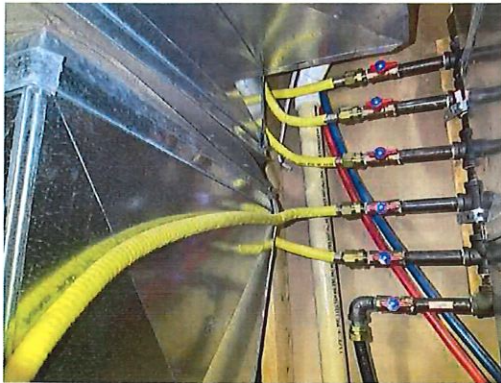
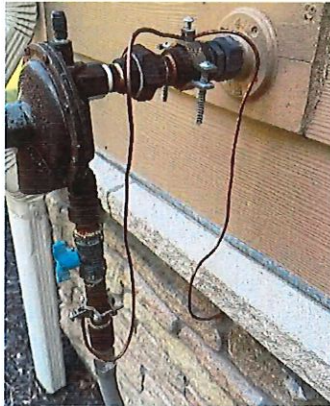
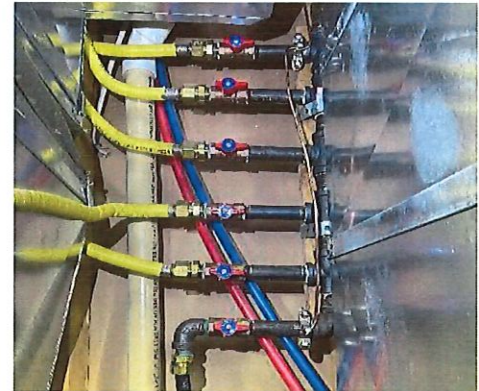
### 10.1.1 - Fuel Systems: Fuel Systems Yellow CSST

Manufacturers recommend direct bonding of gas piping systems incorporating standard (yellow) or uncoated corrugated stainless steel tubing (CSST) to reduce the risk of fire from lightning strikes. Gas line is now properly bonded and grounded.

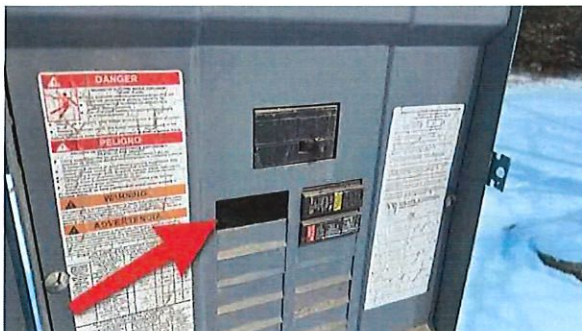
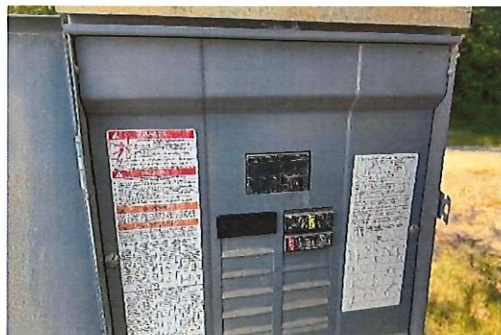
Exterior Service Entry Panel NW of boathouse

### 12.4.1 - Electrical: Exterior Service Panel Open Breaker Slots

Recommended cover has been installed over open breaker slot in electrical panel.

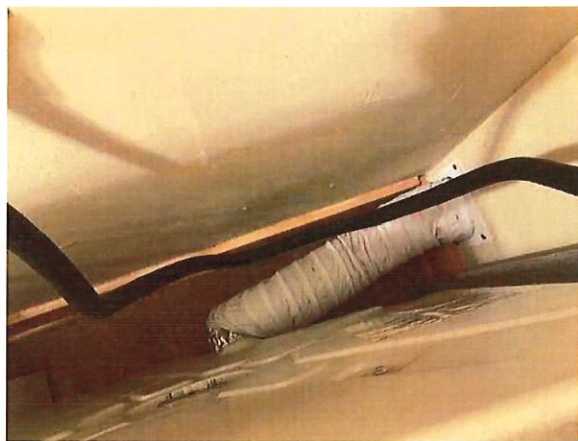
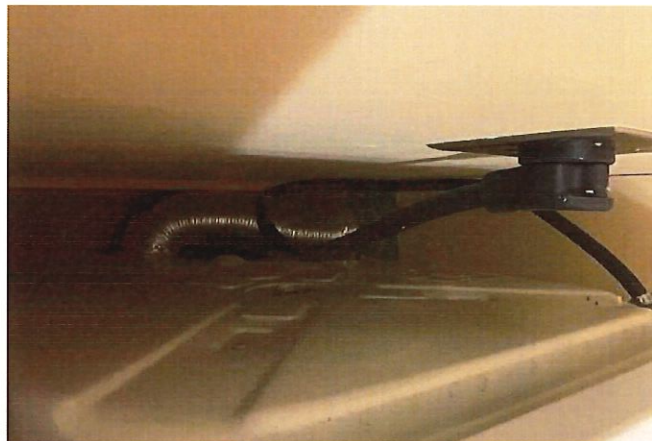
15.1.1 - Laundry Room: Laundry Room  
Plastic Dryer Vent

Metal duct has been installed to replace the plastic dryer vent.

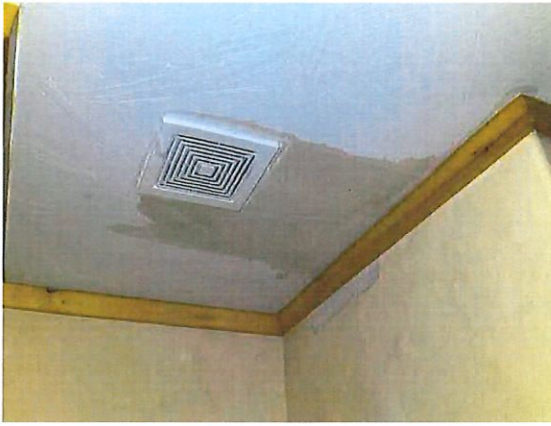
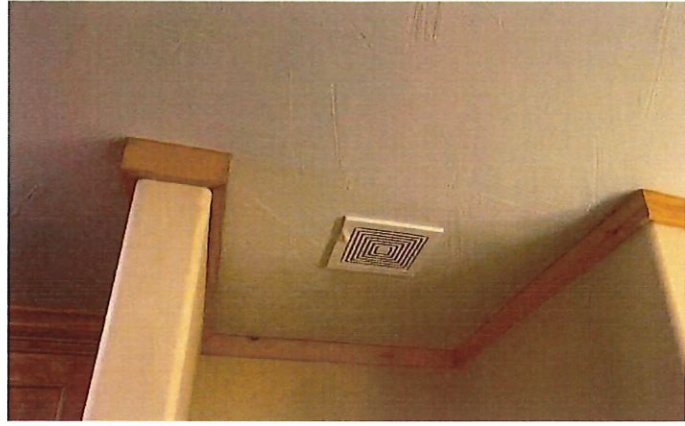
17.4.1 - Master Bathroom: Floors, Walls & Ceiling  
Stain(s) on Ceiling

Basement master bathroom ceiling has been painted. Staining is no longer visible.

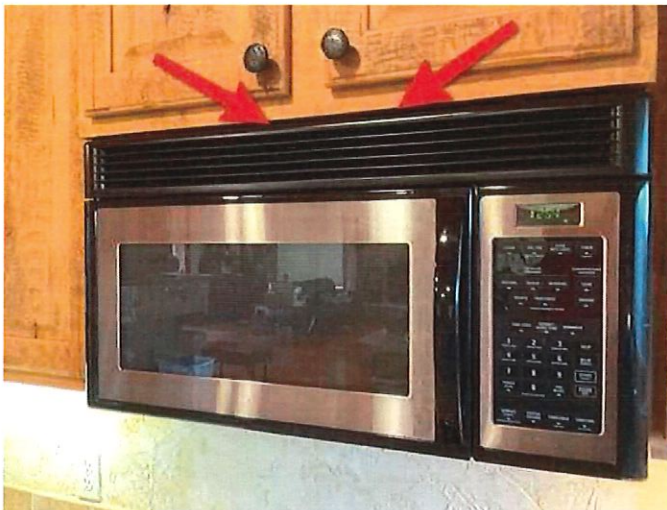
23.11.1 - Kitchen: Hood Vent  
Improperly Vented

The microwave hood vent fan is now properly configured to recirculate.

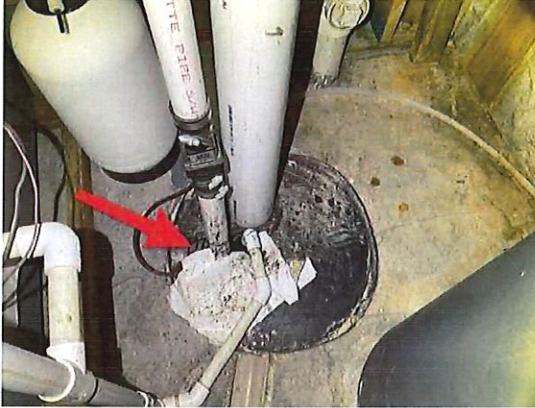
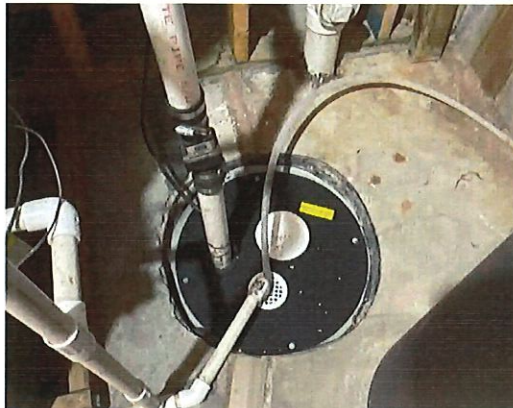
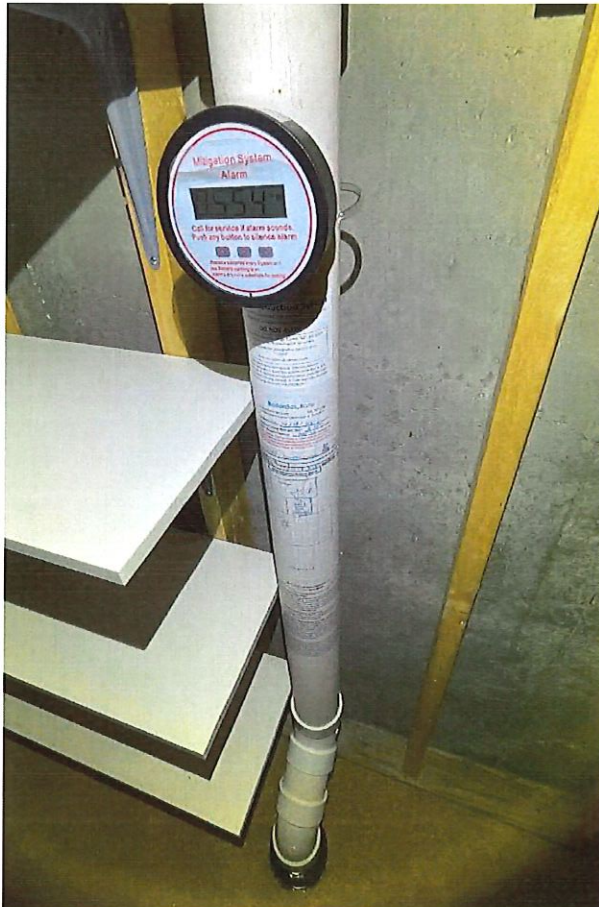
Basement Mechanical Room

25.1.1 - Radon System: Radon System  
Recommend Sealing Sump Pit

The sump pit is now properly sealed and a new radon mitigation has been installed in an alternate location. A verification test to confirm efficacy of the new system was being run by the installers at the time of this follow up inspection.

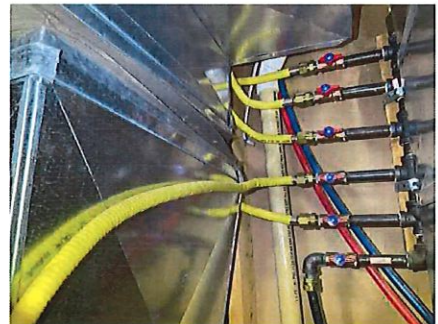
Manufacturers recommend direct bonding of gas piping systems incorporating standard (yellow) or uncoated corrugated stainless steel tubing (CSST) to reduce the risk of fire from lightning strikes. Recommend having an electrician or plumber assure gas line is properly bonded and grounded.

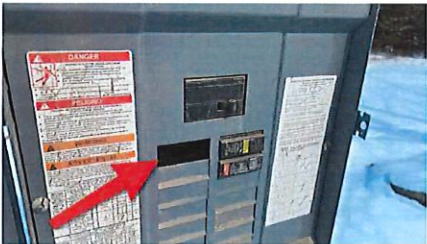
12.4.1 Exterior Service Panel  
**OPEN BREAKER SLOTS**  
EXTERIOR SERVICE ENTRY PANEL

Recommend covers over open breaker slots in electrical panel.

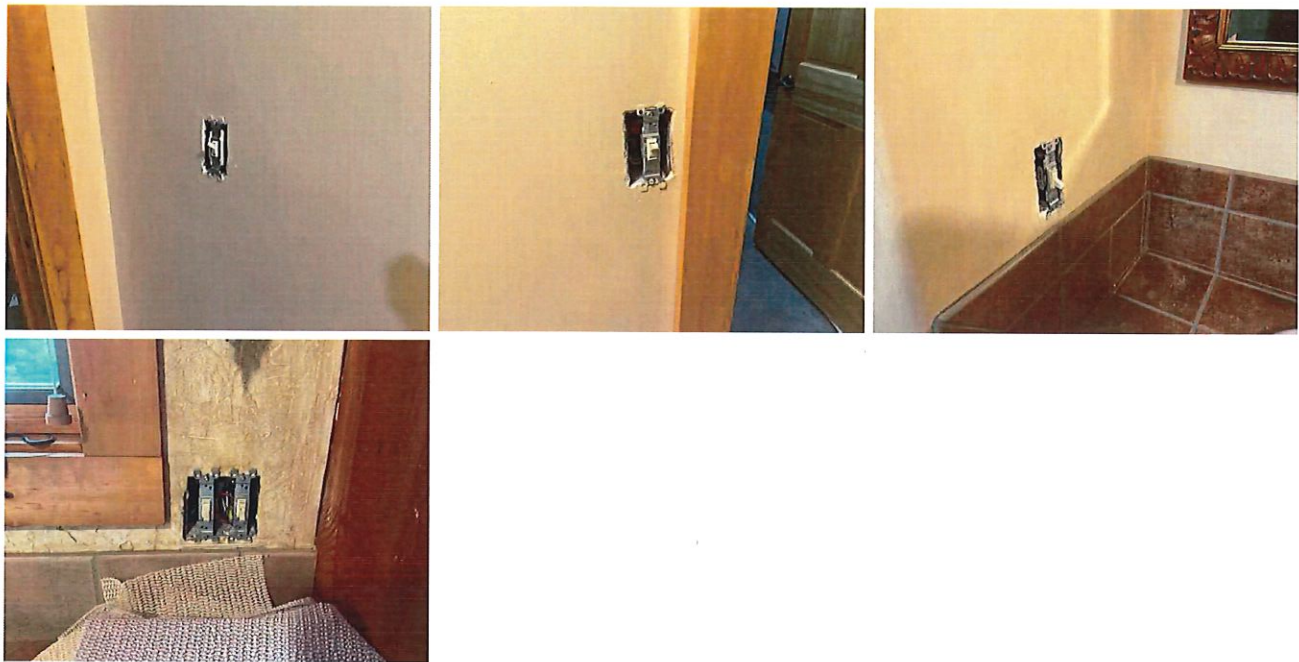
BASEMENT HALLWAY, MASTER BEDROOM, BASEMENT MASTER BATHROOM, KITCHEN

12.7.1 Lighting Fixtures, Switches & Receptacles

COVER PLATES BROKEN/MISSING

Receptacles have damaged/missing cover plates creating increased risk of short/shock. Recommend installation of plates.

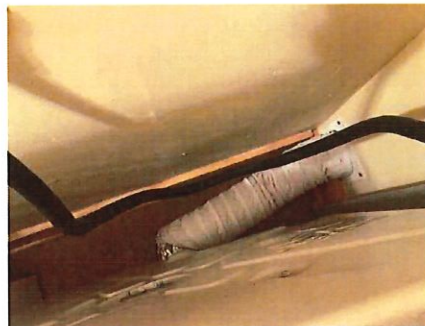
Metal ducts are required by many code authorities for dryer vents over plastic because metal withstands heat better and is not subject to static electricity which has been known to accumulate lint and cause blockages. Recommend replacing plastic vent lines with approved metal ducts.

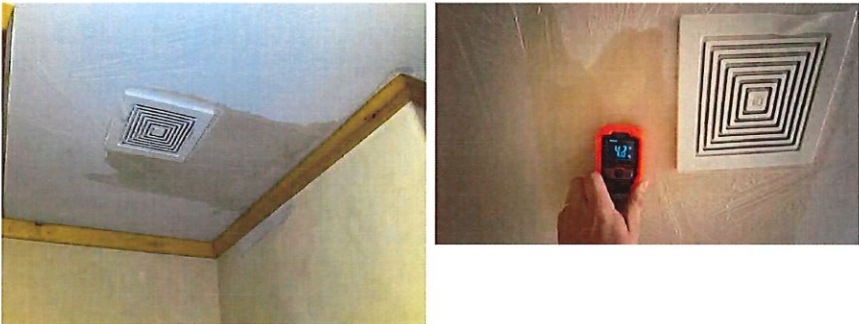
**STAIN(S) ON CEILING**

There appears to be water staining on ceiling of the basement master bathroom. Testing with a moisture meter did not detect high moisture levels on May 26, 2025.

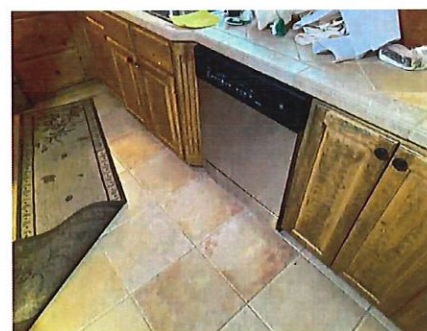
23.8.1 Dishwasher

### DISHWASHER LEAKED

Dishwasher ran but failed to drain when finished and leaked onto the tile floor when a test cycle was run. Recommend repair.

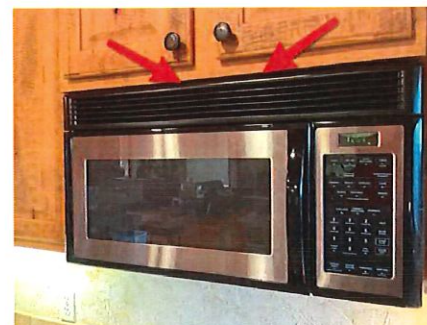
23.11.1 Hood Vent

### IMPROPERLY VENTED

The microwave hood vent fan is not properly configured to recirculate or exhaust to exterior. Recommend reconfiguring fan diverter on the back of the microwave.

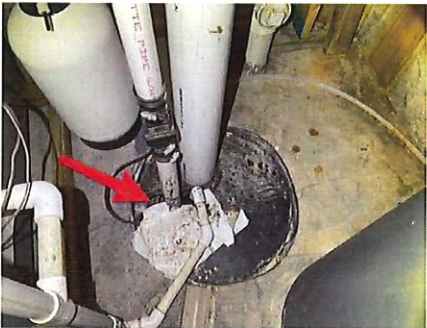
BASEMENT MECHANICAL ROOM

RECOMMEND SEALING SUMP PIT

Radon gas should be pulled from under the concrete slab. Without the sump pit being properly sealed, air is just generally being pulled from inside the basement. Recommend having a qualified Radon Mitigation Technician evaluate and seal properly.
