13 July 2022

SUBJECT: Structural Inspection and Report – **1190 Starcher Road, Gallipolis, OH 45631**

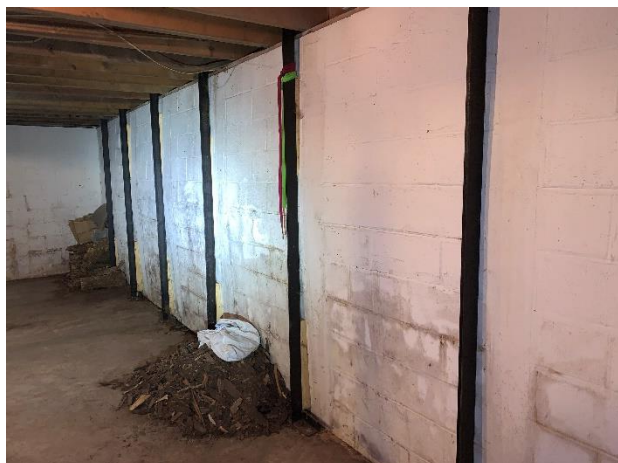
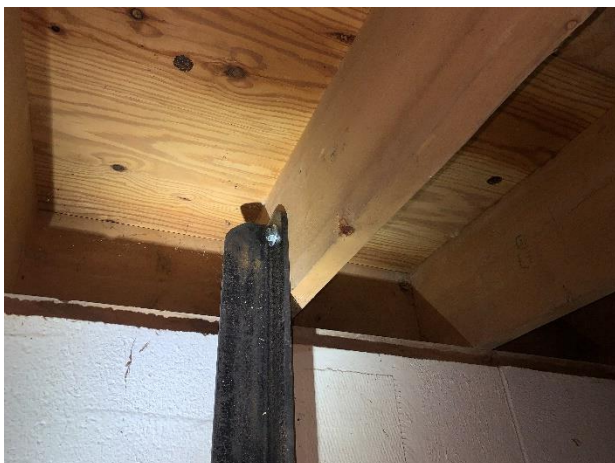
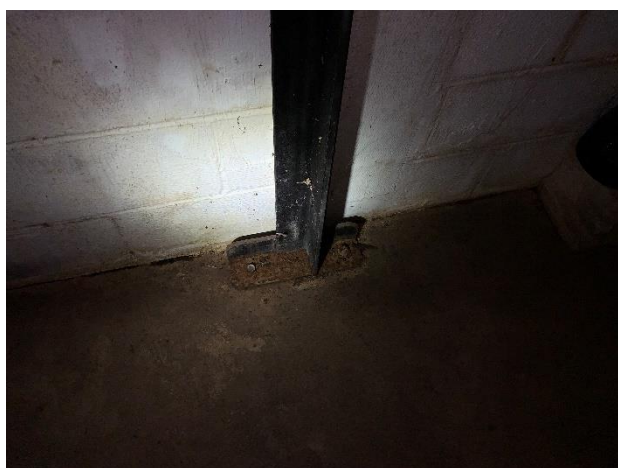
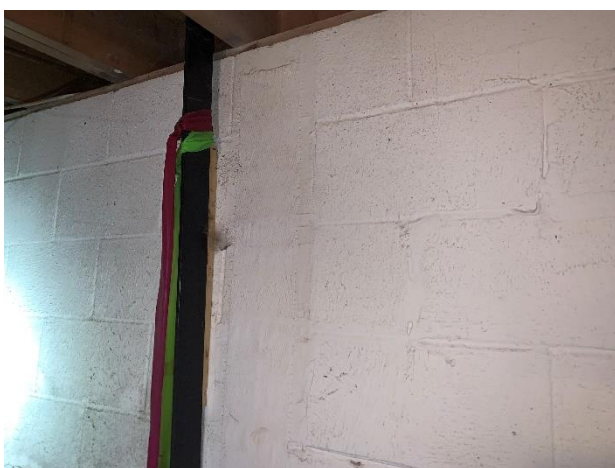
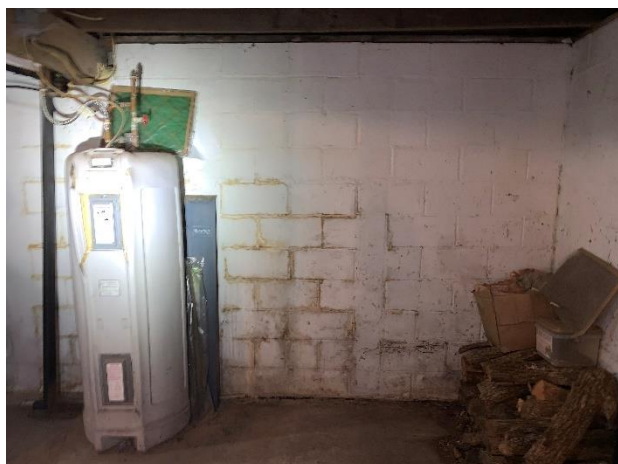
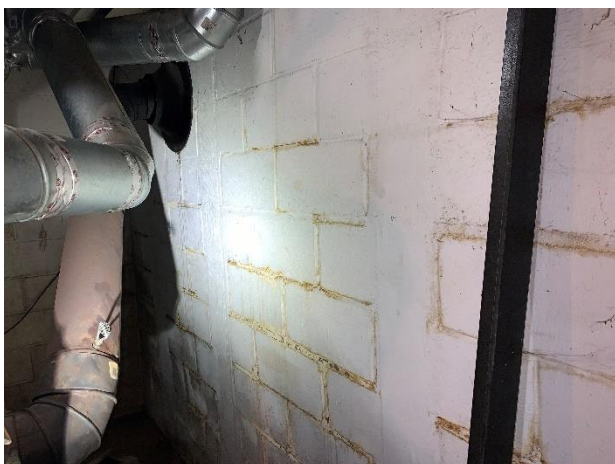
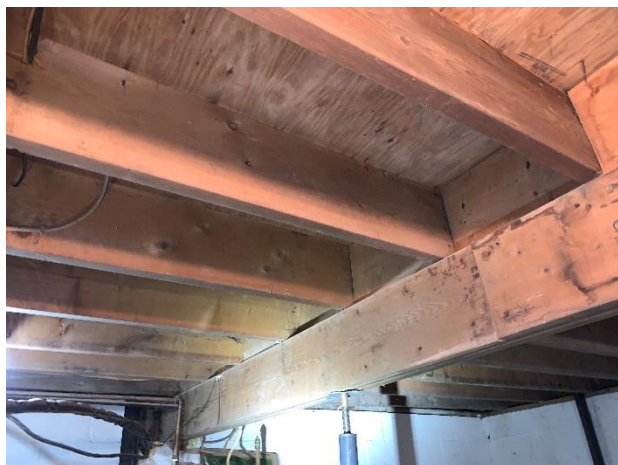
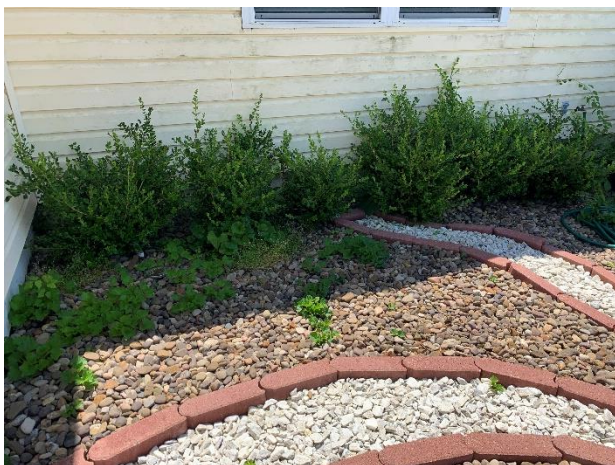
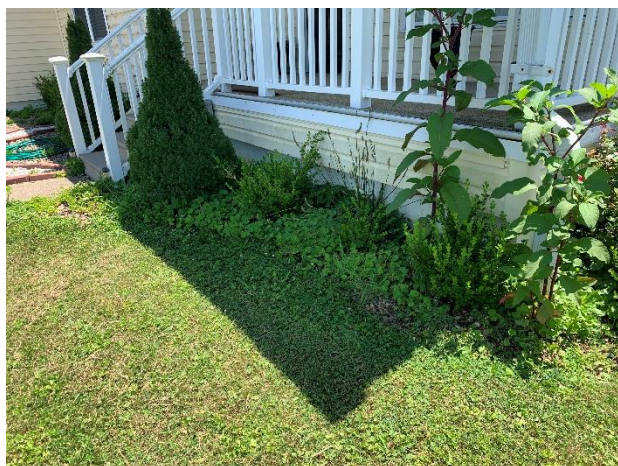
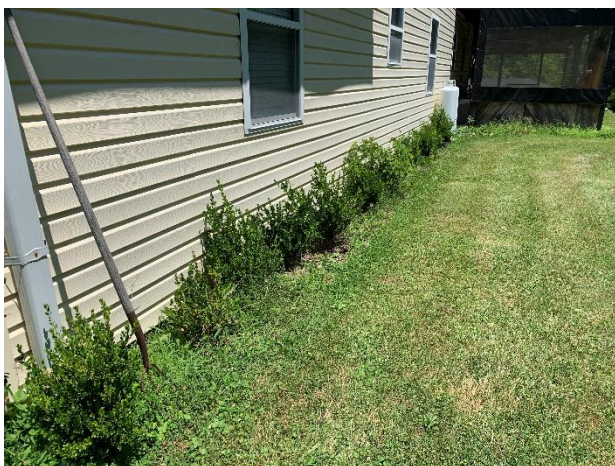
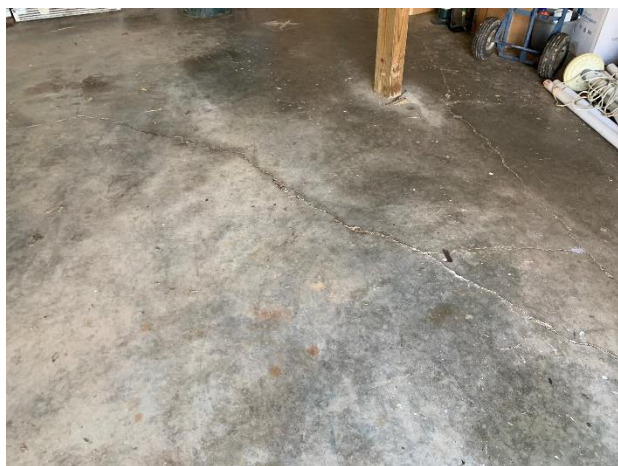
1. The attached photographs show views of the steel angles installed on the front foundation wall of the home. Based on the current conditions of the home and foundation walls, it is my best engineering judgment that the home and foundation walls are safe, stable, and structurally sound. The past work to the home was proper for the application and should prevent further movement or cracking in the basement foundation walls.

- a. The front masonry wall has been stabilized with seven (7) steel angles (also called tension beams or force brackets). This is a common and effective wall strengthening technique for masonry walls with lateral (horizontal) soil pressure.

- b. The front basement foundation wall also has seven (7) carbon fiber straps applied to the interior face of the block. This is also a common wall strengthening method.

2. Although the movement and cracking is not a severe, the right wall also has been stabilized from additional lateral movement with five (5) carbon fiber straps.

- As with any masonry home with foundation walls below grade, drainage is critical to the longevity of the structure. Ensure that all foundation drains and gutter downspout drains are kept clear and functioning. Where possible, slope ground surfaces adjacent to the home to provide positive drainage for surface water away from the foundation walls. As much water as possible should be directed away from the home and the foundation walls to ensure the long-term service life of the structure.
