## YOUR INSPECTION REPORT

**3157 Horstman Rd  
Berger, MO 63014**

**Prepared By: Jason Ratliff**

**Inspected Date: 9/23/2025  
Report ID: 1109974**

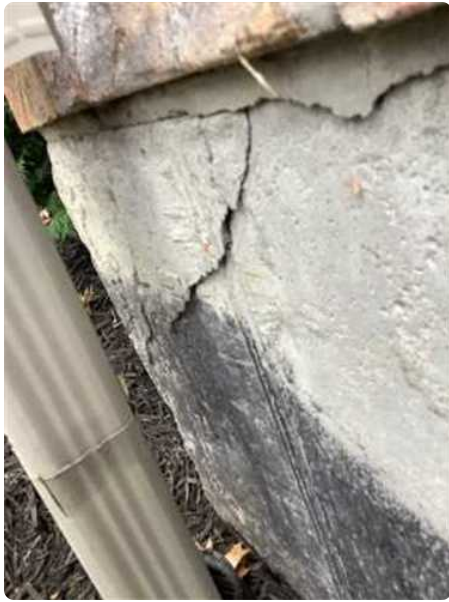
- Reference Seller Disclosure Statement for additional comments.
- The foundation front right corner below the bricks there is cracking, common on a brick home. Recommend sealing to keep moisture out of the crack and making the crack worse.

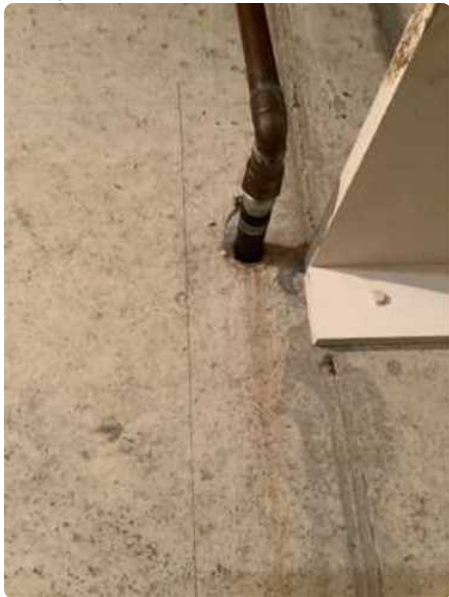
- Where the water line enters the foundation there is evidence of moisture wicking. Recommend a professional seal to keep moisture out.

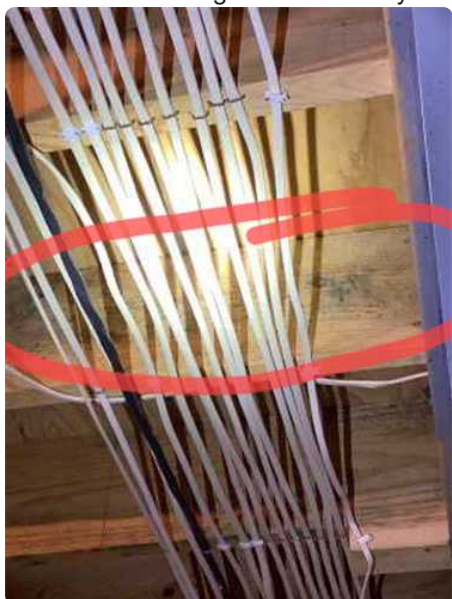
- The insulation conditions in the basement were typical for this age of home.
- 🔑 ■ There is light possible mold on the floor joist in the front right room of the basement. Recommend a mold professional evaluate and mitigate if necessary.

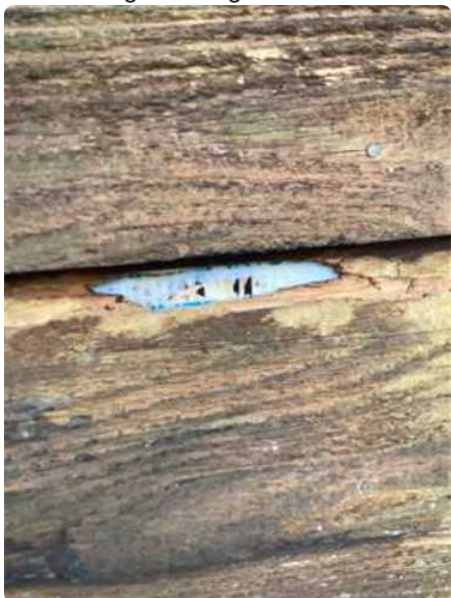
- 🔑 ▪ The back side of the home by the screened porch there is a hole on the wood siding. Recommend a contractor replace the damaged siding.

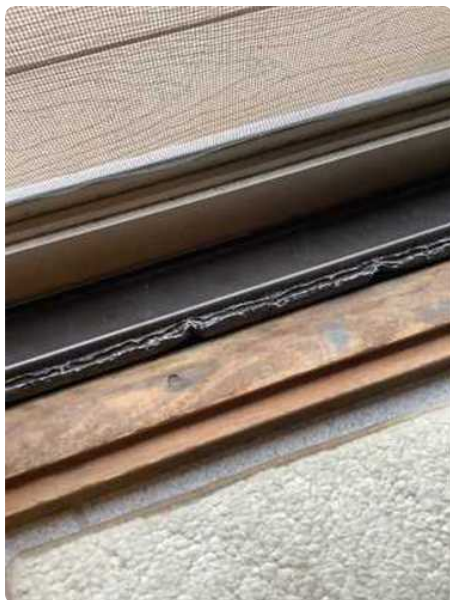
- Better weather-stripping always improves energy efficiency. We did not specifically check the door locks for function, but recommend as a best security practice changing the locks after closing.
- Entries not protected with a roof often leak at the trim joints and threshold surrounding the doorway during certain weather conditions. Check these joints regularly and caulk and seal as necessary. Chronic leaks can cause wood decay at the trim above the door and the bandboard/joists below the threshold. Concrete patio slabs can also move because of frost action, creating a gap at the door threshold and possible wood decay. Monitor and seal as needed. Adding storm doors may help, but an extended roof always provides the best protection against the elements.
- The kitchen exterior door the bottom seal is damaged. Recommend replacing the seal.

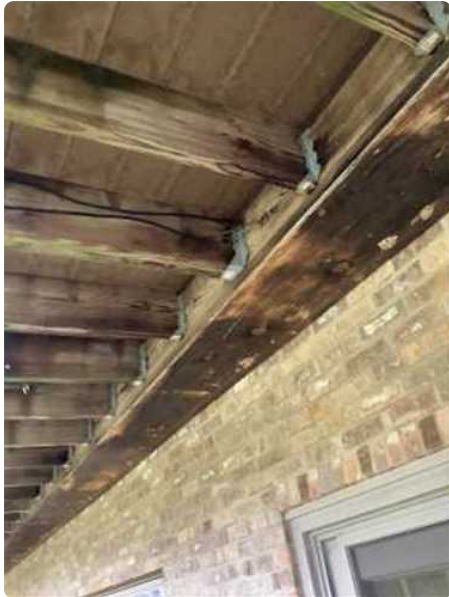
- The deck is attached to the house bump out, not proper recommend a qualified contractor further evaluate. May need a beam installed under the deck along the bump out with support post to help take some of the weight off the bump out.

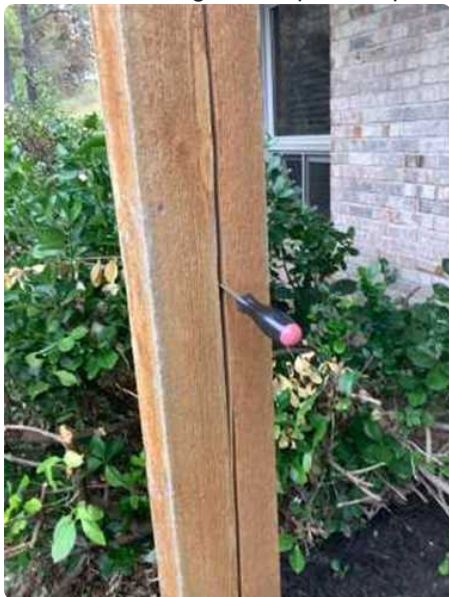
- The 2nd from right deck post is split. Recommend a qualified contractor evaluate and replace if necessary.

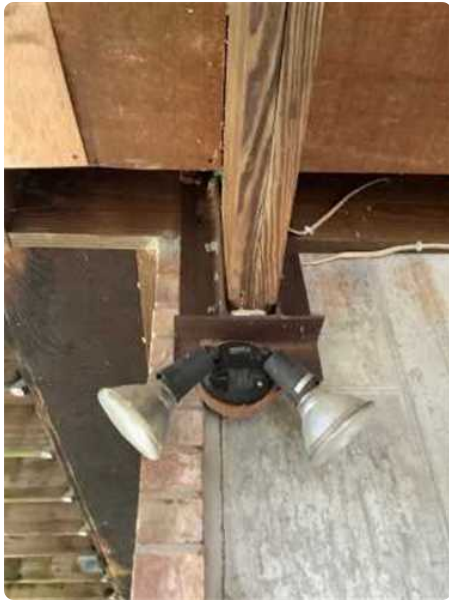
- The beam under the screened porch has a non typical metal beam pocket attached to the framing. Recommend a qualified contractor further evaluate and follow their recommendations if repairs are needed.

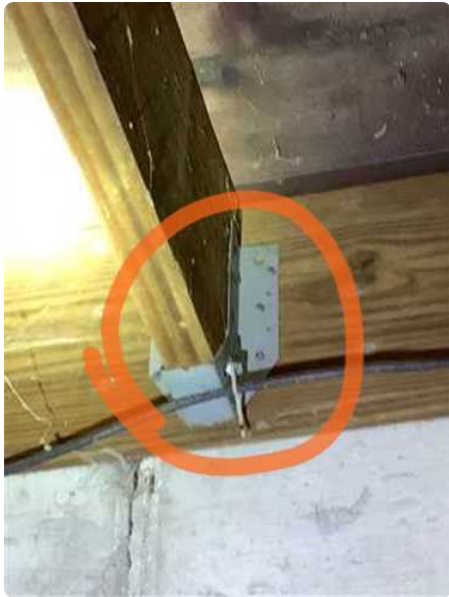
- The floor joist hangers are missing some of the fasteners. Recommend installing the missing fasteners.

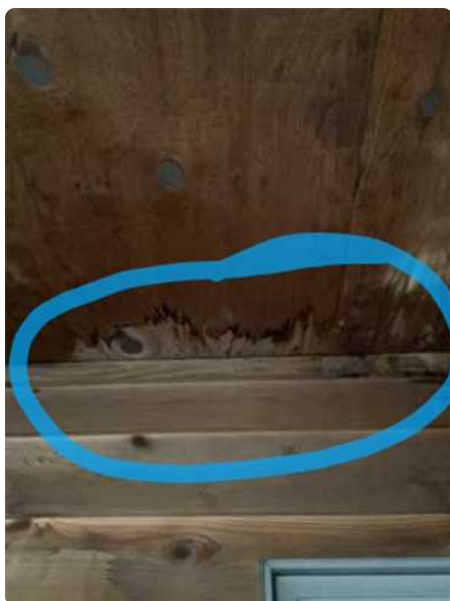
- Front porch is in typical physical repair.
- The screened porch needs re stained on the exterior side.
- 🔑 ▪ There is a stain on the screened porch ceiling by the window to the kitchen. Tested damp at time of inspection with a moisture meter. Recommend a contractor further evaluate, roof could possibly be leaking.

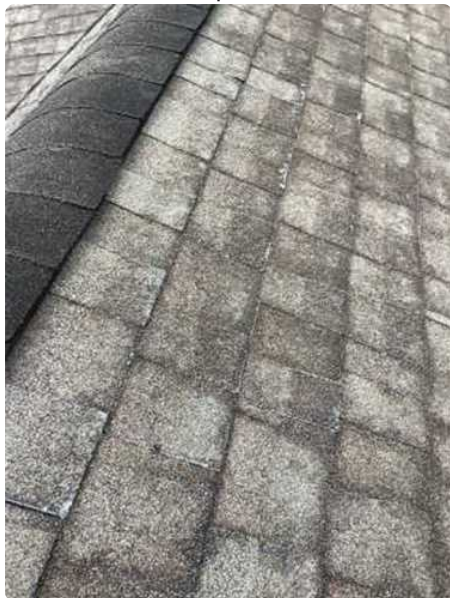
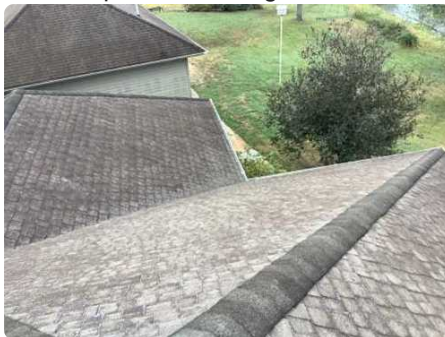
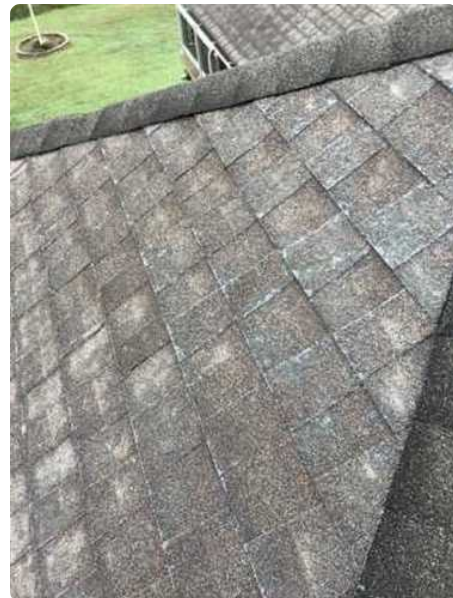
- The shingles have heavy granular loss/ possible hail damage. The shingles are at the end of their serviceable life. Recommend a reputable roofer evaluate and replace the shingles.

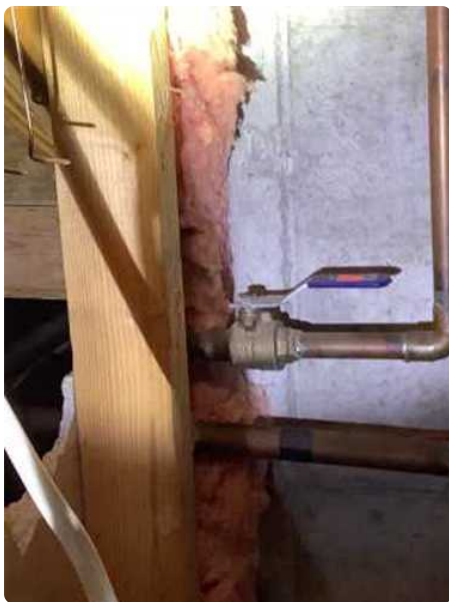
Main shut off above pressure tank

- 🔑
  - When the well is running there is a ticking noise at the pressure tank. Recommend a licensed plumber evaluate and repair/replace as necessary.
- 🔑
  - The on site private water well on this property was not evaluated. Have the water quality tested by others. A well service company can provide additional information about the pump's condition, which is recommended.

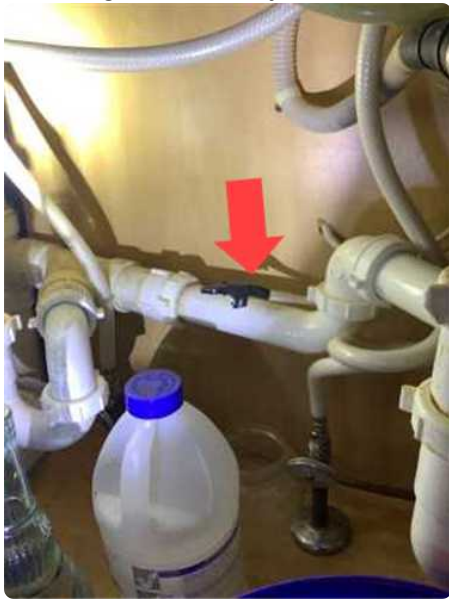
- Under the kitchen sink there is a loose wire for a garbage disposal it is only taped. Recommend installing wire nuts and installing the wire in a junction box.

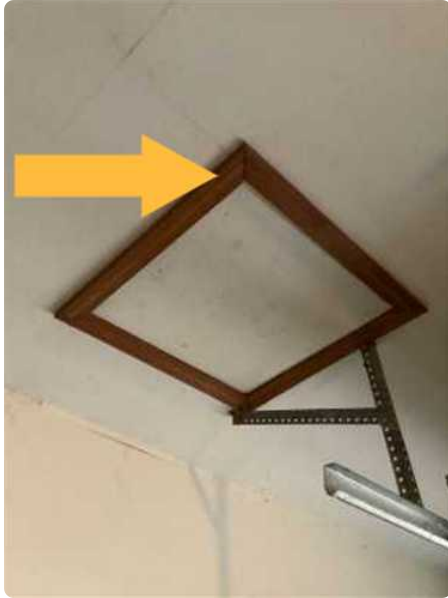
- The garage attic access trim is not fire rated. Recommend replacing with a 2x4 trim to maintain proper fire separation.

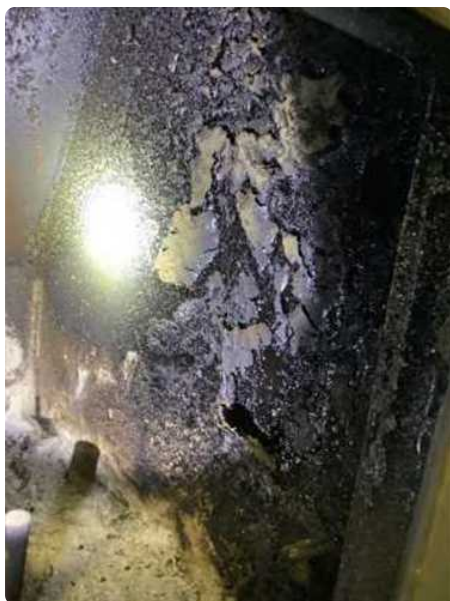
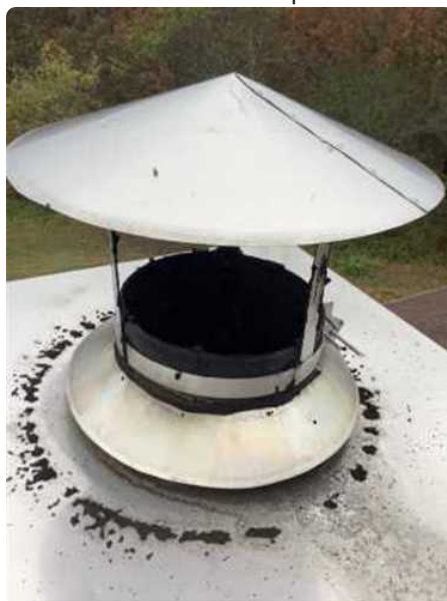
- The basement wood burner and it's flue have a creosote build up. Recommend a fireplace professional clean.

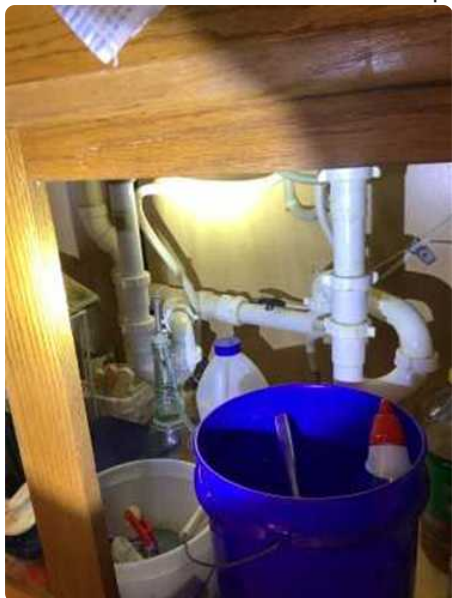
- The kitchen sink has two P traps and a non typical configuration. The drain goes uphill to the tee, not proper installation. Recommend a licensed plumber evaluate and repair/replace as necessary

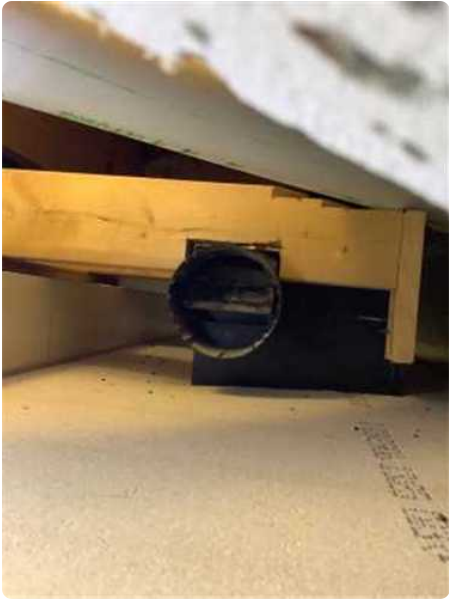
- 🔑 ▪ The basement bathroom exhaust fan does not vent to the exterior of the home. Recommend a professional route to the exterior of the home.

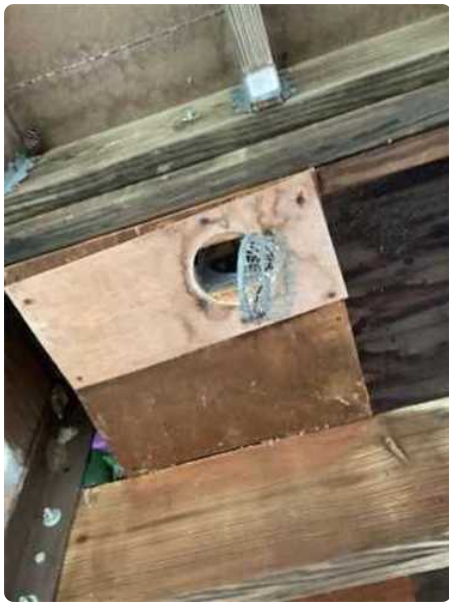
- 🔑 ▪ The dryer vent the screen cover is not attached, reattach to the wood.
