Wood Destroying Insect Inspection Report Notice: Please read important consumer information on page 2.			
Section I. General Information Company's Pest Control			Date of Inspection
Inspection Company, Address & Phone		09/23/2025	
7 Oaks Home Inspection A service of BPG Inspections Address of Property Inspected		pected	0072072020
10097 Manchester Rd. Ste. 200	3157 Horstman Road Berger, MO 63014		
St. Louis, MO 63122 (636)456-0001			
		Ctm. at. ma (a) Imam a	vi a d
Inspector's Name, Signature & Certification, Registration, or Lic. # Jason Ratliff - N7018 Radio	Structure(s) Inspected Resident		
Jason Ratliff - N7018 John Ratliff			
Section II. Inspection Findings This report is indicative of the condition of the above identified structure(s) on the date of inspection and is not to be construed as a guarantee or warranty against latent, concealed, or future infestations or wood destroying insect damage. Based on a careful visual inspection of the readily accessible areas of the structure(s) inspected:

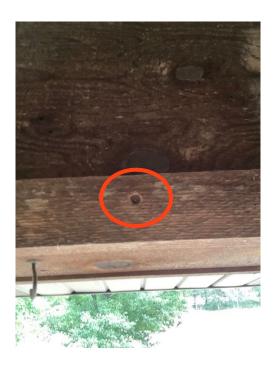
1. Live insects (description and location):			
2. Dead insects, insect parts, frass, shelter tubes, exit holes, or staining (description and location): There are a couple of carpenter bee holes on the front porch beam.

Front porch carpenter bee holes.
