Wood Destroying Insect Inspection Report Notice: Please read important consumer information on page 2.				
Section I. General Information	Address & Phone on ections Ste. 200 Company's Pest Control Business Lic. No. Date of Inspection 10/15/2025 Address of Property Inspected 201 W 2nd Street		Date of Inspection	
Inspection Company, Address & Phone 7 Oaks Home Inspection			10/15/2025	
A service of BPG Inspections 10097 Manchester Rd. Ste. 200				
St. Louis, MO 63122 (636)456-0001	Hermann, MO 65041			
Inspector's Name, Signature & Certification, Registration, or Lic. #		Structure(s) Inspec	ted:	
Jason Ratliff - N7018	Resident		NOG	
Section II. Inspection Findings This report is indicative of the condition of the above identified structure(s) on the date of inspection and is not to				
be construed as a guarantee or warranty against latent, concealed, or future infestations or wood destroying insect damage. Based on a careful visual inspection of the readily accessible areas of the structure(s) inspected:

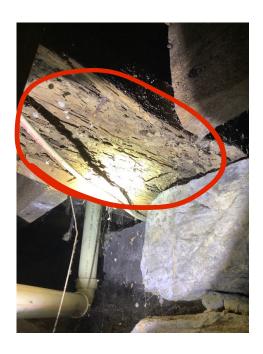
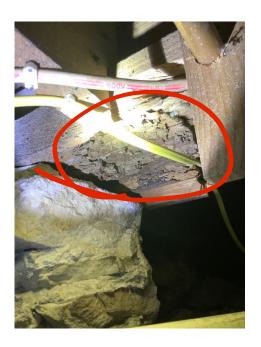
2. Dead insects, insect parts, frass, shelter tubes, exit holes, or staining (description and location):				
3. Visible damage from wood destroying insects was noted as follows (description and location):				
The crawl space opening in the basement to the crawl space on the beam over the opening there is old termite damage. The old basement stairs to				
exterior of home there is a floor joist that has old termite damage going in under the kitchen.				
NOTE: This is not a structural damage report. If box B above is checked, it should be understood that some degree of damage, including hidden damage, may be present. If any questions arise regarding damage indicated by this report, it is recommended that the buyer or any				
interested parties contact a qualified structural professional to determine the extent of damage and the need for repairs.				
Section III. Recommendations				
□ No action and/or treatment recommended: (Explain if Box B in Section II is checked)

Both pictures crawl space opening beam over opening termite damage.

Recommend action(s) and/or treatment(s) for the control of: Recommend a contractor evaluate the damage and repair/ replace if necessary.				
Continuity Obstantians and Incorposite Arras		The in	nspector may write out obstructions	
Section IV. Obstructions and Inaccessible Areas The following areas of the structure(s) inspected were obstructed or inaccessible:		or us	e the following optional key: d ceiling 15. Standing water	
☑ Basement 11, 24		2. Sus	pended ceiling 16. Dense vegetation 17. Exterior siding	
 ✓ Crawlspace 11, 13, 24 ✓ Main Level 1, 3, 4, 6, 11 			r covering 18. Window well covers	
✓ Attic _5, 11, 13		6. Cab	inets or shelving 20. Snow ed items 21. Unsafe conditions	
☐ Garage NA 8.1		8. Furr	ishings 22. Rigid foam board	
7 Porch 11 13 10. No access or entry 24. Duct work, wiring			access or entry 24. Duct work, wiring,	
Addition				
Other	13. Only visual access insulation 14. Cluttered condition 26. Equipment

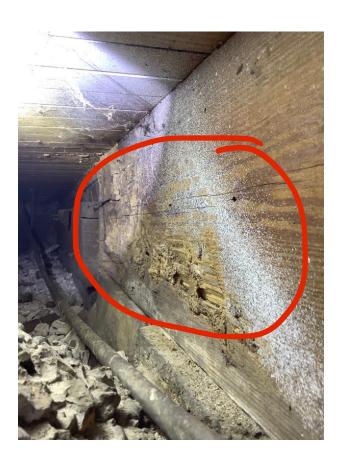
Basement exterior stairwell joist looking towards kitchen termite damage.
