## I. STRUCTURAL SYSTEMS

### A. Foundations

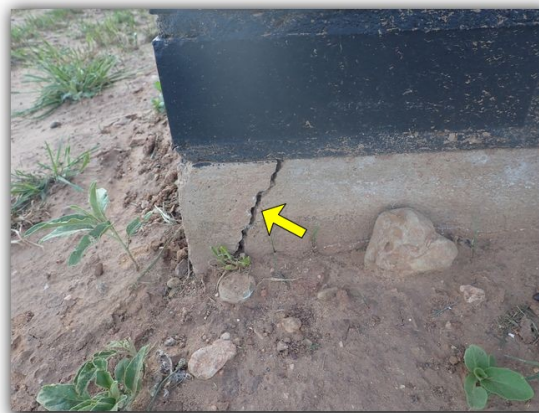
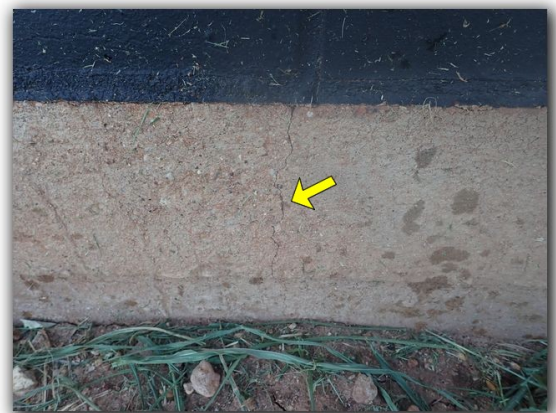
- Typical crack(s) were observed in the exterior foundation perimeter beam.
- One or more of the foundation perimeter beam corners were observed to be sheared off (corner pop). This is a common condition to observe and is do to thermal expansion and contraction of the different building materials. This condition does not adversely affect the foundation performance. However, in some cases, some cosmetic improvements may be necessary.

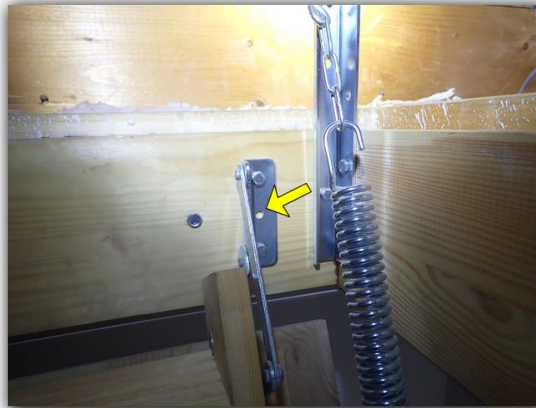
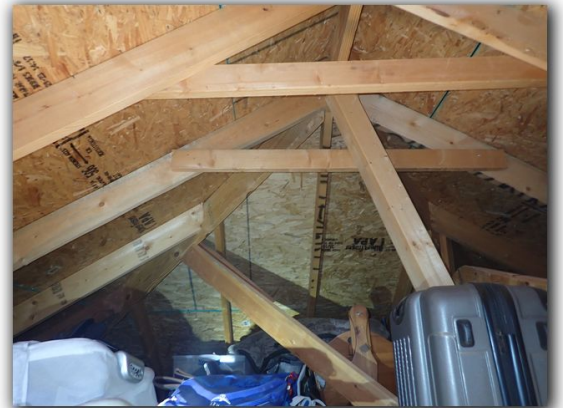
- One or more of the attic ladder fasteners were observed to be missing.

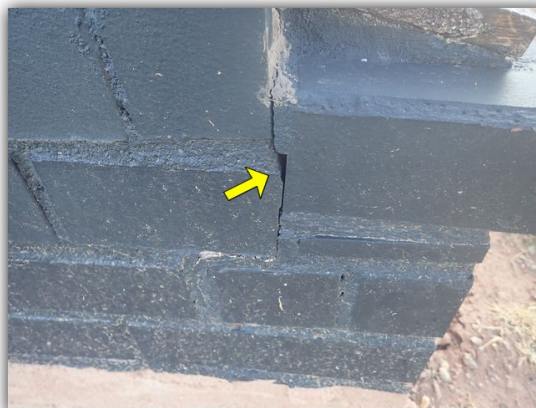
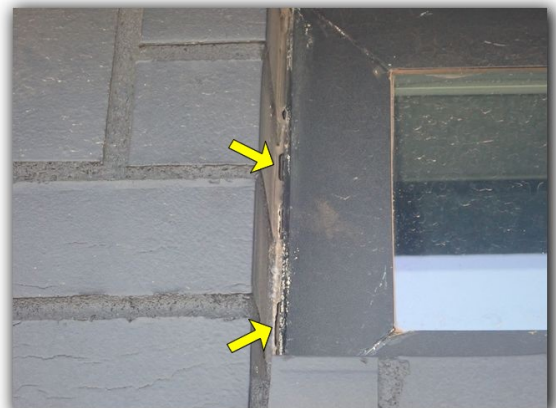
- **Note:** There is evidence of painting and patching to the interior finish and prior interior finish repairs. This condition could limit the Inspectors visual observations and ability to render accurate opinions as to the performance of the structure.
- Interior wall stress cracks were observed in the garage.
- Wall surface damage was observed in the hall bathroom.

- Caulking improvements are recommended for the area between the exterior veneer and the window frames. It is recommended to use an industry approved low-modulus elastomeric sealant (exterior caulking).
- Caulking improvements are recommended for the area between the exterior veneer and the garage door trim boards. It is recommended to use an industry approved low-modulus elastomeric sealant (exterior caulking).
- Stress cracks were observed in the exterior veneer on the west side of the structure.

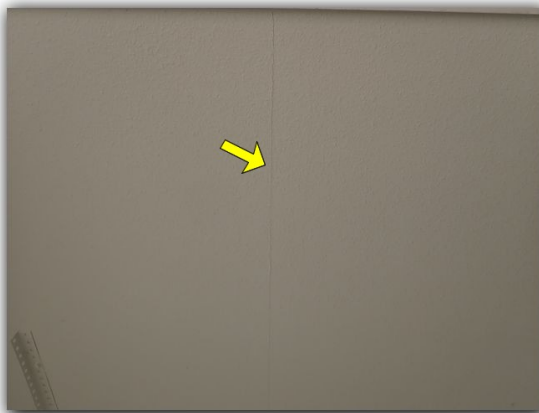
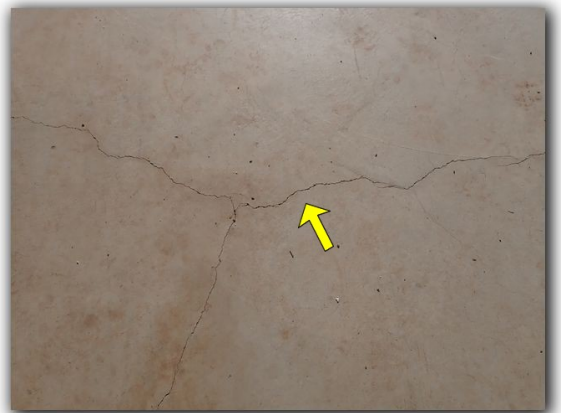
- Ceiling stress cracks were observed in the garage and laundry room.

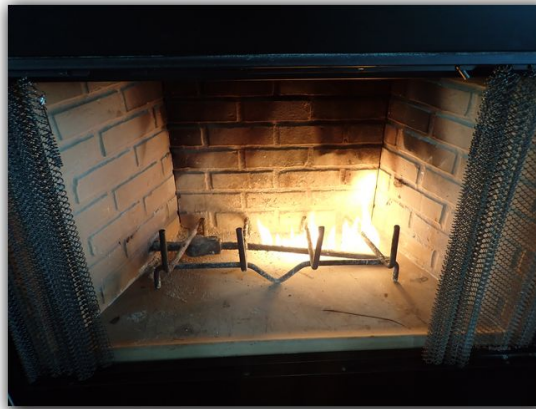
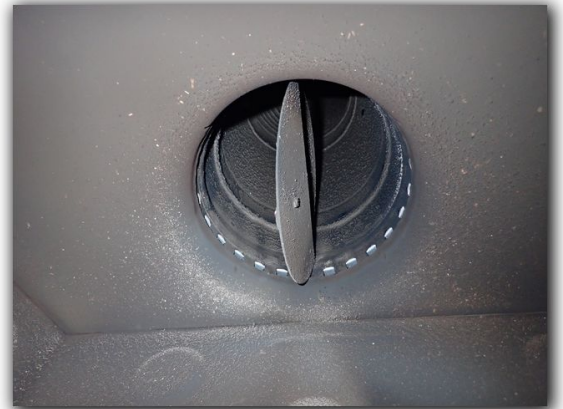
- The chimney flue needs to be cleaned by a Qualified Chimney Sweep. A creosote / soot build-up was observed in the visible flue area.

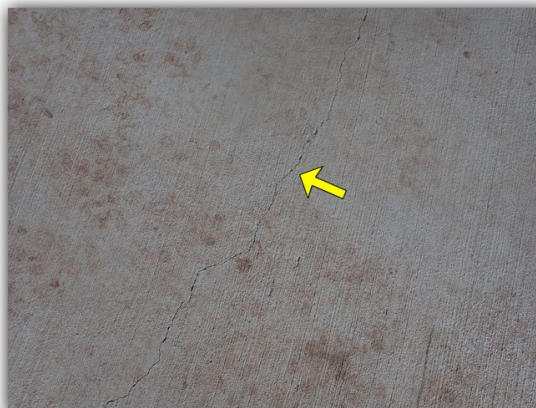
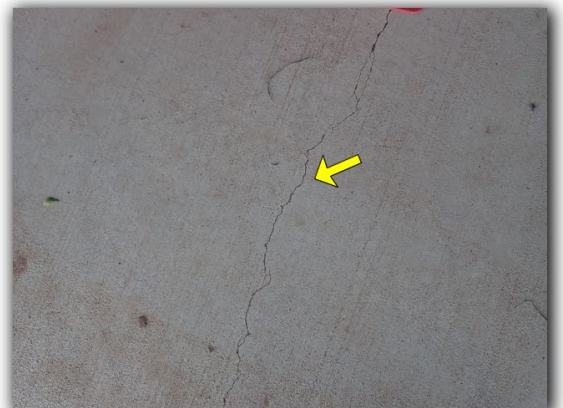
- Some typical cracking of the patio concrete flatwork was observed.

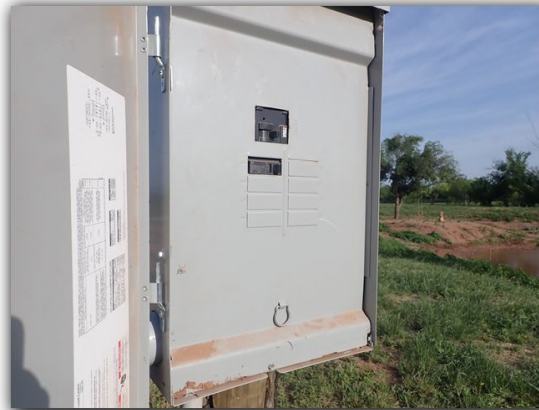
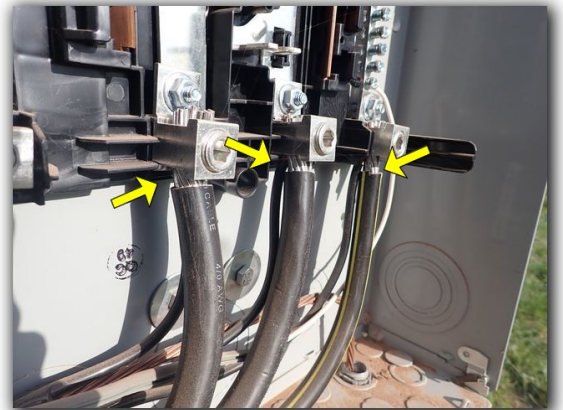
- One or more of the main service connections in the electrical cabinet were observed to be double lugged (i.e. two wires under one screw). The connectors in place are not listed or labeled for this type of installation and should be corrected as necessary.

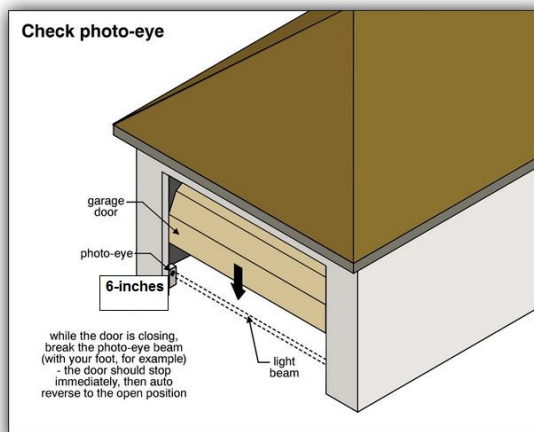
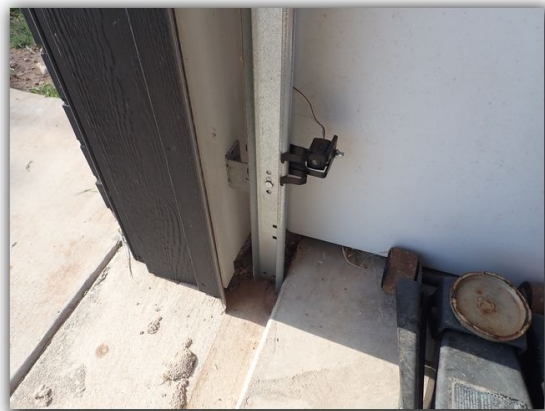
- The garage door reverse sensors are not properly installed. The garage door reverse sensors should be installed within 6-inches of the garage floor.
