REQUEST FOR SITE APPROVAL

TO: Hardy County Health Department, Moorefield, W.V.

RE: Property Location Ashton Woods Sub.

*Lot 146*

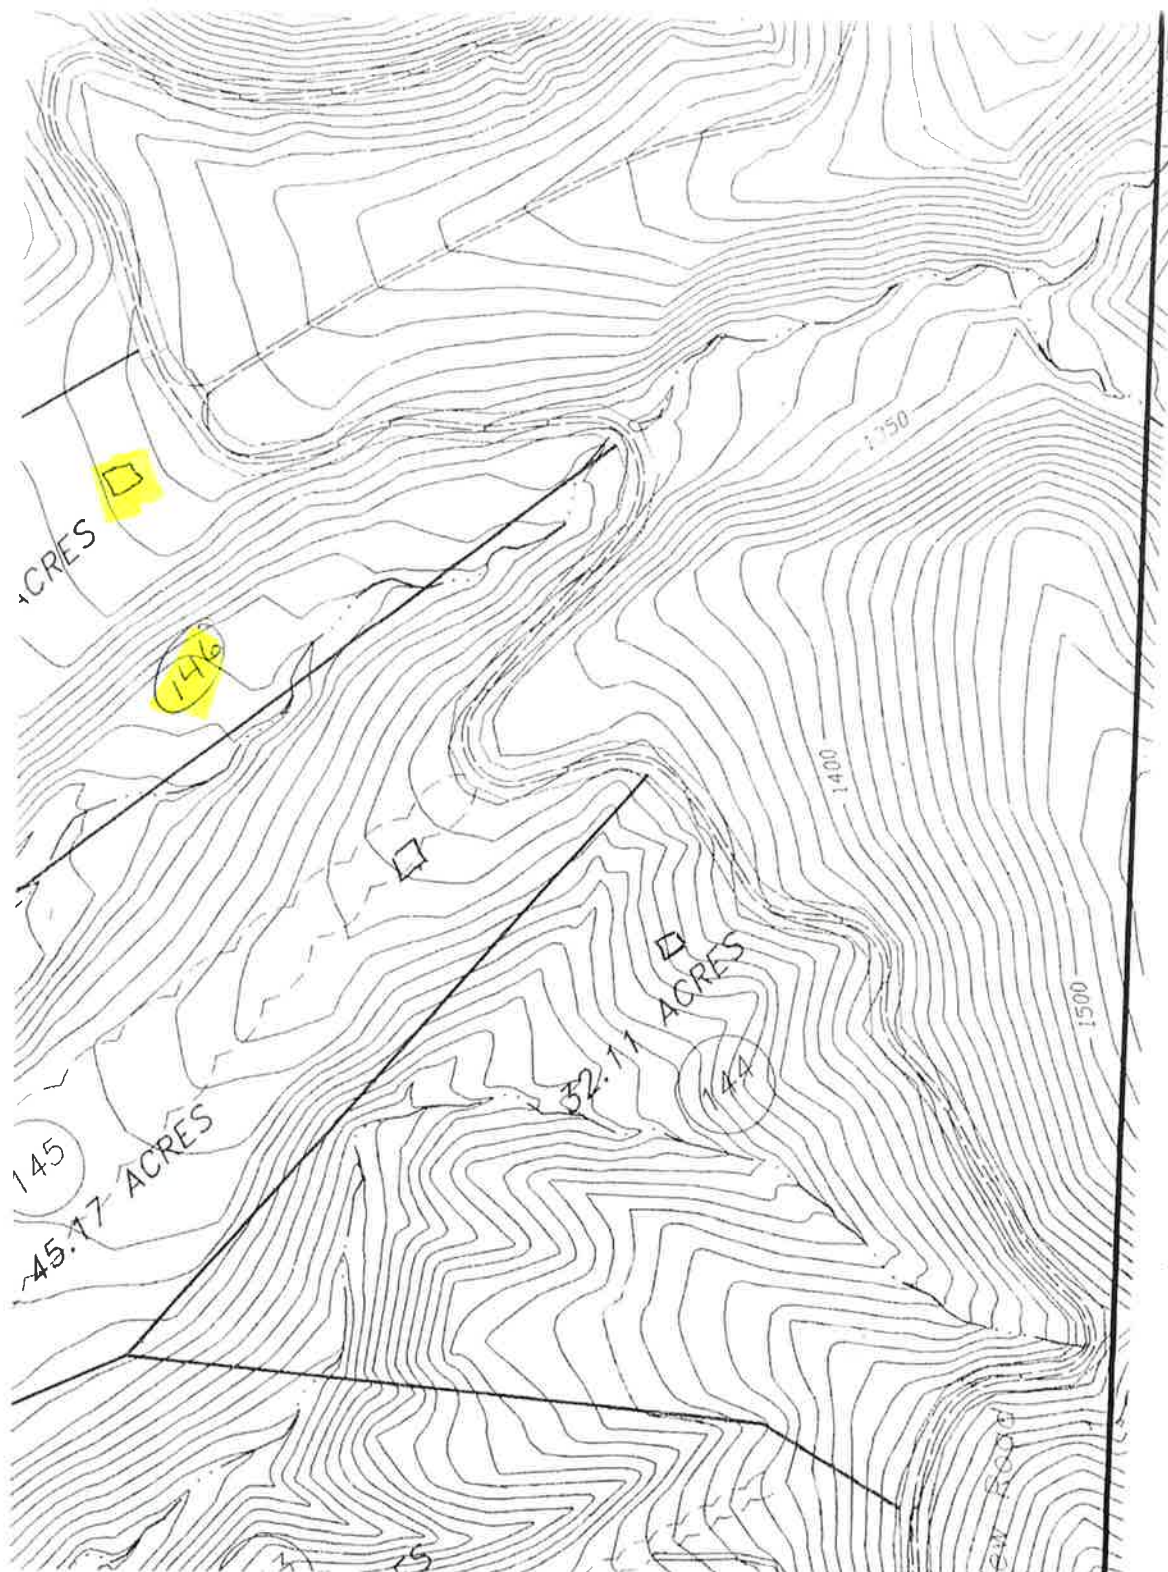
Water 12"

NOTICE: Water in the 6-ft observation hole indicates a potential problem with ground water movement on this site. A french drain may be required to intercept water
