Re: Repair Plan Review Zachary and Amanda Bolton 4451 CR 4410 Commerce, Texas 75428

PRESSED CONCRETE PIER

Ref: Foundation Visual Inspection Zachary and Amanda Bolton 4451 CR 4410 Commerce, Texas 75428

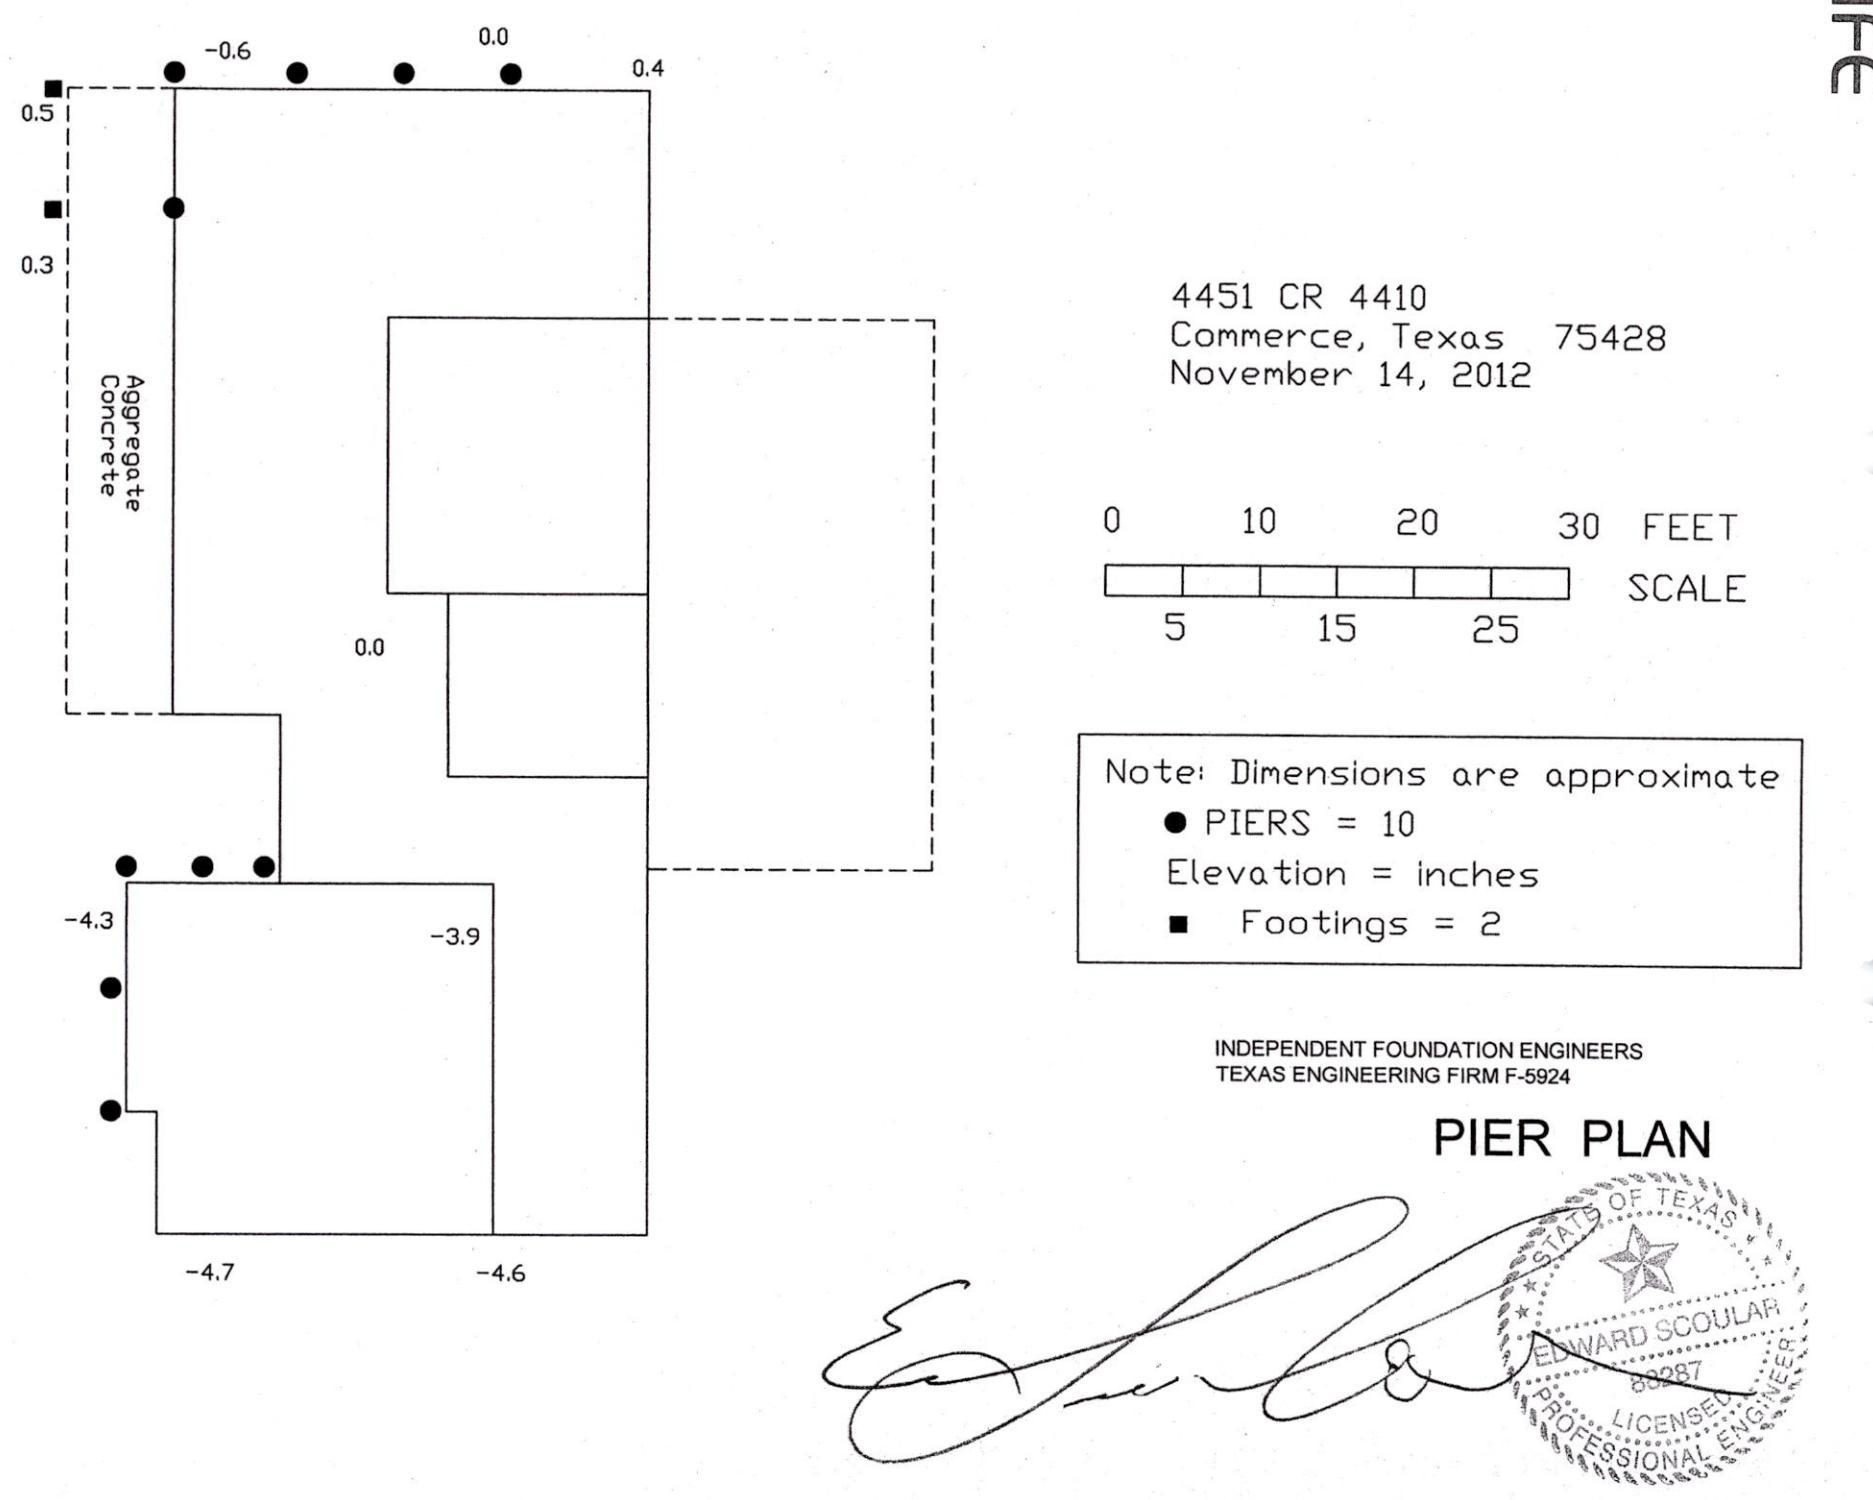
The slab deflection exceeds the standards normally expected for a slab on grade foundation.

The foundation of this residence can be stabilized by the installation of concrete pilings located at the approximate locations shown on the attached Pier Plan. The concrete pilings should be driven to the underlying bedrock or until they can be driven no deeper. Installation of concrete pilings in the general locations as indicated on the attached drawing (maximum spacing 8 feet) should correct the foundation deflections. Field conditions (utility line locations, etc.) may require the adjustment of some of these locations. Some slopes may remain in the slab, in areas supported by pilings, after the installation of the pilings.
