# PROPERTY INSPECTION REPORT

Concerning: 208 SE CR 3149 Corsicana, Texas  
(Address or Other Identification of Inspected Property)

By: Chuck McClanahan #5461 06/17/2013  
(Name and License Number of Inspector) (Date)

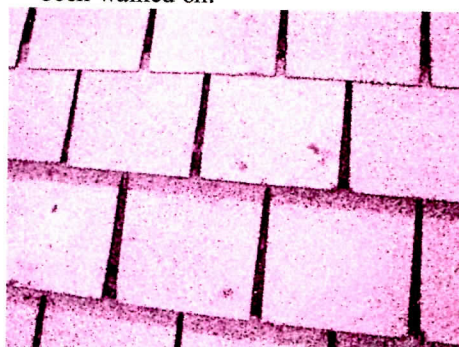
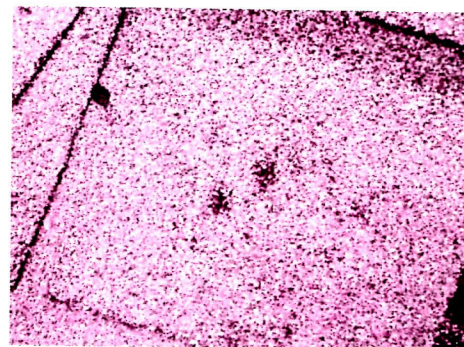
Minor bruising noted along the east (lake) slope in various locations. These spots have been caused by walking on the roof. The spots are typical when the roof has been walked on.

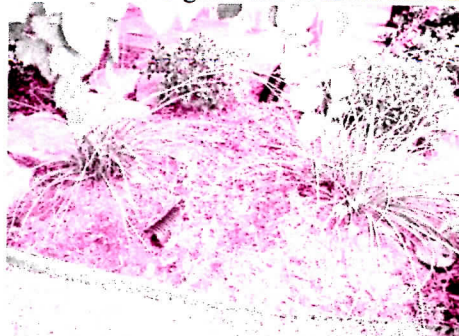
The downspout in various locations discharges water into the flowerbed. Should cause discharged water to move a minimum of 5 feet away from the house.

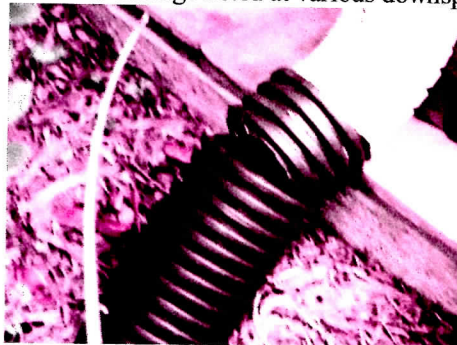
Minor damage noted at various downspouts.

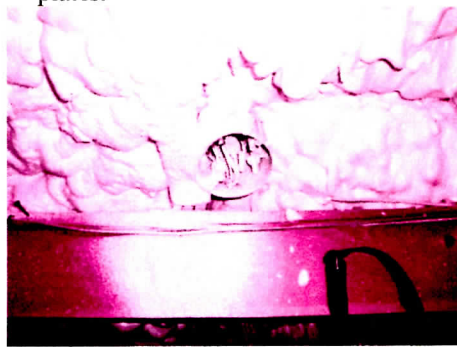
Open junction boxes were observed in the attic in the south upstairs AC/heater closet. All electrical connections should be made inside junction boxes fitted with cover plates.

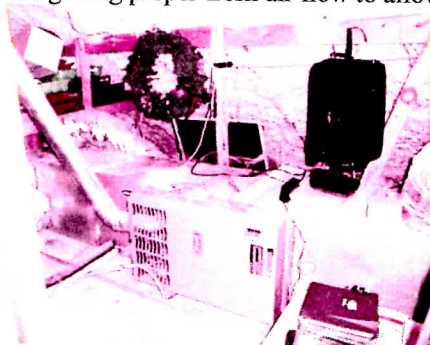
The heating units are gas operated and need fresh air to burn properly. The areas where the units are located are sealed using foam insulation. This type of insulating normally cuts off all outside air. Normally a fresh air pipe is present to allow air to be drawn into the burner chamber. Further investigating is needed to know if the units are getting proper fresh air flow to allow the units to burn properly.
