CONCERNING THE PROPERTY AT 905 N. Orange St.  
Fredericksburg, TX 78624

This property inspection report does include an "Inspection Contract" (page 2), addenda, and other information related to property conditions. If any item or comment is unclear, you should ask the inspector to clarify the findings. It is important that you carefully read ALL of this info.

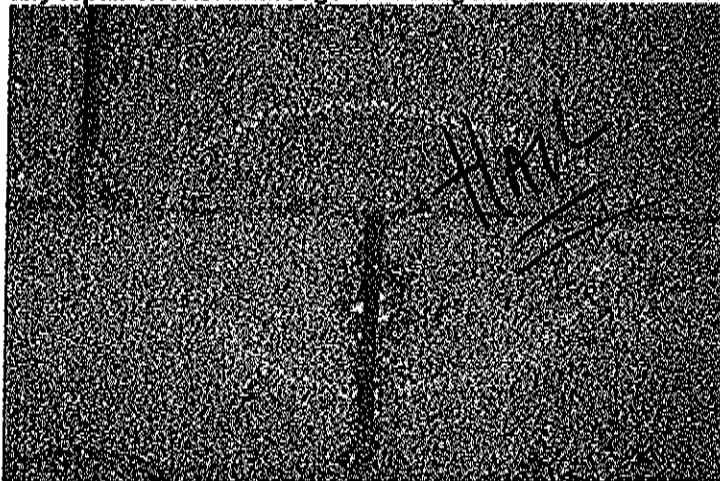
**Comments:** Noted surface cracks, pits and splits and/or curling commensurate with age/exposure. Noted signs of prior hail impact on roofing. Clients should request sellers seek a hail damage claim from insurance company or a letter from the insurance company stating that roof is not hail damaged. (for use with client's carrier) Locations where caulking, roof tar and/or other sealant have been applied would indicate locations of prior moisture migration. These products become dry and cracked over time due to exposure and need to be reapplied. see like at furnace flue vent pipe (see photo). Tree growth in contact with roof's surface. Cut back to protect roof's surface. The probability is high that the roof covering needs replacement or extensive repairs and further investigation of its overall condition should be carried out by a licensed roofer prior to authorizing any repair efforts. Exact age of roofing material was not determined.

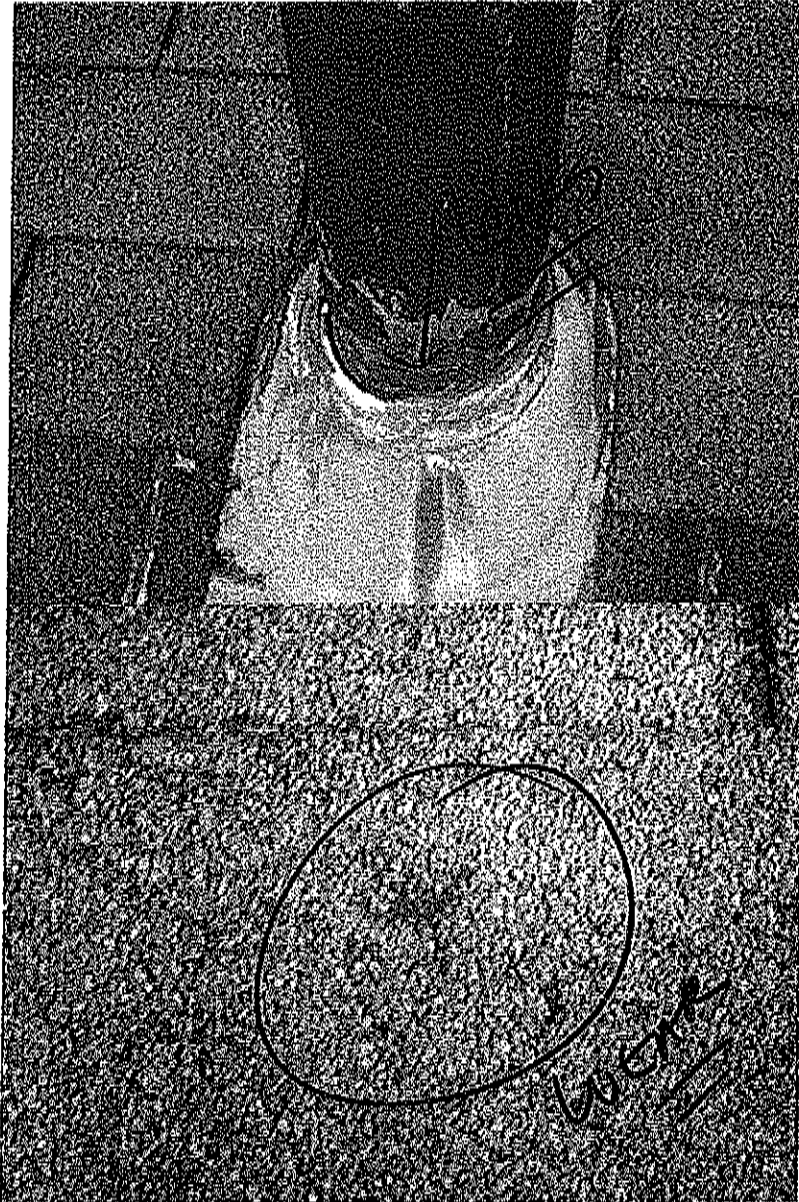
(Ask sellers for any information they may have that would detail the roofing materials age).
