**PHASE I ENVIRONMENTAL SITE  
ASSESSMENT**

**199.51-Acre Tract**  
Smith Road and Klutts Drive  
McLendon-Chisholm, Texas

**ALPHA REPORT NO. E05873**  
**September 16, 2005**

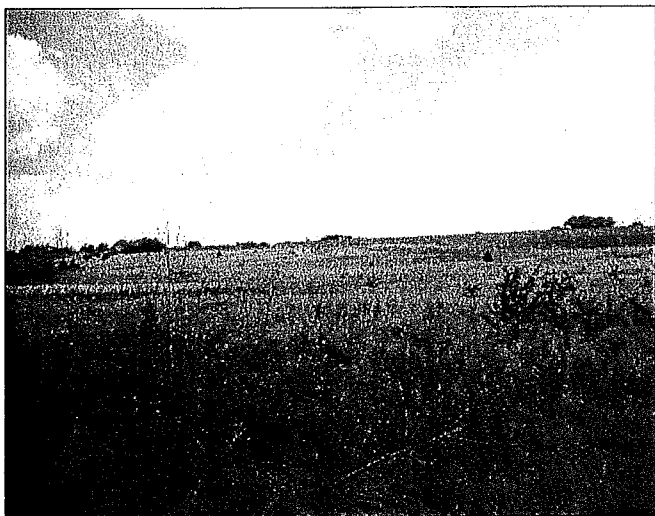
1.) General view of the northeast portion of the Site.

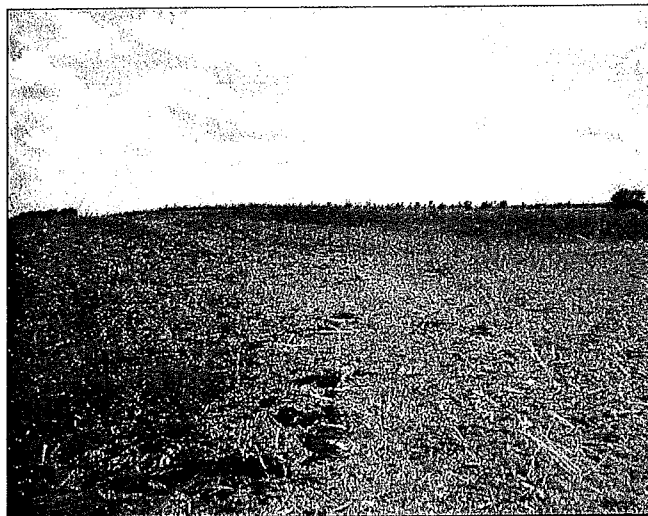
2.) General view of the southwestern portion of the Site.

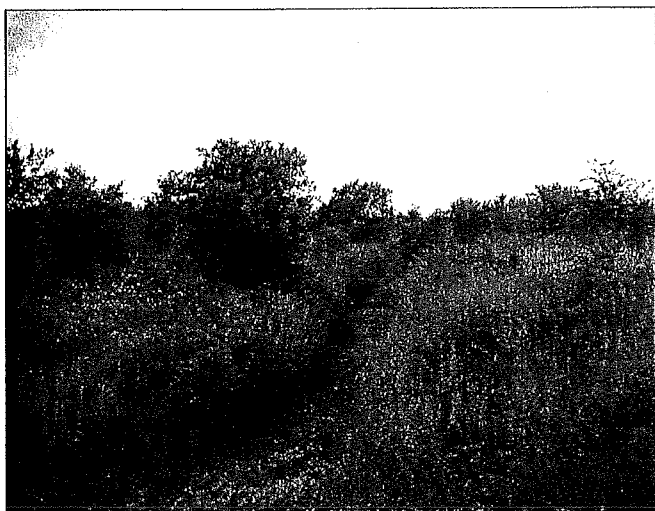
Dry creek beds were observed crossing the northeast and southwest portions of the Site. Some small stock-ponds were also observed on the Site. No visible evidence of other notable site features including quarries, pits or water wells was observed at the Site during the site inspection.

3.) View of the creek beds on the Site.

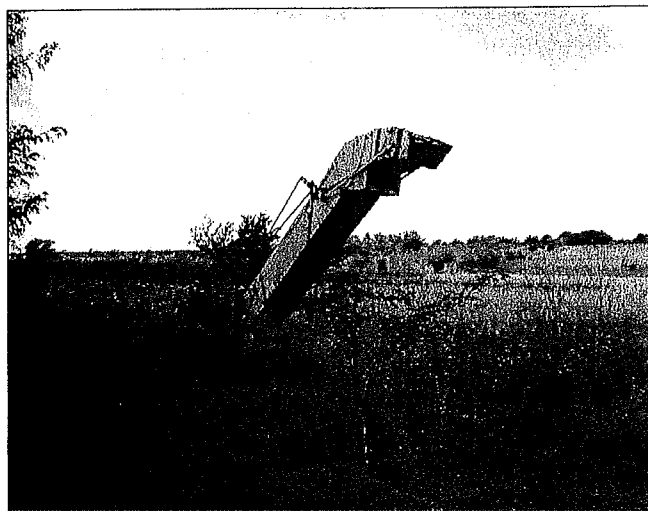
4.) View of the old farm equipment at the Site.

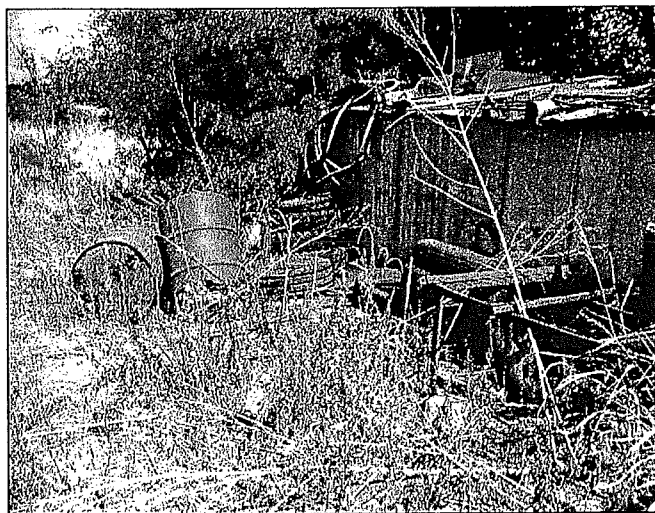
ALPHA observed several 55-gallon drums in the vicinity of the AST. The drums were filled with household-type trash and debris, and appeared to have been used as trashcans. Additionally, household-type trash and debris was observed within and around the on-site metal shed. No evidence of stains, leaks or spill was observed on or around the 55-gallon drums or metal shed.

No points of general municipal waste collection or dumpster type collection bins were observed on the subject Site. However, some trash and debris was observed on the south-central portion of the Site, located along Klutts Drive and the unpaved road that crosses the central portion of the Site. The debris consisted of general household waste, tires, lumber and old farm equipment. Most of the debris was contained or in the near vicinity of the on-site corrugated metal shed.

5.) General view of the corrugated metal shed with the trash and debris on the Site.

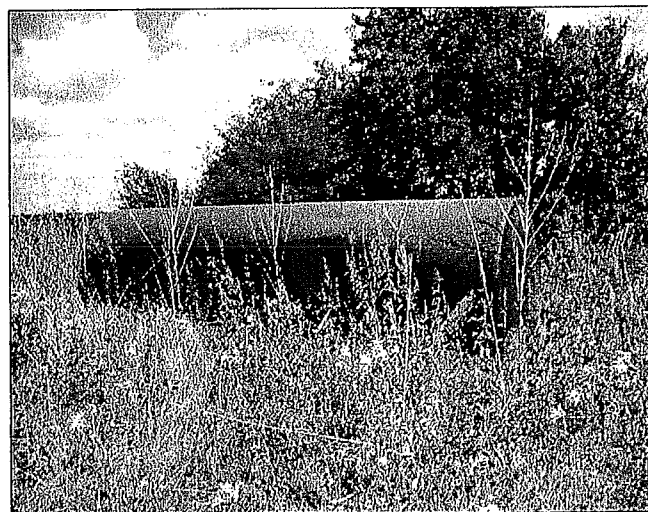
ALPHA observed one (1) approximately 2,000-gallon, farm-type AST located at the south-central portion of the Site, off Klutts Drive and an on-site unpaved road that crosses the central portion of the Site. The AST did not appear to be currently utilized, and was observed to be empty and stored on it's side. No evidence of stains, leaks or spills was observed on or around the AST.

6.) View of the empty AST at the Site.
