21.66 ACRES +/- PRINCE GEORGE COUNTY, VA

**Preliminary Soils Analysis and Infiltration Testing
Proposed On-Site Sewage Disposal System
TP430(0A)00-100-0, 430(0A)00-055-0 & 430(12)00-00A-0
South Crater Road
Prince George County, Virginia**

RE: Onsite Sewage Disposal System Feasibility Study
TP# 430(0A)00-100-0, 430(0A)00-055-0 & 430(12)00-00A-0
South Crater Road
Prince George County, Virginia
Project No. 2017234

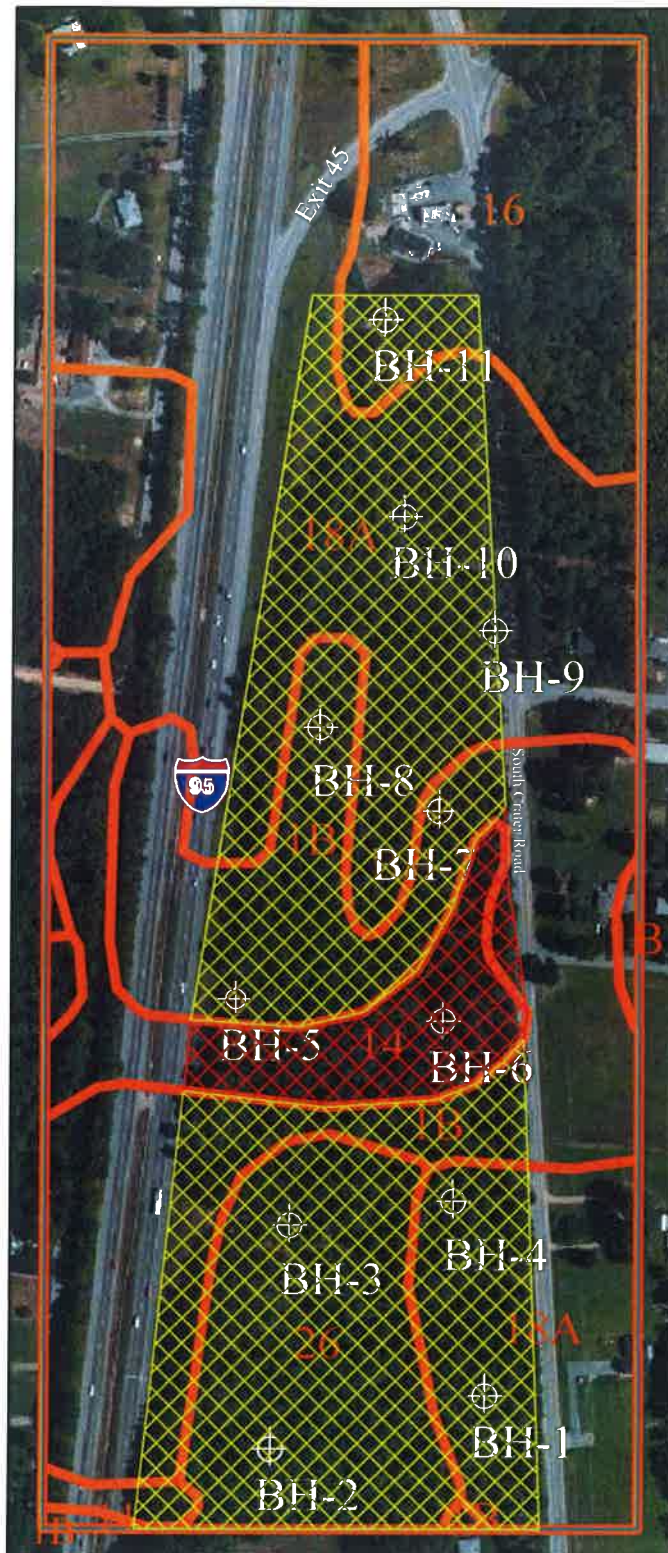
= Unsuitable

= Limited
 TL-2 or TL-3
 Pretreated

⊕ BH-1 HAND AUGER LOCATION

Feasibility Study -Exit 45, Prince George

It is our understanding that proposed development may include a commercial or retail facility with up to 6000gpd of wastewater usage. The soils encountered onsite were unsuitable for installation of a conventional septic tank effluent in-ground system due to shallow depth to seasonal groundwater. However, the soils across the vast majority of the site will support a TL2 or TL3 level of pretreated effluent dispersed to a shallow placed drip dispersal system. Based on our onsite soils evaluation and infiltration testing, hydraulic loading rates, and level of treatment, it is our opinion that the subject parcels should be able to service the following gallons per day of residential strength effluent (See table below). If wastewater strengths are elevated, additional treatment and/or larger dispersal areas may be needed. Our field testing indicates that installation depths across the majority of the site should not exceed 12 inches below grade and percolation rates of 90-110mpi should be utilized for sizing purposes.
