2006 23<sup>rd</sup> St.

## TEXAS OFFICIAL WOOD DESTROYING INSECT REPORT

## SCOPE OF INSPECTION

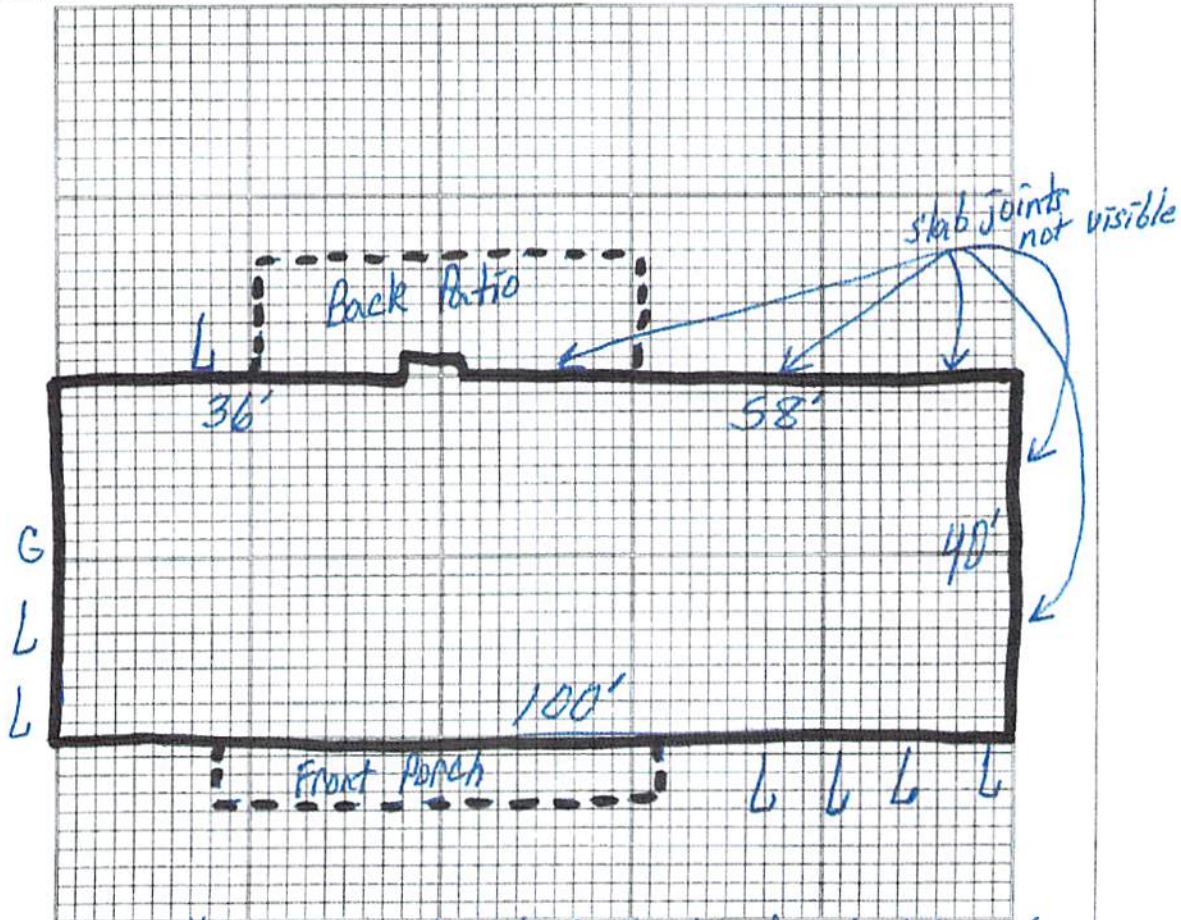
Diagram of Structure(s) Inspected

7B. Conducive Conditions include but are not limited to:  
 Debris under or around structure (K) ☐ Wood to Ground Contact (G) ☒ Formboards left in place (I) ☐ Excessive Moisture (J) ☐  
 Planter box abutting structure (O) ☐ Footing too low or soil line too high (L) ☒ Wood Rot (M) ☐ Heavy Foliage (N) ☐  
 Insufficient ventilation (T) ☐ Wood Pile in Contact with Structure (Q) ☐ Wooden Fence in Contact with the Structure (R) ☐  
 Other (C) ☐ Specify \_\_\_\_\_

The inspector must draw a diagram including approximate perimeter measurements and indicate active or previous infestation and type of insect by using the following codes: E - Evidence of Infestation, A - Active, P - Previous, D - Drywood Termites, S - Subterranean Termites, F - Formosan Termites, C - Conducive Conditions, B - Wood Boring Beetles, H - Carpenter Ants; Other(s) - Specify: \_\_\_\_\_

Additional Comments: Can't see much of slab due to lots of slab joints and high soil

9B. A preventive treatment and/or correction of conducive conditions as identified in 7A & 7B is recommended as follows:  
 Specify reason: Remove all high soil and debris from  
 Refer to Scope of Inspection Part J: slab so that at least 3 to 6 inches of slab is

visible  
around  
entire  
house.
