Subject: MacKay - Critical Slope Consultation
Parcel # 1455600052, Seattle, WA
QG Project No.: QG20-016

Appendix A. Site Region & Vicinity

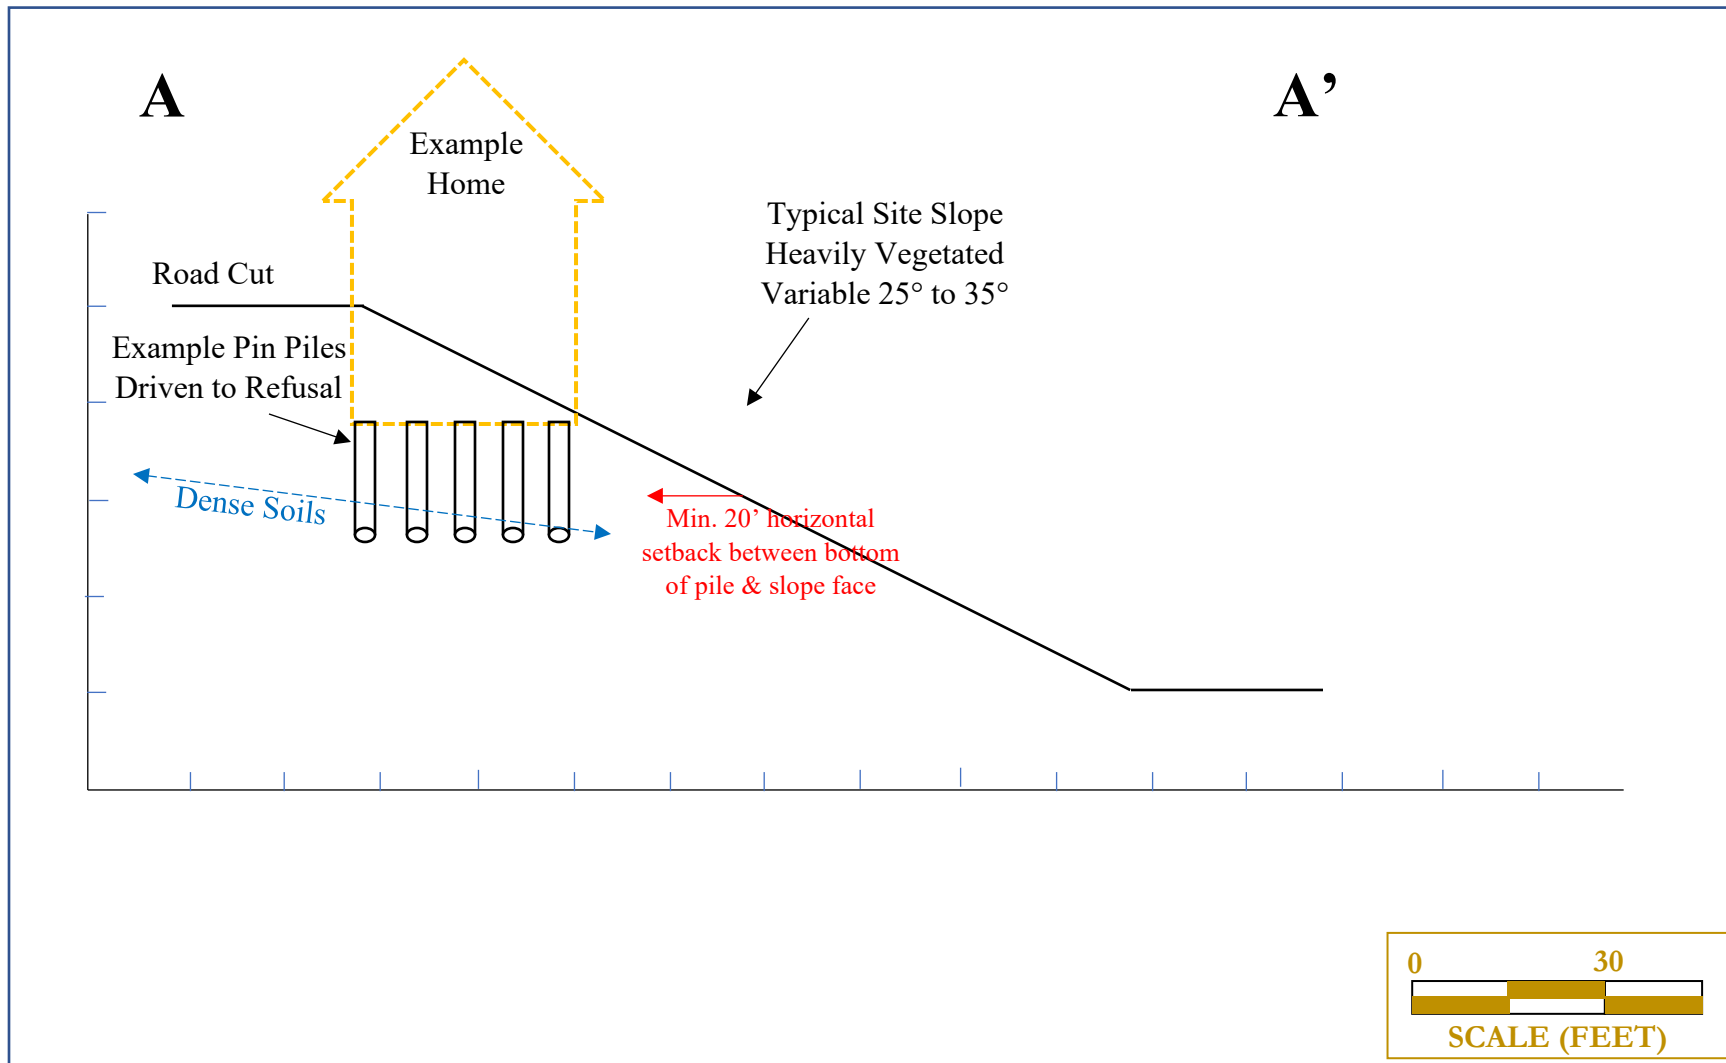
Figure 3

QG performed general site reconnaissance to observe and document any indications of localized surface degradation or large-scale slope instability. The project site is roughly trapezoidal in shape and almost entirely slopes downward to the east towards other parcels. The subject critical slope typically grades around 25 to 35 degrees for about 60 vertical feet, with some minimally oversteepened portions near the crest of the slope. The slope is generally wooded, and heavily choked with low lying brush and few fallen trees across the property. Some trees were partially tilted or bowed indicating some localized shallow soil creep. There were no significant signs of advanced erosional hazards across the accessible areas of the site. The toe of the slope was generally inaccessible due to the thick brush cover and sloped conditions, however portions were visible from a distance, and did not reveal any additional concern.

Slope Profile A – A'
Mackay CAO

QG recommends that piles be embedded to a depth that maintains a minimum horizontal slope face setback of 20 feet between their base and the adjacent surface of the main slope (See Appendix C). This setback is detailed schematically in Appendix C. QG does not recommend reducing the setback unless further site-specific foundation design efforts are undertaken to ensure building and slope stability is maintained.

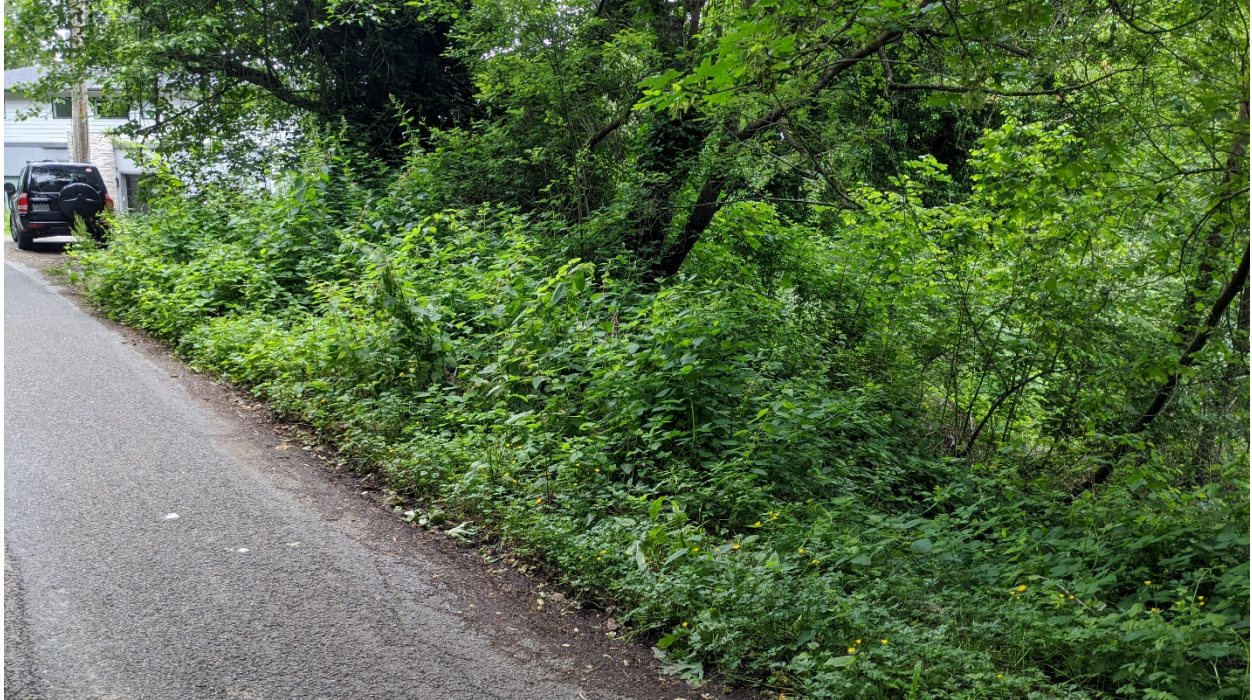
Photo 1. Typical upland site, adjacent to the road. Camera at west end of site facing north.

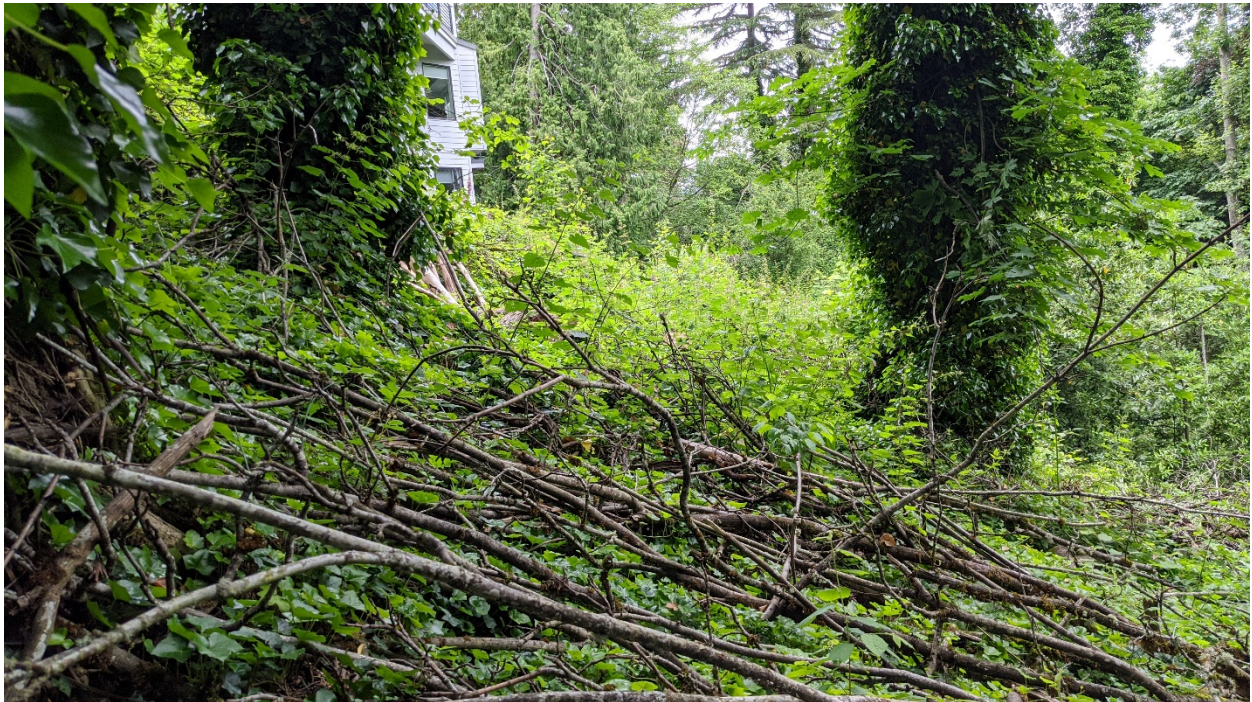
Photo 2. Typical slope conditions, well vegetated, lots of side cast debris.

- Avoid accelerating slope erosion and mass wasting due to human activity such as:
 - ✓ Adding side-cast such as dumping landscape debris or fallen trees on or above the slopes.
