MARX
WETLANDS
LLC

March 10, 2021

Re: Wetland Report: Airport Road & W. Herbison Road
Parcel 050-018-200-020-60 & 050-018-200-020-56
Section 18, DeWitt Township, Clinton County, MI

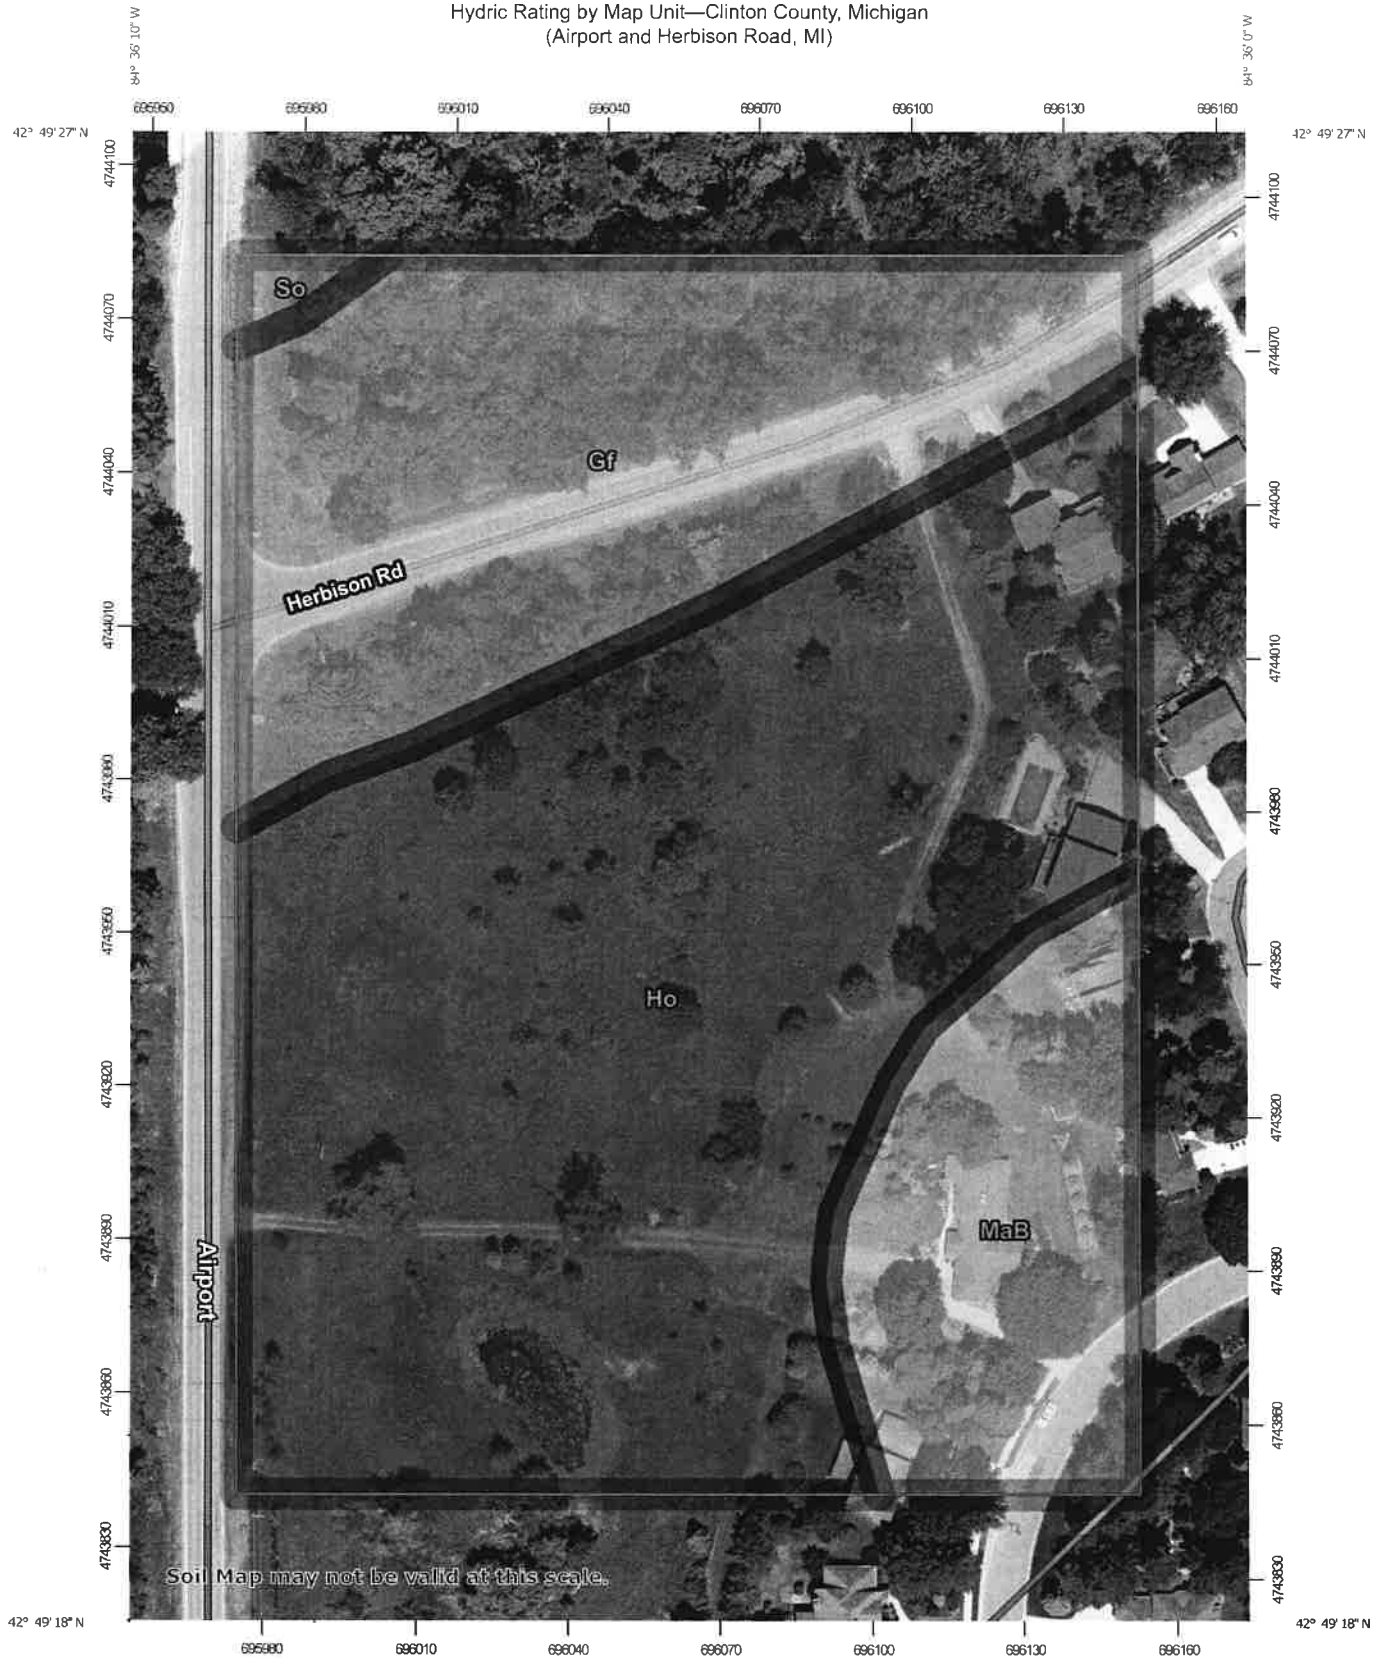
Hydric Rating by Map Unit—Clinton County, Michigan (Airport and Herbison Road, MI)

According to the U.S. Department of Agriculture Natural Resources Conservation Service (NRCS) *Web Soil Survey*, the Site contains two (2) main soil types: Gilford sandy loam, 0 to 2 percent slopes, gravelly subsoil (Gf; 95% hydric rating) and Houghton mucks, 0 to 1 percent slopes (Ho; 100% hydric

rating). These soil types are considered hydric soils, which generally corresponds to the delineated wetland areas (**Enclosure 1-Background Research**).

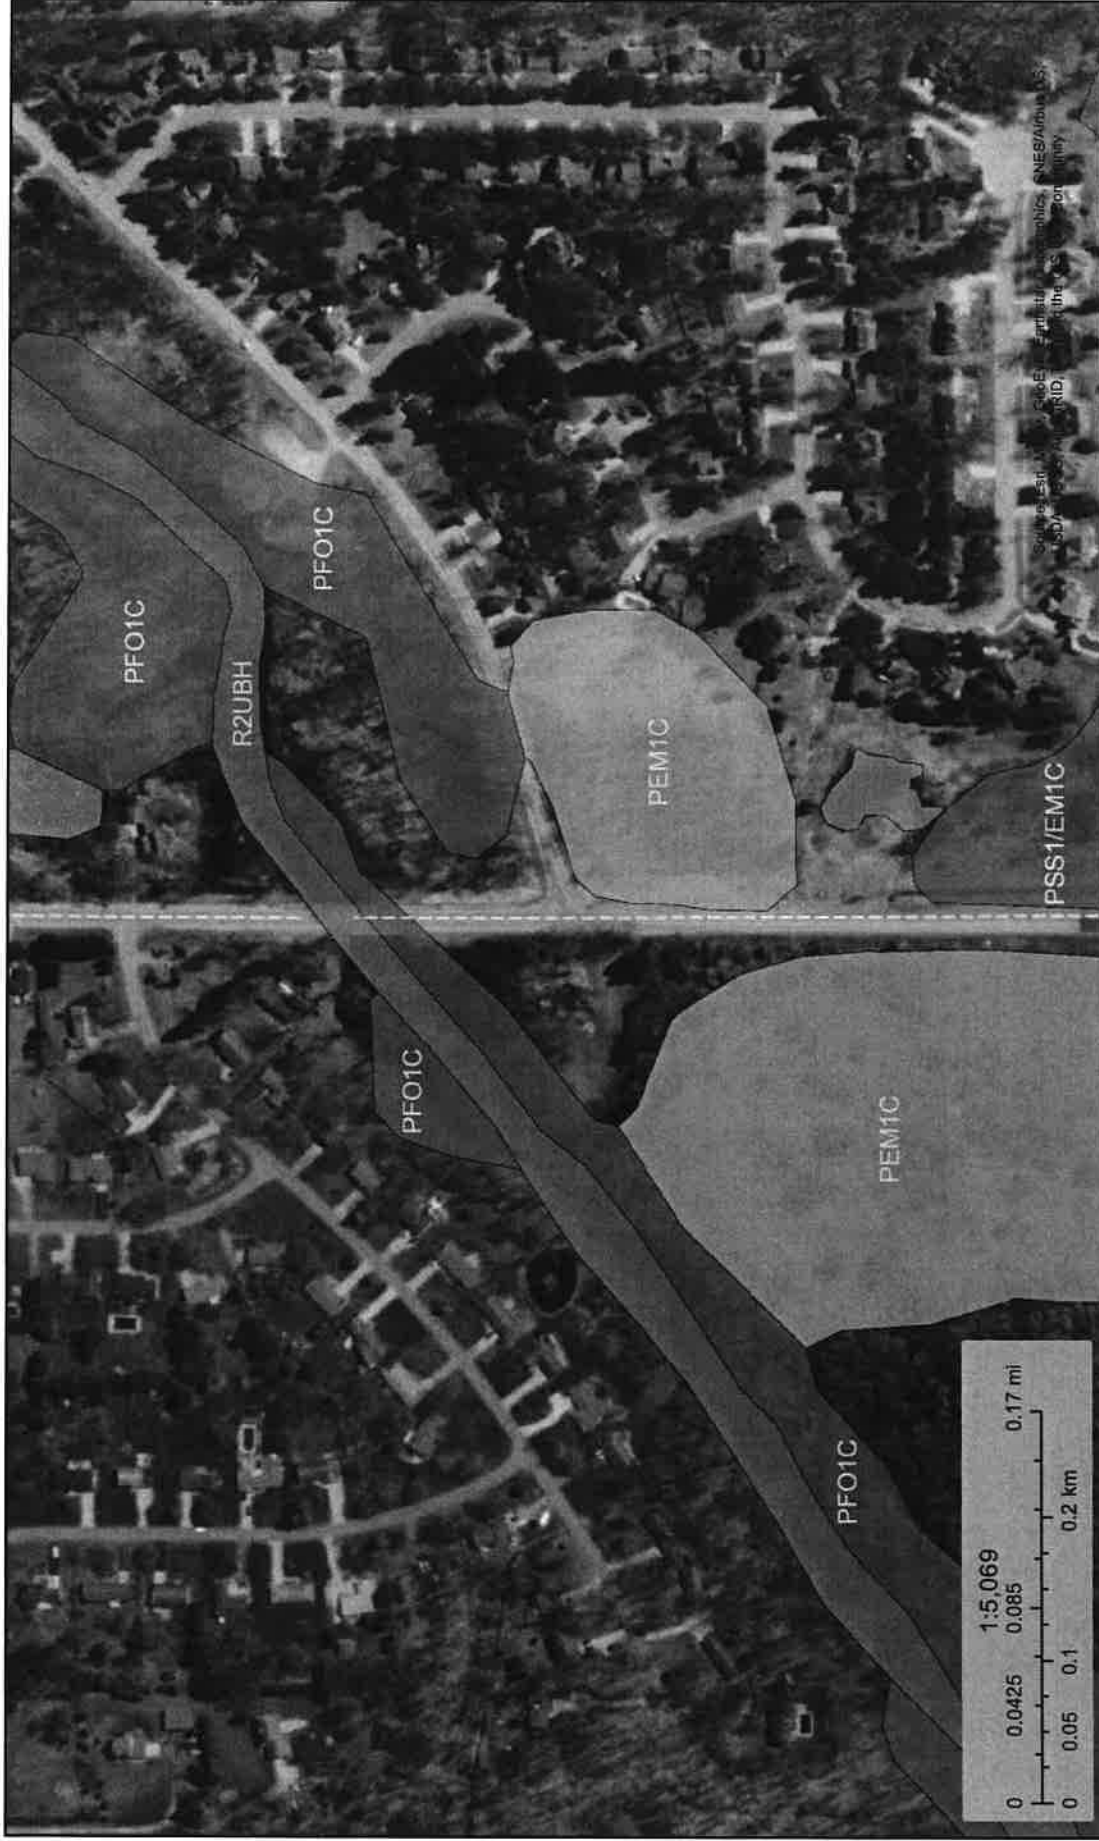
The National Wetlands Inventory (NWI) map indicates one (1) emergent wetland and an approximately 0.40-acre freshwater pond are likely within or along the perimeters of the Site (**Enclosure 1-Background Research**). The delineated wetlands generally correspond to the NWI mapped potential wetlands.

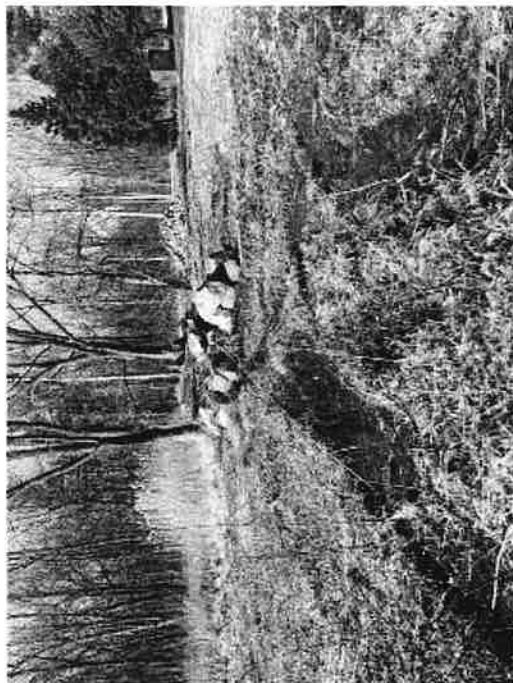
1) A typical view of upland lawn identified West Herbison Road.

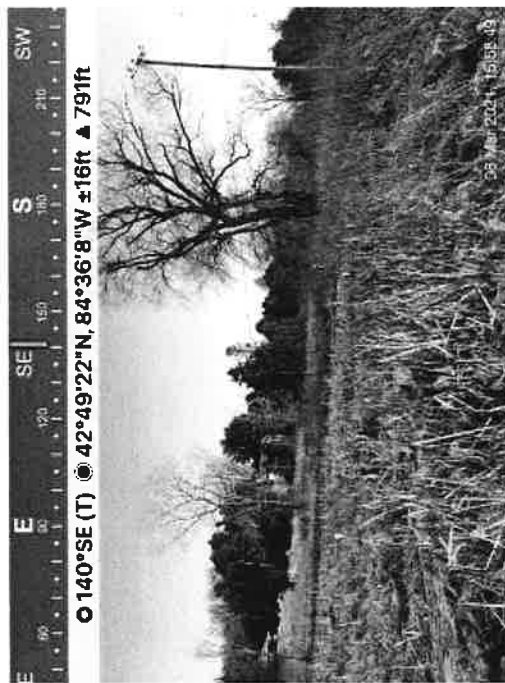
3) View of Wetland A, emergent wetland, identified within the majority of the northern parcel.

Wetlands A and B are primarily emergent wetlands with scattered trees and shrubs. Wetland A is mainly contained within the property; however, extends north and drains into the roadside ditch (south side of W. Herbison Road). Wetland B extends south off-site and adjoins a freshwater pond and presumably the Loesch Drain. Prevalent herbaceous vegetation observed include strict sedge (*Carex stricta*), reed canary grass (*Phalaris arundinacea*), cattails (*Typha spp.*), sensitive fern (*Onoclea sensibilis*), late goldenrod (*Solidago gigantea*), and calico-aster (*Symphyotrichum lateriflorum*). Less

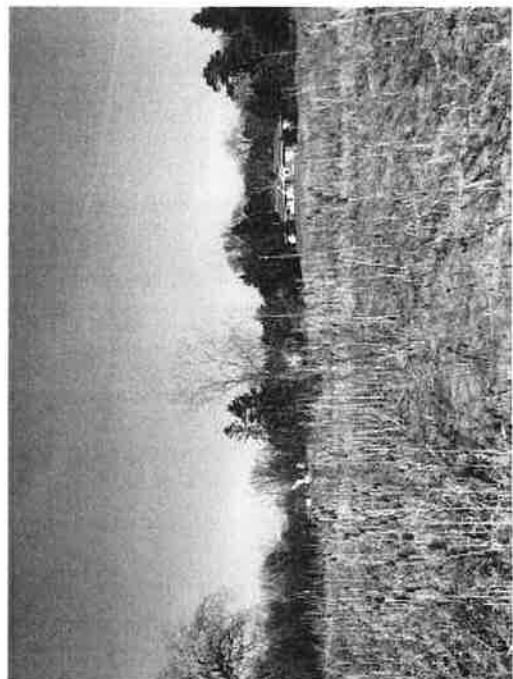
2) Another view of upland field.

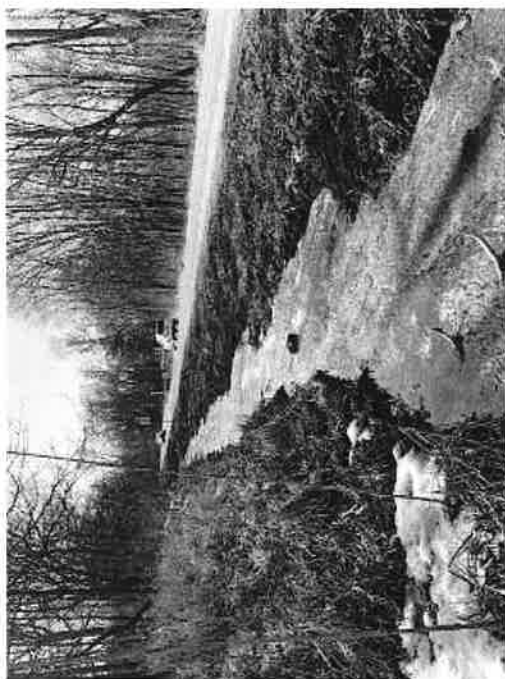
4) Roadside ditch where Wetland A drains into the storm system.

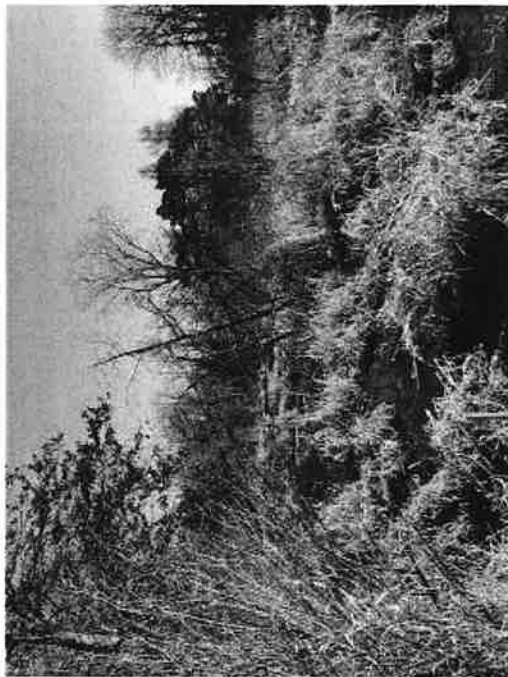
5) View of Wetland B, extending off-site into a large, emergent wetland area.

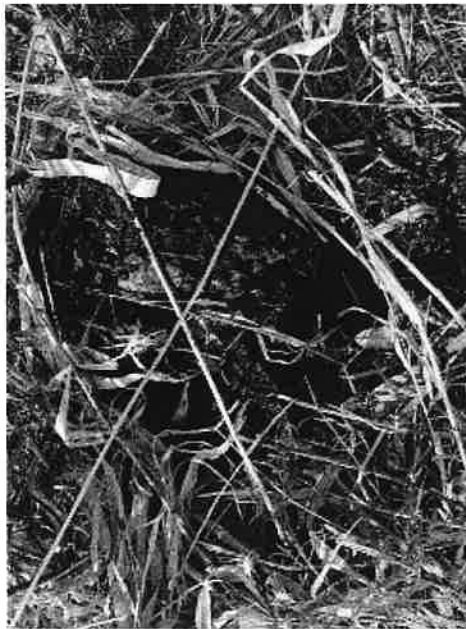
7) Typical muck soils observed in wetland areas.

Hydric soil indicators were observed within the soil sample plot taken in the on-site wetlands. Adjacent upland soil sample pits were also taken as well. Please refer to the *USACE Wetland Determination Data Forms* (**Enclosure 3**).

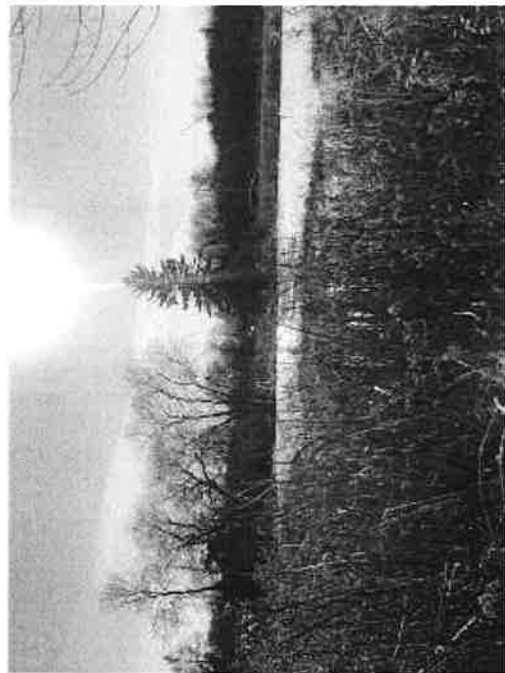
6) Another view of Wetland B and open water pond located along the southern boundary of the site.

Part 301, Inland Lakes and Streams, states that a feature is considered a regulated watercourse by the EGLE if it possesses a defined bed, bank, and evidence of continued flow or a continued occurrence of water. **No watercourses or ponds meeting Part 301 definitions were identified within the Site boundaries. The freshwater pond that adjoins Wetland B will likely be considered a deep-water wetland.**

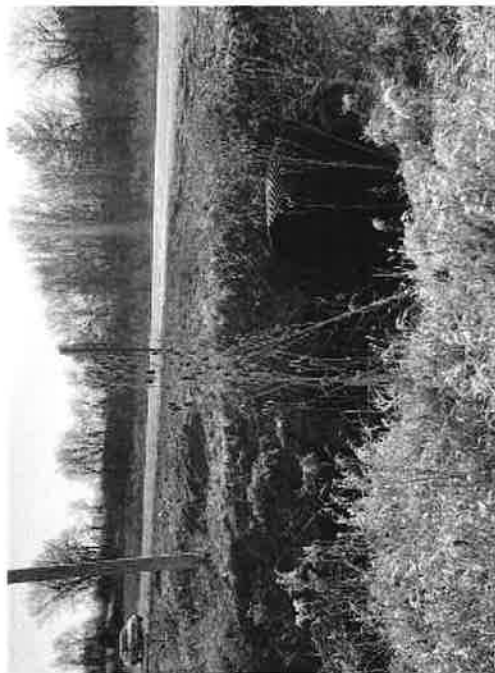
8) View of off-site county drain (Loesch Drain).

Although, the Loesch Drain is located off-site to the southwest, it is a Clinton County drain, which may have a permanent drain easement. Typically, no permanent structures can be built within county drain easements. The drain easement is used for any maintenance work or emergency access to the drain. Some activities can be permitted within drain easements through the county drain commissioner. **Be sure to contact the Clinton County Drain Commission office to see if site development requires any approvals or permits through Clinton County.**

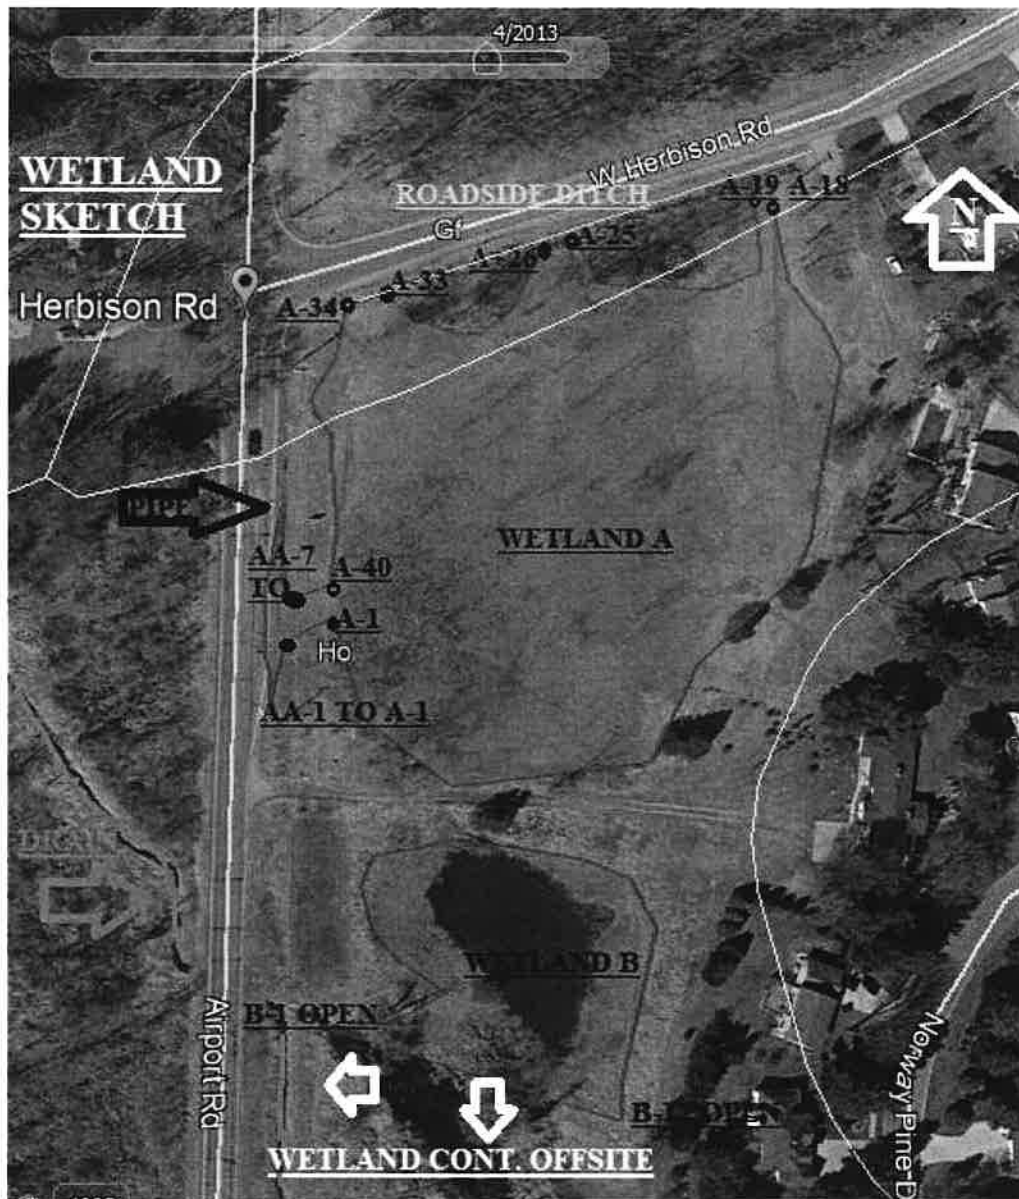
Two (2) (Wetlands A and B) were identified within the Site. Wetland B adjoins an open water (pond). No watercourses were identified within site boundaries. Refer to the *Wetland Sketch* (**Enclosure 3**).

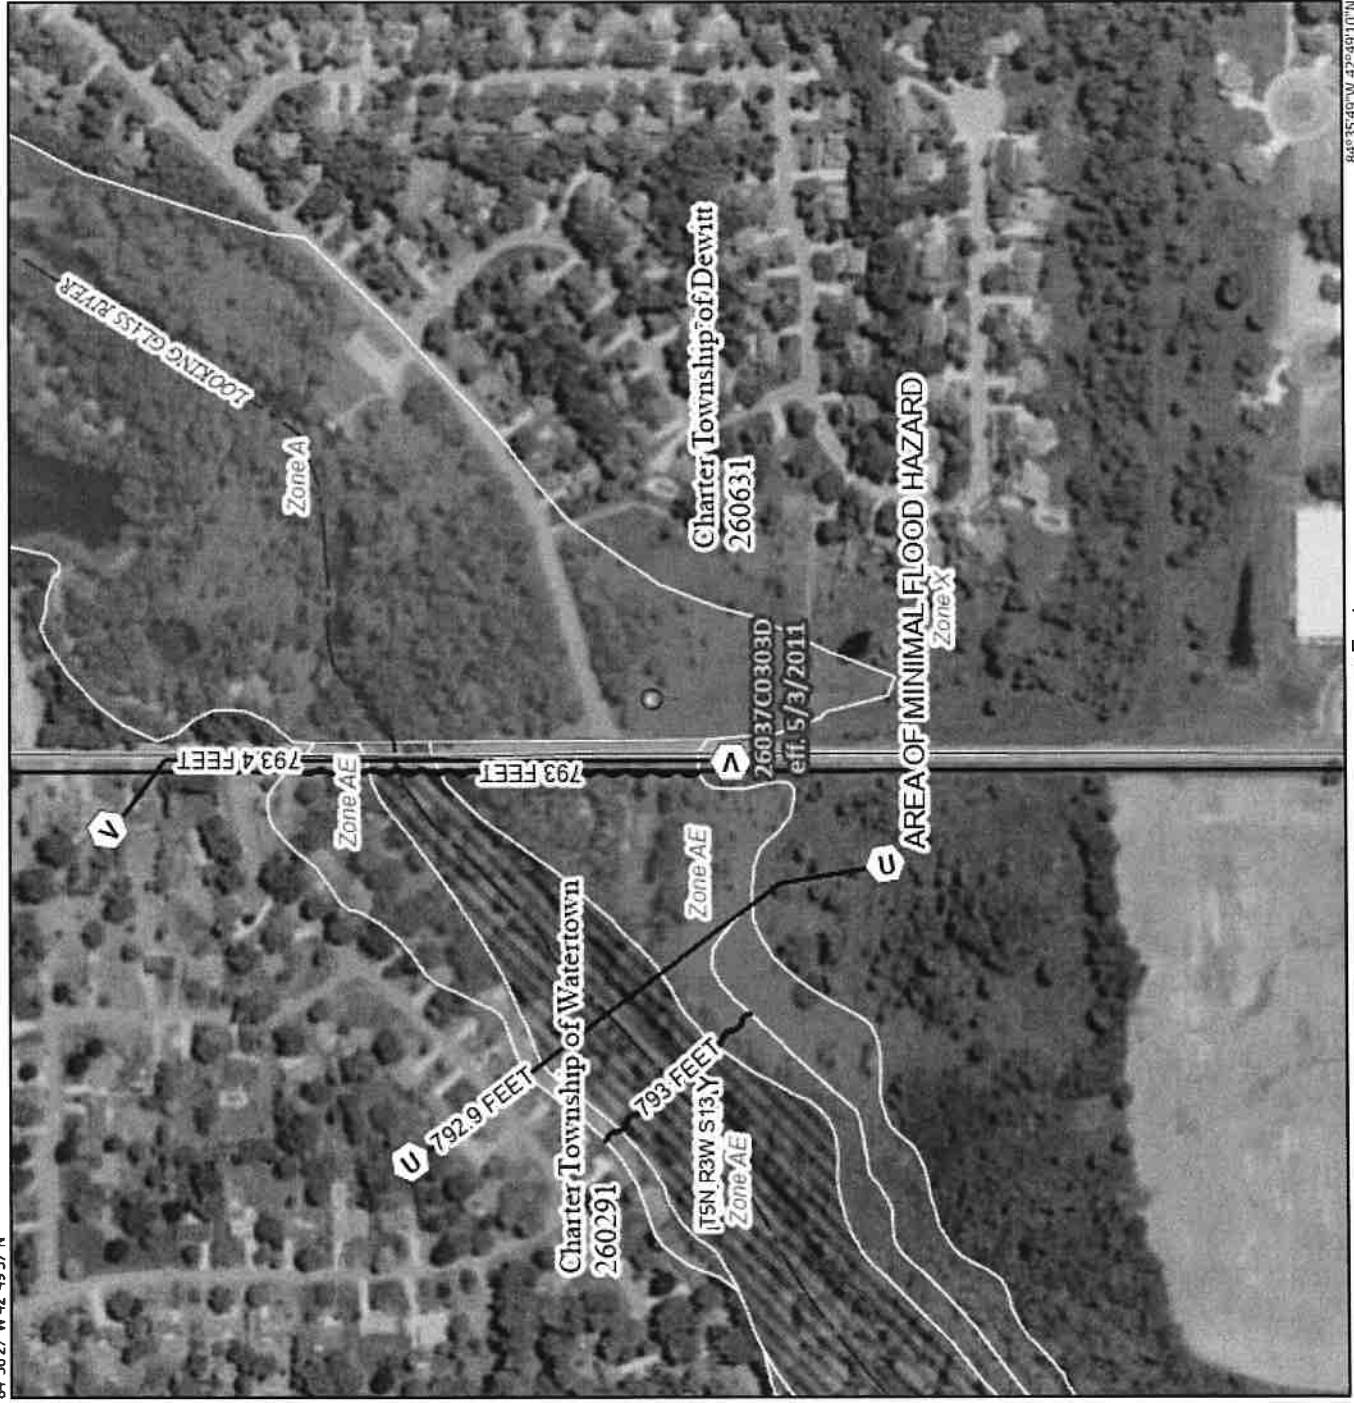
National Flood Hazard Layer FIRMette

Part 31, Water Resources Protection, of the NREPA regulates activities within the 100-year floodplain and floodway of a river, stream, or drain, and within the floodplain of any watercourse with an upstream drainage area of two square miles or larger. A Part 31 permit is required for construction within a regulated floodplain or floodway. MW's preliminary review of FEMA FIRM Panel No. 26037C0303D, (eff. 05/3/2011) revealed that the Site contain a

special flood hazard area mapped as Zone A (without available base flood elevations) associated with the 100-year floodplain of the Looking Glass River. The remaining areas of the Site lie within Zone X, an area with minimal flood hazards (Enclosure 4). **A floodplain elevation request or pre-application meeting through the EGLE can assist with the project development process and/or floodplain permitting, if applicable.**
