36388 LESLIE LN

OREGON FARM & HOME BROKERS

GENERAL INFORMATION

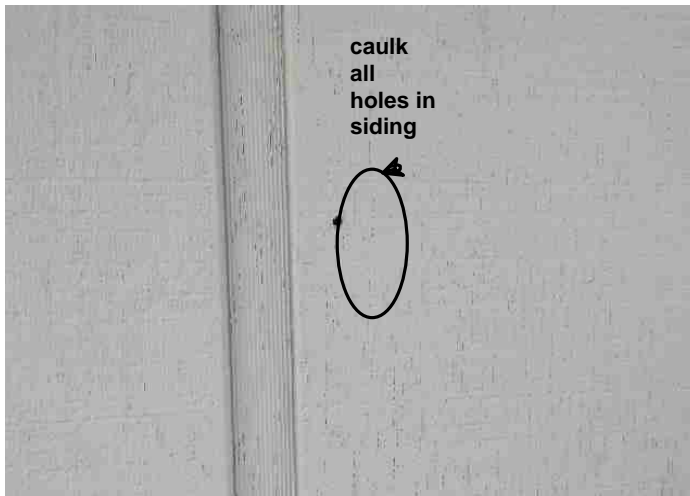
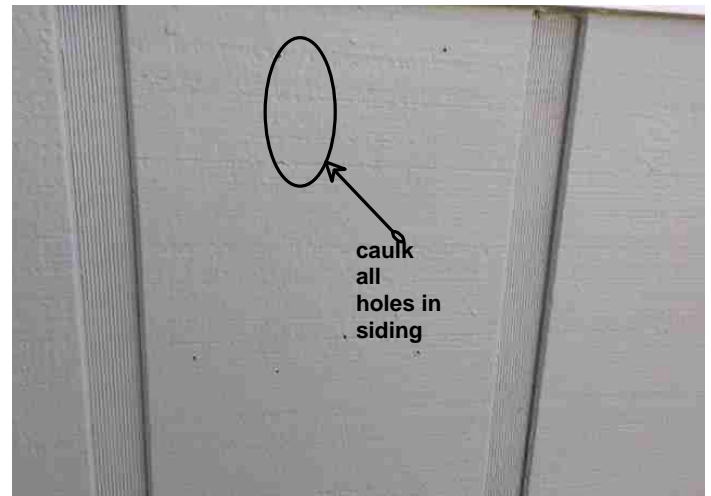
There are holes in the siding that should be caulked to prevent moisture damage.

- There are holes in the siding that should be caulked to prevent moisture damage.

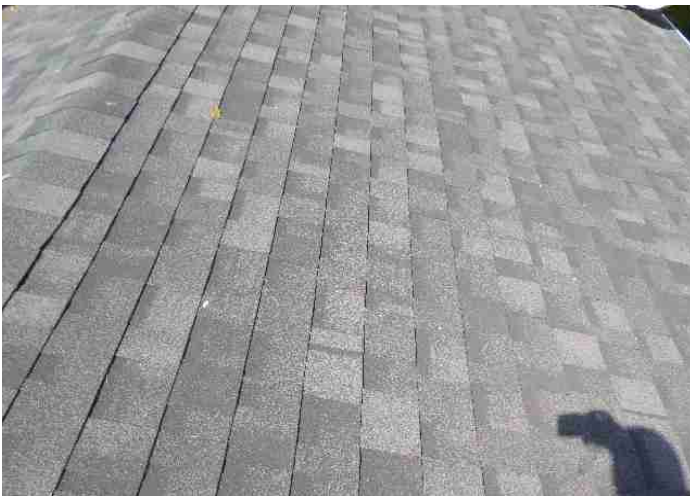
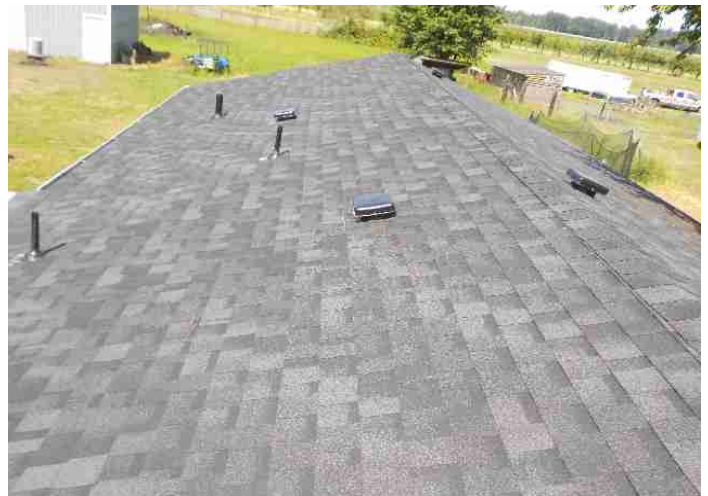
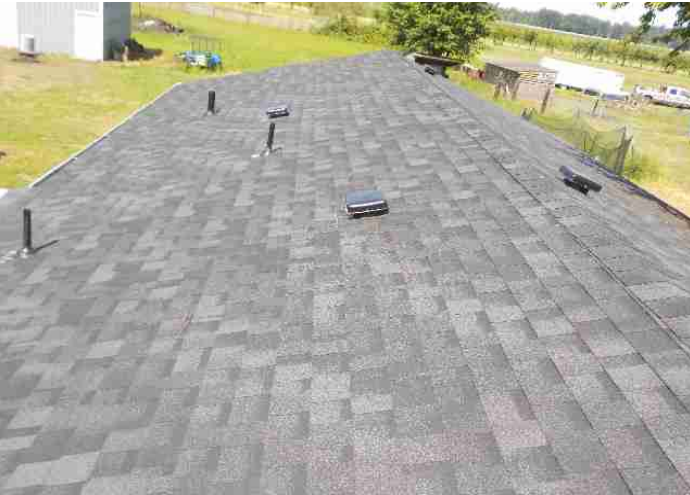
The roof appears to be relatively new and is not the original roof - *Continued*

The roof appears to be relatively new, and is not original. However, this is just an estimate and you should request the installation permit from the sellers, which will reveal its exact age and any warranty or guarantee that might be applicable.

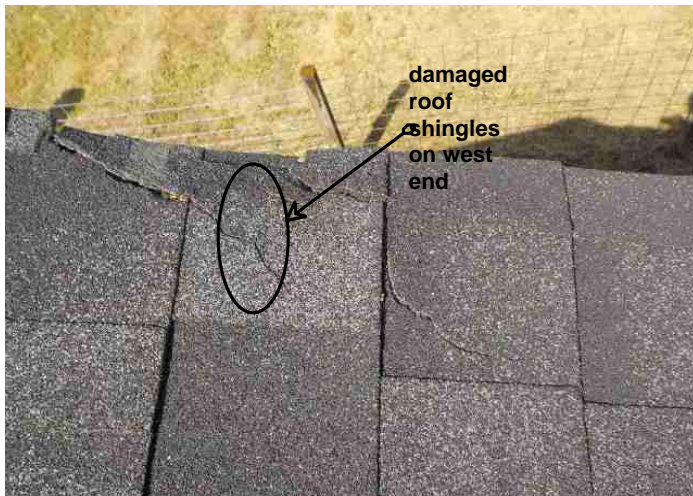
Roofing Material

There is damaged roofing shingles that should be evaluated by a licensed roofing contractor

- There is damaged roofing shingles that should be evaluated by a licensed roofing contractor

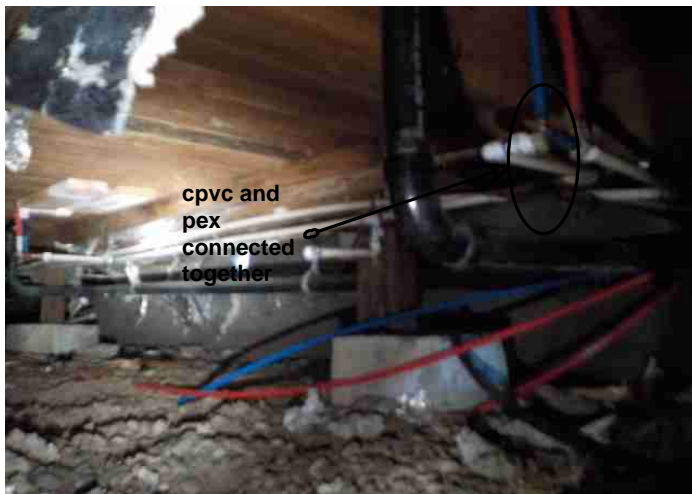
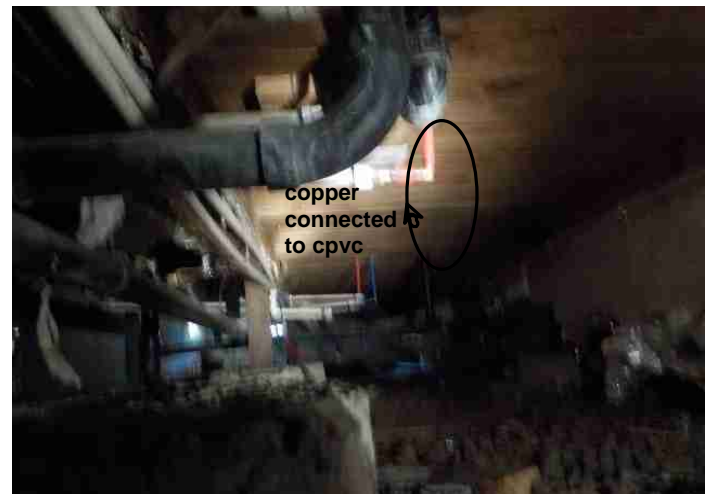
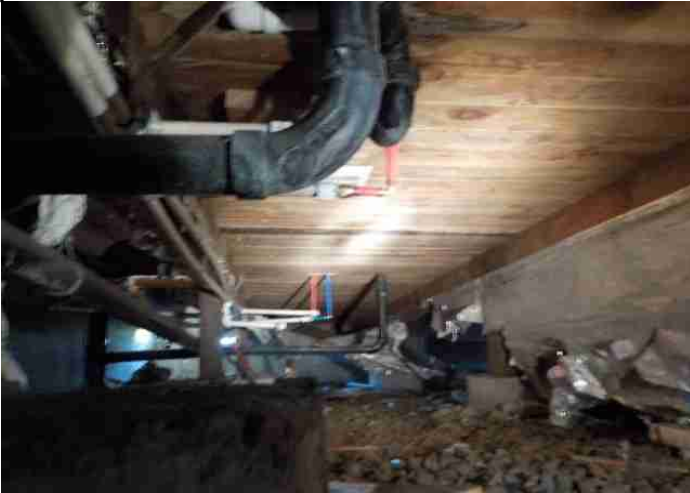
There are 3 different types of water supply pipes - *Continued*

The supply water pipes do not appear to be installed by a professional plumber.

- There are copper, CPVC and pex supply water pipes in the crawl.
The supply water pipes do not appear to be installed by a professional plumber.
I recommend the plumbing and the connections be evaluated by a licensed plumber.

I recommend the plumbing and the connections be evaluated by a licensed plumber.

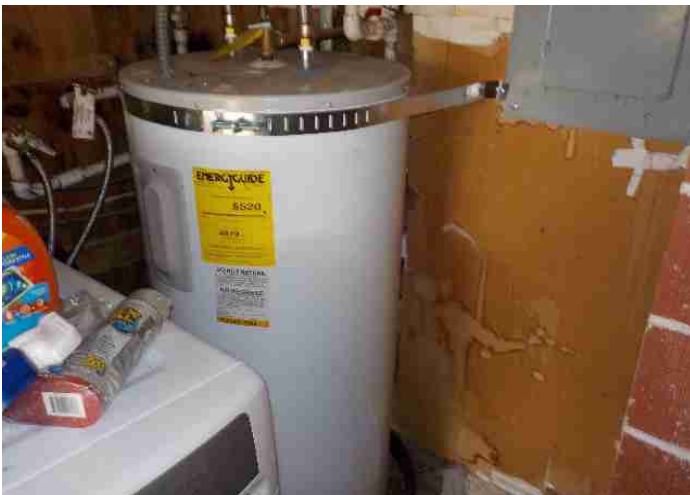
Hot water is supplied by a __8__ year old __50__ gallon water Heater located in the garage.

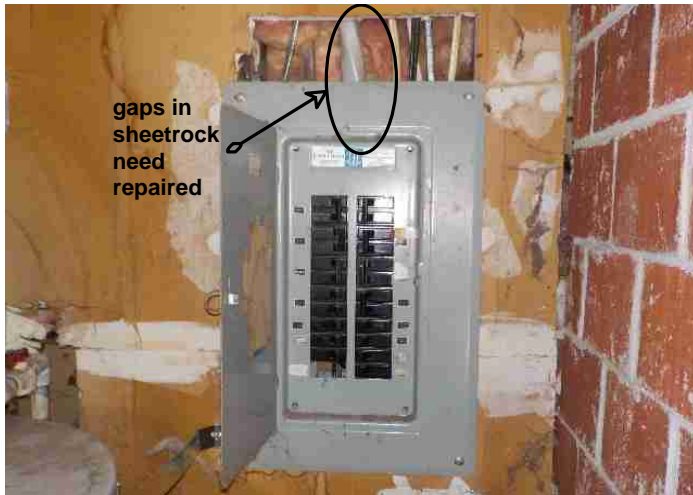
The gaps in the sheet rock over the panel should be repaired - *Continued*

The interior panel cover has voids, or open knock-outs that should be covered, could prove to be hazardous to small children.

- The interior panel cover has voids, or open knock-outs that should be covered, could prove to be hazardous to small children.
- The gaps in the sheet rock over the panel should be repaired.

The gaps in the sheet rock over the panel should be repaired.

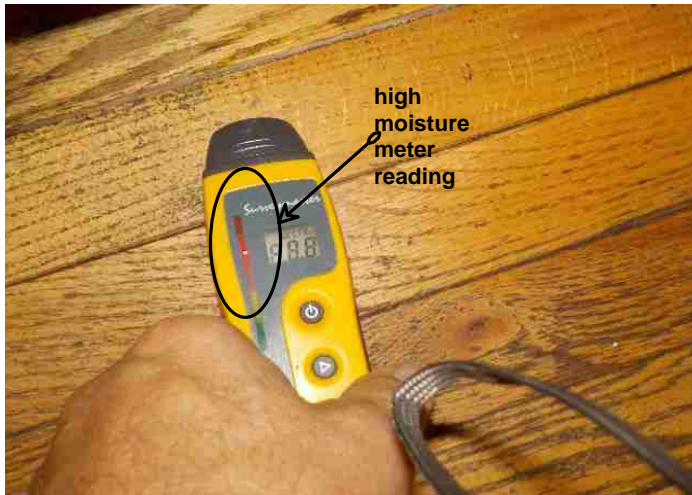
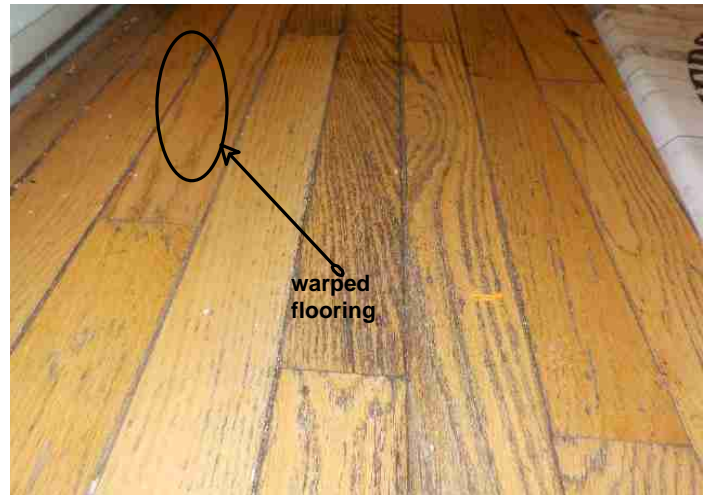
There is high moisture reading on the floor - *Continued*

There are high moisture reading and warped flooring in front of the sink in the kitchen.
I recommend the kitchen floor be evaluated by a licensed contractor.

- There are high moisture reading and warped flooring in front of the sink in the kitchen.
I recommend the kitchen floor be evaluated by a licensed contractor.

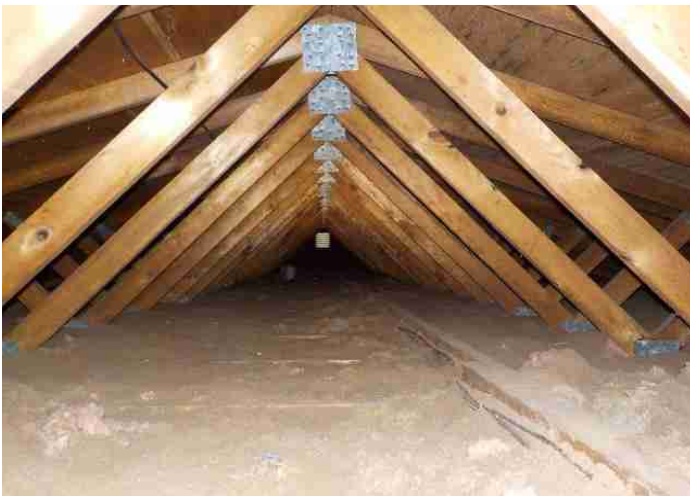
We have evaluated the attic in compliance with industry standards, and found it to be in acceptable condition.
