2055 CR 178  
Purmela, TX 76566

# INSPECTEXAS

2055 County Road 178 West  
Purmela, TX 76566

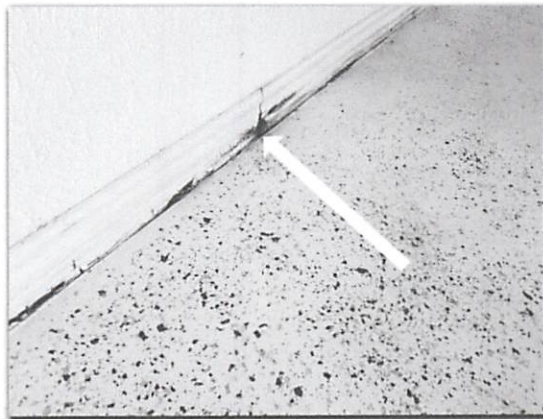
There is moisture damage on the wall between the garage and screened porch. The source of the moisture was not determined.

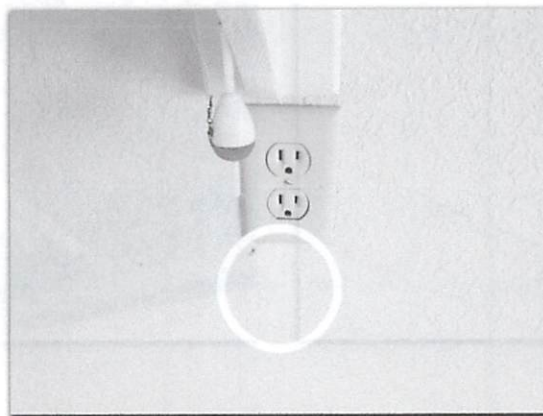
There is minor moisture damage under a receptacle in the garage beneath the fishing pole rack. The source of the moisture was not determined.

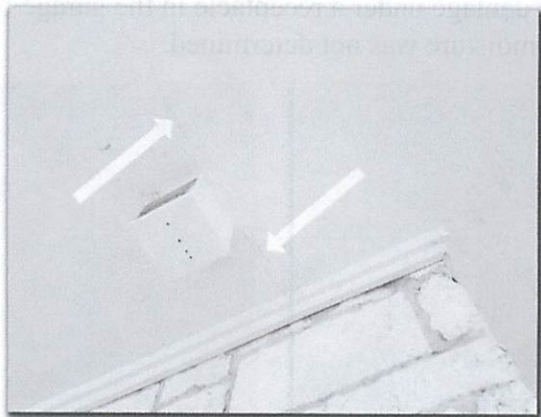
There is some cracking and drywall tape separation on the upper deck walkway ceiling. These pictures are typical.

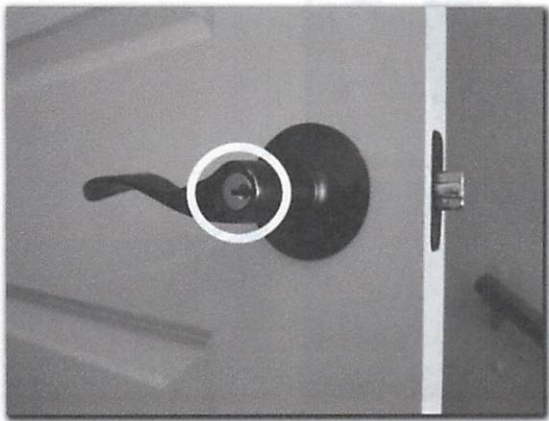
The attic door should be locked to prevent unauthorized access which could lead to property damage and/or personal injury.

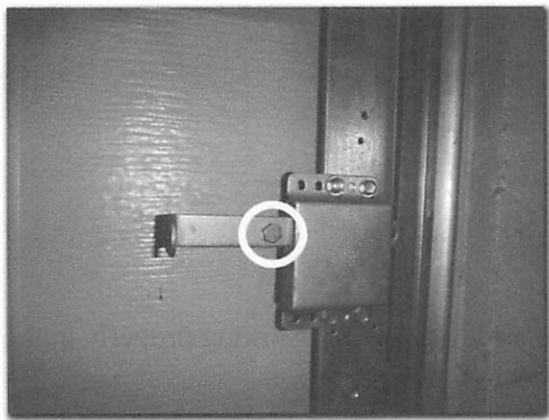
When an automatic garage door opener is present, the mechanical lock should be disabled to prevent potential motor damage and/or an electrical fire hazard. An example of a disabled lock is shown in the picture on the left.

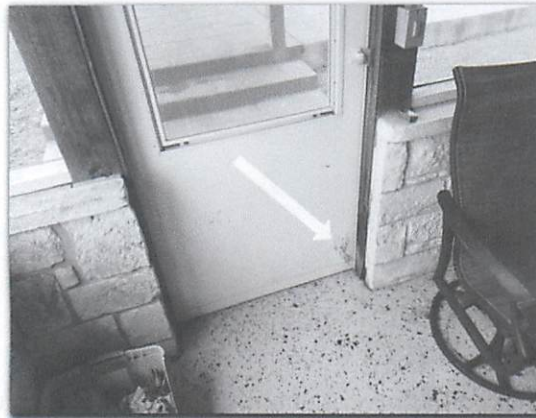
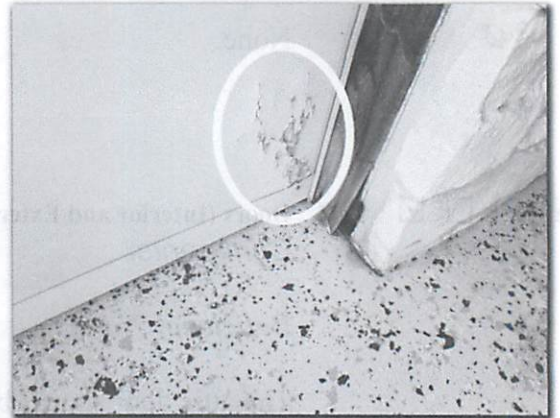
There is moisture damage on both of the doors to the screened porch. The arrow indicates the general location and the the circle shows a close up of the damage.

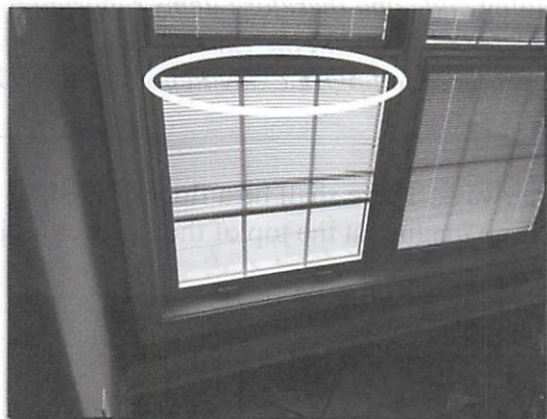
One of the screens next to the exterior kitchen/dining room right side door is slightly damaged.

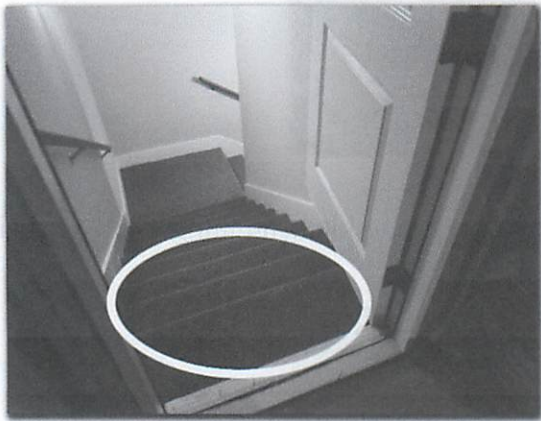
R311.7.6 Landings for stairways. There shall be a floor or landing at the top and bottom of each stairway. There is no landing at the top of the stairway going into the attic.

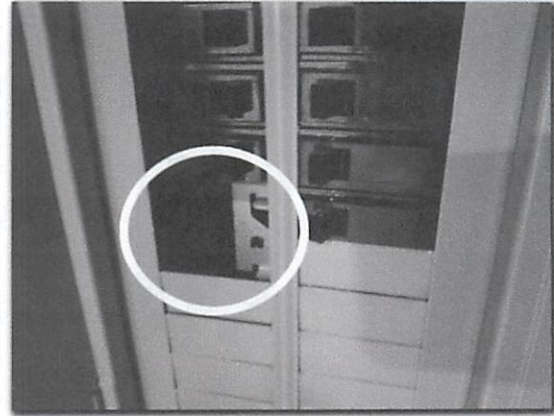
*E3404.6 Unused openings shall be closed to afford protection substantially equivalent to the wall of the equipment.*

The panel box in the house is no longer allowed in a clothes closet. "BC".

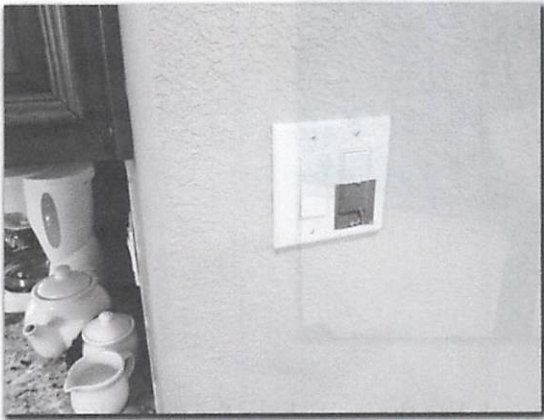
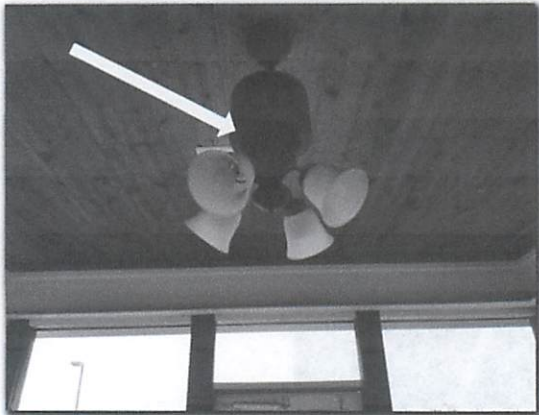
There are fan blades missing on the fixtures in the screened porch and outdoor BBQ area.

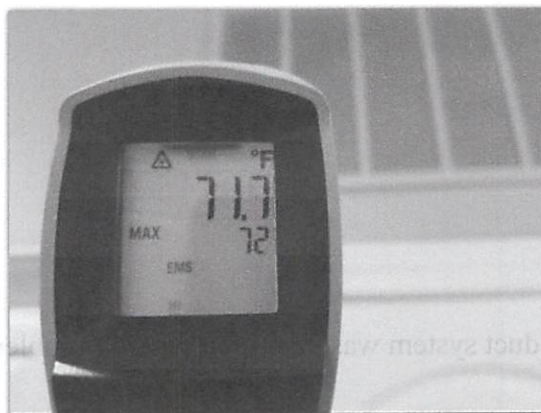
Upstairs

The air conditioner was inspected and tested and the temperature difference between the return and supply air was at least 15 degrees which is good.

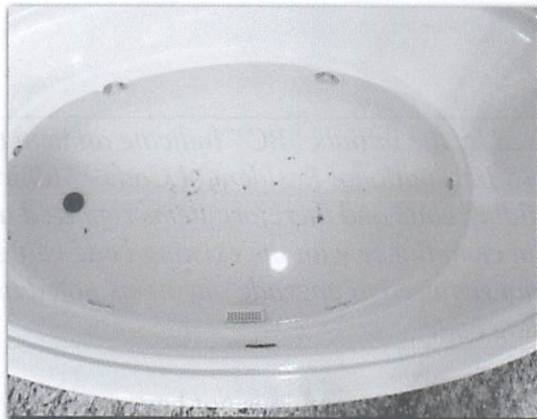
There is debris in the master bathroom jacuzzi tub from testing the system. This is usually due to lack of use and not indicative of a problem..

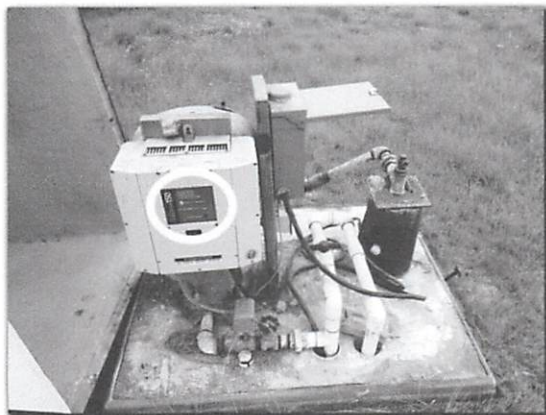
The water well on the right side of the home by the utility pole did not work. The panel box indicated "Error" on it.

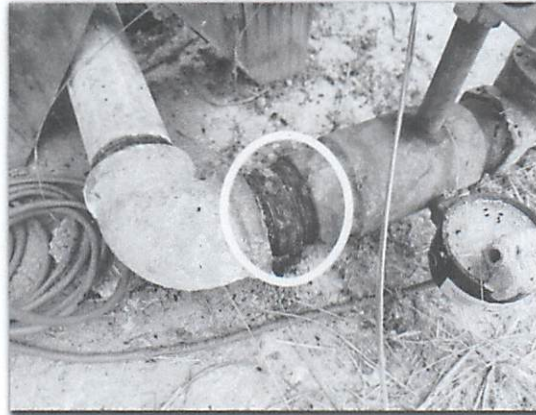
The valve handle and iron fittings are quite rusted.
